**Vincent House,
Vincent Drive, Birmingham
Archaeological Evaluation
2004**

Project No. 1197

July 2004

By Mary Duncan

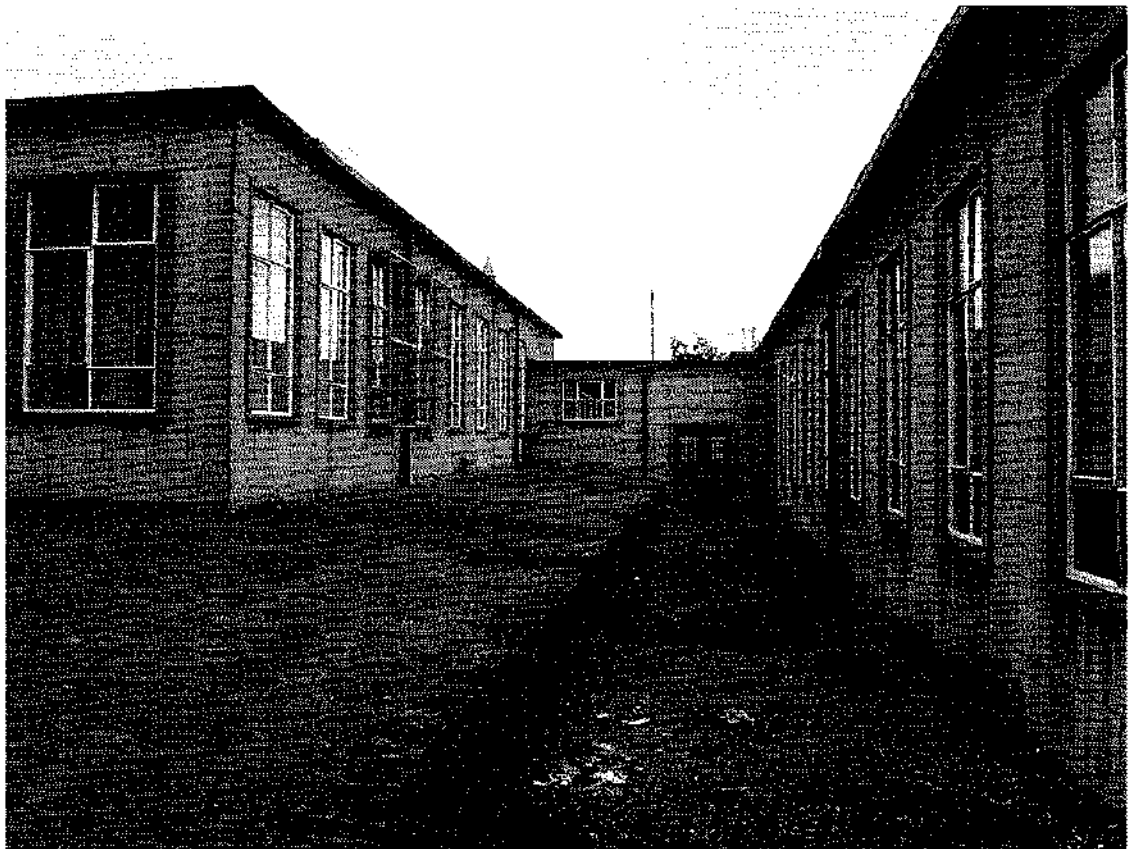
Plate 2

A brick terrace retaining wall (Plate 2) is approximately equidistant between Blocks A and B. The height of this terrace (approximately 0.7m) is approximately similar to the depth of overburden overlying the subsoil in Test-pit 2. At the southeastern end of Block B (Test-pit 2) some horizontal stratigraphy may have been removed, and some truncation of features cutting the subsoil may be predicted. At the northwestern end of the block (Test-pit 1) all horizontal stratigraphy will have been removed, and significant downcutting to features cutting the natural subsoil is likely to have occurred.

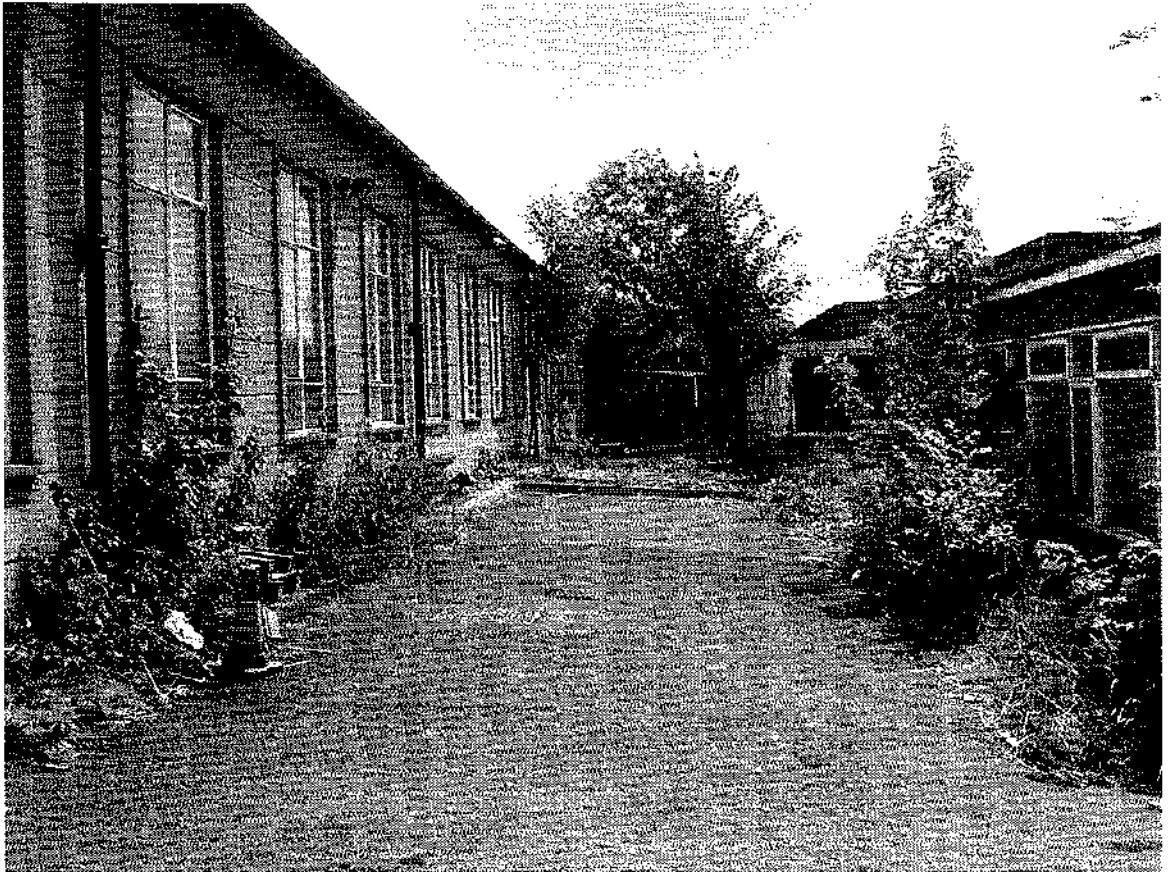
Plate 3

- 1 Block A and SAM to northeast, view south
- 2 Change of level between Blocks A and B, view east
- 3 Paved area between Block C and Garage, view east
- 4 Blocks A-B and associated driveway, view south
