**Blackladies Farm, Brewood,  
Staffordshire**

**Archaeological Building  
Recording and Watching Brief  
2004**

Project No. 1223  
March 2006

By Kate Bain and Malcolm Hislop

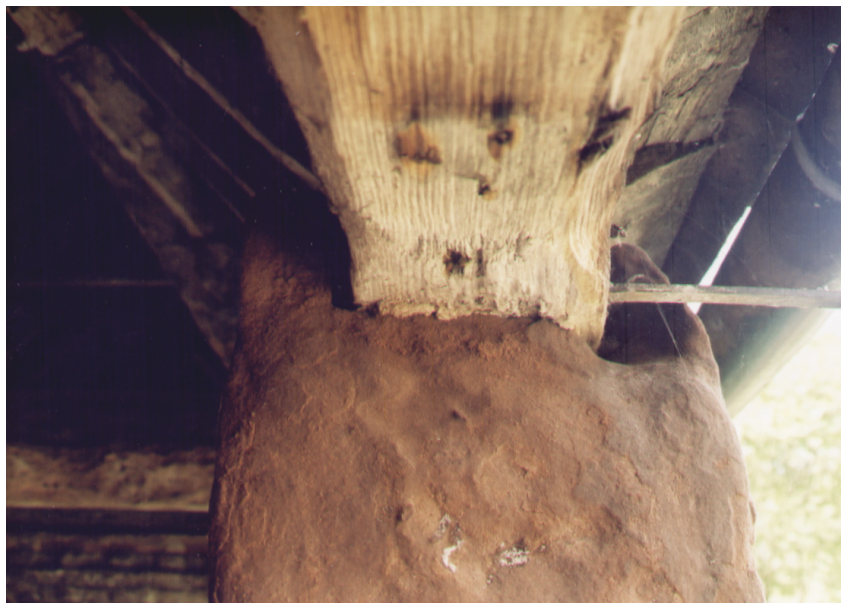
Plate 3

1. The building from the north
2. The building from the southwest
3. Shelter shed pier from the southwest
4. Shelter shed pier detail from the northeast
5. Junction between shelter shed and loose box
6. Shelter shed interior from the northeast
7. Shelter shed interior from the southwest
8. Shelter shed roof truss from the northeast
9. Shelter shed hip rafter from the northwest

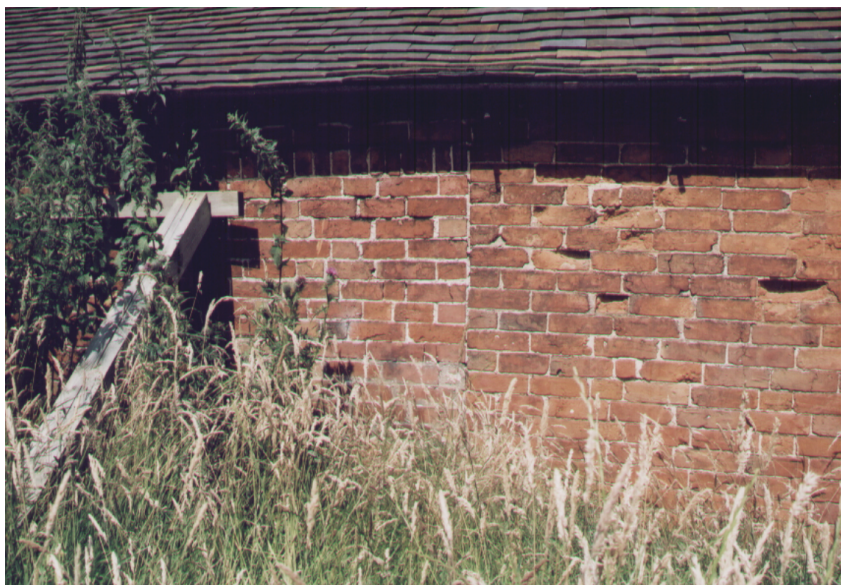
Plate 5

The two loose boxes were housed in a building attached to the right-hand side of the shelter shed and under the same roofline. To the rear (southeast), the junction of the two phases was marked by a vertical joint in the brickwork (Plate 5). The front of the loosebox extension had been much altered, and contained at least three phases of brickwork. The earliest of these was a c. 1m high area of 8¾" x 4¼" x 2¾" bricks laid
