**Thomas William Lench Ltd, Carnegie Road, Blackheath, West Midlands (BHT WL04)**

**Historic Building Recording and Archaeological Evaluation, 2004**

By Mary Duncan, Christopher Hewitson and Malcolm Hislop

**David Wilson Homes**

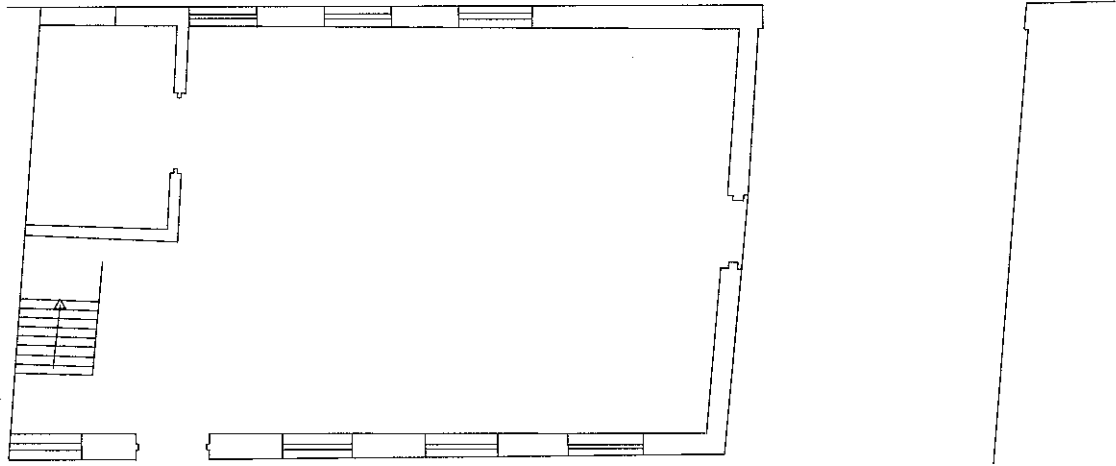
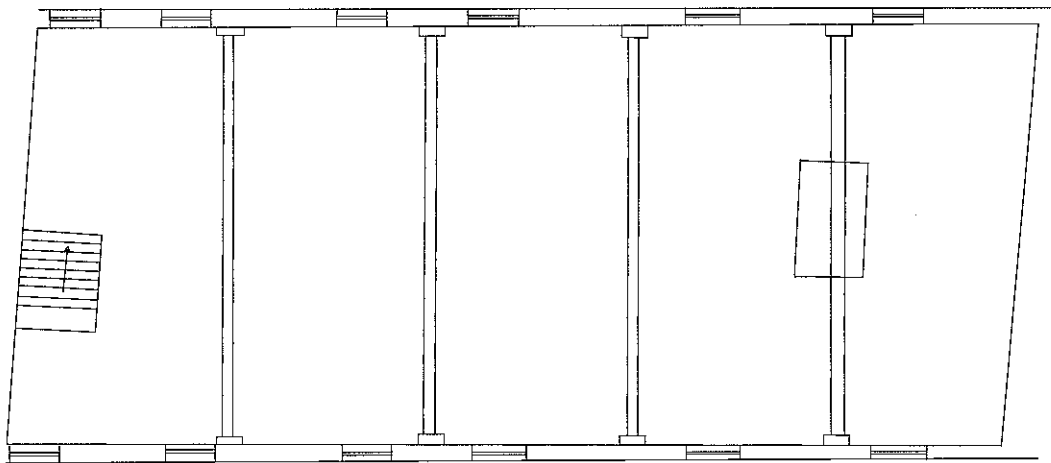
Building P Ground & First Floor

Judging from the position of Building P, adjacent to the main gateway to the factory, it probably functioned as a despatch warehouse. It was constructed from red brick laid in English garden wall bond at ground floor level, changing to Flemish stretcher bond at first floor level, and had a hipped plain tile roof. It was rectangular in plan, aligned north-south facing east and fronting Ross, with a wide carriage entrance providing access to the nut and bolt works from Ross.

With primary access from the door in the west elevation, the ground floor was originally one large open space. Access to the carriageway was provided through a door in the south wall of the building. This door opened onto the carriageway, and was probably used to load and/or unload goods from vehicles, or perhaps to control the flow of traffic entering and leaving the works.

A small room within the building had been inserted at a later date, causing one of the windows on the east elevation to be blocked. The room had a large wooden door with a four-pane overlight, and may have been used as an office.

Constructed between this office and the north internal wall of the building was a substantial wooden staircase, which provided access to the first floor of the building. Further inspection of the staircase showed it to have been a later addition to the building. The position of the staircase meant that it blocked a window and door in the north wall at both ground and first floor-levels.

The upper floor was constructed from wooden floorboards, supported by wooden joists, which in turn were supported by metal beams. The ends of these beams could be seen on both the west and east elevations. At the south end of the first floor was a large hatch, which opened directly onto the carriageway below, it was probably used to load goods into vehicles below. There were six windows either side of the first floor, articulated by brick columns, which provided support to the exposed wooden roof trusses.

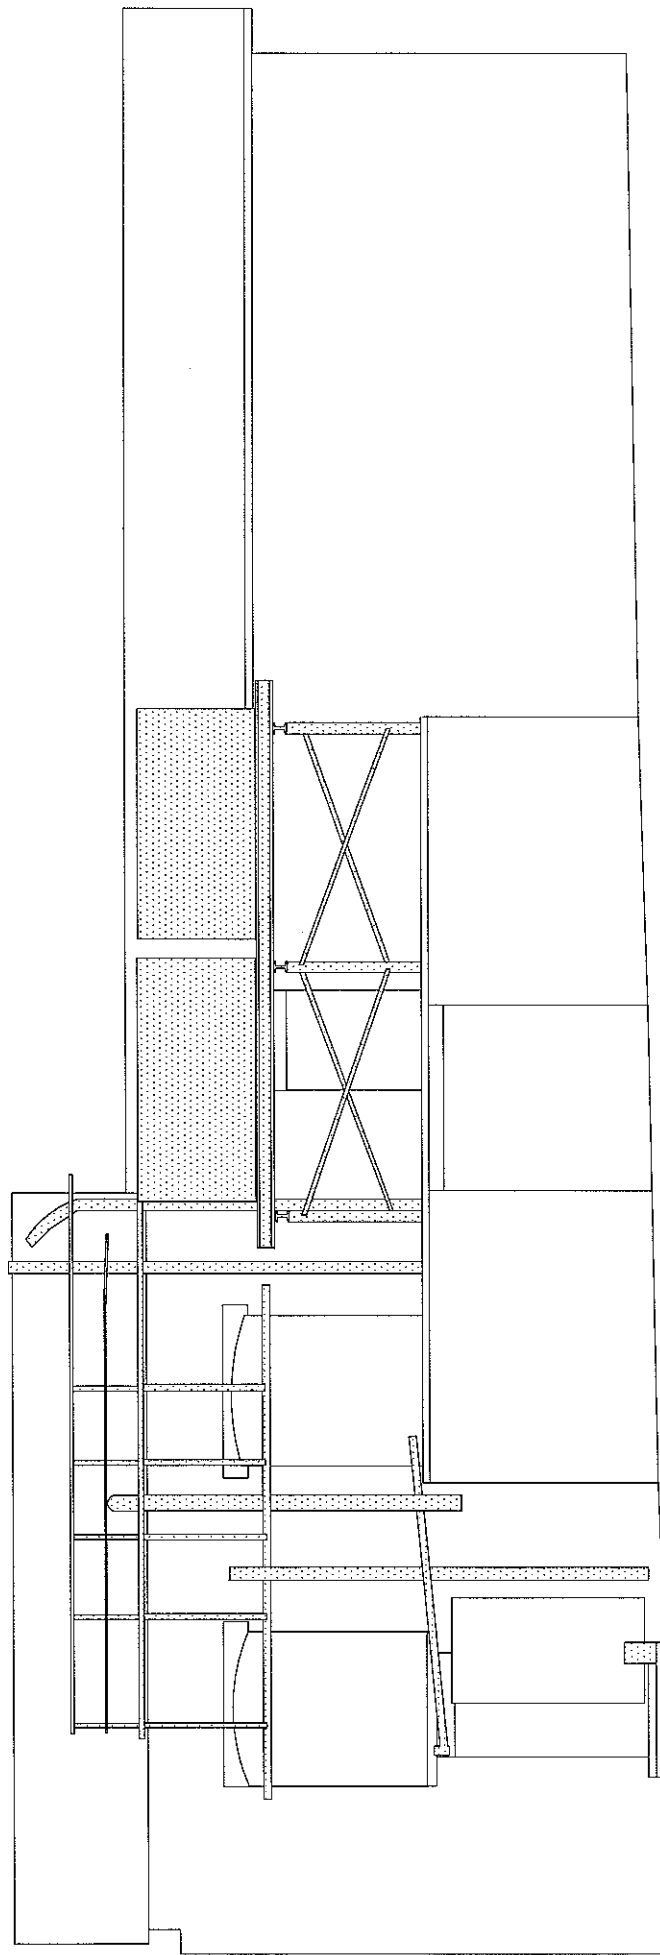
0	10m	Building Q, Elevation 6 (north facing)	Sandwell MBC BHT WL04 Pn1224	NGR: SO 9685 8670 birmingham archaeology
---	-----	---	---------------------------------	---

The east end of the north elevation comprised a two-storey structure supporting large metal tanks on its roof. Access to this part of the building was via a small wooden sliding door at the northern end. This part of the building had three windows. Two were large segmental-arched, cast-iron framed windows, one located above the door and the second to the side of this. The third was smaller and positioned further to the south, above a later (mid-20<sup>th</sup>-century) extension to the front of the building.

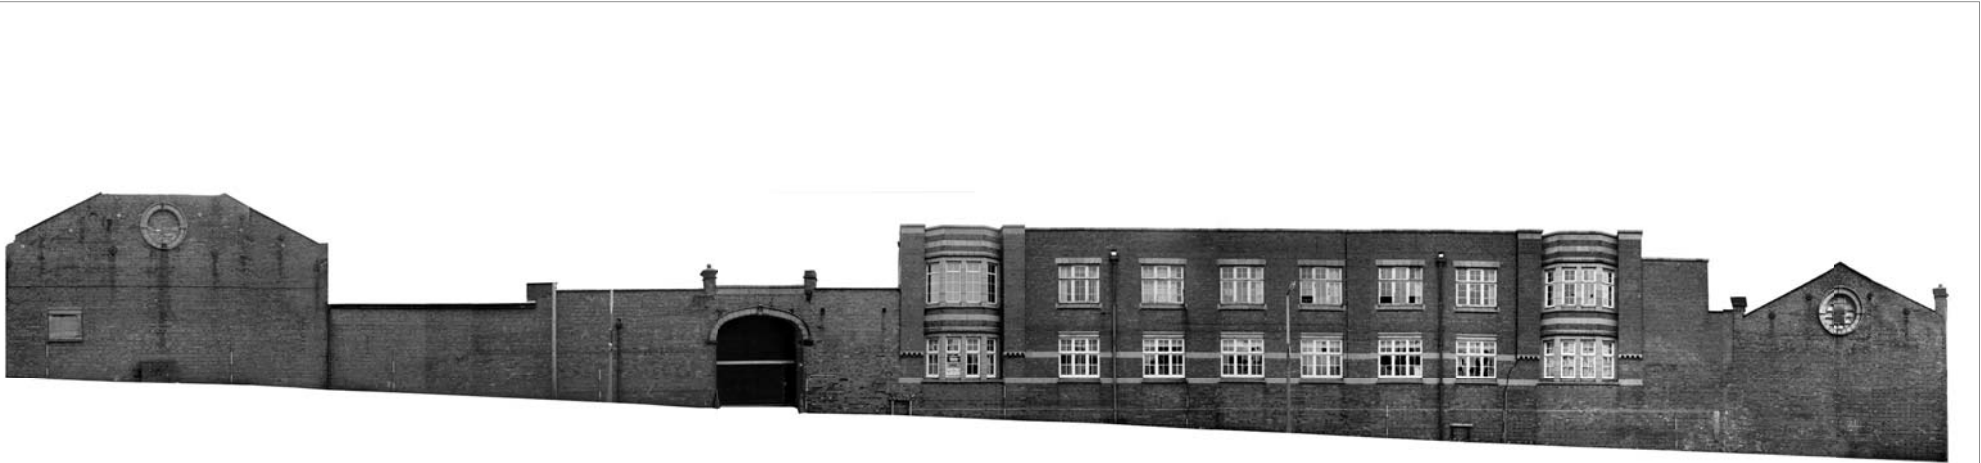
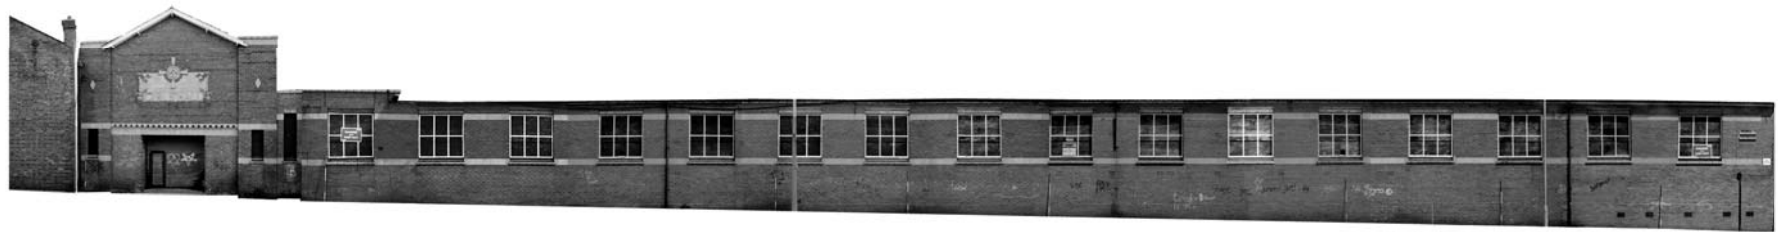
Plate 1

This large single-storey workshop was built of red brick laid in stretcher bond with terracotta banding and had a slate roof with bracketed eaves, a continuous skylight and crested ridge tiles. The building was a double pile construction aligned northwest-southeast facing southwest towards Carnegie Street. There were sixteen bays of windows with terracotta sills and ovolo-moulded concrete lintels. Inside, the floor was of concrete, and there was a central row of steel columns by Dorman Long & Co. Ltd of Middlesborough supporting the ends of the double-span steel roof trusses. No other features of interest were recorded.

Building B was a workshop built of red brick laid in stretcher bond with terracotta dressings. It was aligned east-west and recessed between Buildings A and C with its gable end towards the street recessed between two plain piers. This single-building had a terracotta corbel course supporting the projecting upper part of the central recess, and an oversailing roof on two pairs of purlins and ridge piece with barge boards. A wide central entrance with a terracotta lintel band joggled over the opening was furnished with a later roller shutter at time of survey. Above was a terracotta panel flanked by drapes and bearing the embossed legend 'GIRL'S HALL'. The panel was crowned by a keyed roundel, with a crossed bolts motif in the centre and the circumference embossed with the words 'THOMAS WILLIAM LENCH LIMITED'. There were vertical joints between Building B and the two adjoining structures (Buildings A & C). The fact that the terracotta banding of Building B was abutted by Building A shows that the latter, although part of the same historical phase was slightly later in date.

Building C was a single-storey workshop built of red brick laid in English bond, the building being aligned east west with its gable end towards the street breaking forward from Building B to the right (south). The elevation was blind except for a keyed oculus in the gable with raised terracotta surround. The gable had a raised coped verge and was

This building housed the main offices, and was built of red brick laid in English bond with terracotta dressings. It was a two-storey structure with a plain, terracotta-coped parapet. Each end bay of the eight-bay front was articulated with pilaster strips rising from a corbel course half way up the windows. These two end bays contained four-light bay windows at both ground and first-floor levels, but otherwise the windows were mullioned and transomed with terracotta sills and joggled lintels; there were two terracotta bands at sill and mid-height of ground-floor lights.

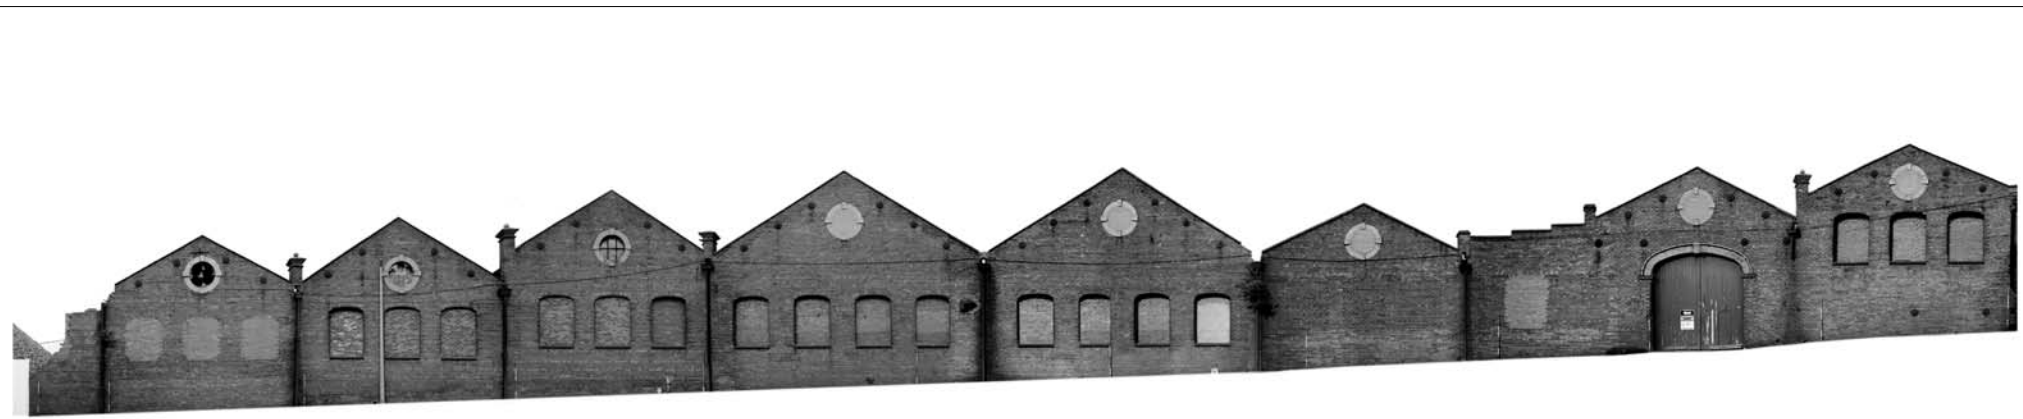
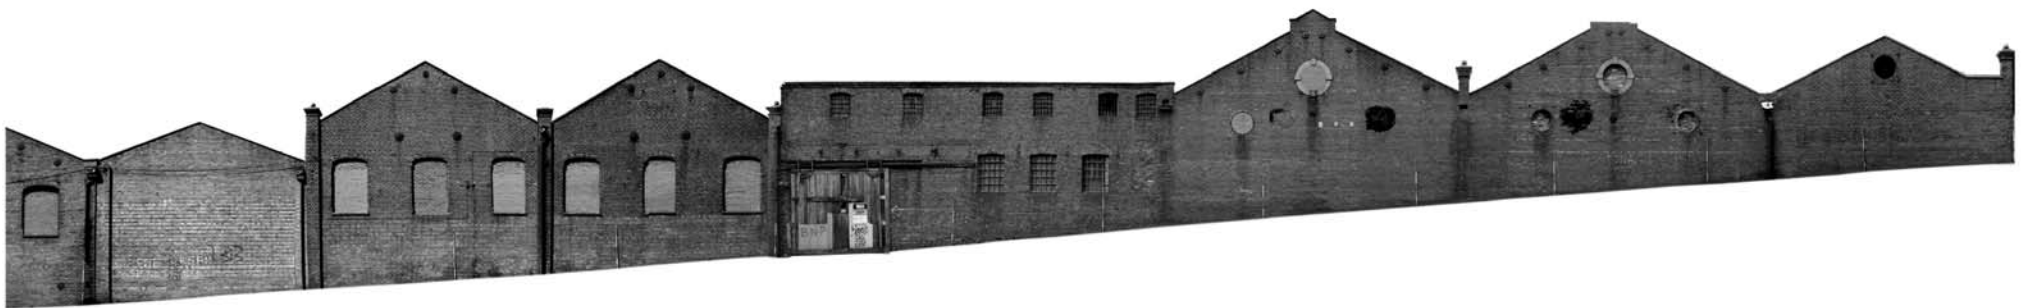
Plate 2

Building L was a double pile workshop range aligned east-west with the gable ends towards Ross. It was built of red brick laid in English bond up to mid-height, then Flemish stretcher bond above. The two single-storey three-bay gabled ranges were articulated by pilaster buttresses surmounted by ball finials on squat pedestals, and had high-set segmental-arched windows with blue brick surrounds.

Building M was constructed in red brick laid in English bond, and was aligned east-west with a blind gable end towards Ross. There were straight joints in the brickwork between Buildings L and N. The interior was floored in concrete and had tie-beam roof trusses with raking struts.

Building N comprised a block of workshops aligned east-west facing east towards Ross. Built in red brick laid in English garden wall bond. It had blue brick and terracotta dressings and was roofed in a mixture of slate and corrugated asbestos, with raised tile-coped verges. The Ross front of this single-storey building presented a series of eight gables graduated in height, with blocked segmental-arched windows, cast iron drainpipes at the junctions, and, at eaves level, pedestals carrying cornice caps and ball finials. There was a gateway beneath the second gable from the left (south) with chamfered blue brick jambs and terracotta four-centred arch springing from imposts. Interior Concrete floors throughout. The southernmost bay retains timber king-post roof trusses with raking struts, plank ridge and two pairs of purlins. Otherwise, steel roof trusses prevail.

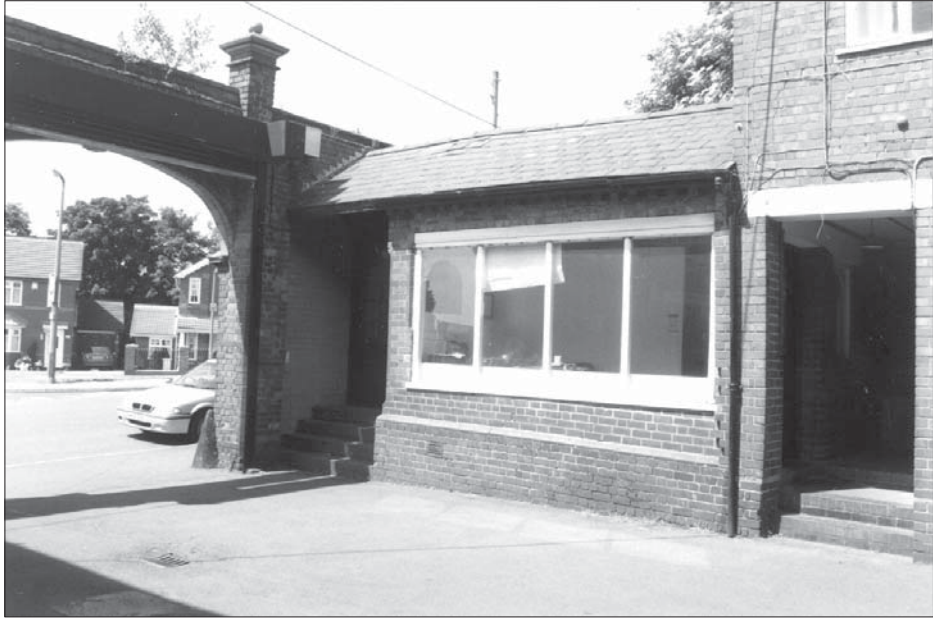
Plate 3

Attached to the left-hand end of the building was a screen wall and gateway forming the main public entrance into the works. It too was built in red brick laid in English bond with chamfered blue bricks to the gate jambs supporting a terracotta three-centred arch springing from egg and dart-moulded imposts, with a roll-moulded dripstone with raised key. The gateway gave access to a courtyard. On the right (north) immediately inside the entrance was a partially rebuilt gatekeeper's lodge built in red brick with blue brick quoins and slate roof (Plate 3).

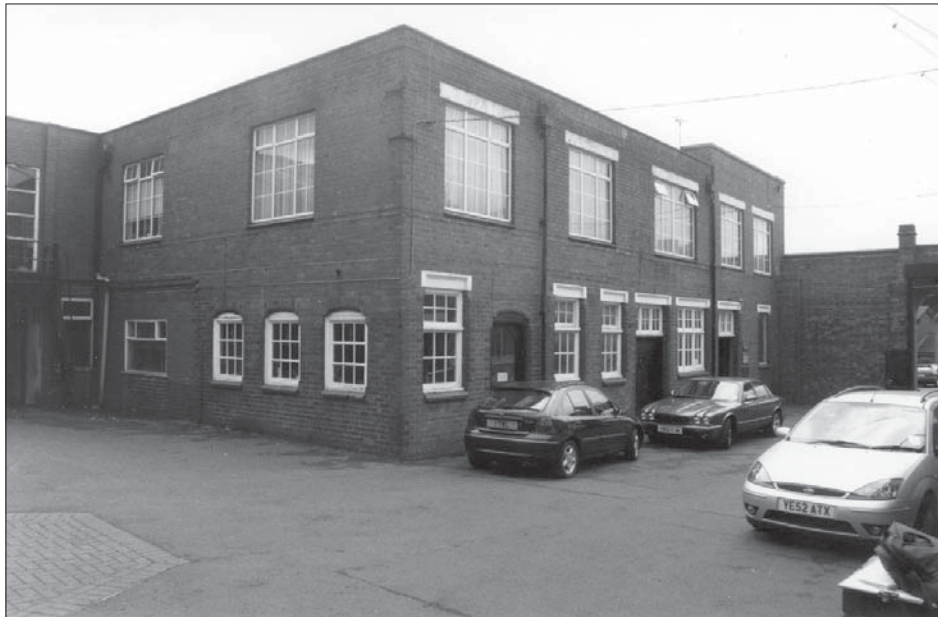
Plate 4

The entrance to Building D was from the south side of the courtyard (Plate 4). The door gave access to an entrance lobby with small receptionist's lodge on the left-hand (east) side, and a waiting area on the right-hand side. Beyond the lobby to the south was a corridor communicating with ground-floor offices and a staircase leading to the first floor. At first floor level was another corridor extending north-south through the length of the building and giving access to offices on both sides.

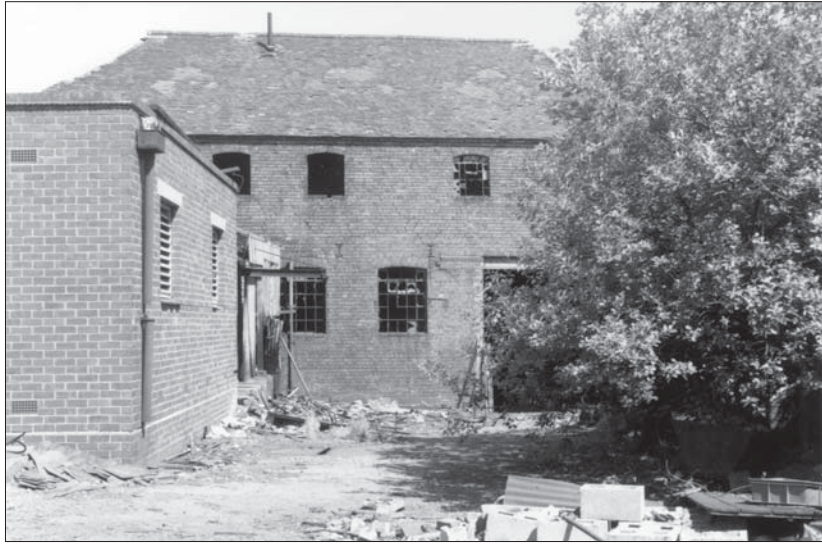
Plate 7

This substantial workshop was built of red brick, had a slate roof with crested ridge tiles and continuous skylights. To the north was a series of inserted mid-20<sup>th</sup> century windows to the north. Inside were concrete floors and steel roof trusses.
