**Rounds Timber Yard, Castle  
Street, Tipton:**

**An Archaeological Evaluation**

**Project No. 1299**  
December 2005

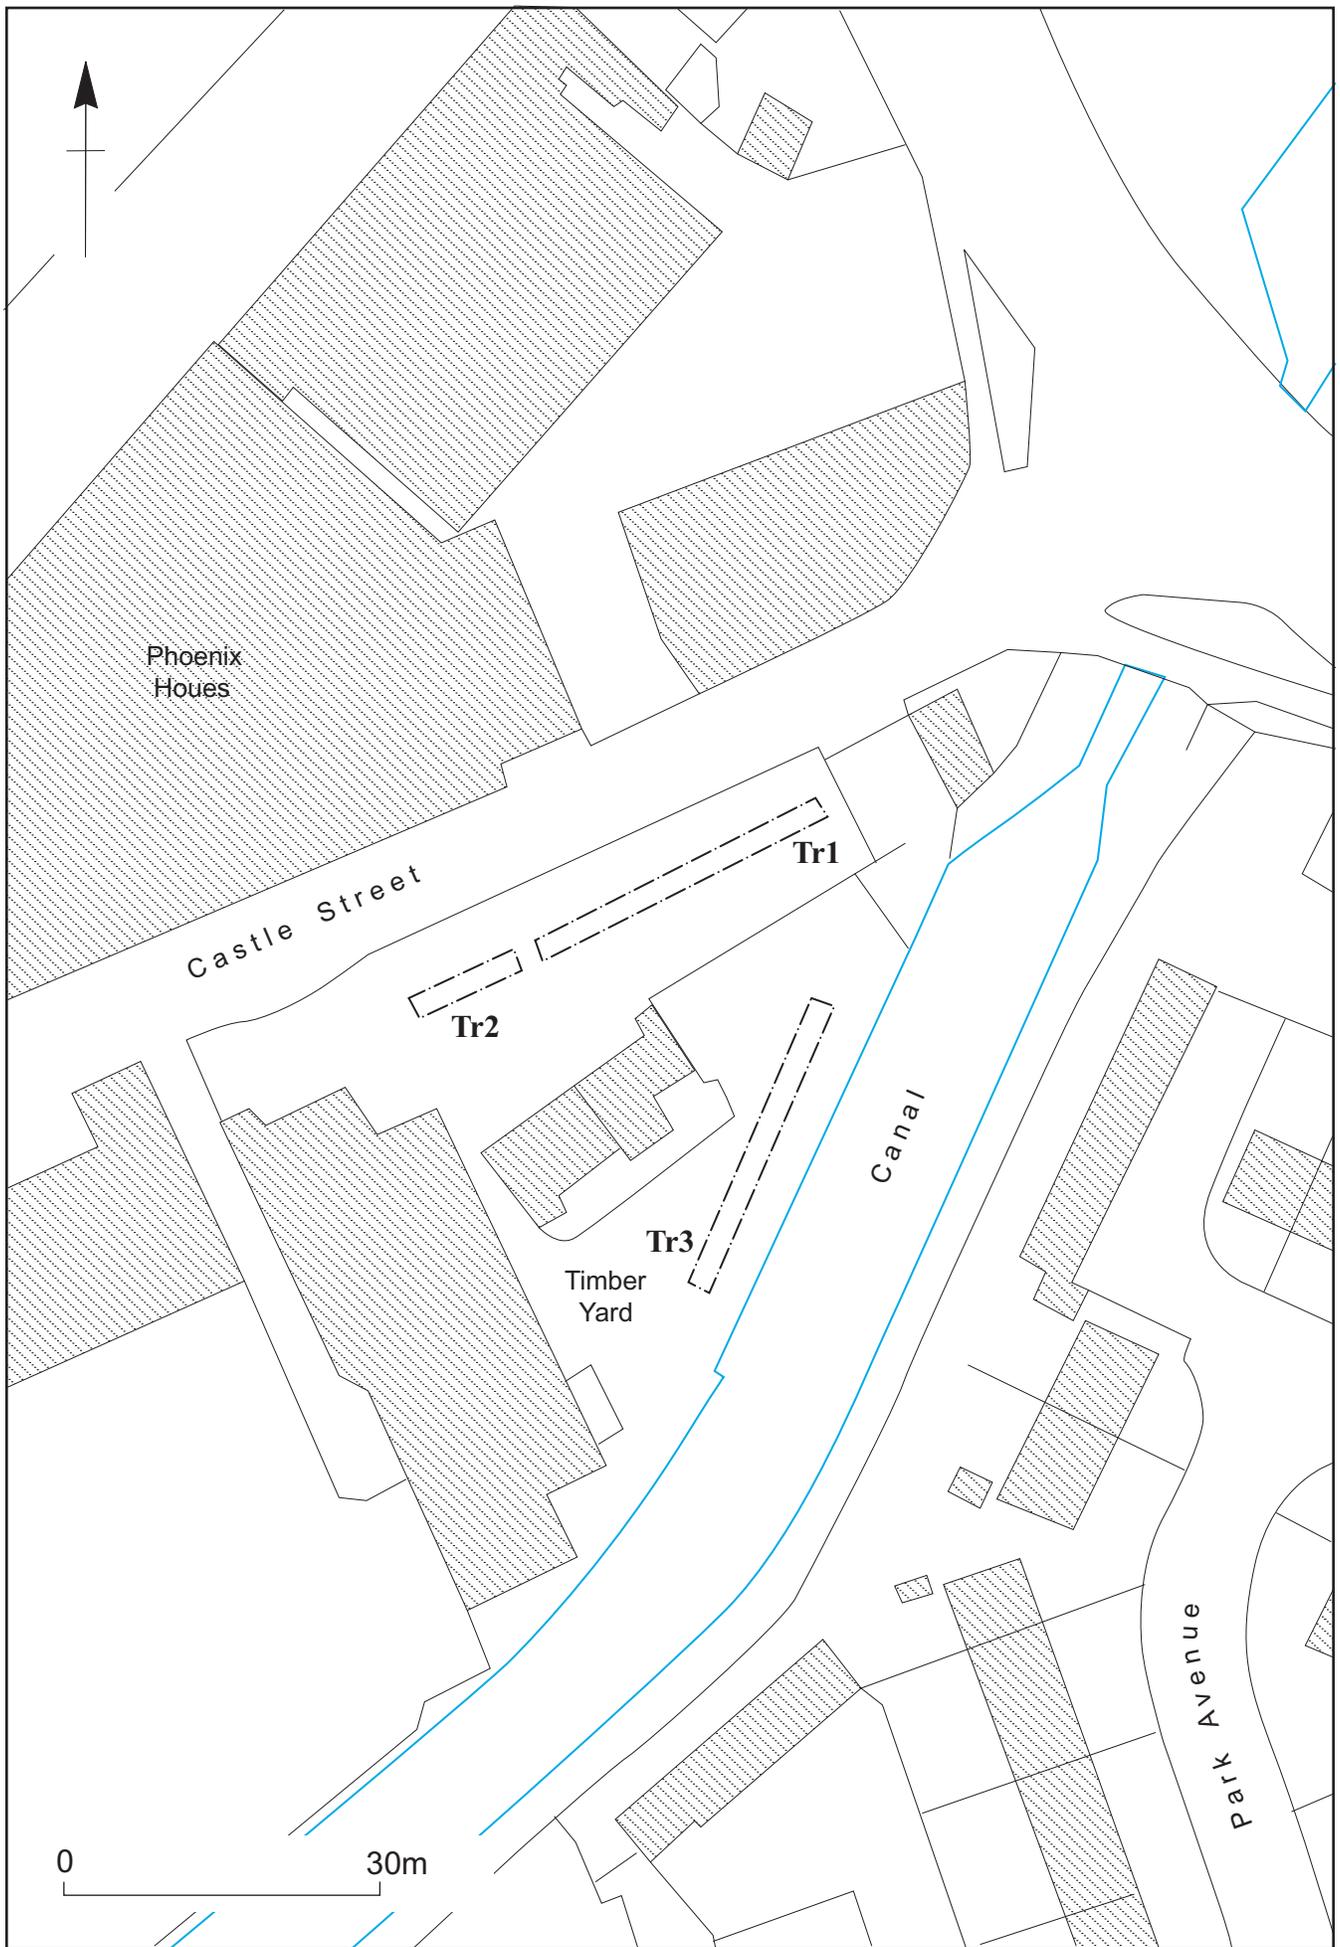
Fig.2

Two trenches were parallel to Castle Street, with the third located to the rear of this building parallel to the canal (Fig. 2). The concrete and overburden was mechanically removed by a JCB, under direct archaeological supervision, to the top of the uppermost archaeological deposit, to a safe working depth, or to the top of the natural subsoil where no archaeological deposits were encountered. The exposed horizon was defined and hand cleaned as necessary, and a representative sample of all significant archaeological deposits was excavated in order to understand the structural record and stratigraphic relationships of deposits.

Adjacent to the canal, in Trench 3 (Fig. 2), the natural yellow clay subsoil (3003) was identified at a depth of just 1m below the modern ground level (at a height of 143.50m Above Ordnance Datum). In Trench 2, it was reached at a height of 142.75m Above Ordnance Datum, and across the whole site, the natural subsoil was shown to be overlain by significant deposits of made-up ground.

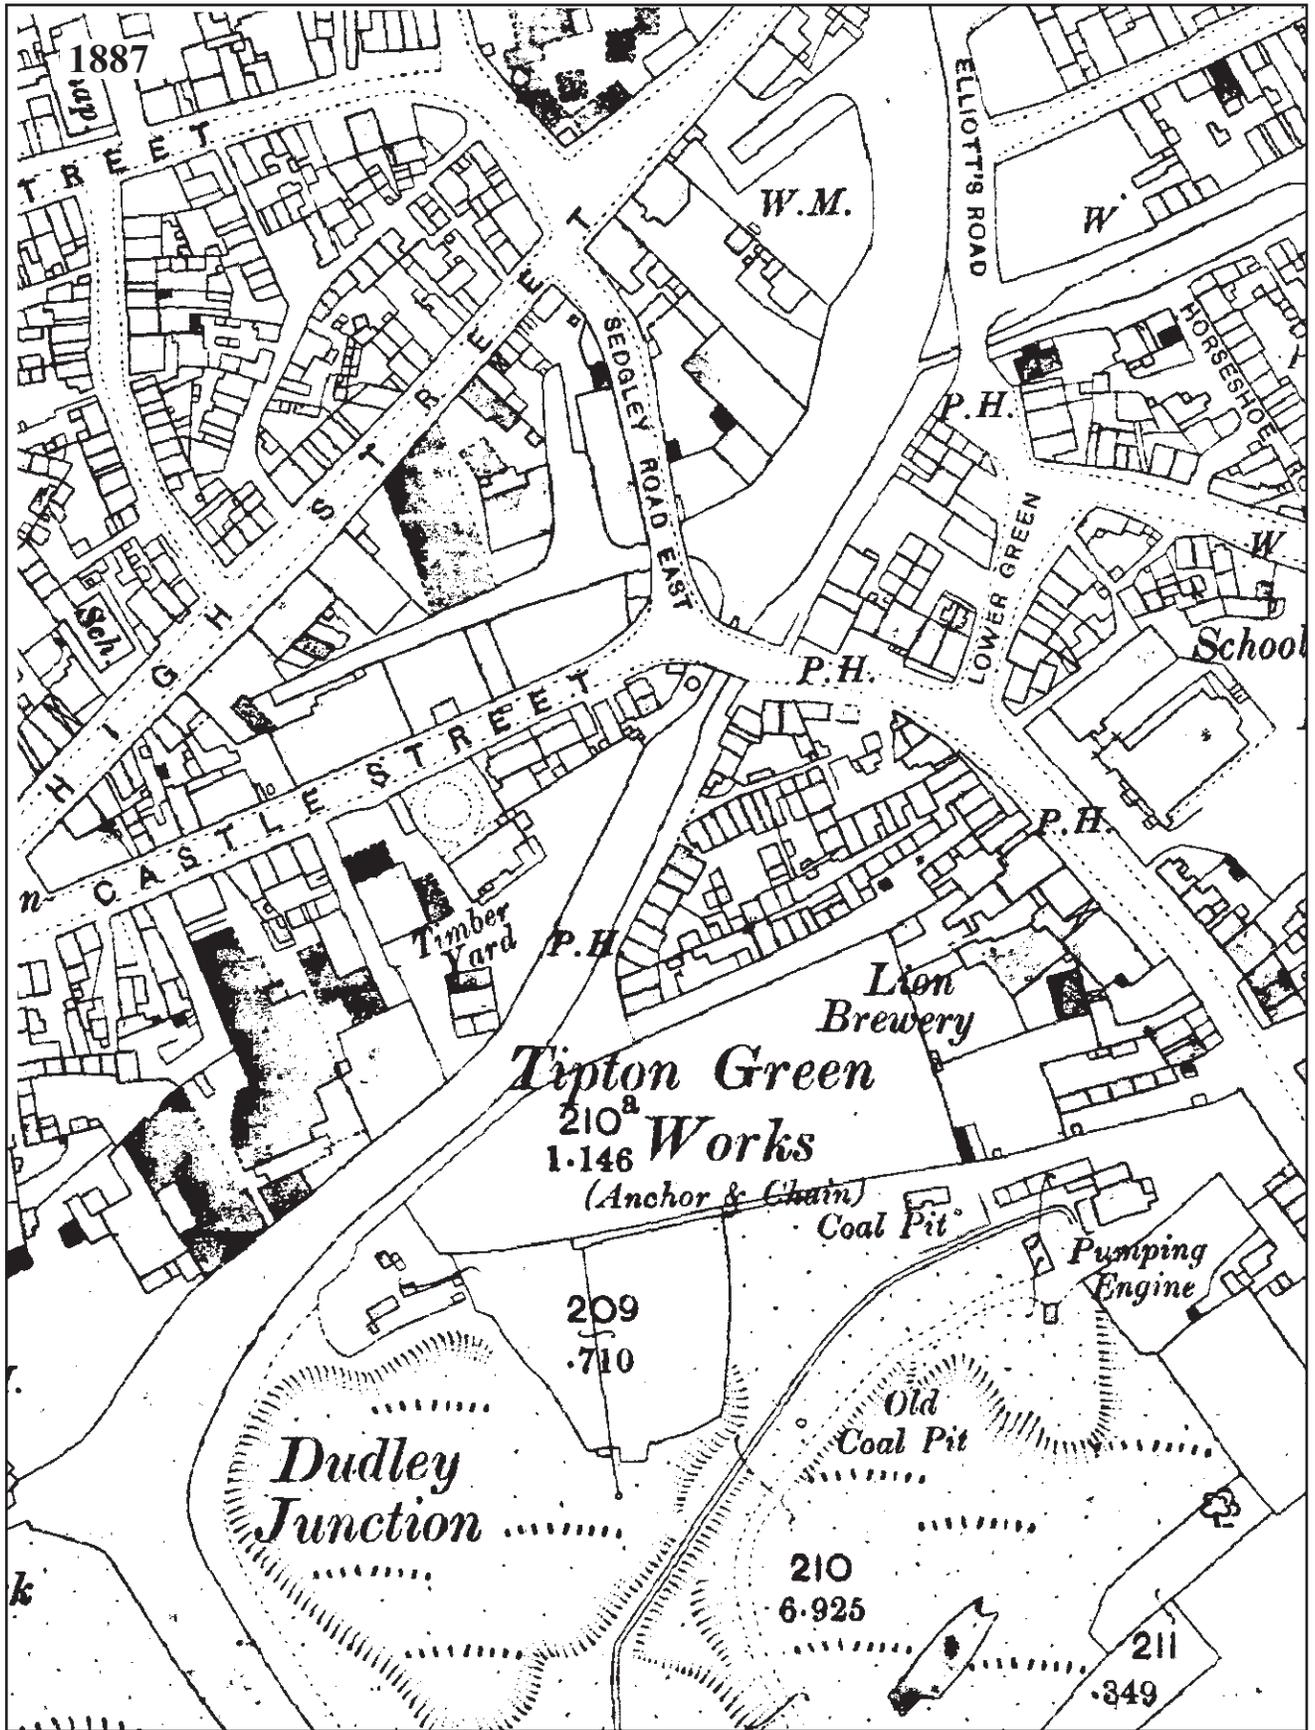
Fig.3

A two-storey house was built on the site c.1800 and has been little changed since (Framework Construction Ltd 2004). The First Edition Ordnance Survey Map (Fig. 3) shows the house with a circular driveway at the front, and three houses with outbuildings fronting onto Castle Street. The Ordnance Survey Map sequence (not illustrated) show these houses undergoing extensions and alterations to the rear of the properties over the years, but by 1988 they had been demolished.

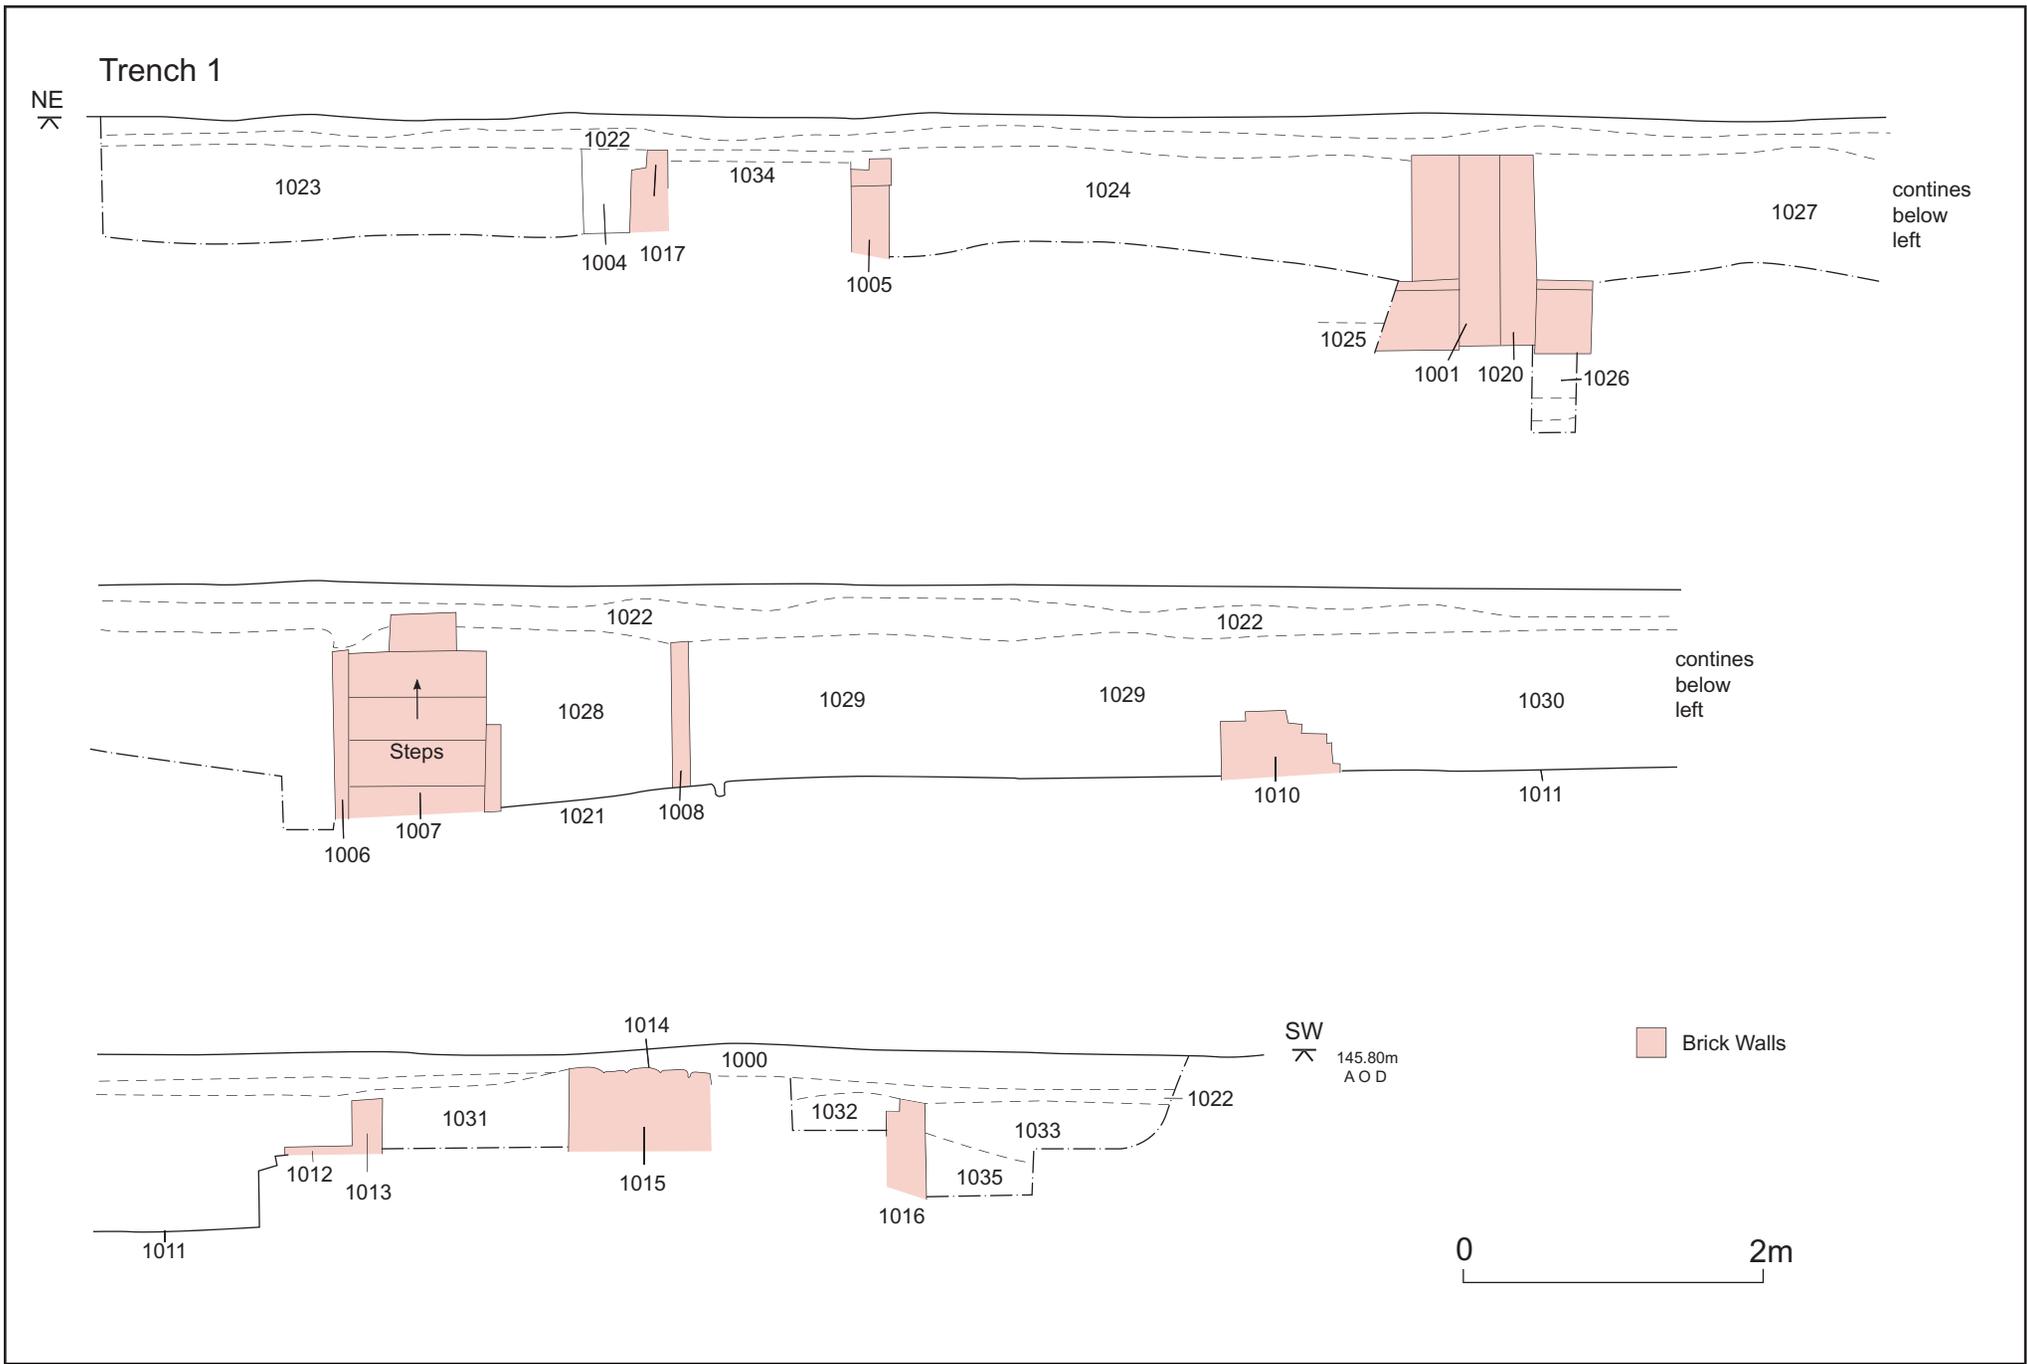
Fig.4

In Trench 1 (Fig. 4), a sequence of layers (1026) was identified below the base of the terrace wall foundations (see below), which was hand excavated to a depth of 2.3m (to 143.35m Above Ordnance Datum). These layers included lenses of black ash and clinker, grey brown clay-silt and redeposited yellow clay natural which contained pottery datable to the late 18<sup>th</sup>-early 19<sup>th</sup> centuries. However, the full depth of these layers could not be ascertained for health and safety reasons.

Structural evidence for the early cellar, were two walls (1002 and 1004, Figs. 4 and 5, Plate 2). Wall 1002 was only visible in the south-facing section of the trench. Wall 1004 was a half brick thick and at right angles to 1002. A gap between these two walls probably relates to an entrance to the cellar in its northwest corner. The underside of the ceiling (1003) had been rendered and whitewashed or painted. The cellar had been constructed using hand made clamped-bricks that were thinner than 3" suggestive of a relatively early date.

The cellars were infilled with loose brick rubble (1024, 1025, 1027, 1028, 1029 and 1030 Figs 4 and 5). Deposit 1027 contained large fragments of sandstone that showed some evidence of being worked.

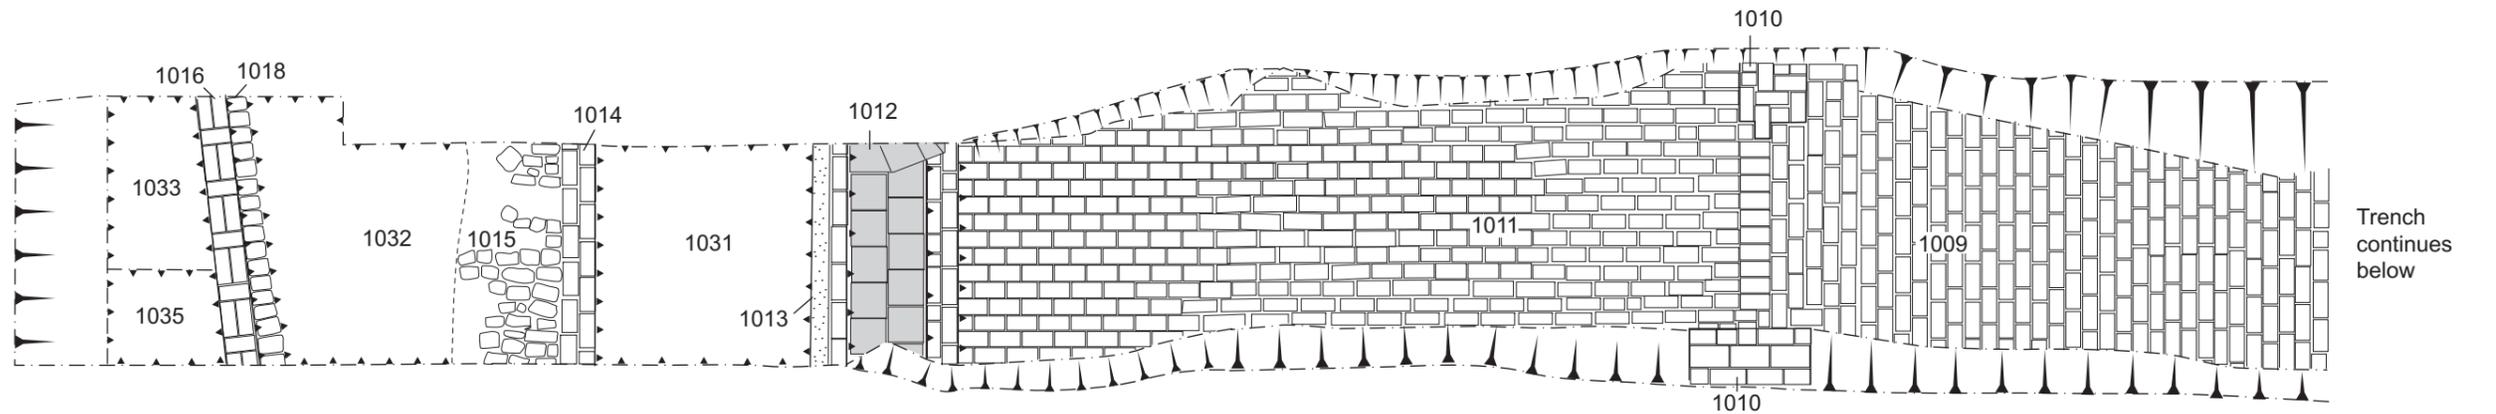
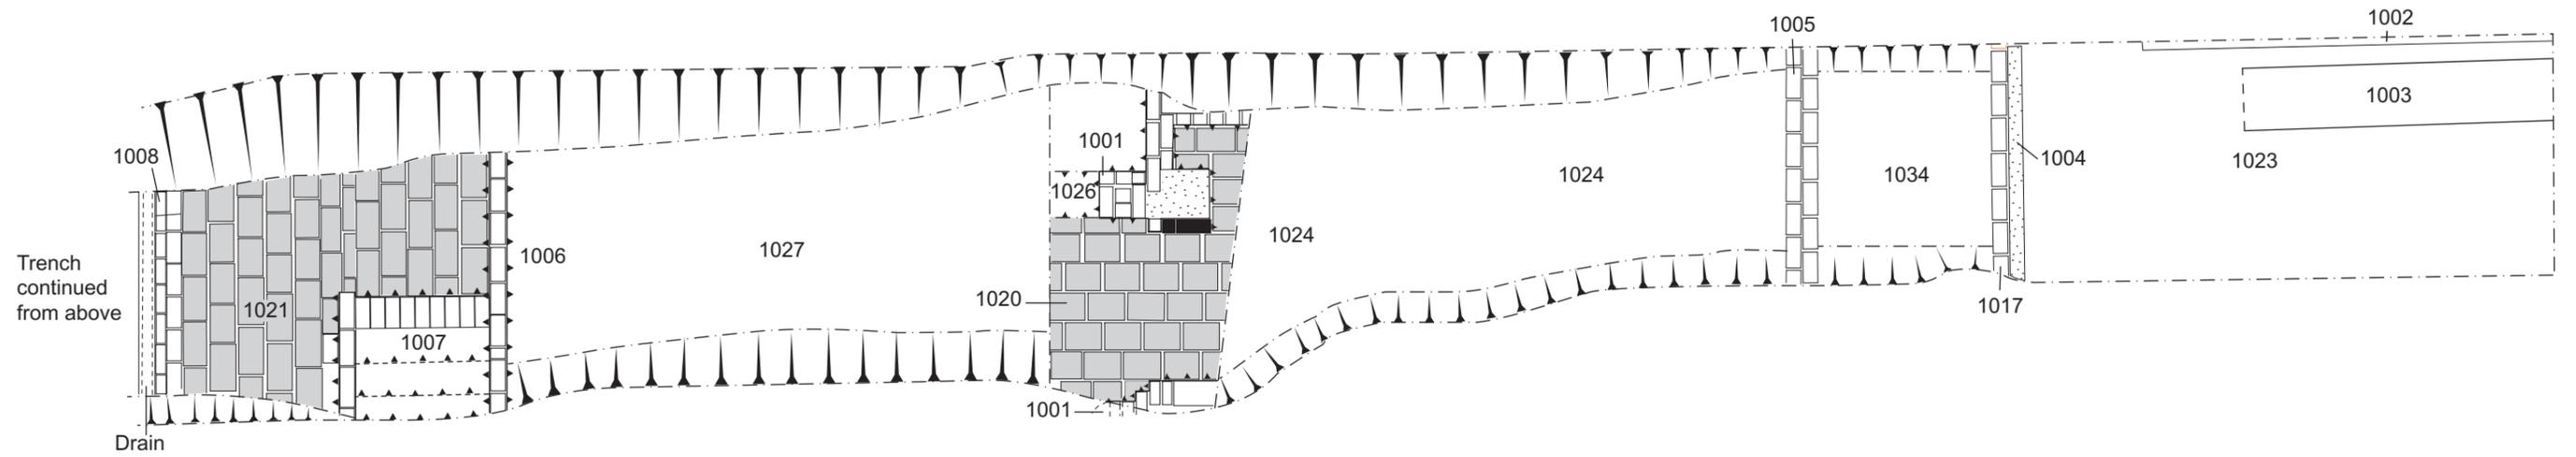
Fig.5

Immediately outside the terrace (to the west) a deposit of grey clay-silt containing coke, charcoal and brick fragments was identified (1032), with the remains of a cobbled surface set into it (1015, Fig. 5). The garden wall associated with the house with the circular drive depicted on the First Edition Ordnance Survey Map (Fig. 3) was also revealed at this end of the trench (1016/1018). It appeared to have been constructed in two phases, although this may equally have represented repairs. A garden soil had built up against it on the house side of the wall (1033 and 1035). Pottery dating to the late 19<sup>th</sup> centuries was recovered from both the cobbled surface and the garden soil (Ratkai, pers. comm.). Overlying the whole of the trench was a levelling deposit of crushed brick and mortar (1022) with a surface of Type 1 hardcore (1000).

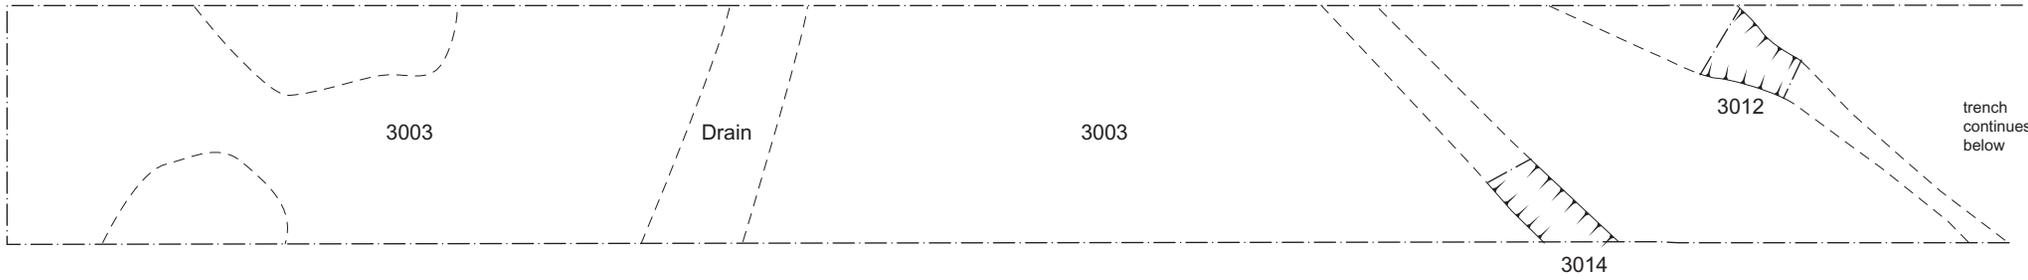
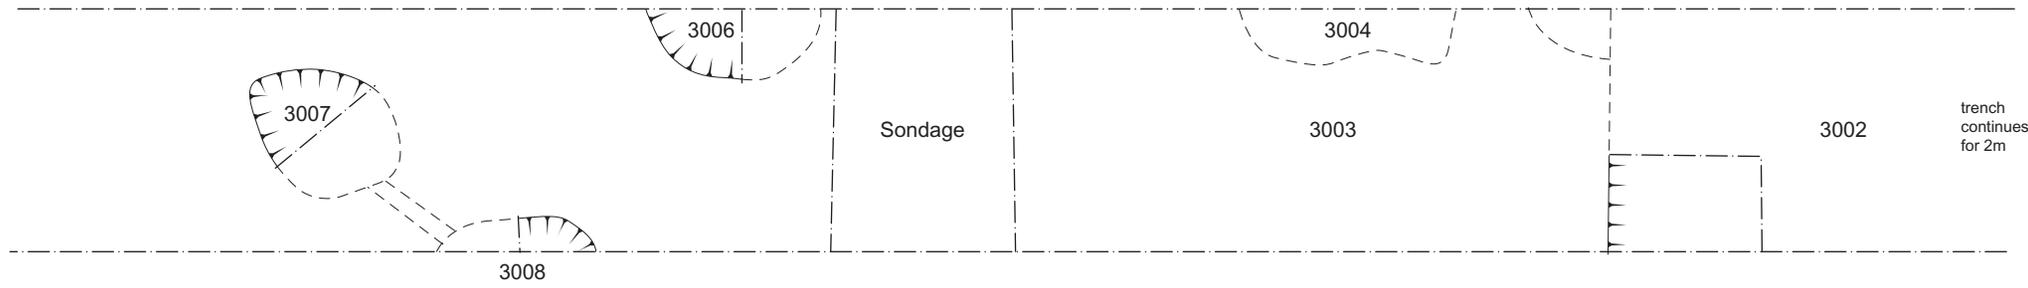
Fig.6

Several features were observed cutting the natural subsoil in Trench 3 (Fig. 6) however, they were ephemeral, and it was unclear as to whether they related to the construction of the canal, the construction of the wharf or were later disturbances (Plates 8 and 9). Overlying these features, was a 0.3m deep layer of dark grey clay silt (3002), containing brick and tile fragments, mortar flecks and 19<sup>th</sup> century pottery. Sealing this deposit was a modern layer of hardcore.

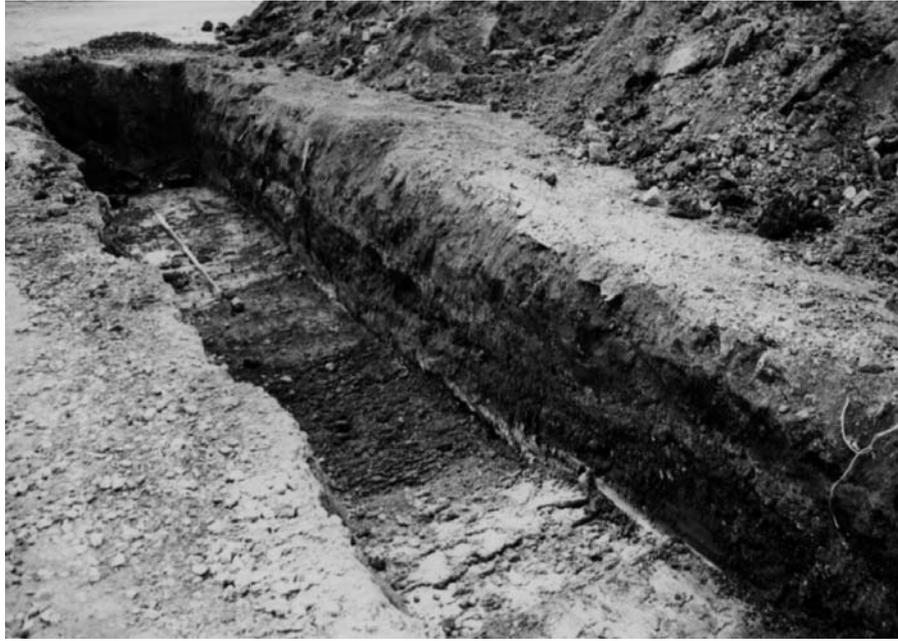
Plate 1

Trench 2 was initially excavated to a depth of 1.2m, then a machine excavated sondage was dug in the centre of the trench. The archaeological deposits were characterised by a 2.3m deep sequence of layers, comprising layers of black silt with coke and ash, crushed brick, redeposited yellow clay subsoil and pink sandy gravel (Plate 1). A similar sequence of deposits was identified in Trench 3.

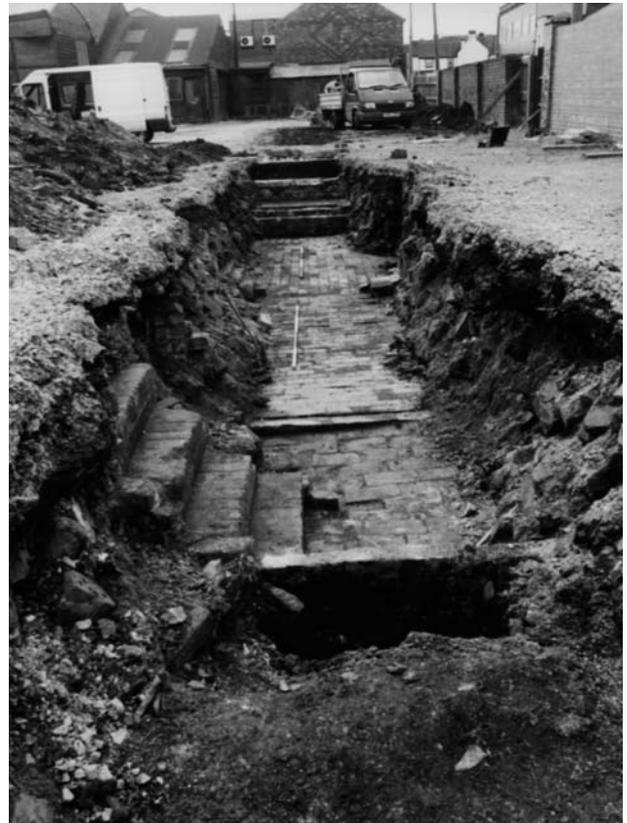
Plate 3

To the west of this cellar, walls and floors associated with cellars belonging to a double terrace were observed. The floor levels of these later cellars were not as deeply sunken as the earlier building. In fact, they were probably semi-sunken, and were therefore similar to those in the remaining standing building on the site. They appeared to be of one phase of construction, and were divided by a half brick thick wall (1006, Fig. 5). However, the floor level in the westernmost terrace was slightly higher than the other (Plate 3), and brick dimensions and mortar varied between walls.

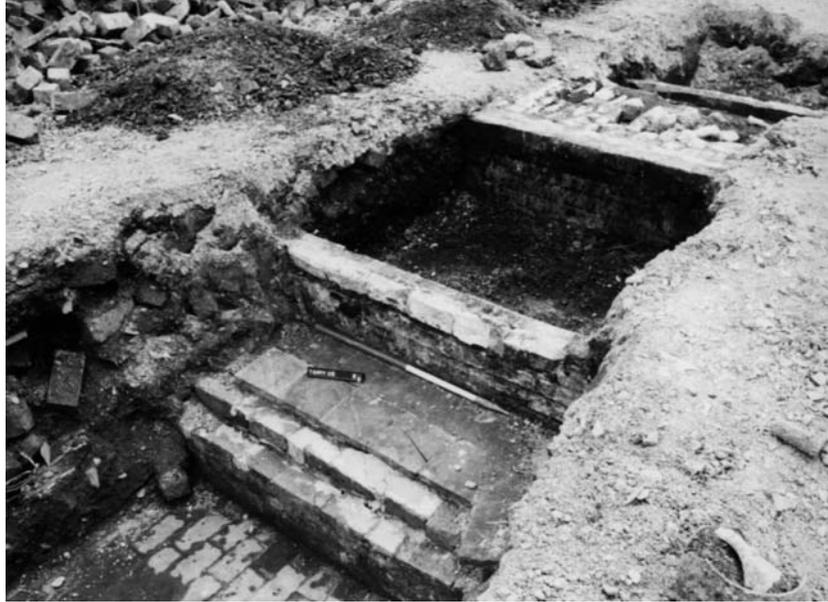
Plate 4

Both cellars were originally accessed by staircases on the outer walls, the remains of which are represented by walls 1005 and 1017, and 1013 and 1014 and the remains of a red quarry tile step (1012, Plate 4). This may also explain why the eastern gable wall was only a half-brick thick at this level. The stairwells had been infilled with a deposit of coke, ash and clinker (1031 and 1034). A second staircase into the western cellar (1007, Plate 5) gave access from the rear of the house, and it is not inconceivable that this was actually from the outside of the property.

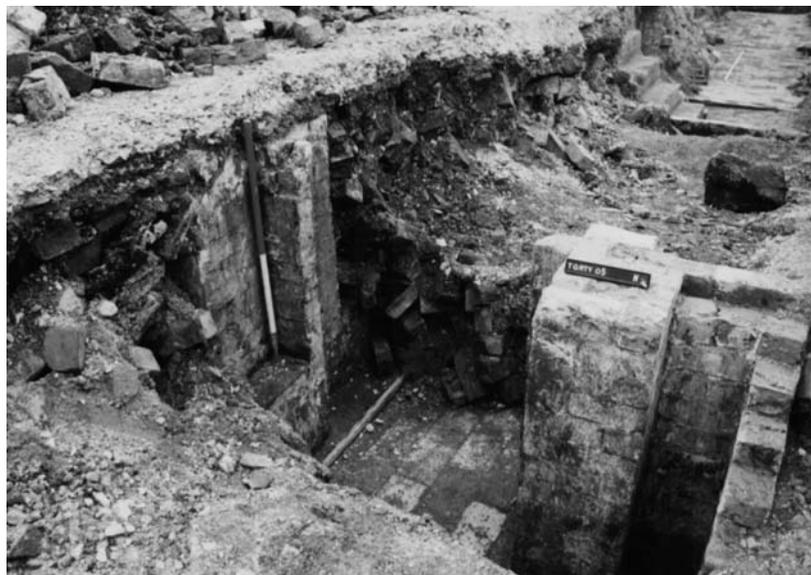
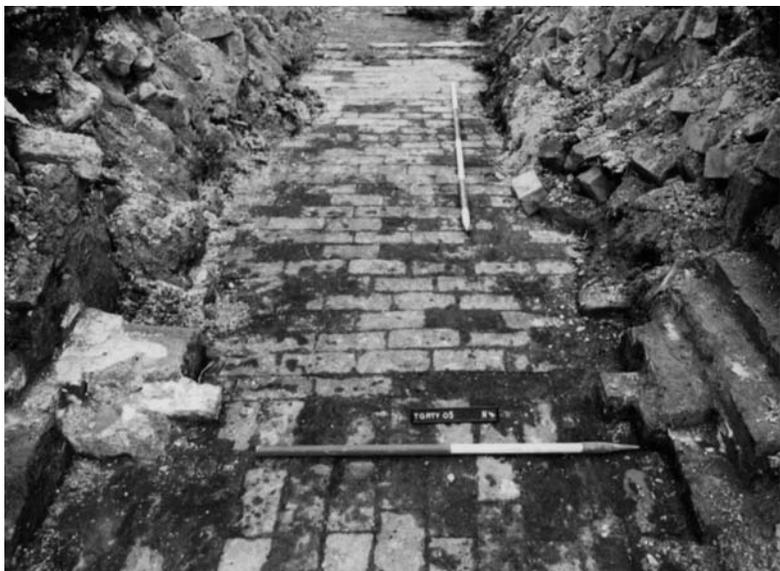
The cellars were divided by a half-brick thick wall (1006), and both had been further sub-divided into smaller rooms by walls 1001, 1008 and 1010. There was also evidence of linking doorways through 1001 and 1010 (Plates 6 and 7). The floor of the easternmost cellar was constructed from brick pavers throughout (1020). The western cellar had several different floor types denoting different rooms; brick pavers (1021) at the bottom of the central staircase, and engineering bricks in the other rooms (1009 and 1011). Floor surface 1009 had a shallow drain running parallel to wall 1008, which was constructed from grey flue tiles.
