Lower Beanhall Farm,
Bradley Green,
Feckenham,
Worcestershire

Historic Building Recording
and Interpretation
2005
(WSM 33752)

**Project no.1311
May 2005**

By Christopher Hewitson

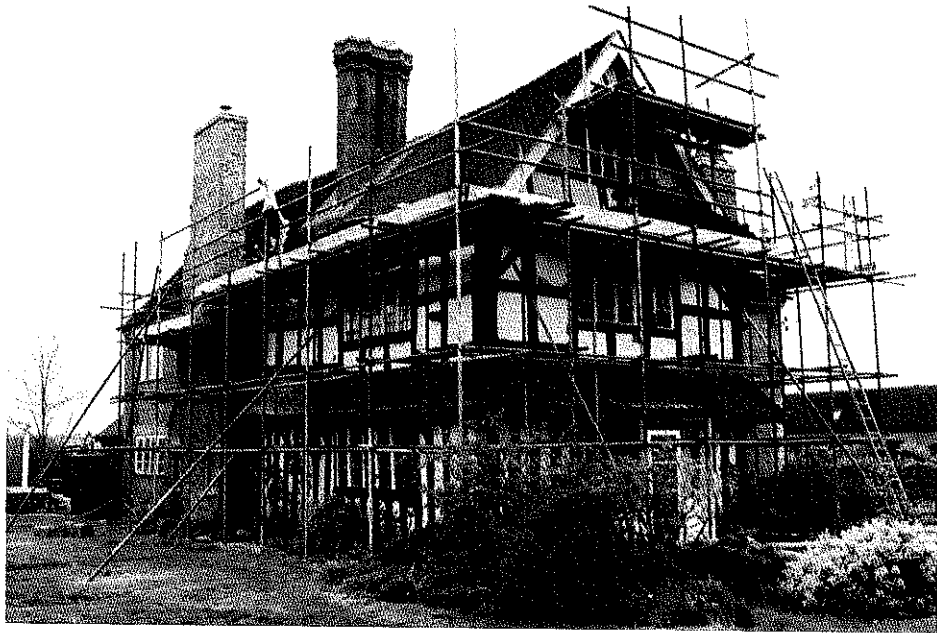
Plate 1

This was a two-and-a-half-storey building constructed principally of oak timber-frame with a wattle and daub in-fill. At the time of the survey the principal façade was located to the west. A later addition porch entrance was centrally located at ground level, and the present owner had sought to alter this and revert the opening to its original form as a window. Above this was an original five-light, three-pane window with a further three-light, three-pane window above. The windows had wood mullions but contained replacement panes.
