**Recording of an Air Raid Shelter
at the Upper Green,
Tettenhall, Wolverhampton,
Black Country (BCSMR 9455)**

Project No. 1321

An air raid shelter located on the Upper Green, Tettenhall (NGR SJ 8870 0017) was recorded in June 2005 by Birmingham Archaeology for the City Council. The shelter was L-shaped in plan, with two entrances, and completely subterranean, taking advantage of the steep natural slope of the Green. It was constructed using corrugated iron shuttering with internal braces, and was reminiscent of wartime tunnels surviving below Dover Castle. The shelter had been provided with electricity, with a backup supply, and had been fitted out with toilets. Unfortunately documentary research could not provide a confident date for the monument, and there is anecdotal evidence that it was never used. This, and photographic evidence, suggest a late date of construction, post 1943, which is unusual.

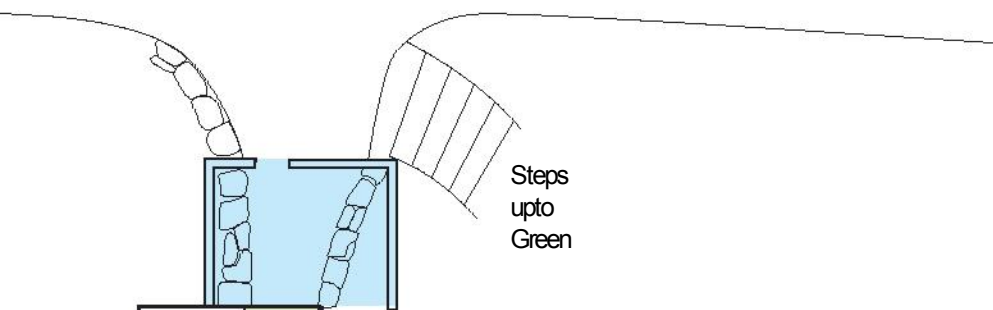
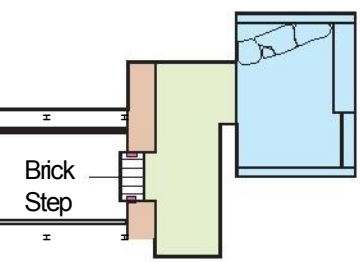
The north-south tunnel from the Wergs Road entrance was the wider of the two (Fig. 3), measuring c. 2.3m, or seven foot six inches, in the specification that it would have originally been built to. Although this tunnel was slightly shorter, measuring 18.5m in length from the modern front entrance to the recent blocking of the third tunnel, it was clearly the primary tunnel. This was indicated by the fact that the second east-west tunnel was only five feet six inches (or c. 1.7m) wide, although it was longer, measuring 18.5m from the modern entrance to the junction with the main tunnel (Plate 7). Both tunnels were six feet six (or 2m) tall (in-set, Fig. 3). Before the construction of the later entrances in brick (see below) both tunnels would have been 2m shorter.

- Poured Concrete Roof
- Brick Walls Contemporary with use of Shelter
- Wooden Door Jambs
- I-Beam Braces
- Later Alterations

Emergency Hatch

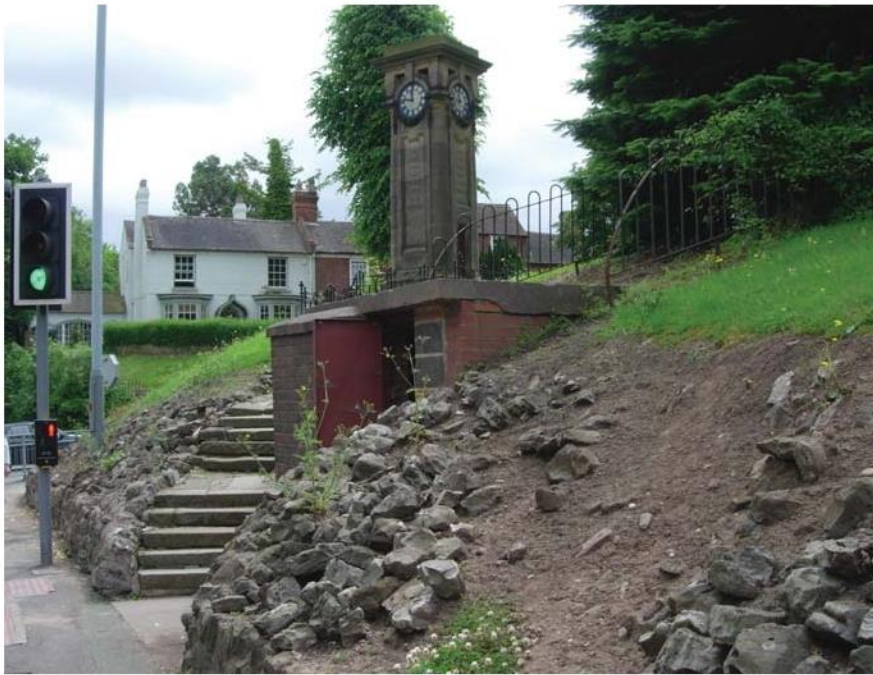
Plate 4 Northern Entrance with clocktower

The shelter was built into a natural bank at the northeast corner of the Upper Green in Tettenhall (Plate 4). It was L-shaped in plan (Fig. 3) with two blocked entrances, one from Wergs Road and the other from Upper Green road. A modern manhole cover set into the grassland cover of the Upper Green marks the location of the original emergency escape hatch, positioned at the junction of the two tunnels. There was some evidence for a third tunnel having run to the south of the junction of the two tunnels possibly making the original plan more of a T-shaped one. It may have led to another entrance from the Upper Green, or, alternatively formed a closed tunnel of unknown length. However, in all probability it corresponds to the small recess depicted on the site plan accompanying the site visit made by Sue Whitehouse of Wolverhampton M.B.C. in 1996 (Fig. 4). Unfortunately this area is in shadow on a photograph taken at the time (Plate 5) and it is not possible to say for certain that what is shown was part of the original build. This possible third opening has since been blocked with cinder-type blocks, of which there were three distinct builds represented by vertical breaks in the masonry (Plate 6). These may have been the result of the difficulty of fitting the blocks against the curving sides of the shelter, although an alternative is that the blocking conformed to the apparent wall stubs located here which were marked upon the 1996 plan. These may have supported a ladder to the escape hatch, but this is supposition as no physical evidence of this had survived.

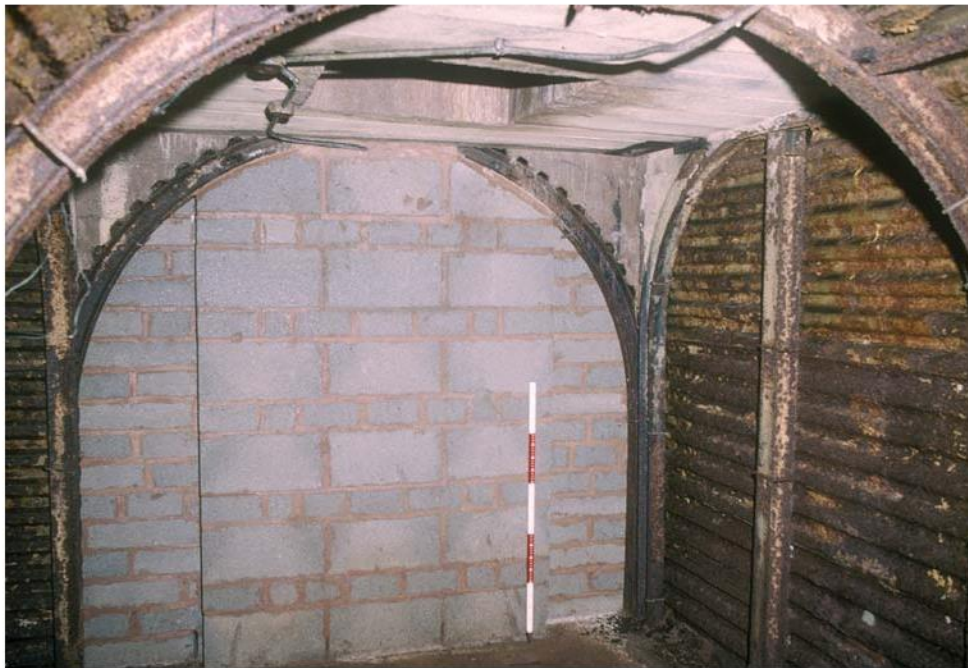
Plate 6 Junction of Two Tunnels Showing Blocking, with Emergency Exit

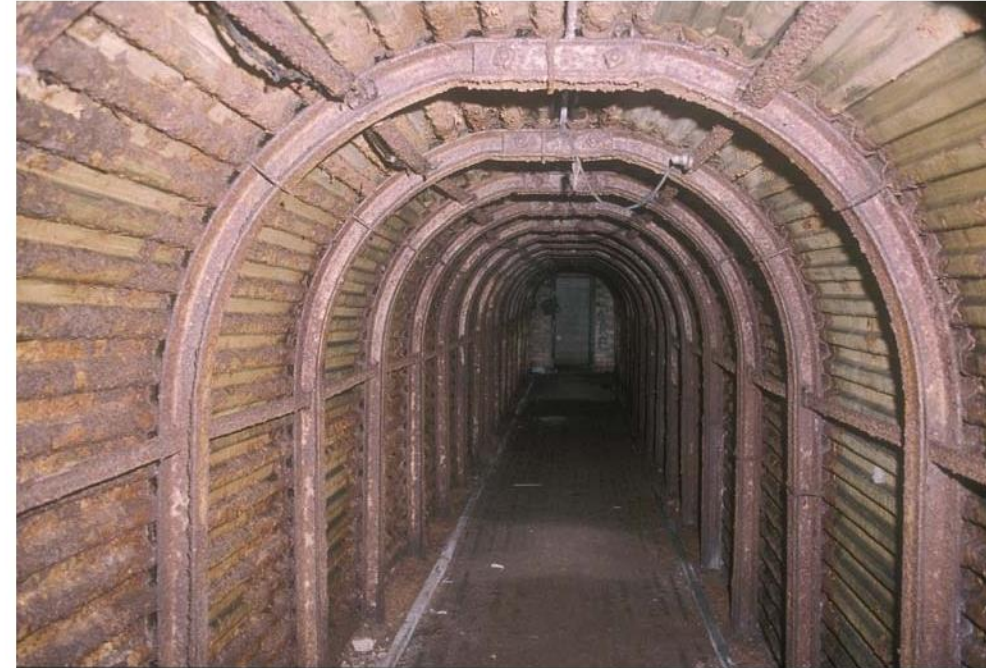
Plate 7 East-west Tunnel Looking back Towards the Entrance

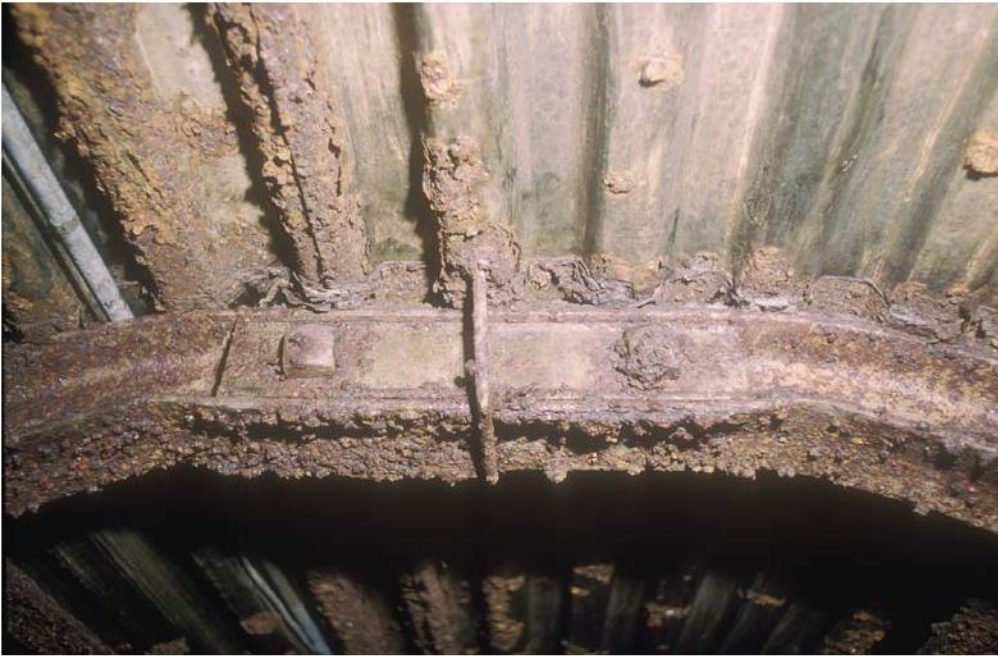
The tunnels were lined with sheets of corrugated iron that had been painted a regulation wartime green. The corrugations were two and a half inches wide and the sheeting was heavier duty than normal. Each sheet was overlapped with the next, both vertically at the apex of the tunnel, and also horizontally behind each frame. The frames were placed at three feet intervals along the tunnel, and so the sheeting is likely to have been between four and six feet in length and eight to ten feet in height to allow for a reasonable overlap between sheets. The frames were prefabricated from three-inch-square steel I-beams. These were curved to form the tunnel roof and the two sections were jointed together with a fish plate secured by a pair of three quarter of an inch bolts that were five inches long (Plate 8). Each frame was designed with a pair of mortices cut into the I-beams through which rectangular steel tension rods were passed in order to provide the frame with more lateral stability. These rods measured one and three quarters by one quarter inches and were held in position with simple wooden chocks. The corrugated sheets were further tied to the frames using angled steel ties (Plate 9) in a method reminiscent of that outlined in field manuals providing instruction on

Plate 8 Detail of Fishplate

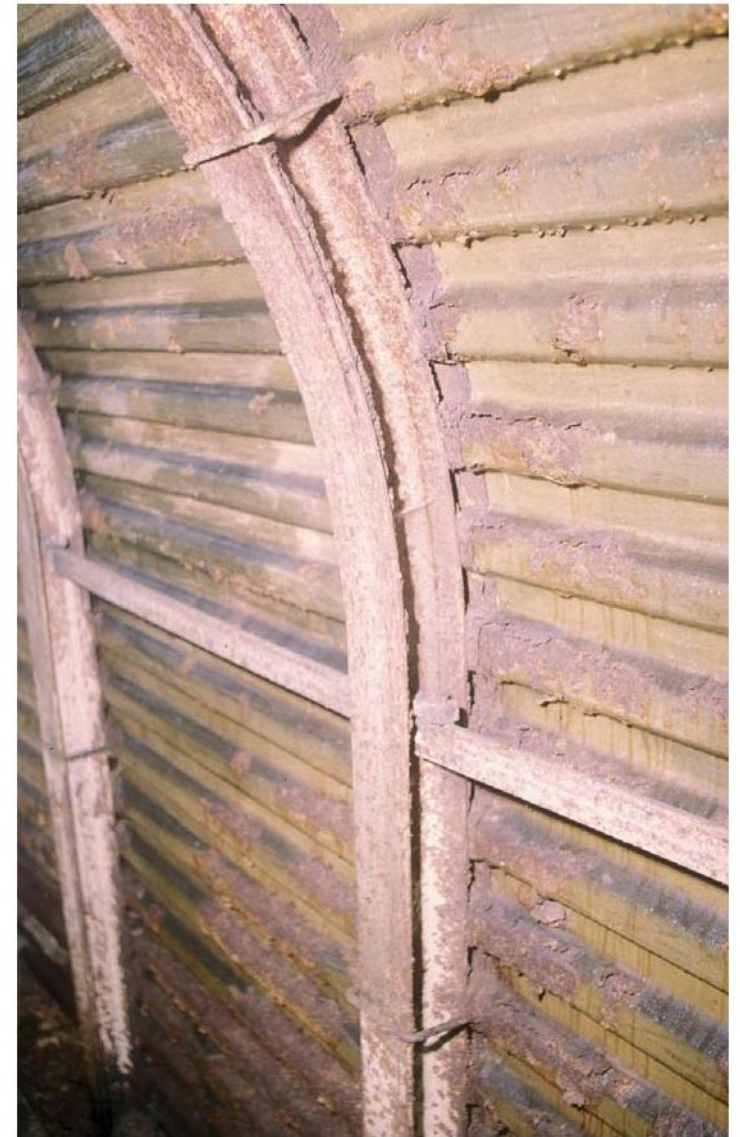
Plate 9 Detail of Steel Ties

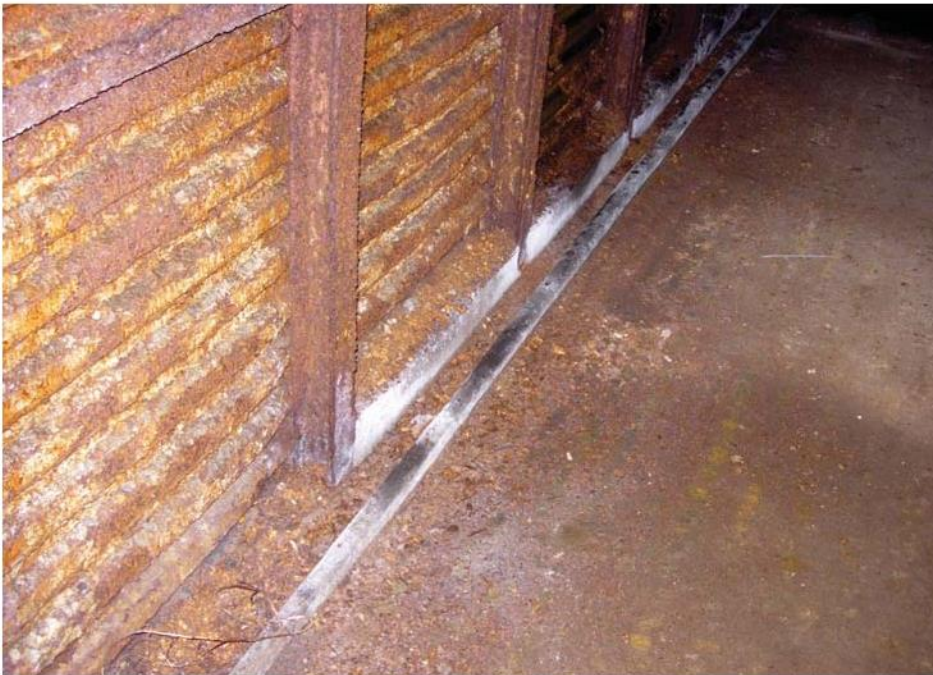
the revetment of trenches dating back to the Great War. There were commonly two of these ties on each side of the trench and one at the top. A steel conduit for the electrical supply was generally sited at the apex of the tunnels and a pair of drains ran down each side of the tunnel. The drains were designed to funnel away condensation from the walls of the shelter and had been formed after the concrete floor had been poured (Plate 10).

Plate 10 Detail of Drain

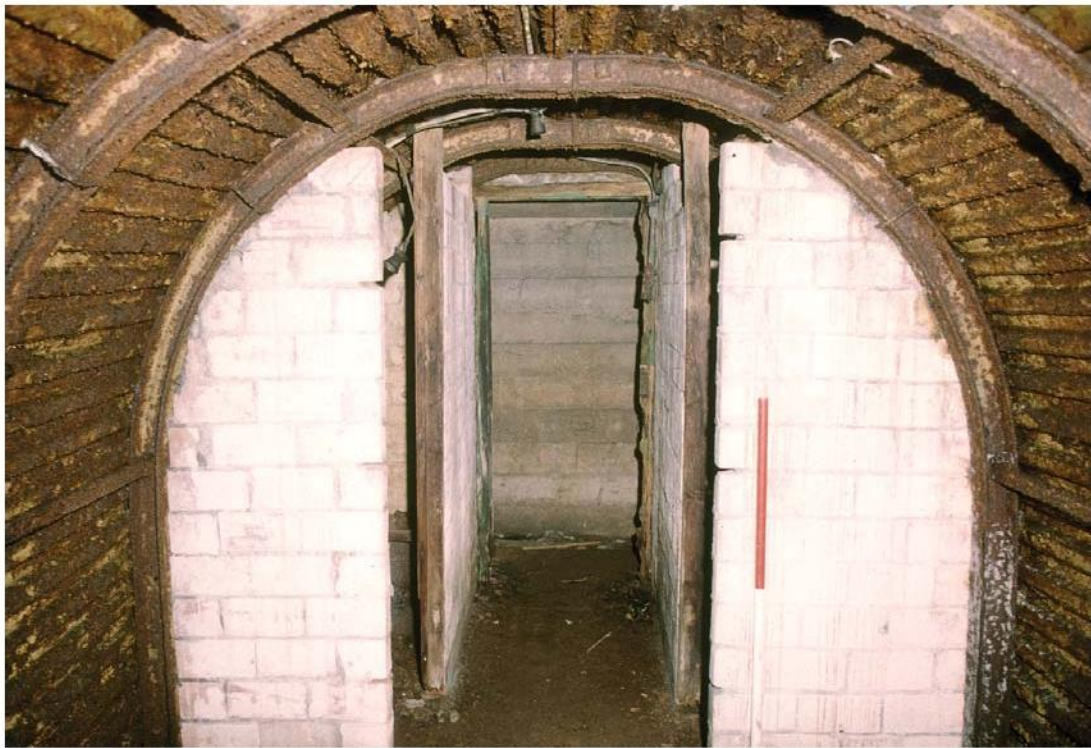
Both original entrances consisted of a poured concrete blast wall with a secondary doorway behind (Plate 11). These doorways had wooden frames to which rubber tubing had been nailed to help with the blackout (Plate 12). The characteristic imprint of the wooden shuttering for the concrete walls showed that the roughly sawn planking used was seven and a half inches (or 19cm) wide. The original brick walls forming part of both entrances were made of orange, but irregularly-fired brick that were laid as part of a conventional one brick-wide wall. The dimensions of the brick were nine by four and three-eighths by three inches. The quality of the concrete work was rough, typical of so called 'economy concrete' of this era, that used a greater proportion of aggregate than normal in order to conserve the limited supplies of Portland cement. The escape hatch was twenty six inches square, and looking up it, it could be seen that the concrete roof was at least one foot thick at this point. Four courses of original brickwork survived, but the upper part of the escape hatch had later been adapted to fit a modern drain cover (Plate 13).

Plate 11 Blast Wall and Secondary Doorway

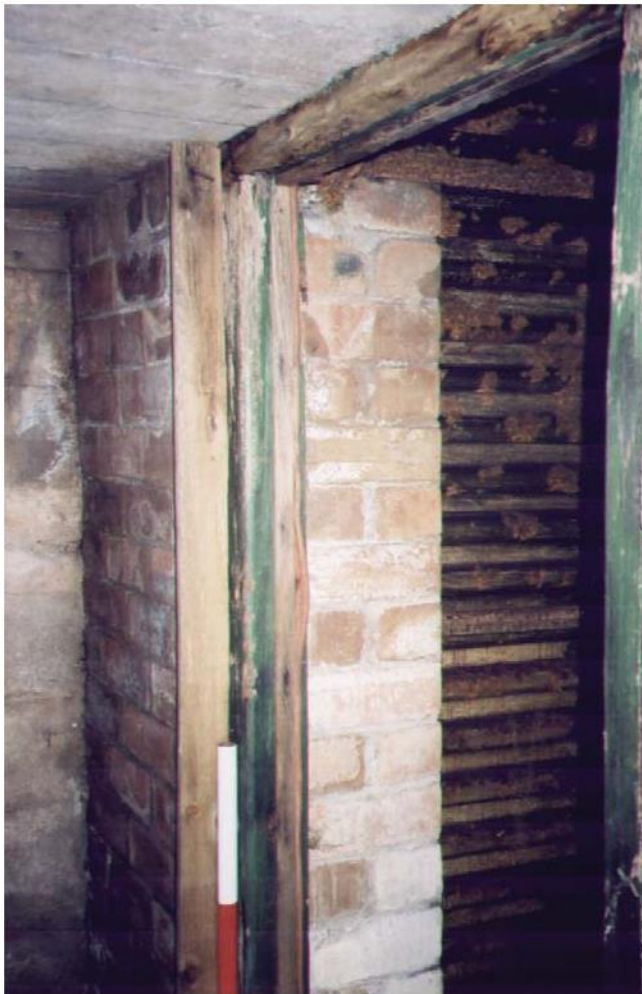
Plate 12 Detail of Door Frame with Rubber Tubing

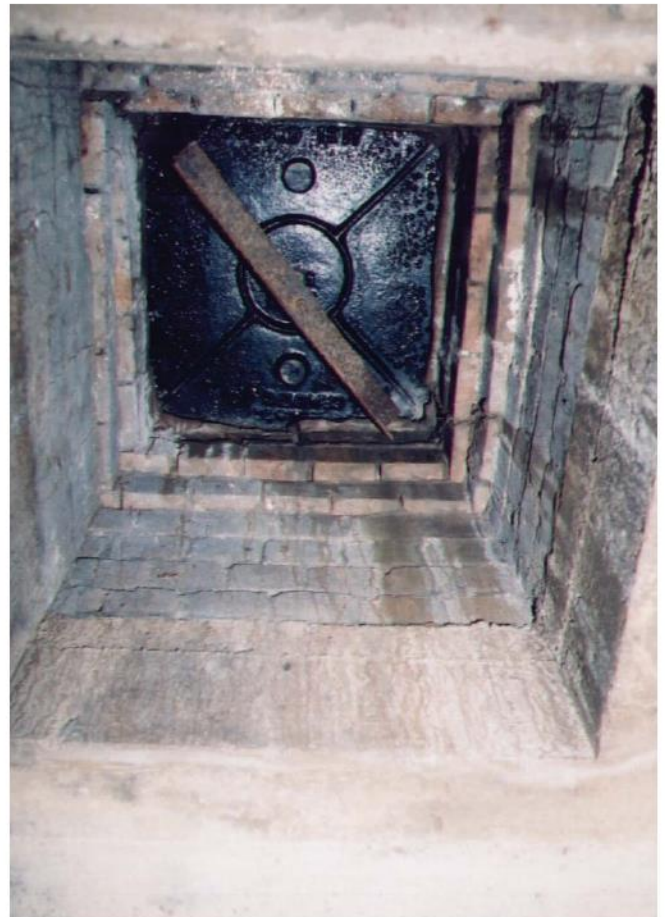
Plate 13 Detail of Later Adaption of the Emergency Exit

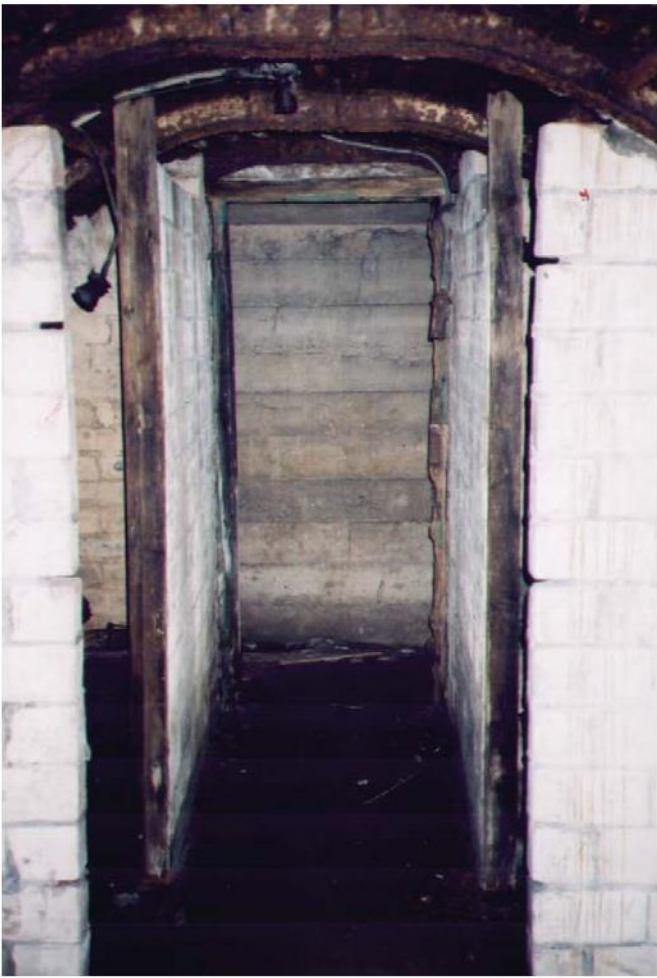
Just inside the Wergs Road entrance two small rooms had been built on either side of the tunnel (Plate 14). The bricks of these walls had been laid on edge, which was a common way of economising when constructing non-load bearing walls during the war, and a staple trick of the jerry builder. These bricks were of a different design to those used in the original build and had been extruded, the pressure points being quite noticeable along with a trademark consisting of two Bs (Plate 15). This may be the mark of Baggeridge Brick, a local company that had been operating from the former Earl of Dudley's colliery in Sedgley since the 1930s. At this time the company produced bricks from Etruria Marl that were mixed with colliery shale to lower the firing temperature. Significantly, this type of brick was commonly used for internal walling (www.baggeridgebrick.co.uk). Each of these rooms still contained a pair of rusty tins (plate 16), and were probably added to provide male and female toilet facilities.

Plate 14 Detail Showing Extra Rooms

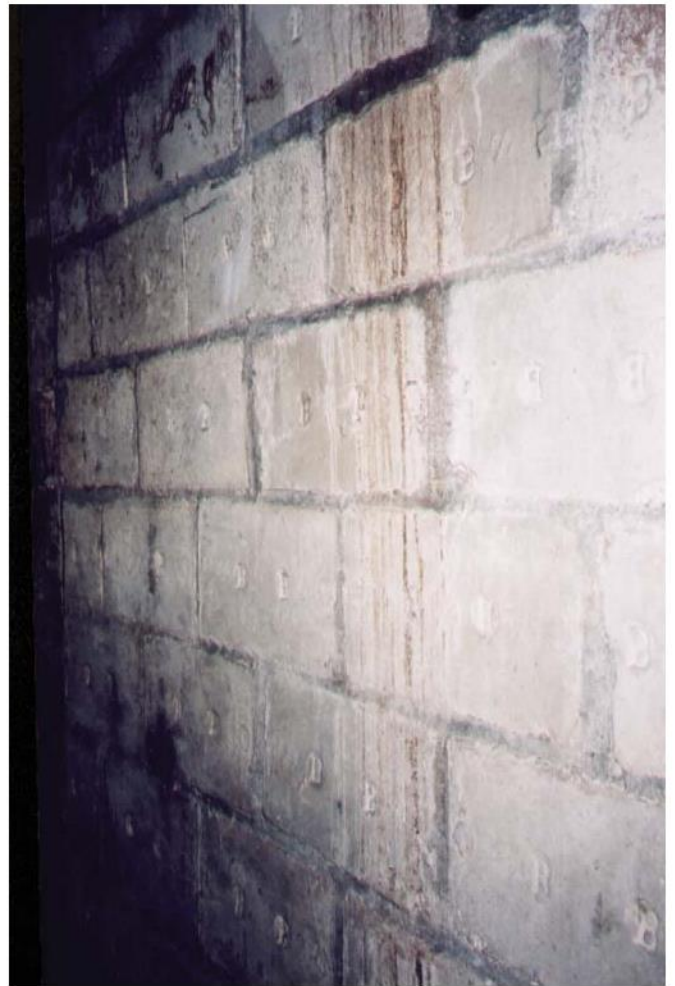
Plate 15 Detail of Bricks

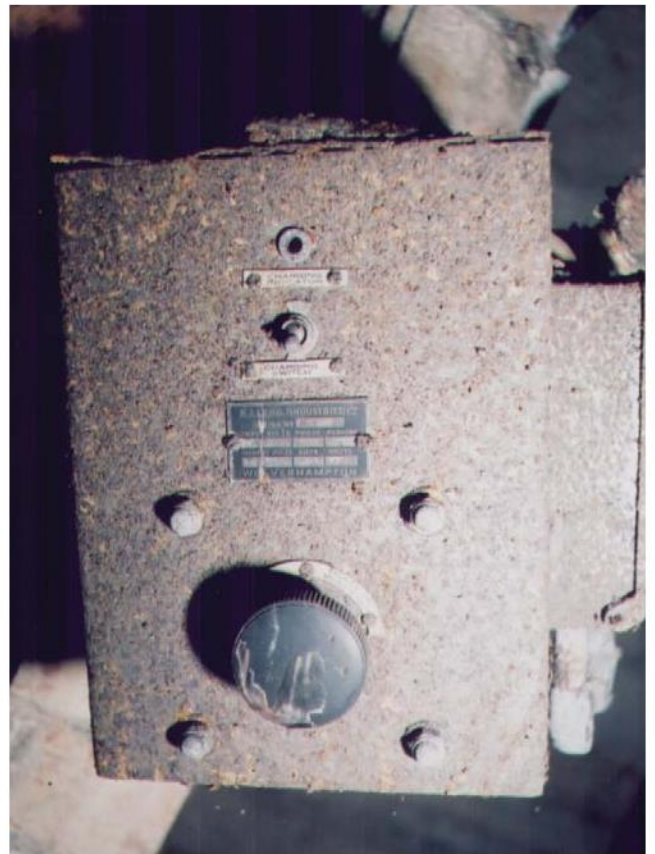
Electric lighting had been fitted and inside the Upper Green entrance was a control box and charger for a battery, presumably to run emergency lighting. The control box was manufactured by a local firm, B.J. Legg (Industries Limited) of Wolverhampton and was labelled as having an input of 200volts in one phase and 50 periods and an output of 12v in one phase and 100 periods (or cycles, Plate

17). There may have been an accidental electrical fire at some point during the life of the shelter, as part of the ceiling near the escape hatch showed signs of fire damage.

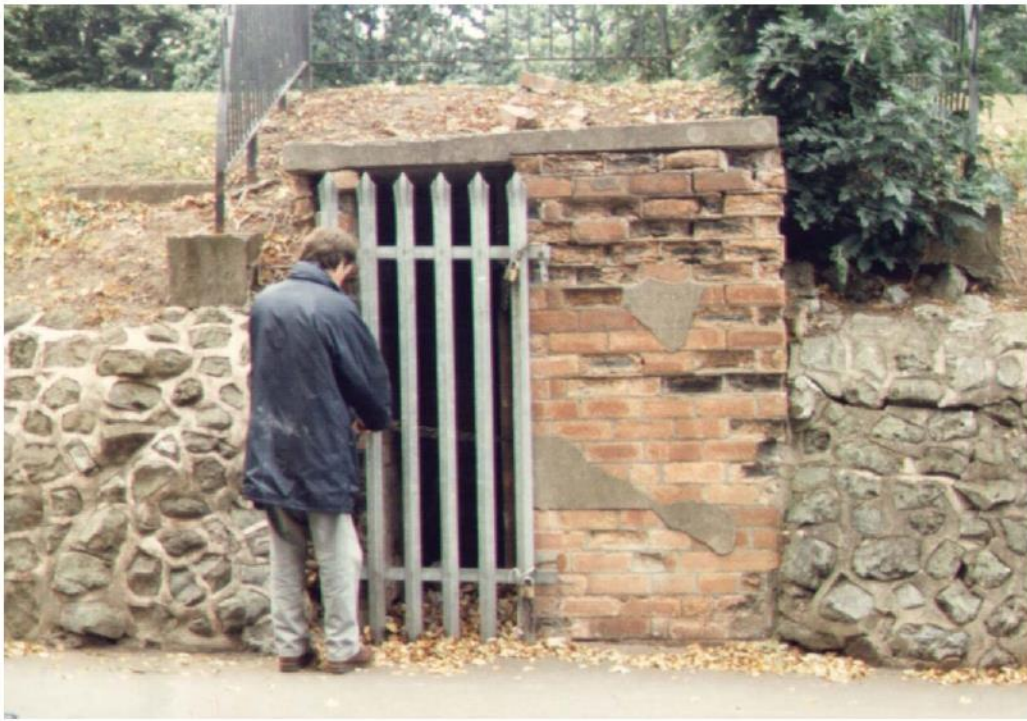
Both outer entrances were added later and consisted of brick enclosure walls supporting a quality concrete roof in which the shuttering was only five inches wide. Both entrances had originally had a door (Plate 18), although the Upper Green entrance has been closed off until c.1996, apart from a pair of air bricks to add ventilation (Plate19), this was the entrance that had latterly been open. All of these changes were probably made after the war in an effort to regulate access into the shelters, which, like other subterranean structures such as icehouses for example, may easily become magnets for anti-social behaviour.

Plate 18 Entrance from Upper Green Road in 1996 (Whitehouse)

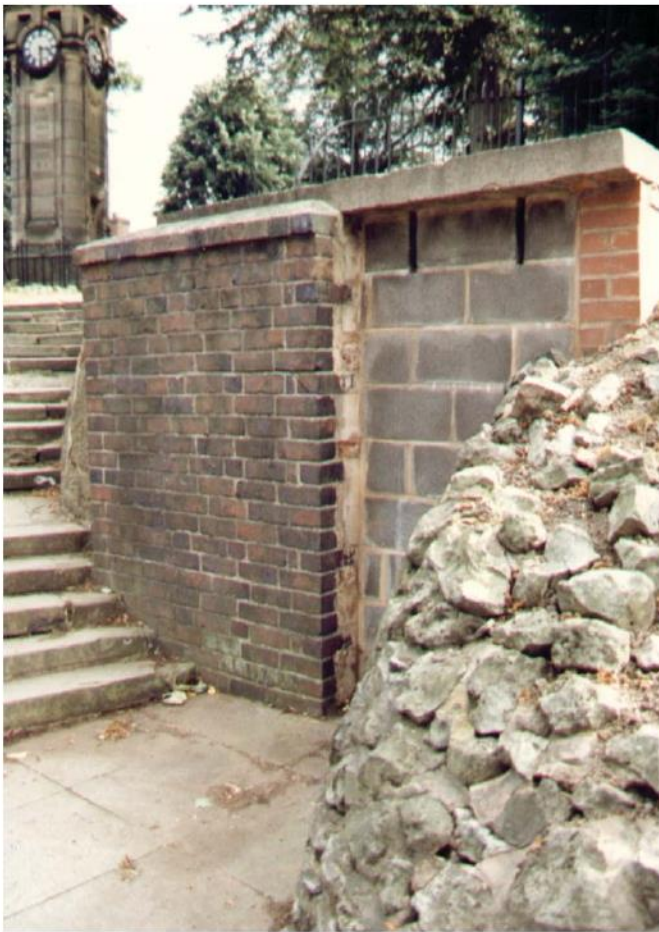
Plate 19 Entrance from Wergs Road in 1996 (Whitehouse)

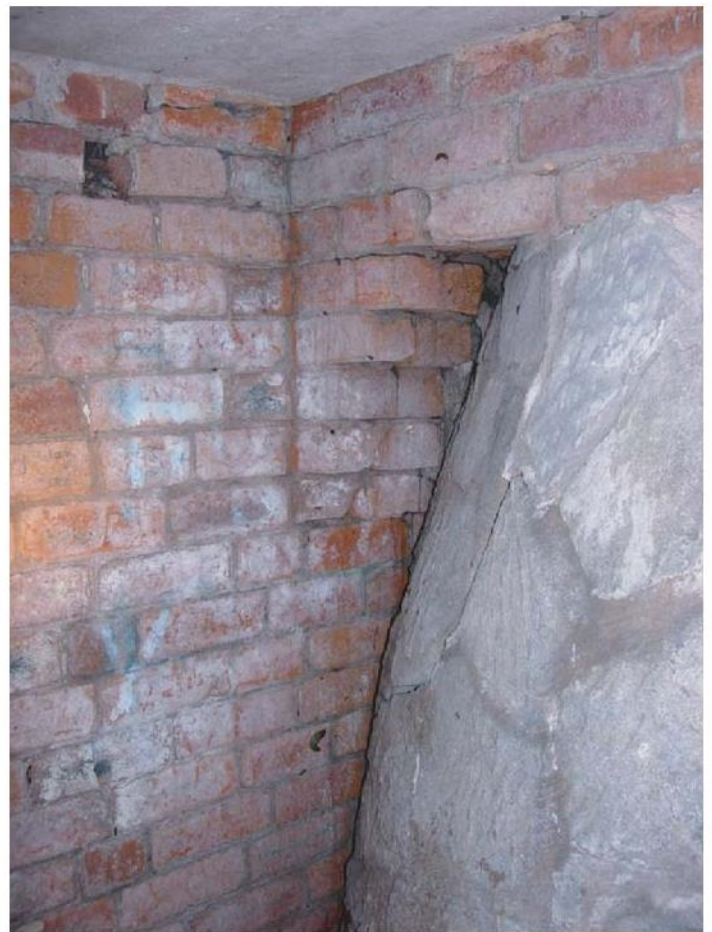
The precise relation of the shelter to the stone walls that surround the bank to the Upper Green here is not entirely clear. They clearly predate the construction of the outer entrances, which are built over them, but the stone walls also abutt the concrete blast walls, although they may be roughly contemporary. The entrances would most probably have been further protected with walls and revetments made of sandbags, no trace of which remain.

Plate 20 Detail Showing Brick Entrance Built Over Earlier Stone Walls
