Connecting Derby

Archaeological Building Recording 2005: Stage 1

Project No.1325.01 February 2006

By Leonie Driver and Malcolm Hislop

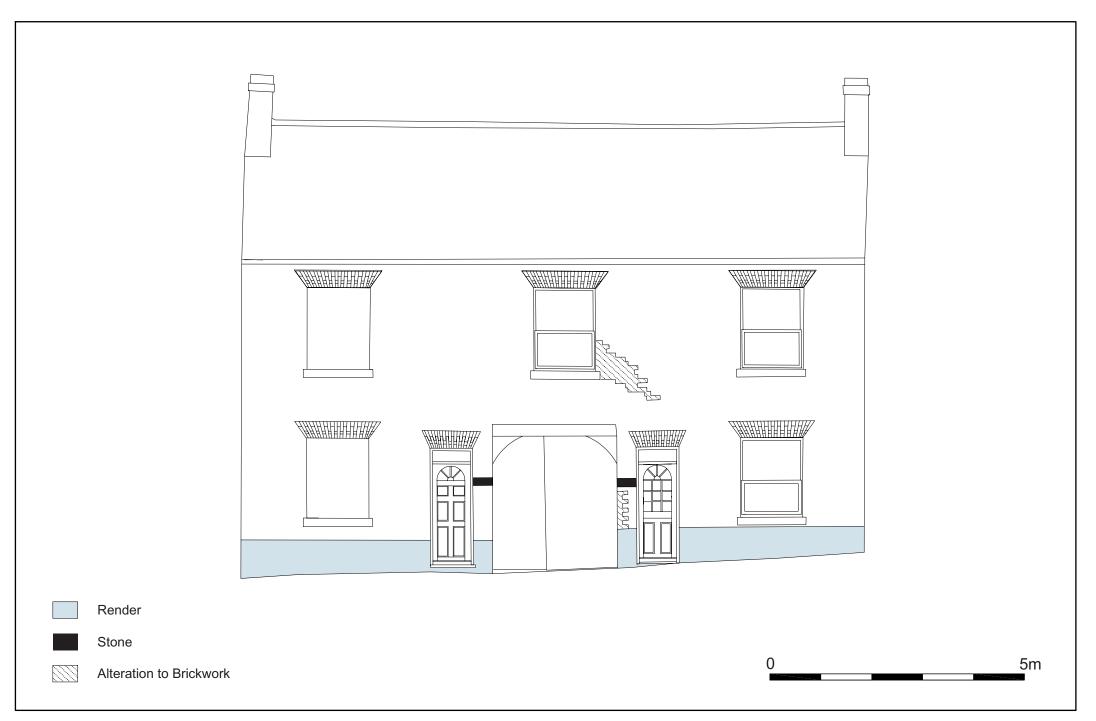
Fig.15 43-44 Talbot Street, Southwest Facing Elevation

Pair of semi-detached houses and associated workshop, probably a small manufactory, now forming part of a three-phase terrace with Nos. 36-42 Talbot Street. Early to mid 19th century. Red brick laid in Flemish stretcher bond on rendered plinth, slate roof, brick end stacks. Two storeys, three bays with large central carriage entrance flanked by two house doors. Between the carriage entrance and each door is a stone hinge block. All windows had been replaced in the late 20th century but were within the original openings, which, like the doorways, had gauged brick heads. To the rear was a yard containing a large contemporary two-storey workshop. The ground storey was brick built and had large double doors with 20th-century windows either side. The upper storey appeared to be a later addition, and the workshop may have been single storey originally. There was a small brick-built hearth in the corner of the room with a large brick chimney extending up through the interior of the building. An inserted staircase at the opposite end gave access to the first floor of the building. The workshop had a concrete floor and a fixed wooden desk at the end of the staircase alongside one of the large windows.

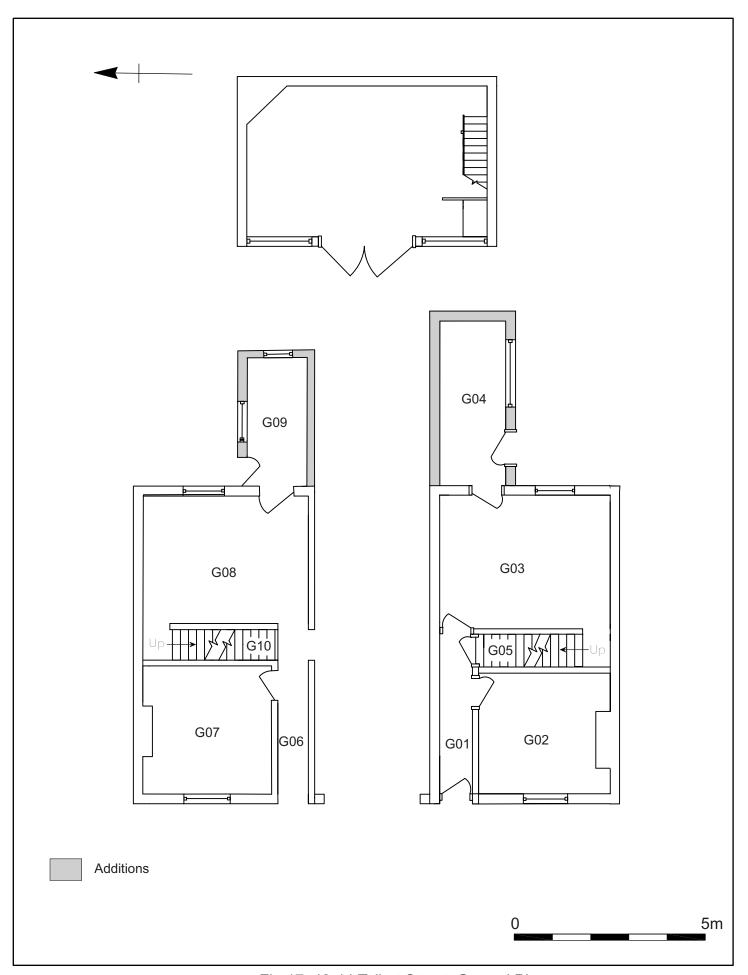
Fig.17 43-44 Talbot Street, Ground Plan

G03 was situated at the rear of the house, and probably served as the kitchen originally. All original features had been replaced in the later 20th century. A single window in the east wall of the room overlooked the rear of the house. G03 gave access to the kitchen (G.04), which was in a single-storey 20th-century extension at the back (east) of the main house.

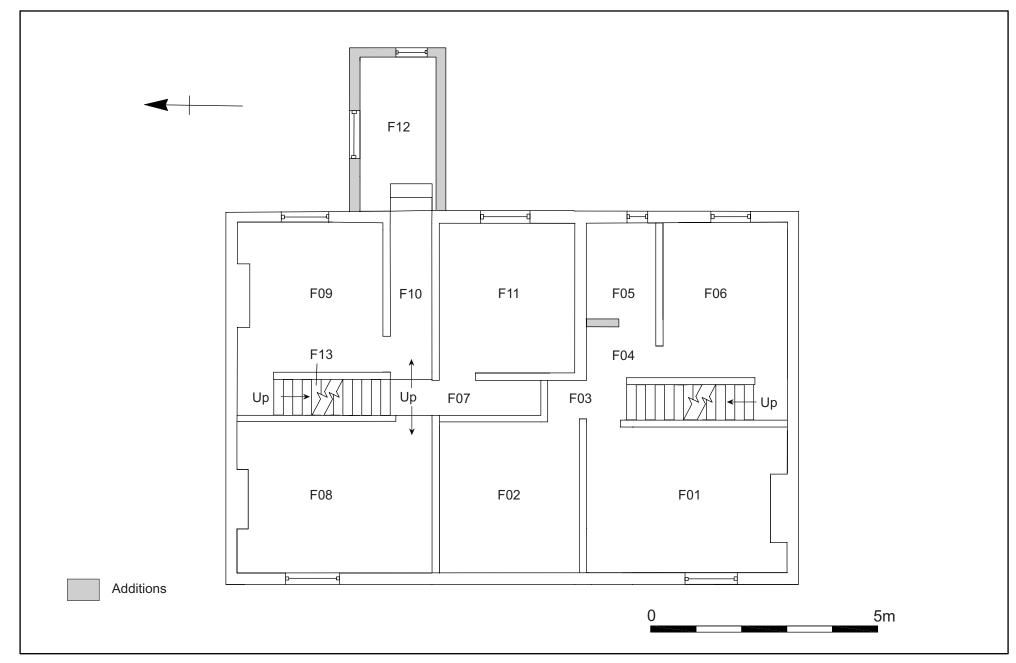
Fig.18 43-44 Talbot Street, First-Floor Plan

G03 also gave access to a 14-step narrow staircase, with plain wooden handrail, (G.05) leading to the first floor landing (F03). F01, at the front of the house, had a chimneybreast on the south wall, but the fireplace had been removed and the opening blocked. All other original features had been replaced in the later 20th century.

A second room, F02, was located to the north of F01, above the large, central carriageway entrance. Like F01 all original features have been replaced. At the rear of the house were two further rooms: F05, the bathroom, had been completely modernised, and F06 had also undergone extensive redecoration and modernisation. Windows, doors, flooring and skirting had all been replaced in recent years.

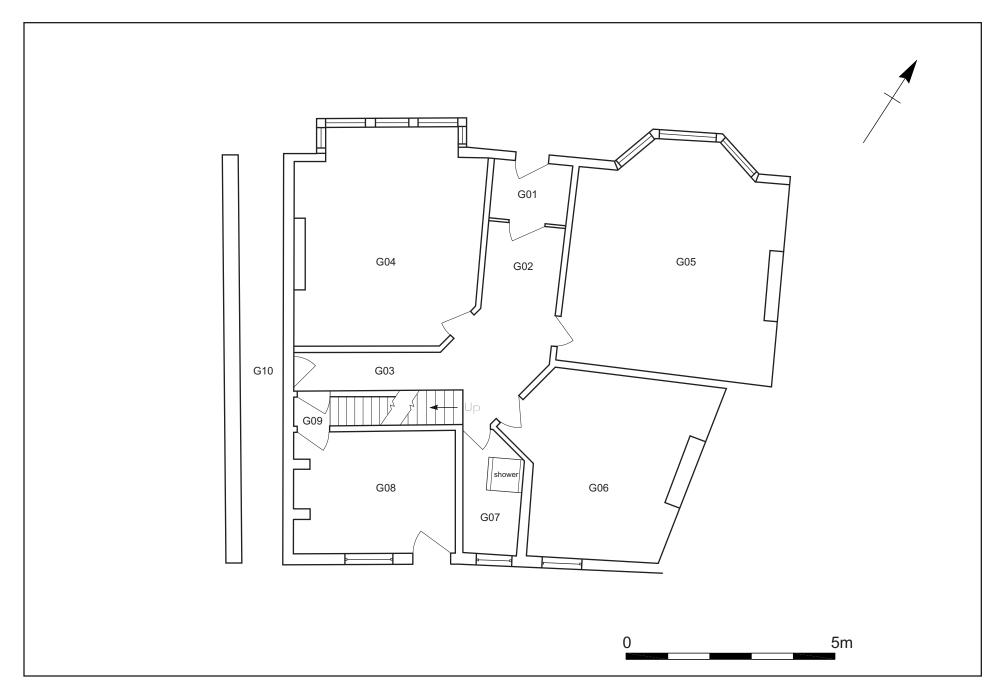
Fig.21 40 West Avenue , Ground Plan

The front door gave access to an internal porch (G01), sectioned off from rest of hall (G02) by a wooden glazed screen, probably original, containing a part-glazed door. Glass panels either side and above the door of frosted glass, probably replacements. The door also had two large glass panels in its upper section. Floor of decorative Minton style tiles and moulded plaster cornice around ceiling.

Beyond the porch was a large hallway (G02) which gave access to all ground floor rooms. The tiled floor, a continuation of that in the porch, had been carpeted over and the skirting replaced. From G02 a large staircase with wood panelled dado led to the first floor. The main hallway also led to a narrow corridor (G03) alongside the staircase which provided access to the alleyway on the west side of the house, the entrance to the cellar, and Room G08 which was located beyond the staircase.

G04 was a large front room on the east side of the hall, entered via a later 20th-century replacement door. The floor was made up of original floorboards, and the room decorated with later 20th-century skirting board, original moulded wood picture rail and original decorative plaster cornice. A chimneybreast with its fireplace removed was positioned along the west wall of the room. A square bay window faced onto West Avenue. It had three sash windows at the front facing north with 16 panes in upper frame and plate glass to lower. In the sides of the bay were two further sash windows of narrower dimensions, having 8 panes in upper frame and plate glass to lower.

The second main reception room, G05, which is located on the west side of the corridor, was entered via a replacement later 20th-century door. The floorboards were of pine. The skirting board were a later 20th-century replacement, but original moulded wooden picture frame and plaster cornice decorated the walls. A chimneybreast occupied the east wall of the room but the original fireplace had been removed. In the centre of the ceiling was a decorative plaster ceiling rose. The main feature of this room was a large canted bay in the north wall facing onto West Avenue. This had a large central sash window with 24-panes in the upper frame and plate glass to lower, flanked by two further sash windows with 12-panes in their upper frames.

Room G06 was also entered the main hallway. This room was located to the rear of the building on its east side. This room had a concrete floor and the skirting had been replaced. A chimneybreast was situated on the east wall but the original fireplace had been removed and the opening blocked. On the north side of the chimney was an original wooden storage cupboard with four doors. A modern window in the south wall and overlooked the garden at the rear of the house. Access to the room was via a later 20th-century door within a later 20th-century door frame.

A partition wall had been inserted along the west side of the room to provide space for a later 20th-century lavatory and shower room (G07). G07, which would originally have been part of G06 also had a concrete floor and later 20th-century window in the south wall. The door which gave access to this room from the hall, together with its architrave, had been replaced in recent years.

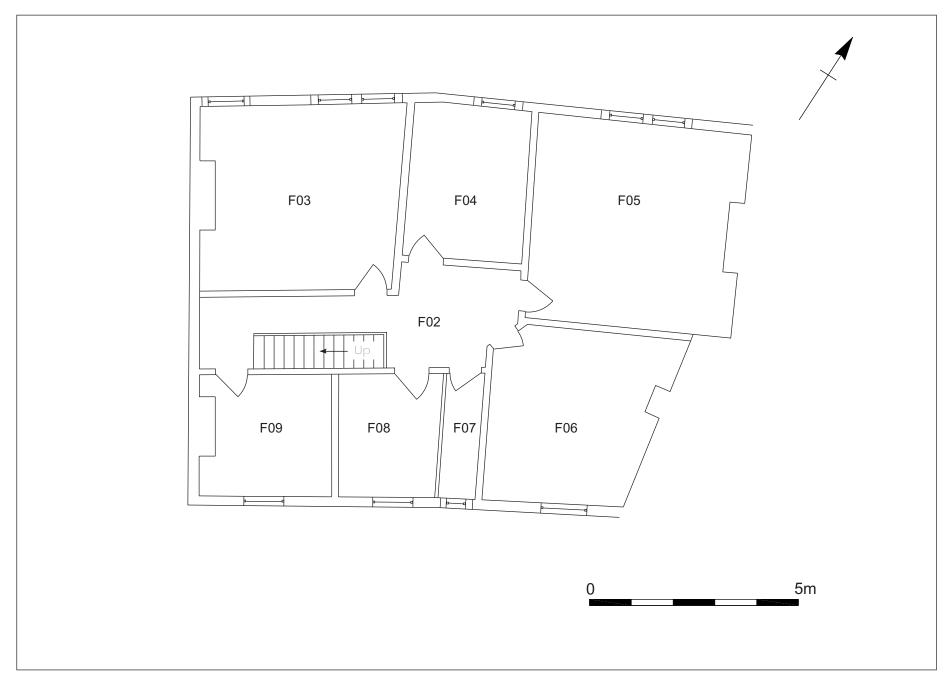
Fig.22 40 West Avenue , First-floor Plan

At the rear of the house were four further rooms. F06 had a later 20th-century door and architrave. The room retained its original skirting, and there was a narrow chimneybreast in the east wall, next to which was a fitted cupboard. The frame of this cupboard was original, but the doors had been replaced. A later 20th-century window was situated in the south wall of the room and overlooked the rear of the house. To the west of room F06 was a very narrow room (F07) providing space for a lavatory on the first floor. This room has retained its original skirting. In the south wall was a small sash window with frosted glass, within a moulded wooden frame.

Room F08 had a carpeted floor and later 20th-century bathroom suite. The original skirting was in place. The window in the south wall was a modern replacement as were the door and doorframe.

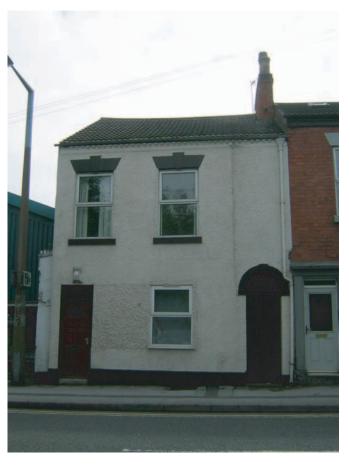
Plate 1 Plate 2

End terrace house. Late 19th century with later alterations. Roughcast with later 20th-century concrete tile roof. Two storeys with dentilled eaves band. Ground floor has a later 20th-century house door to left, central later 20th-century window, and alley entrance to right with semi-circular arch and raised key. Two later 20th-century first-floor windows within original surrounds with wedge-shaped lintels and raised keystones.

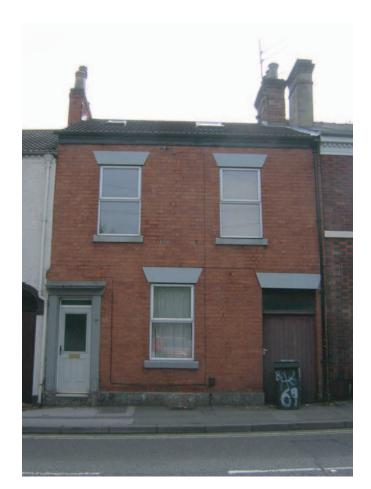
House, latterly part of a three-phase terrace. Late 19th century with later alterations. Red brick with stone and plaster dressings, concrete tile roof. Two storeys on stone plinth, with eaves band. Two bays of later 20th-century windows within original surrounds with stone sills and plaster wedge-shaped lintels. Half-glazed house door to left with plain pilastered doorcase and narrow overlight beneath a cornice hood. Alleyway entrance to the right with boarded door, grilled overlight and wedge-shaped lintel.

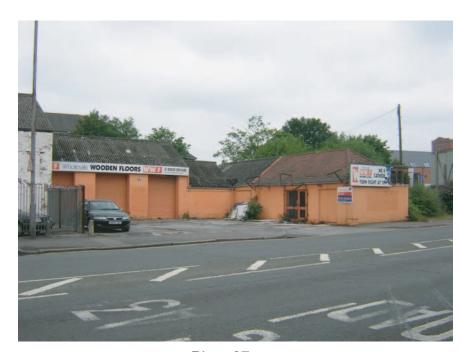
Plate 27

Commercial units. Mid-20th century with later alterations. Painted brick, plain tile and corrugated asbestos roofs. L-shaped group of single-storey buildings set back from Ford Street to partially enclose a forecourt. Three-bay east facing range with large vehicular entrances. South facing range containing one glazed and two boarded doors, probably contained the office.

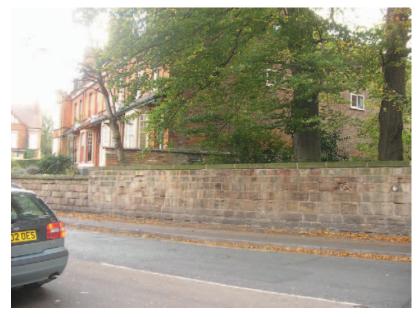
Plate 33

Front boundary wall. Late 19th-century wall of coursed and squared large stone blocks, some with herringbone pattern tooling, and plain slab coping.
