**CONNECTING DERBY**

**Historic Building Recording**

**Land between King Street,  
St. Helen's Street and  
Lodge Lane**

## **Connecting Derby**

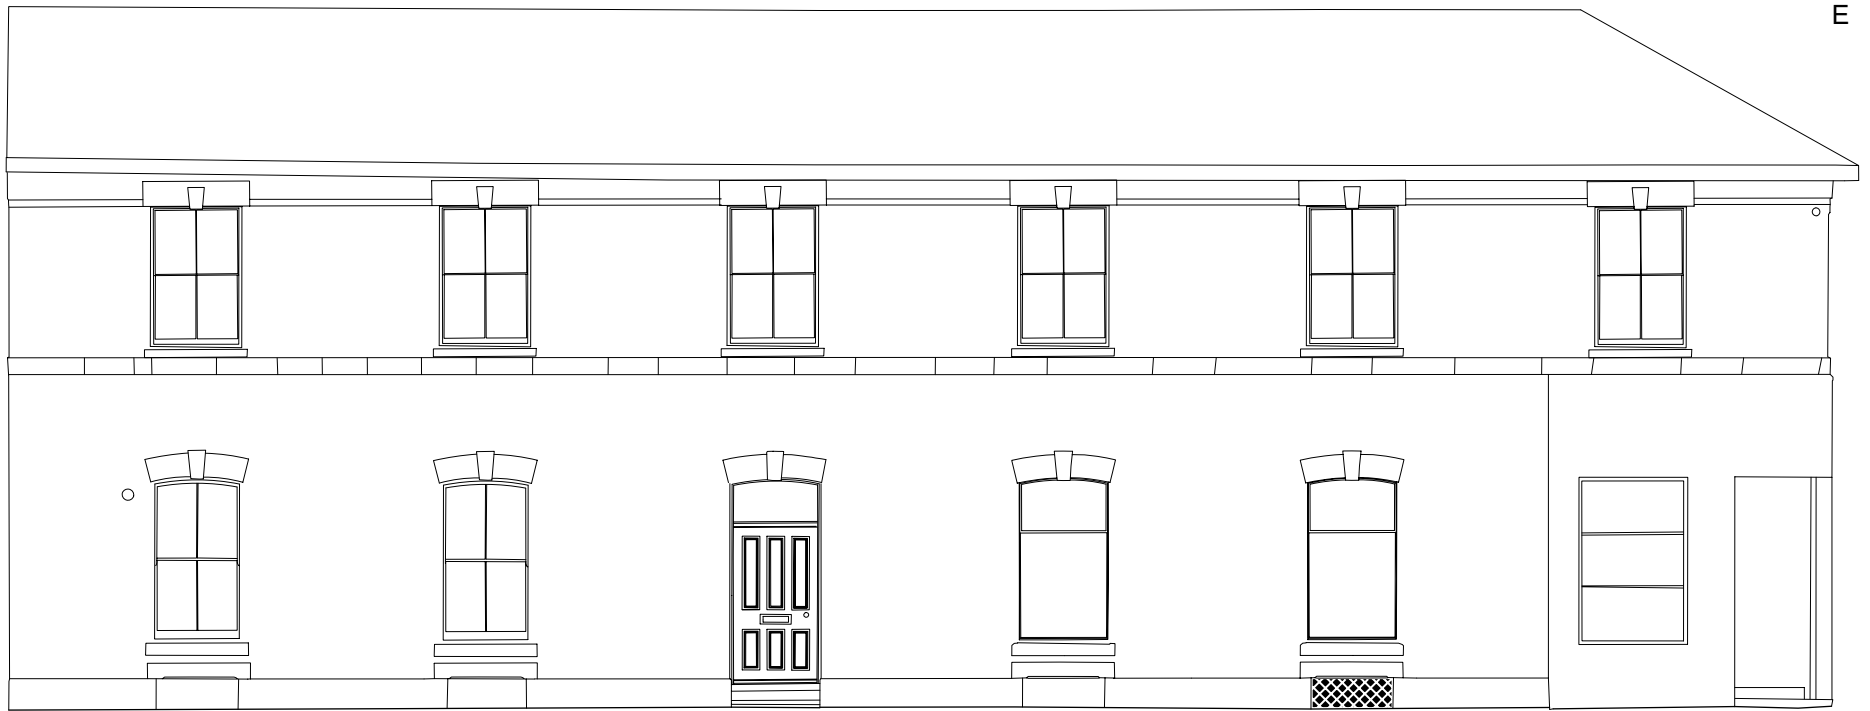
Fig.4

Nos. 2 - 8 St Helen's Street Elevation

Late 19<sup>th</sup> century. Red brick, laid in Flemish bond, with stone dressings and hipped slate roof. Two storeys over cellar. Six bays of four-pane sashes, those to bays four and five (from left) at ground floor level replaced with late 20<sup>th</sup>-century lights. The ground floor windows have segmental arches with raised keys and aprons (Plate 4), the first floor windows flat lintels with raised keys breaking the eaves band. Door to bay 3 (Plate 3), left of centre with overlight. Late 20<sup>th</sup>-century shop front to ground floor right continuing around the corner into the 2-bay King Street elevation (Plate 2). Cellar openings beneath each window bay with flat chamfered lintels, that to far right retains its cast iron grill.

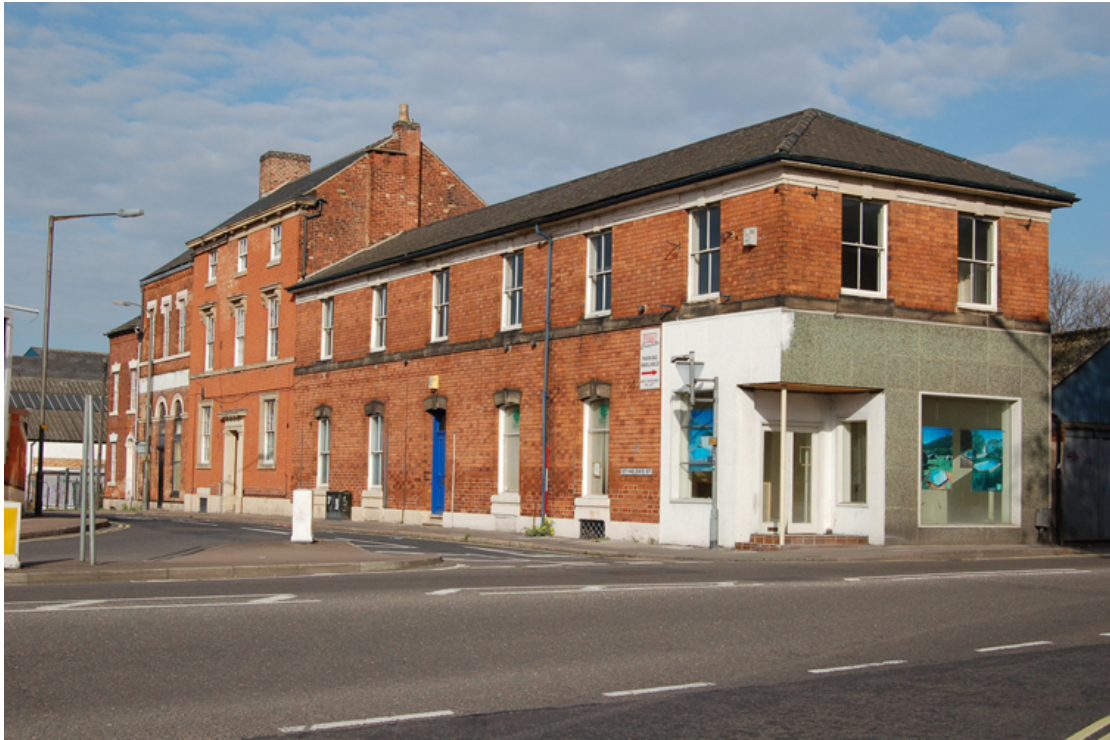
**Plate 1:** 2-8 St. Helen's Street, oblique view from the east.

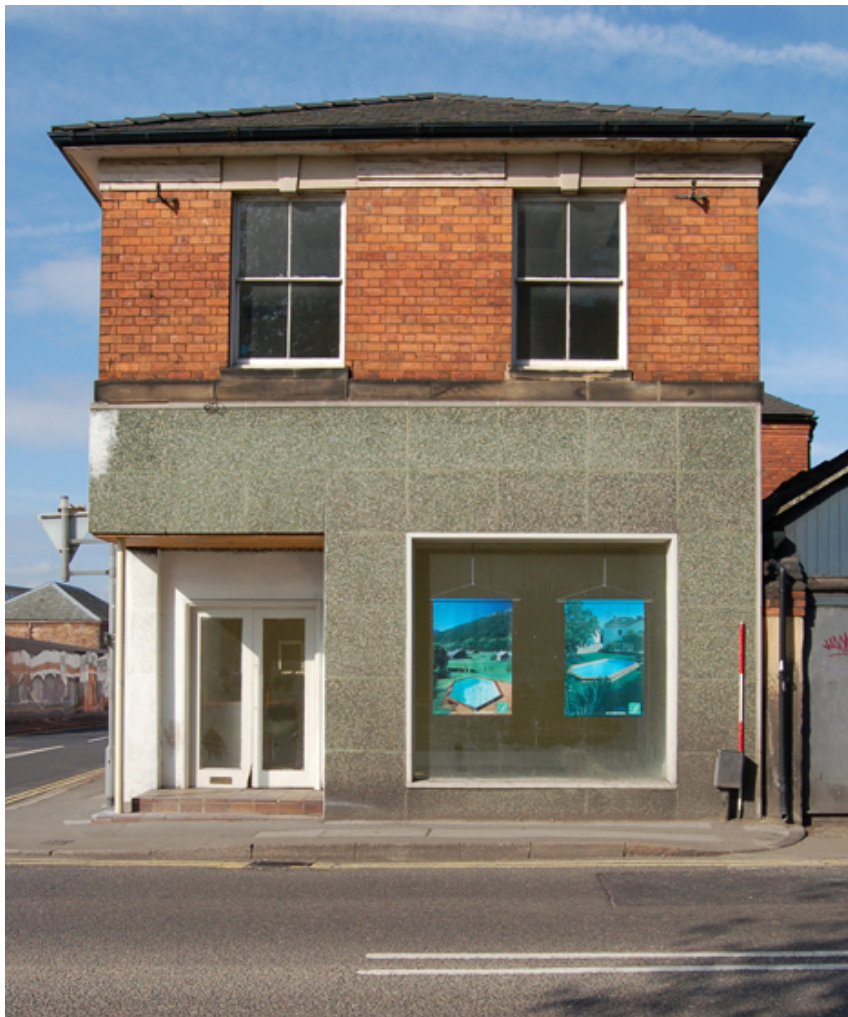
**Plate 2:** 2-8 St. Helen's Street, elevation onto King Street.

Nos. 2-8 St Helen's Street were originally constructed by Joseph Richard St. Helen Hall between 1866 and 1869, as a new showroom for the Spar Manufactory on King Street (Steer 2003a, 4; 2003b, 168). The initial layout of the showroom would appear to have been of a single open space at each floor level, with high coved ceilings at first floor. As noted above, it seems that the St. Helen's Street elevation may originally have been fully fenestrated at ground floor level, with the principal door only being added with conversion to domestic use. Original access from the manufactory to the north would have been via the wide segmental arch, recorded in rooms G2 and G3 (Figure 7; Plates 8 and 9), and main access to the showroom was presumably from King Street, where the ground floor elevation has since been radically altered (Plate 2).

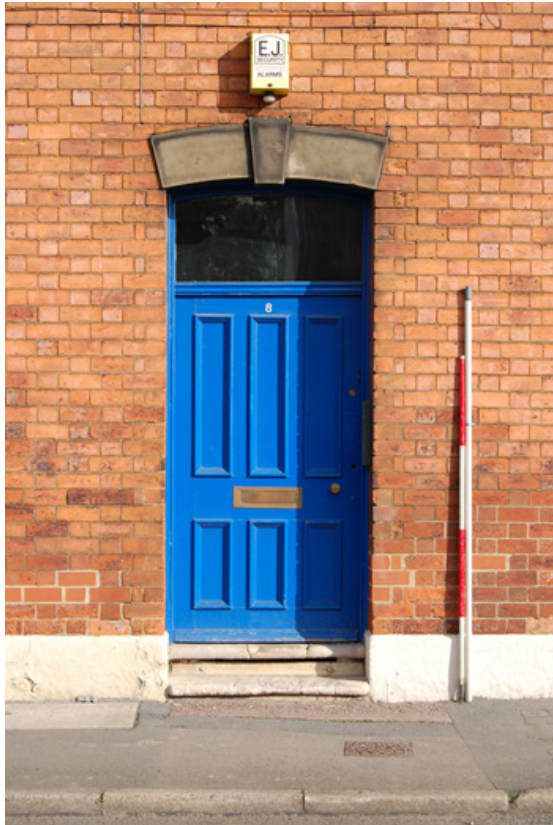
**Plate 3:** 2-8 St. Helen's Street: detail of door.

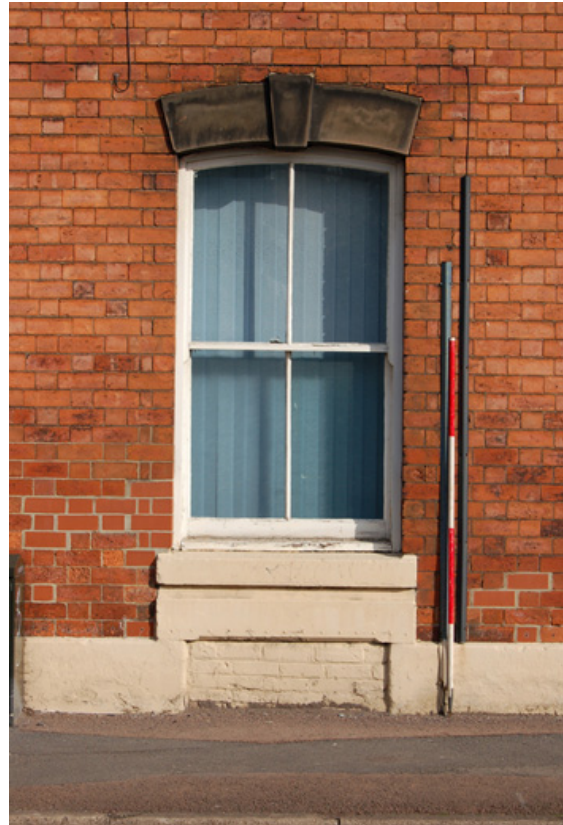
**Plate 4:** 2-8 St Helen's Street; detail of window, note blocked borrow-light below.

The south wall of the basement rooms retained a total of five, evenly spaced borrow-light windows at street level, which repeated the pattern of fenestration of the ground and first floor levels (Figure 4; Plate 1). Openings were blocked in brick save for that to the east which retained its iron grill. A redundant coal chute, also blocked, was located beneath the westernmost window of the wall (Plate 6). Interestingly, a blocked borrow-light was recorded, coincident with the principal doorway to the building at ground floor level. Such an arrangement is unusual and may suggest that the ground floor door has been adapted from a former window opening, although there is no clear evidence of patching within the brickwork around the door to substantiate this hypothesis. A rectangular recess within the north wall in Room B2 possibly represented the original location of stair access, before the erection of the north extension.

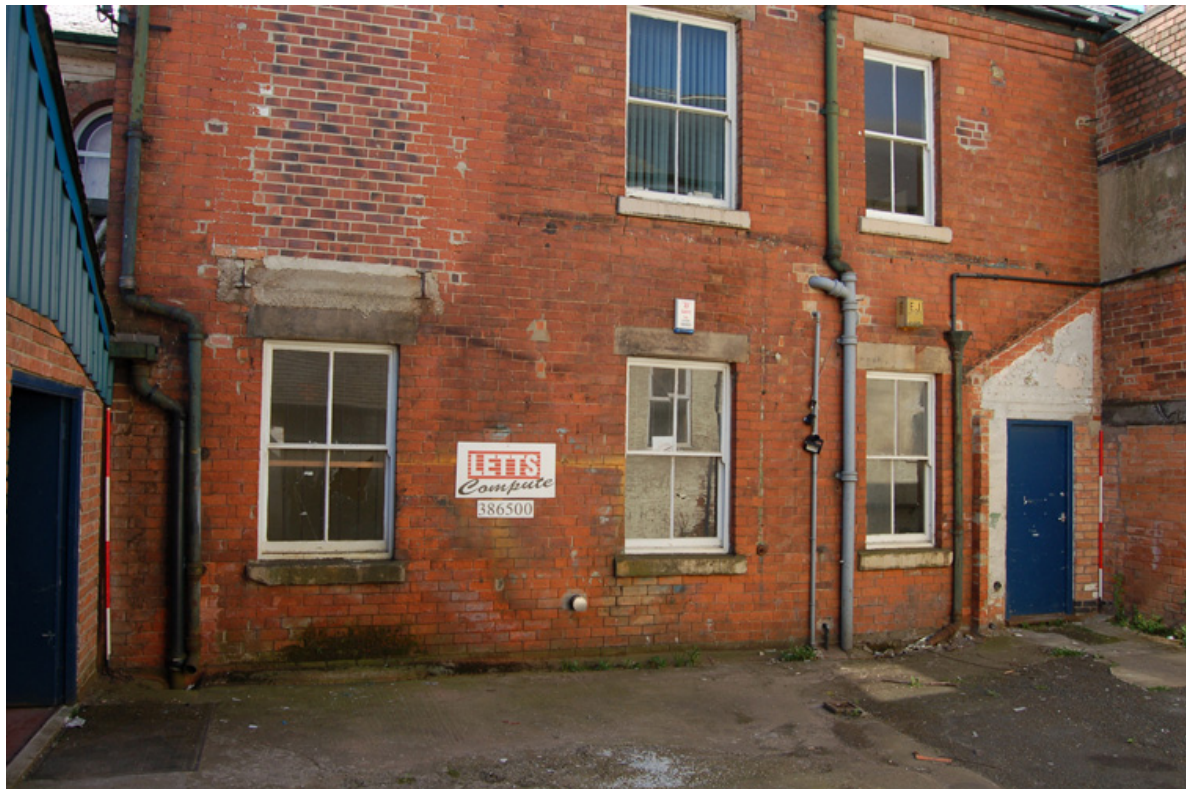
**Plate 5:** North (rear) extension to Nos. 2-8 St. Helen's Street.

The layout of the rear extension mirrored that at ground floor level, with the exception of the (secondary) subdivision of the western room to form F5. The rooms of the rear extension (F4-6) retained plastered walls and ceilings with skirting and cornice details matching those in Rooms F1-3 to the south. Fenestration of the north wall was of two four-pane sashes beneath flat heads, corresponding to the western two windows at ground floor level, the eastern window at first floor level (visible externally; Plate 5) appeared to have been first extended to form a door and subsequently blocked.

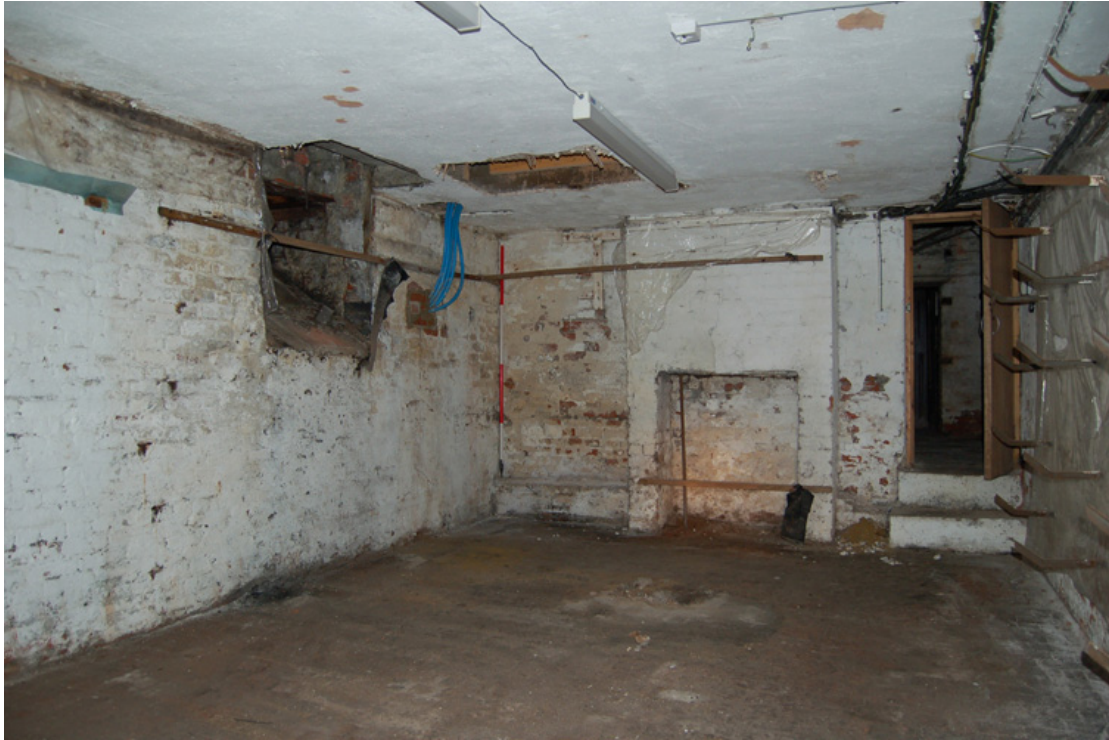
**Plate 6:** Basement Room B1, looking west. Note coal chute to south wall (left).

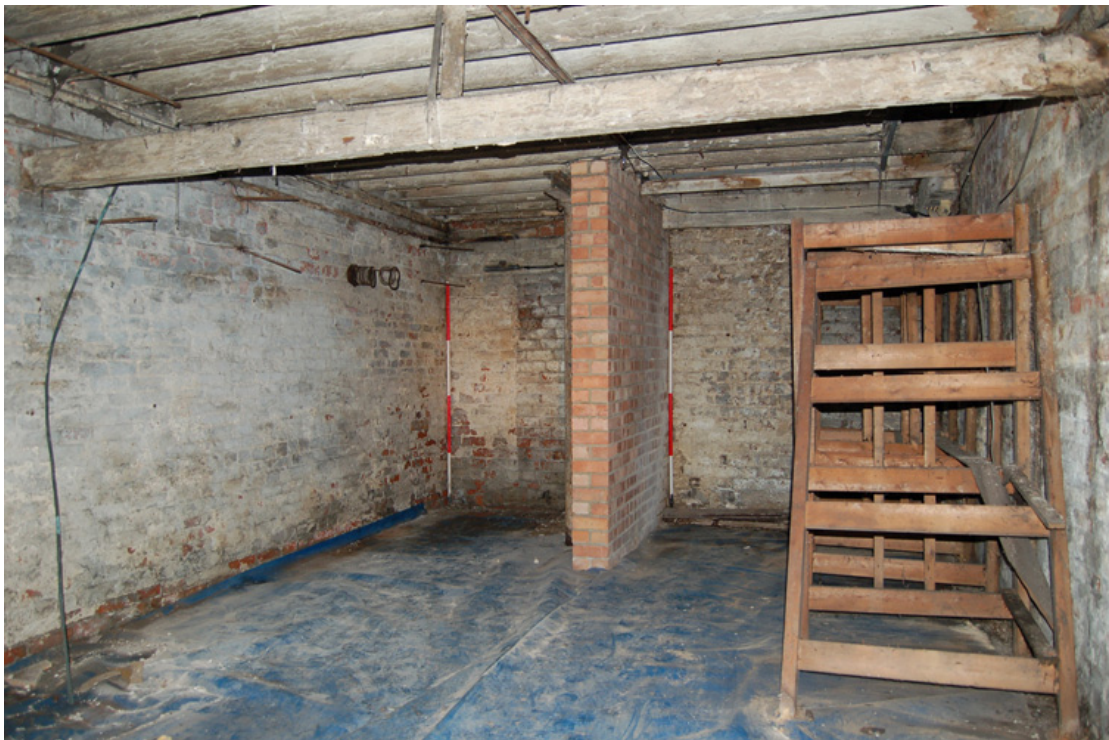
**Plate 7:** Basement Room B4, looking east, with inserted axial partition.

Within Room B4 at the eastern end of the basement, a central, axial partition wall of late-20<sup>th</sup> century date, projected approx. 2.5m into the room (Plate 7), probably related to the alterations of the shop

frontage at ground floor level. To the north of this was a steel post supporting a short, east-west aligned I-section beam, apparently inserted to provide additional support for the joists above.

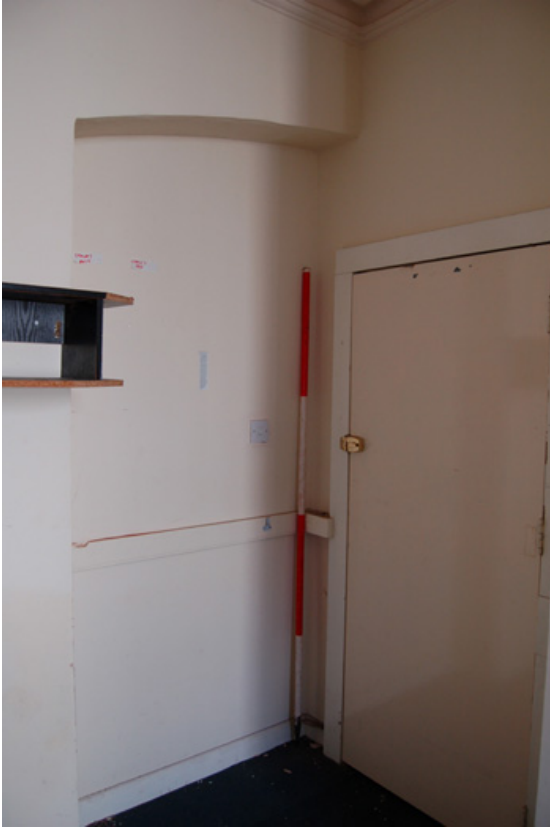
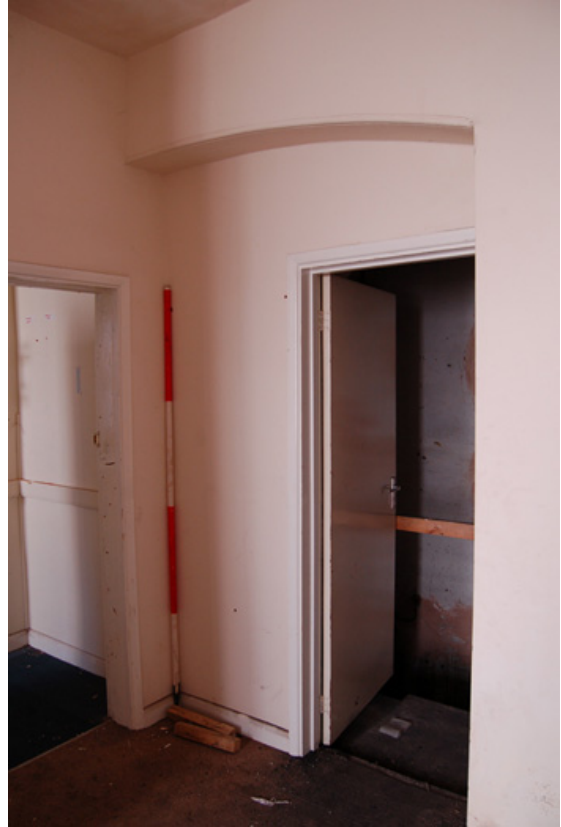
**Plate 8:** Segmental arch visible within Room G3.

**Plate 9:** Segmental arch visible within Room G2.

This partition wall was noted to butt up against the infill of a wide, segmental arched opening which spanned between rooms G2 and G3 (Plates 8 and 9). This opening logically represented a wide access to the south range, pre-dating the erection of the northern extension and the rearrangement of stair access between floors in the south range (see above). At the north end of the west wall of G2, the floor ramped upward to a doorway leading through to No.10 St. Helen's Street to the west.

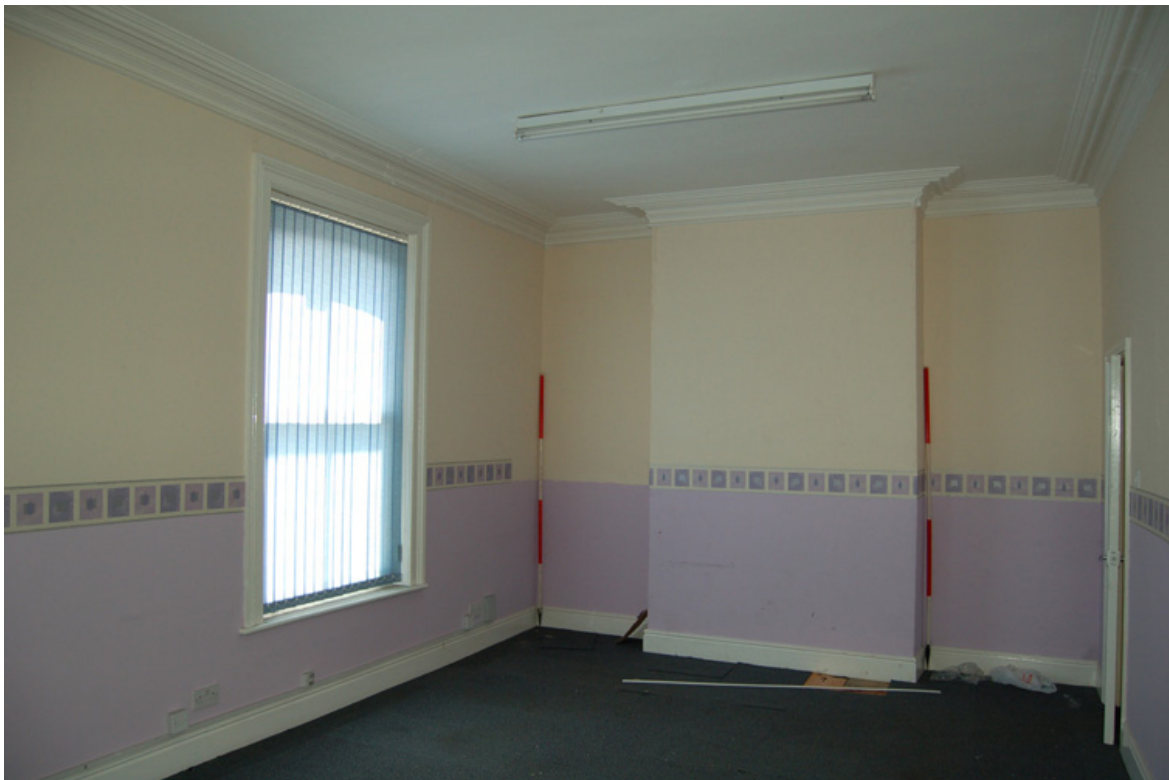
**Plate 10:** Room G1, looking west: projecting stack and moulded cornice.

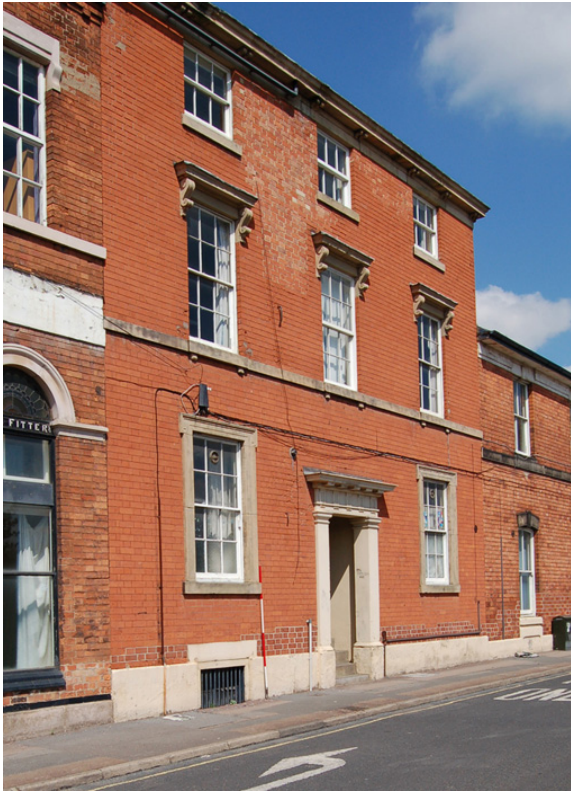
**Plate 11:** No.10 St. Helen's Street.

House. Mid-19<sup>th</sup> century. Red brick, laid in Flemish bond, with stone dressings, slate roof. Three storeys (reduced proportions to second floor) over cellar with plastered plinth and oversailing eaves cornice on paired corbels. Three bays of twelve-pane glazing bar sash windows, the centre ones refenestrated in the late 20<sup>th</sup> century. Ground floor windows have raised and eared surrounds, first floor windows have corbelled sill band and bracketed cornice hoods. Central pilastered Doric portico *in antis* giving access to a flight of steps leading to the front door.

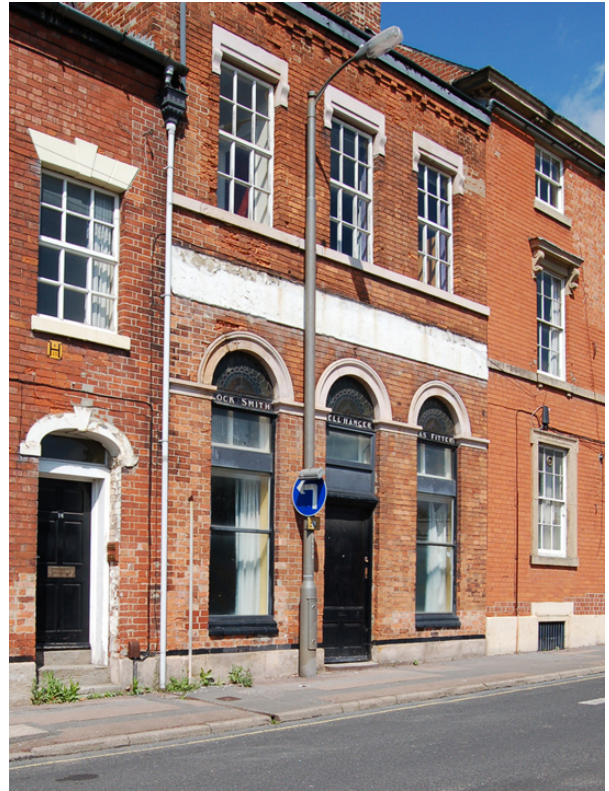
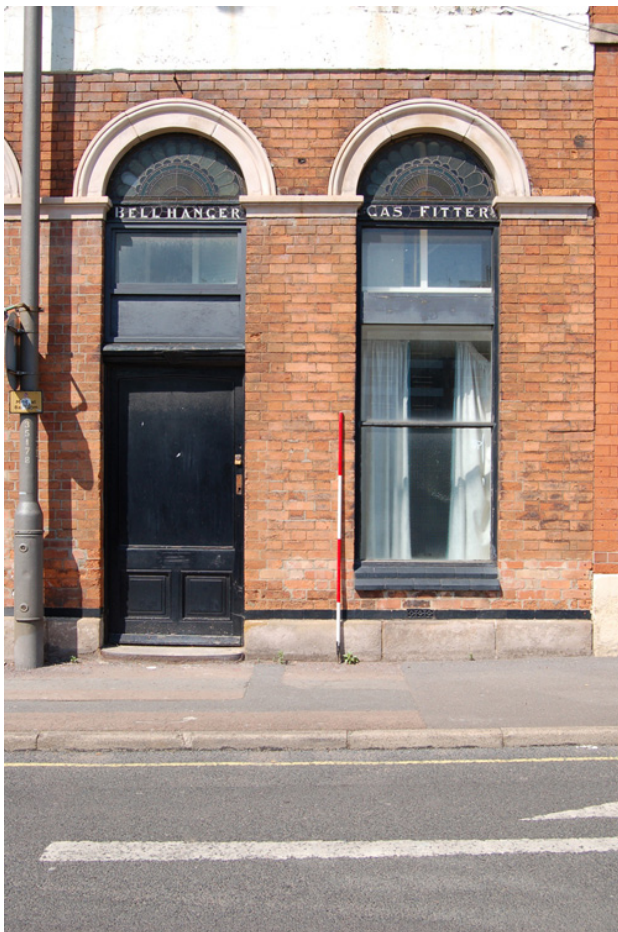
**Plate 12:** No.12 St Helen's Street.

**Plate 13:** No.12 St Helen's Street; detail

House and shop. C. 1850, with later alterations dated 1885. Red brick, laid in Flemish bond, slate roof and brick end stack to right. Two storeys with broad plastered fascia band at first floor level and dentilled brick eaves band. Three bays with central door and flanking late 20<sup>th</sup>-century windows, all three within late 19<sup>th</sup>-century openings under semi-circular arches with moulded surrounds springing from a cavetto-moulded impost band. All three arches contain late-19<sup>th</sup> century decorative glazing bar patterns and stained glass and bear the enamelled legends (from left to right) 'LOCK SMITH', 'BELLHANGER' and 'GAS FITTER'. Twelve-pane glazing bar sash windows at first floor level with sill band and bracketed, rebated lintels, partly replaced by late 20<sup>th</sup>-century top hinged windows in a matching style.

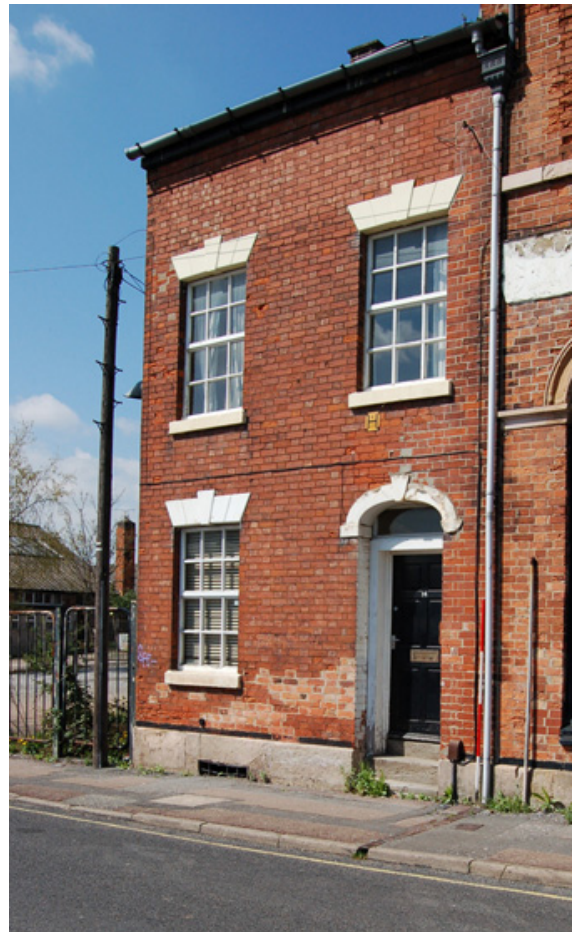
**Plate 14:** No. 14 St. Helen's Street.

House. 1841. Red Brick, laid in Flemish bond, slate roof and brick end stack to left. Two storeys, two bays. Six-panelled door to right with overlight under three-centred arch with plain imposts and raised key. Late 20<sup>th</sup>-century windows within original surrounds with wedge lintels grooved as voussoirs and raised keys. West (left) side rendered.

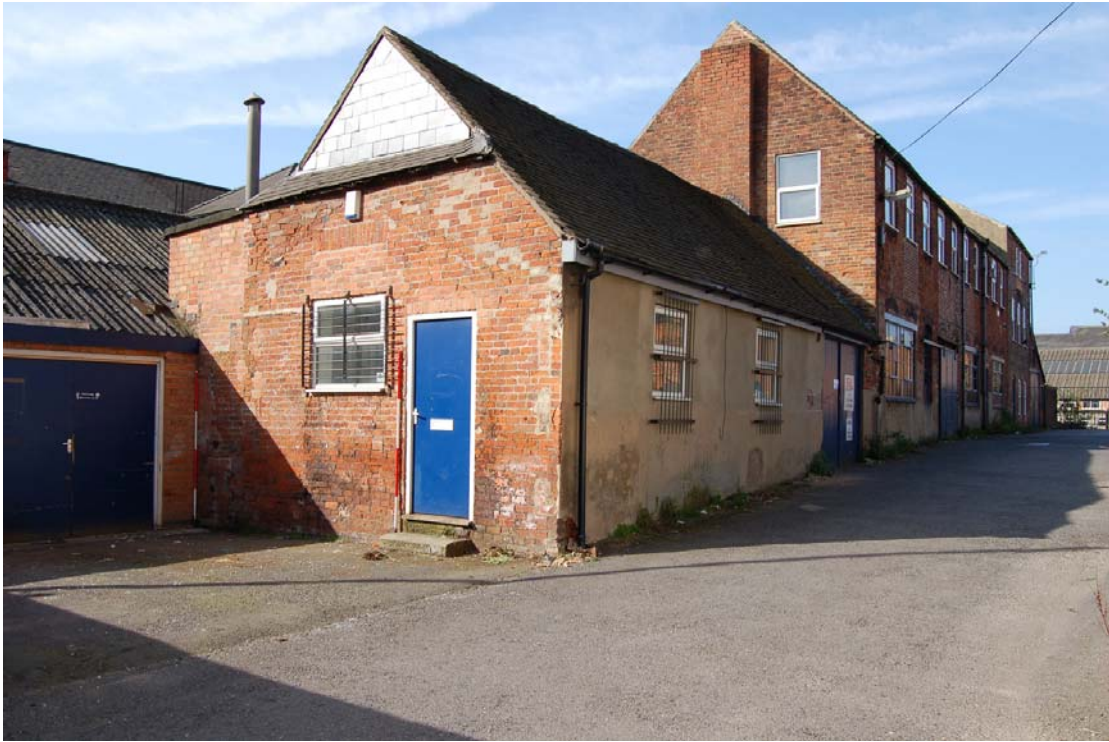
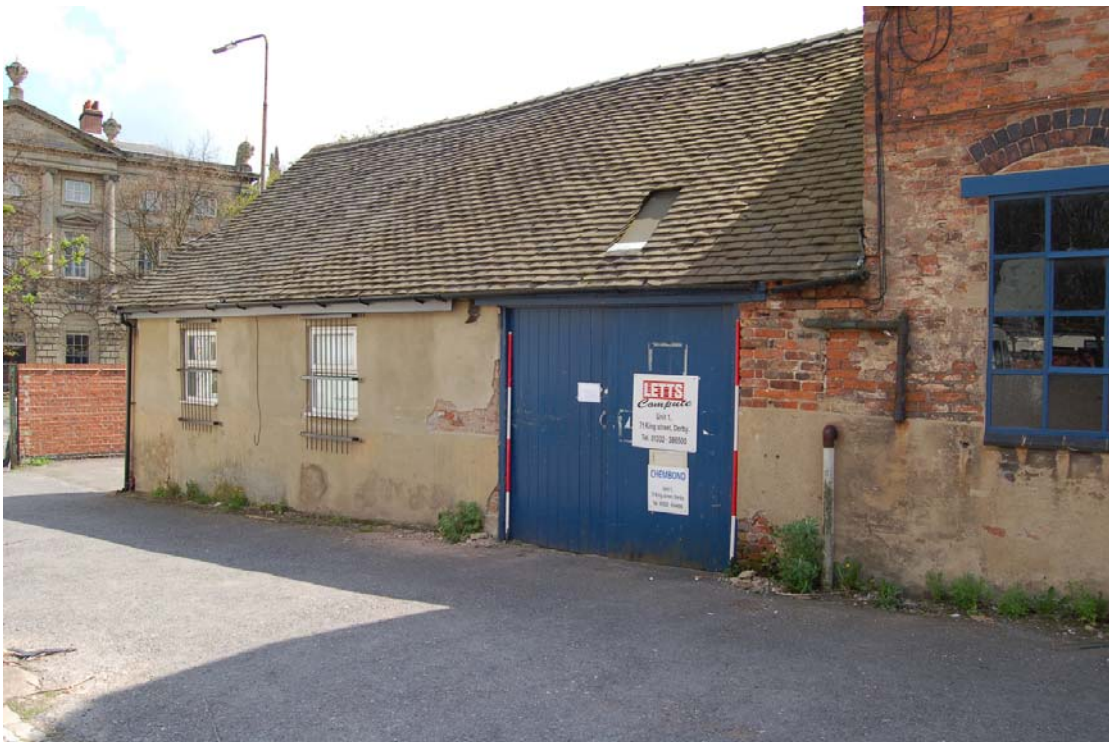
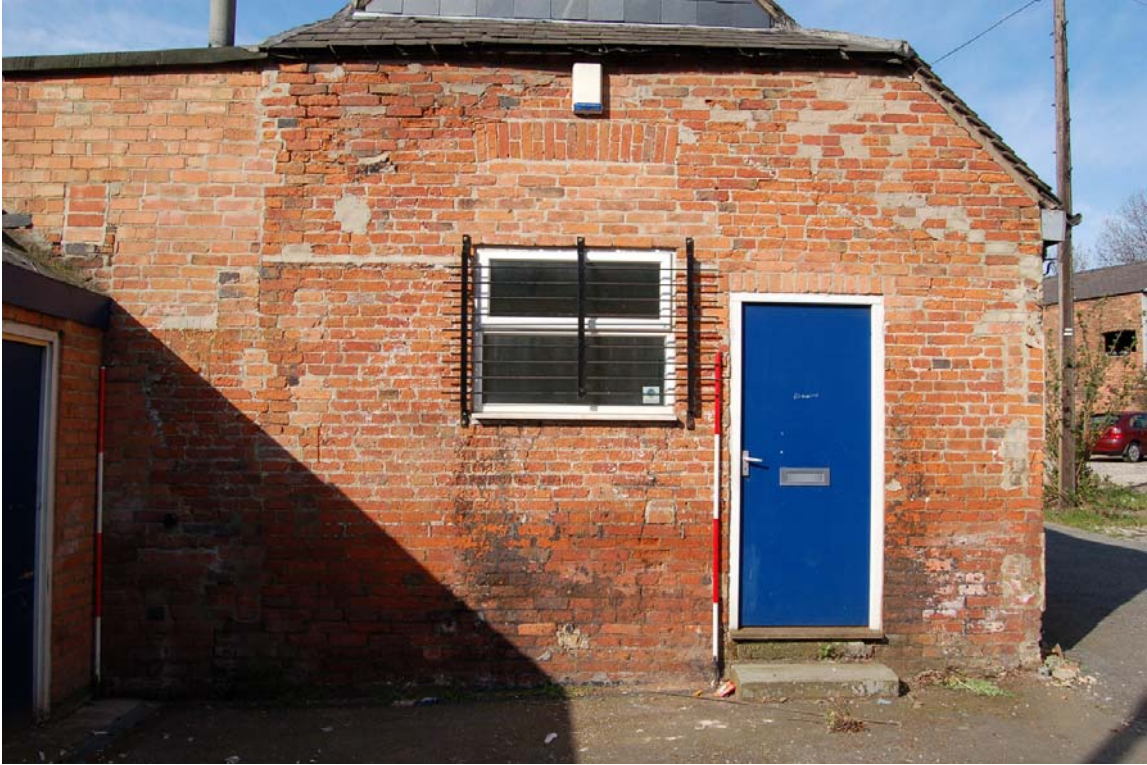
**Plate 15:** Unit 1, 71 King Street, oblique view from the east.

**Plate 16:** Unit 1, 71 King Street, oblique view from the west.

Plate 17: Unit 1, 71 King Street, east elevation.

Office, formerly forming part of the Spar Manufactory and probably a remnant of Old St. Helen's House. Late 17<sup>th</sup> or 18<sup>th</sup> century. 2¼" thick red brick, rendered to north elevation, but visible to east, plain tile roof. One storey, three bays. Double doors to right giving access to rear yard, and early 21<sup>st</sup>-century windows to left and centre (Plate 16). The east elevation retains a partially blocked window with flat brick arch, and the upper part of the gable is set back and hung with slates. The purpose of this unusual arrangement is uncertain but it may have something to do with the building's former industrial function. A scar in the brickwork indicates a single-storey building with low-pitched roof formerly abutted the east elevation (Plate 17), presumably filling in the plot between Unit 1 and King Street to the east.
