Clun Bridge and Waterloo
Ford, Clun, Shropshire

An Archaeological Desk-Based
Assessment, 2005

Project No. 1331
July 2005

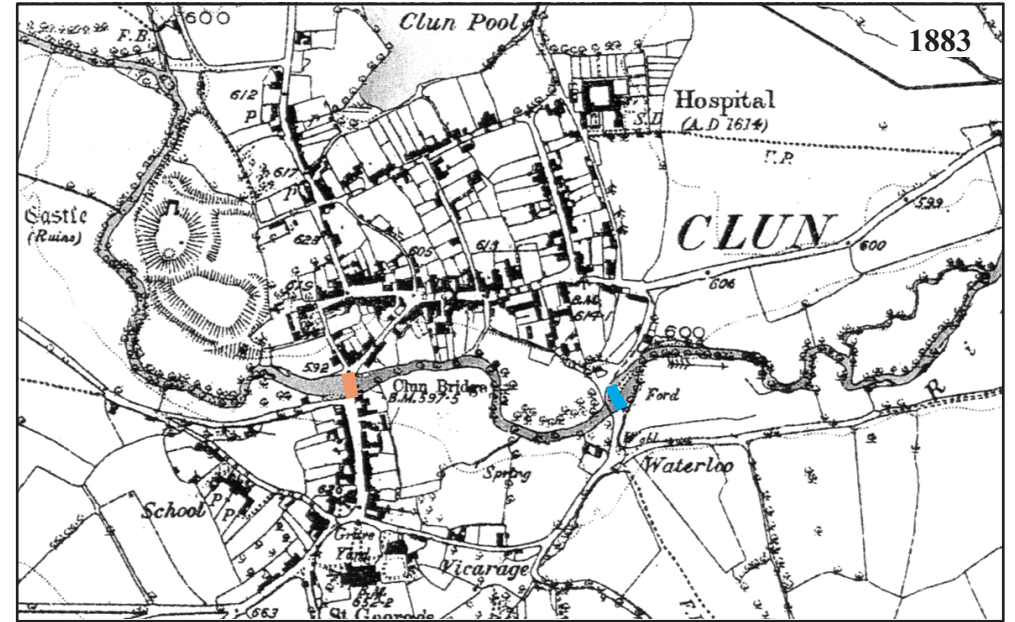
Fig.4

The tithe map shows that the field around the bridge and ford were given over to meadow and cow pasture. There is no evidence of any structures other than the bridge within the study area and the town appears relatively small. The course of the river remains much the same as on the present maps.

The bridge, ford and the course of the river remained unchanged. The division of the town into Saxon and Norman nuclei is evident. Generally, there had been little development within the town.

By the time of the Civil War the castle was a ruin. The church of St George was partially destroyed by Fleetwood, one of Cromwell's generals, and was extensively rebuilt in the nineteenth century (VCH Vol I). There seems to have been very little in the way of specialised industry. By the eighteenth century the estate had been sold to Clive of India (VCH Vol I). In Bagshaw's directory of Shropshire 1851 the earl of Powis is listed as the principle landowner and the local industries seem to range from small scale tanning, brick and tile making, milling and chair making. The tithe map of 1846 shows that most of the land surrounding the bridge and ford was given over to meadow or cow pasture with no additional structures or alterations to its banks (Fig 4).

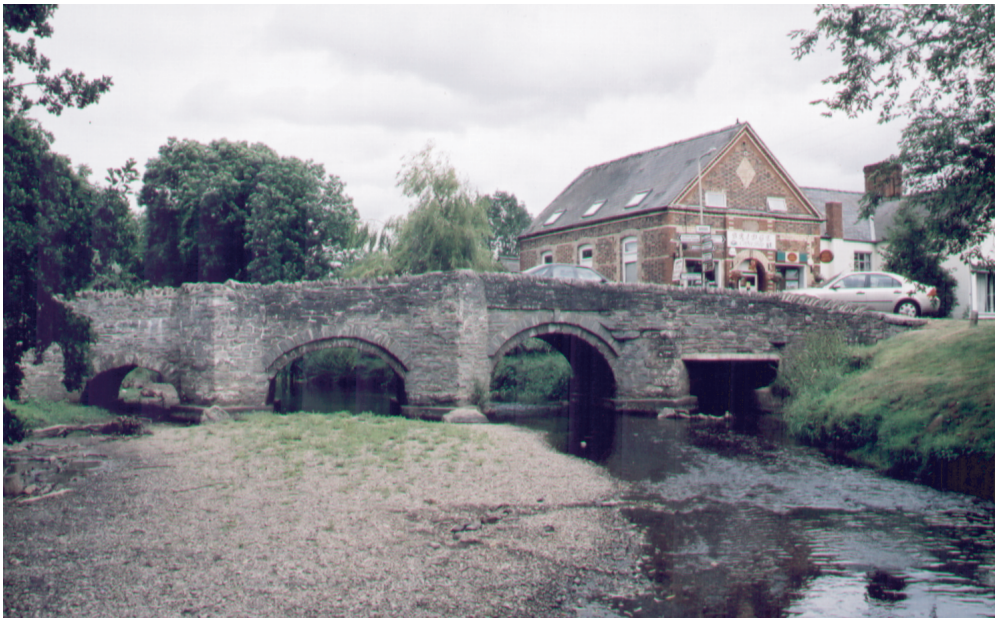
Plate 1

Clun Bridge is humpbacked and spans the river in five arches, interspersed with three triangular-plan cutwaters supporting refuges at parapet level (Plate 1). The arches vary in size in accordance with the asymmetrical humpbacked nature of the bridge, but also in structural character. Two low arches at the north end and one at the south end are plain barrel vaults, not all very distinctive in shape, owing perhaps to repair, though at least one of the northern arches is four-centred (No. 2 from the north, Plate 3), which suggests a date somewhere between the late fourteenth century and the sixteenth century. The southernmost arch has been replaced on its western side by a concrete lintel (Plate 1). The two high arches are almost semicircular, and the vaults are each carried on unmoulded ribs, not incompatible with a medieval date (eg fourteenth century). Both arches were originally of two unmoulded orders, but the larger one (No. 4 from the north) has been rebuilt on its western side, probably in the eighteenth century, in higher quality stone, and with a raised keystone (Plate 4), and the smaller one (No. 3 from the north) has been rebuilt on its eastern side (Plate 5).

The river in the vicinity of the bridge is characterised by low grassy banks (Plate 1). The ford site is similar but the banks either side are partly wooded (Plate 2). Presently, the bridge is accessible by vehicle but is only wide enough for a single stream of traffic and the evident rebuilding of its upper courses may have suffered as a consequence. Frequent damage has meant that most of the upper bridge has been repaired several times. The ford still serves as a crossing and is accessible by road. The river was relatively shallow and slow flowing at the time of the assessment

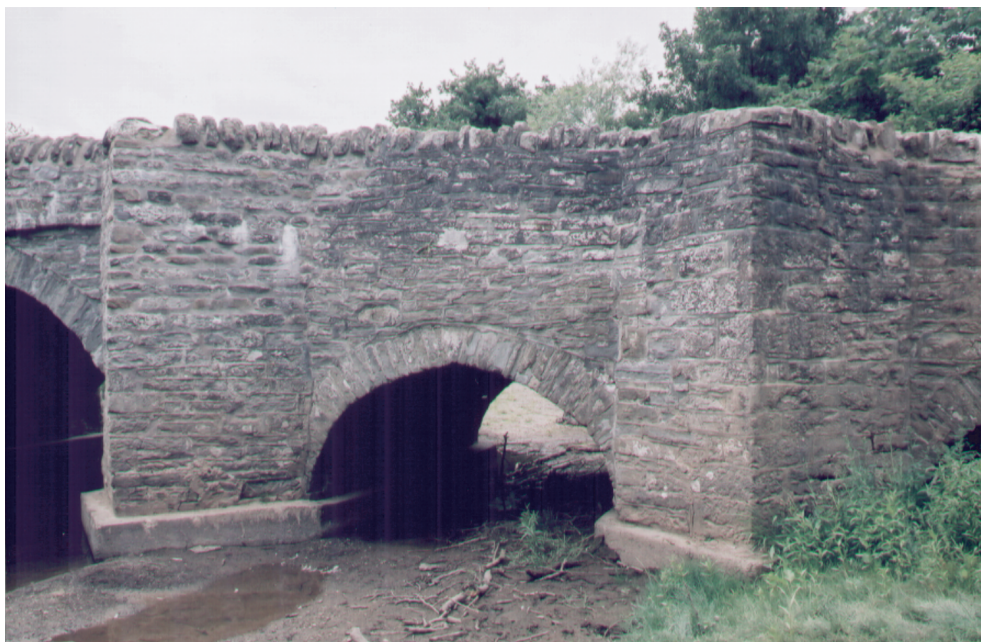
Plate 3

There are straight joints in the masonry between the cutwaters and the bridge, suggesting that the cutwaters are later additions (Plate 6). The southernmost of these on the western side has lost its upper section. The feet of the bridge piers and abutments have been protected with concrete. Much of the parapet has been rebuilt, at different times, this being particularly marked over No. 4 arch (Plate 3)
