Ditherington Flax Mill, Shrewsbury,  
Shropshire

An Archaeological Watching Brief,  
2005

Project No. 1344.01

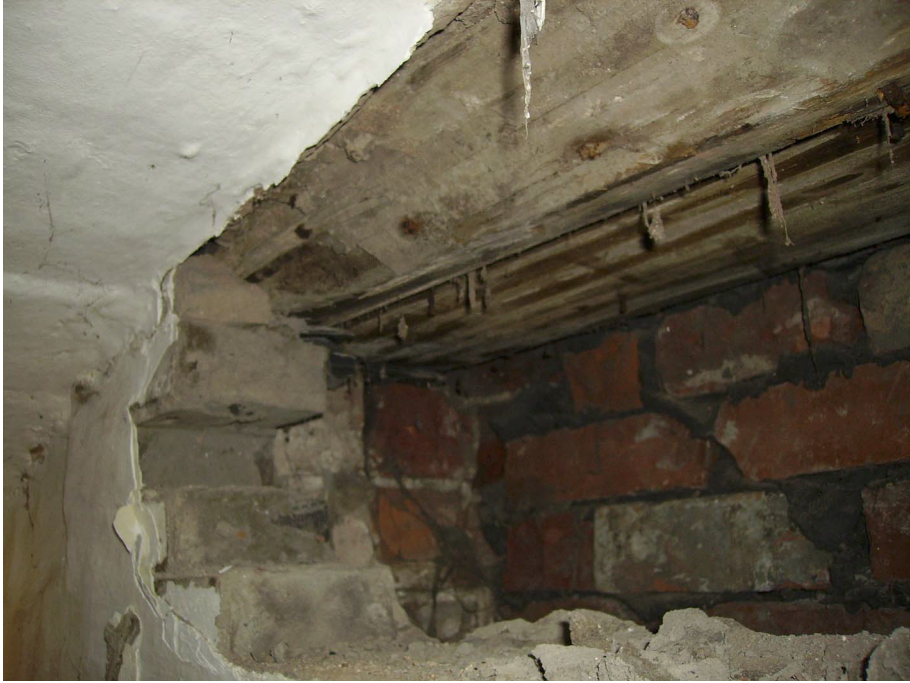
Plate 1

This window, which was on the west side of the building, was blocked with 9¼ in x 5 in x 2 in bricks. Above the opening was a plain 9 in wide timber lintel, and, abutting it towards the interior, a second, narrow, timber with a broad chamfer on its east face (Plate 1).

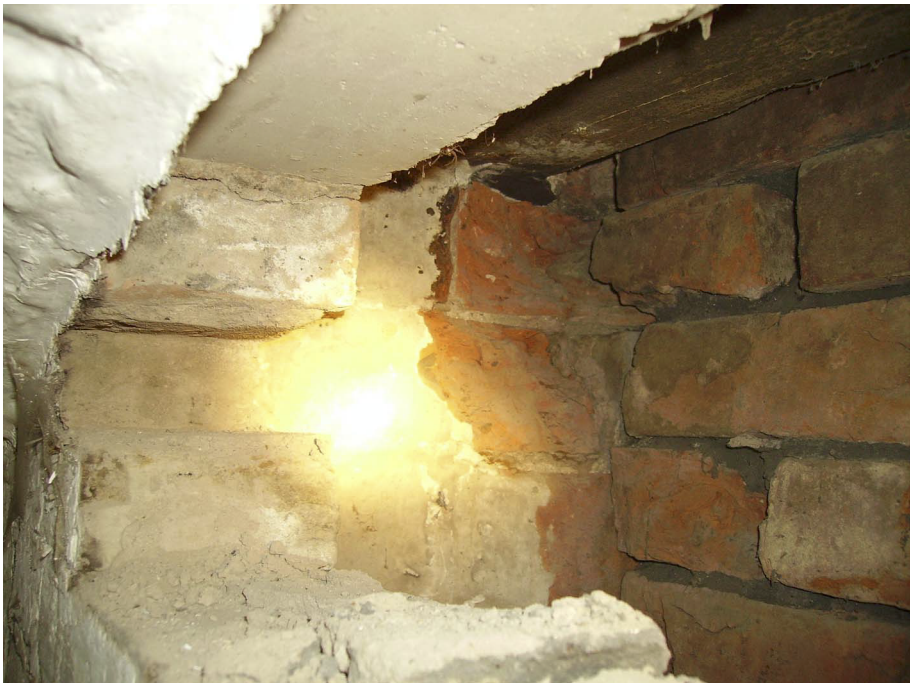
Plate 2

Window B, also in the west wall, was blocked with 9¼ in x 5 in x 2 in bricks. It too had a plain 9 in wide timber lintel. On the south side of the window opening a splayed and plastered jamb could be glimpsed (Plate 2).

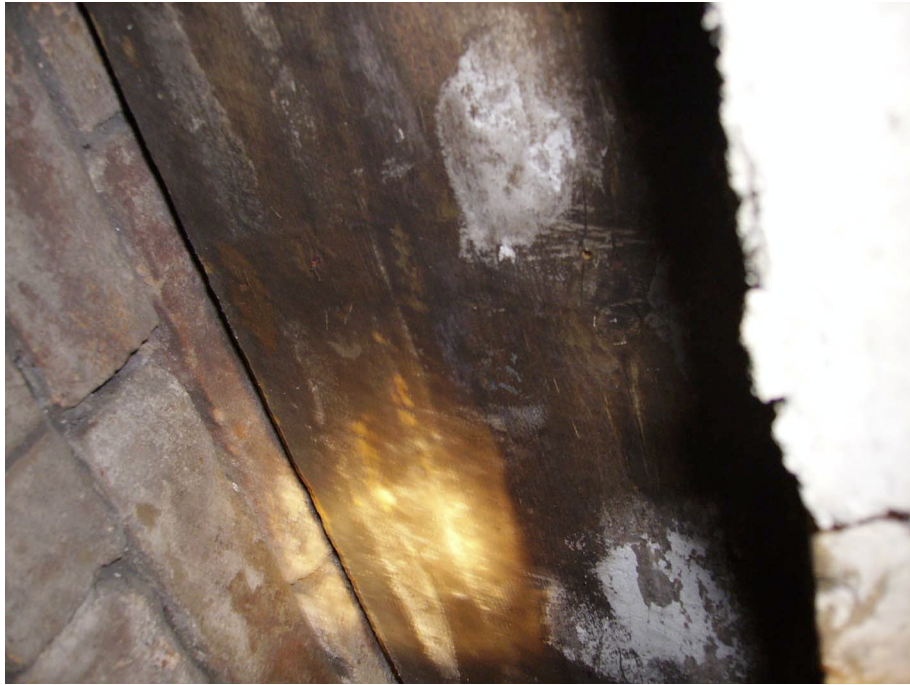
Plate 3

The third window was in the east wall. It was blocked with 9¼ in x 4¾ x 2 in bricks and had a plain 9 in wide timber lintel (Plate 3).

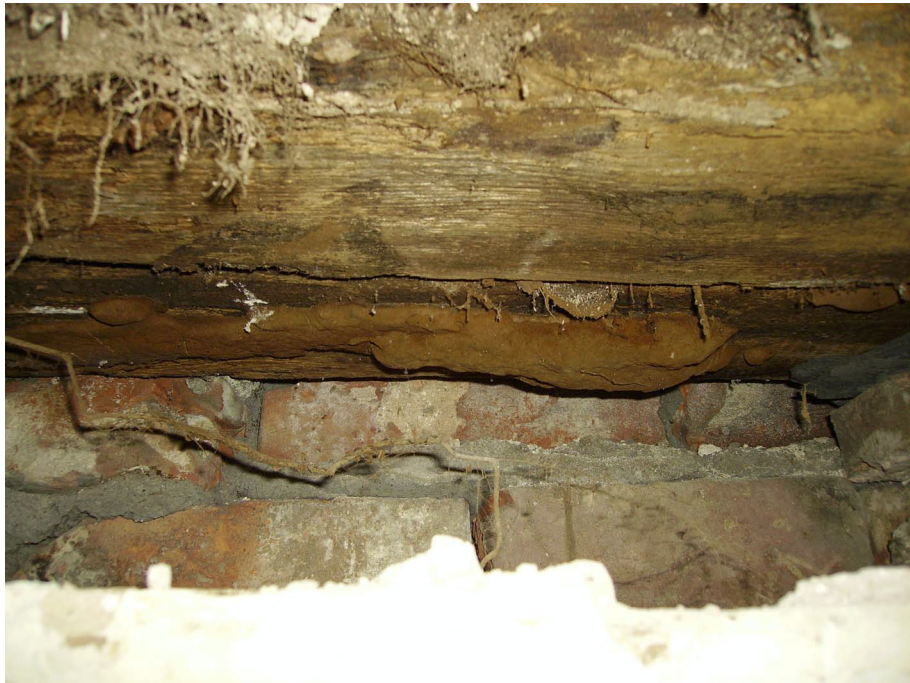
Plate 4

Window D, which was in the west wall, was blocked with 9¾ in x 5 in x 1½ in bricks. A plain timber lintel, approximately 9½ in wide was made up by two timbers, both in poor condition, apparently rotten with fungus adhering to them (Plate 4).

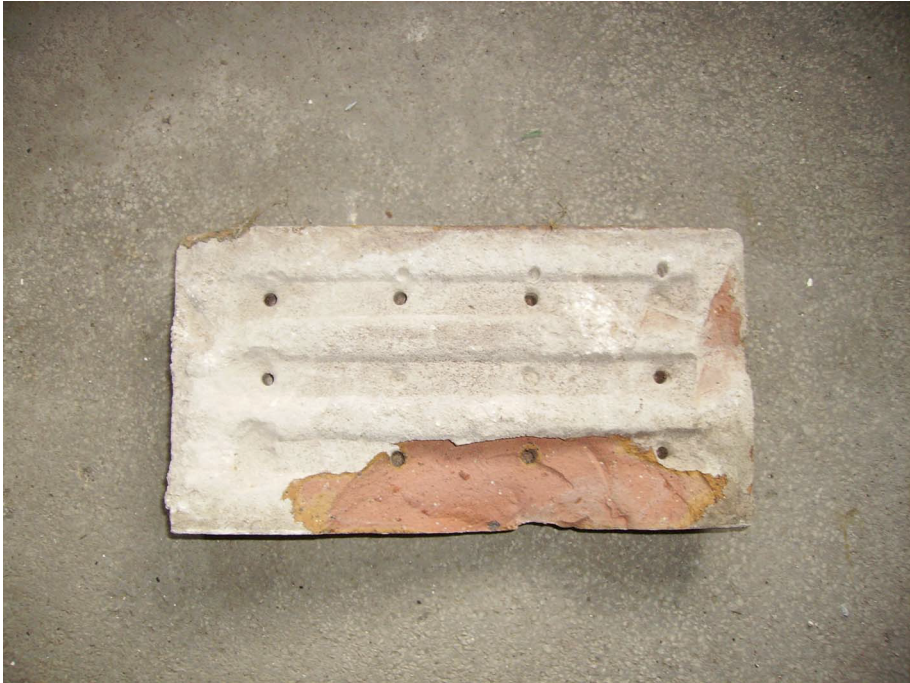
Plate 5

The fifth window, in the east wall, was blocked with 9 in x 5 in x 1½ in brick, including a perforated malting floor tile of the same dimensions (Plate 5). Above the opening was a timber lintel, 9 ins wide by 3 ins thick, which, unlike any of the other lintels was chamfered towards the exterior (east) (Plate 6).

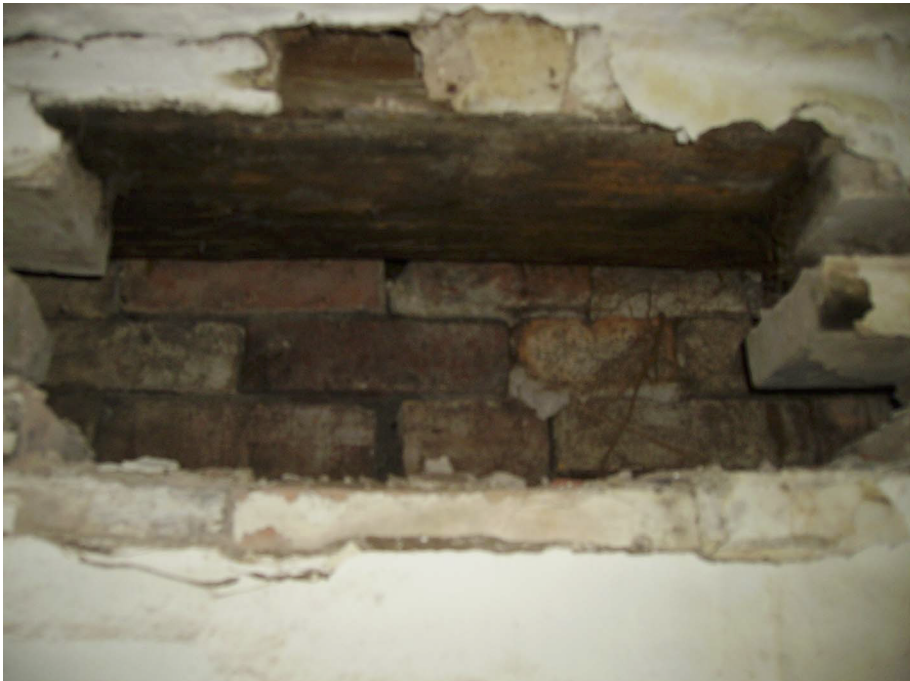
Plate 6

The watching brief has shown that each of the blocked windows investigated retains a timber lintel, generally 9 ins thick, and, in the one case (Location E) that it was possible to measure, 3 ins thick. There seems, however, to have been a degree of variation. At location D, for instance, the lintel was composed of two timbers. Uniquely, the lintel at Location E had a chamfered outer face, whereas equally exclusively another lintel (Location A) abutted a timber with a chamfered inner face. It is difficult to draw any conclusions from this diversity without more extensive investigation.
