**MOLINEUX HOTEL,  
WOLVERHAMPTON:  
AN ARCHAEOLOGICAL  
WATCHING BRIEF, 2006**

Project No. 1394

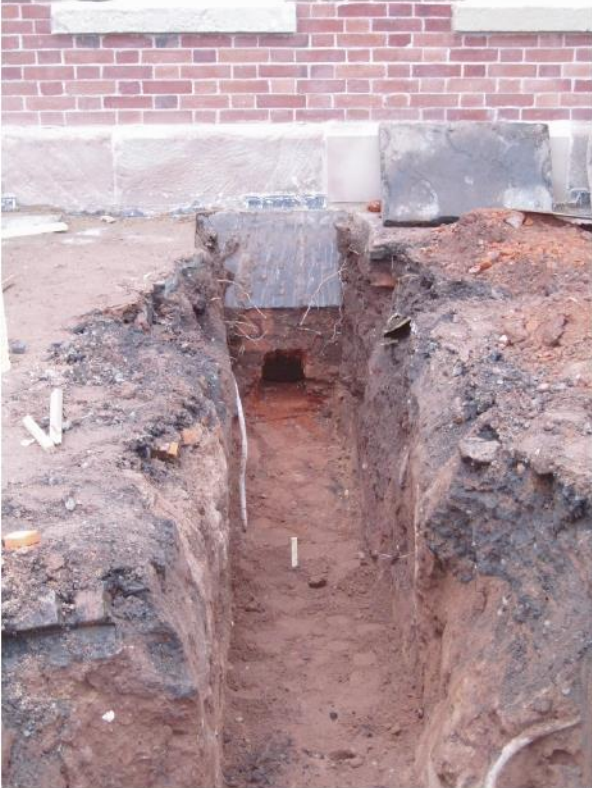
Plate 1

Plate 1:	Service trench - oriented east - west
Plate 2:	Remains of cellar wall
Plate 3:	Infilled cellars, demolition debris and cauldron
Plate 4:	Cauldron <i>in situ</i>

Groundworks comprised the excavation by mini-digger of a trench for the laying of drainage pipes, which ran from the southeast elevation of the building for 6.0m before returning to run east a further 20.0m to the site boundary. The trench was between 1.1m - 1.4m deep and cut natural soft red sand [1000] at its deepest extent, nearest the building (Fig. 4). Natural 1000 was overlain by a layer of brick rubble debris [1001], which was cut by several modern drains aligned northeast - southwest. The remains of brick cellar walls and a cast iron cauldron, resting on its brick base, were also revealed (Plates 1-4).

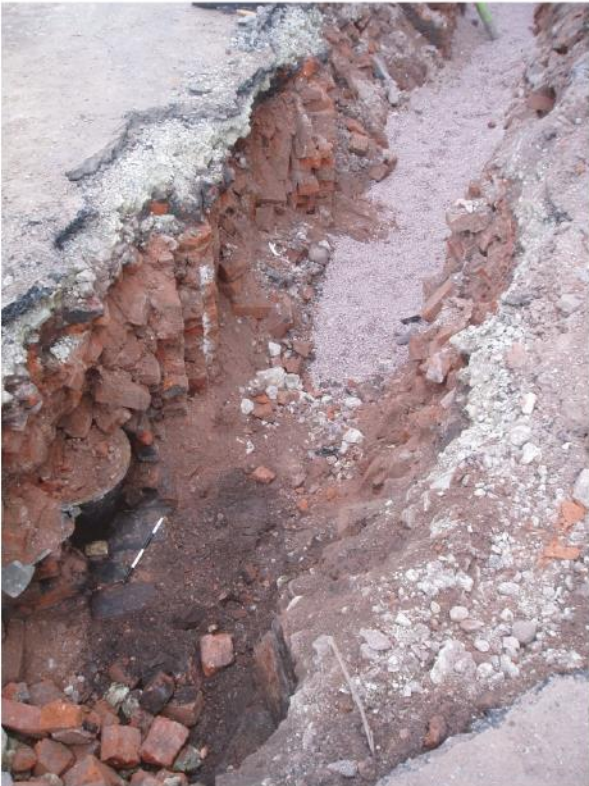
Plate 3

No evidence of significant archaeological features, which pre-dated the construction of the Molineux Hotel was recorded. With the exception of the surviving elements of cellars associated with the formerly adjacent 19<sup>th</sup> century terrace, no significant artefacts or archaeological features were recorded. Layer 1001 derived from the demolition of the short terrace of houses, which had originally been situated adjacent to the Molineux Hotel, on its northeastern side (Fig. 3). These 19<sup>th</sup> century houses had originally fronted onto North Street and were demolished to make way for the current ring road.

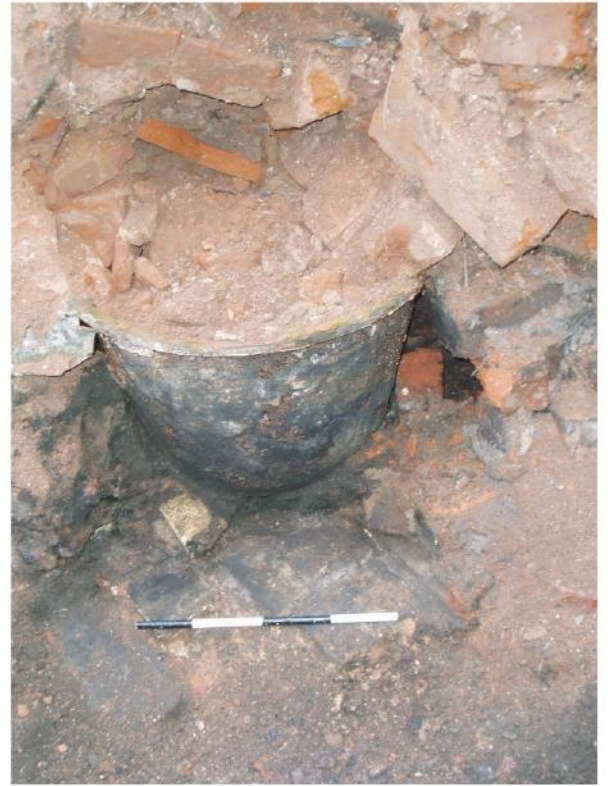
Plate 4

*No significant archaeological features, deposits or finds were recorded during the watching brief. It is likely that the construction in the 19<sup>th</sup> century of a terrace of four houses and associated cellars may have removed any potential evidence of earlier activity. Parts of the infilled cellars were recorded and in one cellar an in situ cast iron water-boiling cauldron survived on its brick platform.*
