**Langley Heath Farm, Fox
Hollies Road, Walmley,
Birmingham**

**Archaeological/Historic
Building Research and
Recording, 2006**

Project No. 1434

May 2006

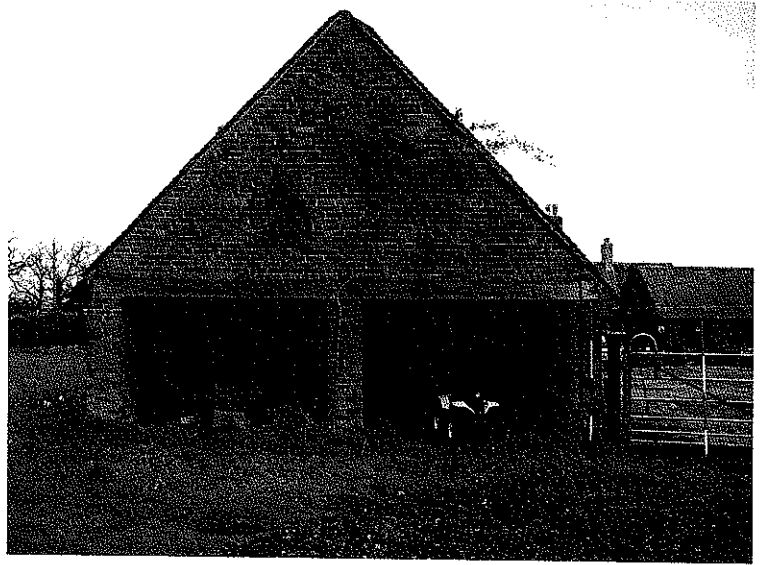
Plate 6

The south gable end has 2 bays of cart entrances with bullnose brick jambs and chamfered timber lintel (Plate 6).
