**BENTLEY CAIRN,
WALSALL, BLACK
COUNTRY
ARCHAEOLOGICAL TRIAL
TRENCHING
2006**

Project No. 1438

BENTLEY CAIRN, WALSALL, BLACK COUNTRY

ARCHAEOLOGICAL TRIAL TRENCHING, 2006

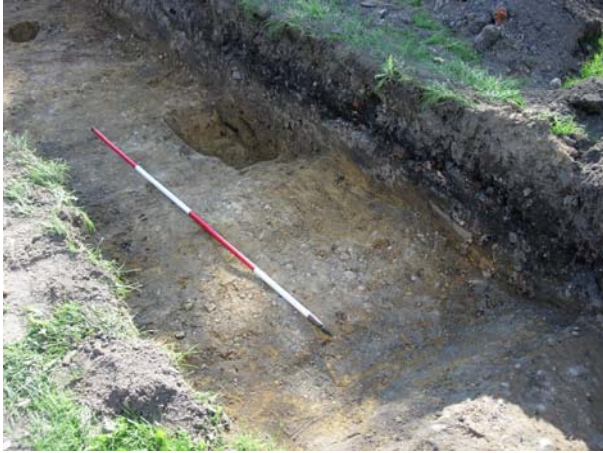
Plate 5 – **1007**

A ditch aligned roughly east-west (**1007** Fig. 4 and Plate 5) was identified in Trench 1. This ditch was approximately 1m wide and 0.4m deep, with a shallow V-shaped profile. A large piece of unabraded pottery dating to the 16th century was recovered from its fill (Plate 6). A second ditch/gully (**1009** Fig. 4) was identified in the centre of the trench, aligned roughly northeast-southwest, and, on the basis of stratigraphy and form, is likely to be of a similar date. Sealing both these features was a light brown layer of sandy silt with rounded stones (**1003**), which was undated, but may also relate to this period (this layer was only present in the northern part of the trench where it had not been truncated by deposits relating to the Victorian farm buildings).

The earliest archaeology on site was represented by cut features, including a ditch (**1007**) which contained 15th – 16th century pottery, and undated gullies. However, although the gullies were undated, they were all sealed by a layer of light brown silt and gravel, present in both Trench 1 and 3, and therefore stratigraphically similar to the dated ditch section. It is possible that these features are either contemporary with, or even pre-dated the Jacobean phase of the Hall.

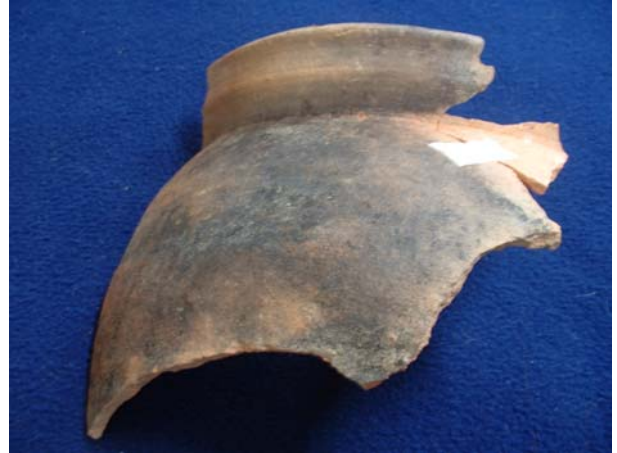
Plate 6 – Pottery from **1007**

The cooking pot or pipkin recovered from **1007** (Plate 6 above) was in good condition and unabraded. The wheel-thrown, oxidised vessel appeared to date to the late medieval period (15th-16th centuries) on typological grounds. The heavy sooting on the exterior suggests that it was used for cooking. Although a post-medieval sherd was also found in **1007**, it was small and somewhat abraded, in contrast to the cooking pot/pipkin sherd which weighed 180g and

was in good condition. This suggests that the post-medieval coarseware sherd was intrusive and that the backfilling of the ditch probably took place in the 16th century.

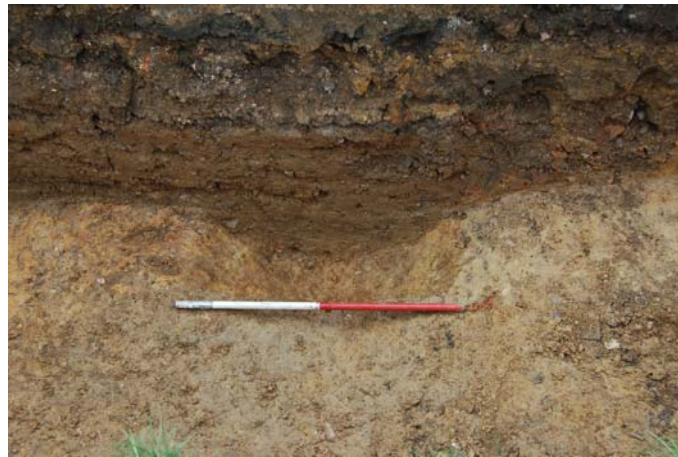
Plate 7 - **3005**

In trench 3, a second ditch feature was identified (**3005** Plate 7), aligned approximately north-south. This feature was also sealed by a layer of light grey-brown clay silt with rounded stones (**3007**), similar to layer **1003** identified in Trench 1.

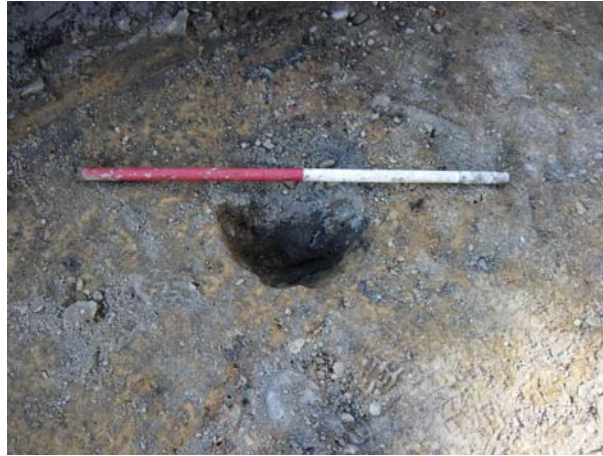
Plate 8 - **1008**

No structures relating to the Jacobean Hall were identified during this phase of archaeological work. A post-hole (**1008** Plate 8) identified in Trench 1, however, contained two large brick fragments of this date.

This current phase of work did not locate the site of the Jacobean Hall, though the brick used as post packing in the posthole in Trench 1 was of this date, and is likely to originate from the Hall. Also some of the pottery recovered from Trenches 1 and 2, dates from the late 17th-early 18th century, and may therefore be associated with the demolition of the Jacobean Hall.

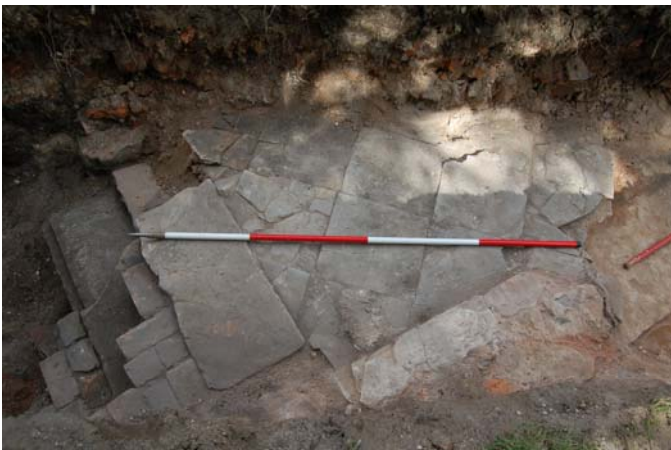
Plate 9 - **2004, 2005, 2006**

THE LATER HALL – Two walls at right angles to each other were identified at the southeastern end of Trench 2 (**2004** and **2006** Fig 4, Plates 9 and 10). Wall **2006** was aligned north-south and was constructed from large, machine sawn sandstone blocks, and had the remains of brick steps (**2007**) constructed above it. It appeared to abut wall **2004**, which was aligned east-west, which was also constructed from large rectangular stone foundations with several courses of brick wall above.

A grey flagstone floor (**2005** Plates 9 and 10) was identified to the north of wall **2004**. This floor surface abutted wall **2006**, and partly abutted and partly overlaid wall **2004**. This floor was set into the levelling deposits of pink mortar and orange sand **2010**.

The structures that were excavated during the evaluation were associated with the later Hall on the site. Within Trench 2, the north-south wall identified (**2006**) has been interpreted as the external wall of the building, with the east-west wall (**2004**) abutting it. The floor levelling deposits on either side of the east-west wall were similar and suggesting that this wall was an internal wall, with the opening between them representing a doorway. The grey slate floor **2005** was laid partially over the east-west wall **2004**, further suggesting that this was an internal doorway. The deep deposits to the west of the north-south wall are indicative of substantial amounts of landscaping in this area, perhaps levelling up a garden terrace on this side of the house. This terrace is possibly evident on the Ordnance Survey map (Fig. 3) as a dotted line against the west side of the building.

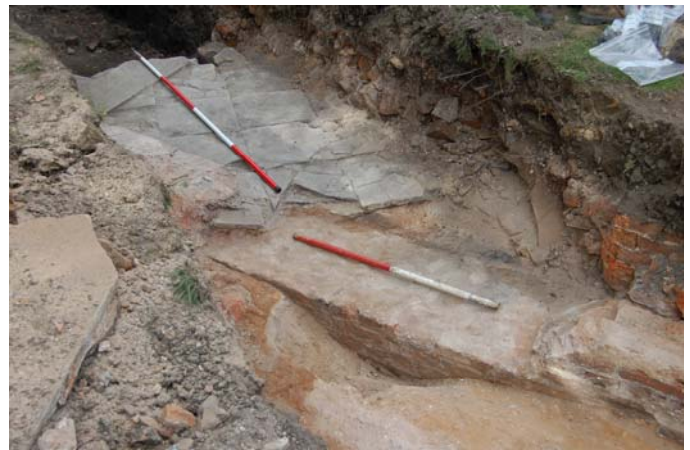
Plate 10 - **2004, 2005, 2010**

On either side of wall **2004**, a deposit of black-grey silt-sand containing rubble fragments and charcoal was identified (**2011**). There was no evidence for a cut for wall **2004** through this layer, and the full depth could not be ascertained. Overlying layer **2011** was a deep layer of pink mortar and orange sand (**2010**). This layer was also present to the north and south of wall **2004**, though it was deeper on the southern side (Plate 10).

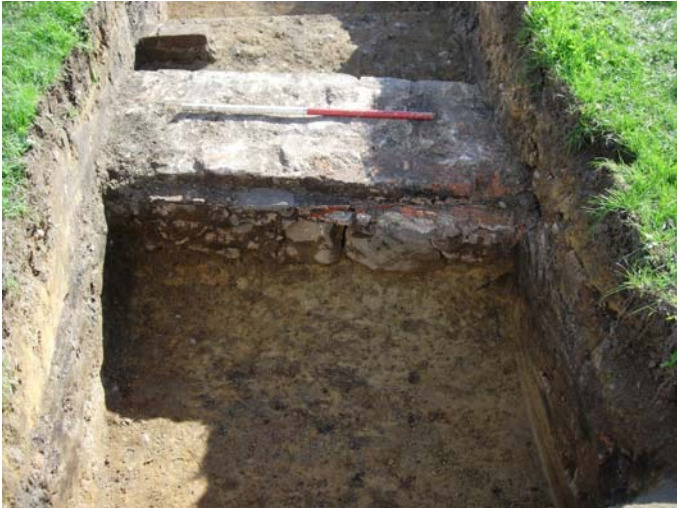
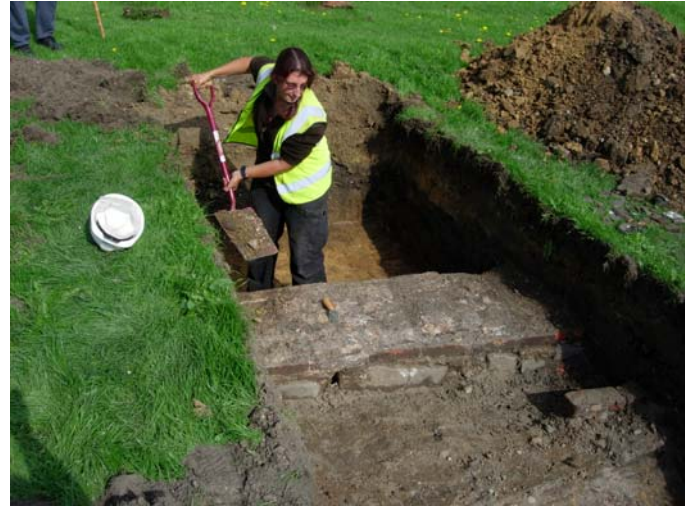
ANCILLARY BUILDINGS - At the northern end of Trench 1 (Fig. 4) a substantial east-west aligned wall (**1005** Plates 11 and 12) was identified. It was constructed by a course of thin red bricks laid on top of a stepped foundation formed by large rectangular stone blocks, rubble and mortar. It was approximately 0.5m wide and 0.5m deep with the foundation course sitting directly on the natural subsoil. Parallel to this wall (to the south) was a second wall (**1006** Plates 11 and 12), which was less substantial, and comprised one course of bricks and pinkish white mortar.

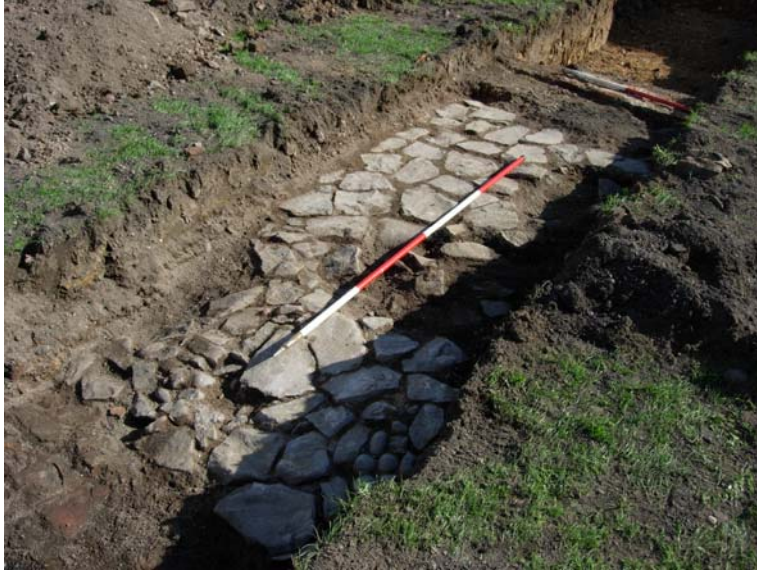
Plate 13 - **1011/1012/1013**

At the southern end of Trench 1, a second substantial wall similar to **1005** was observed (**1013**, Fig. 4 and Plate 13). This wall (**1013**) was 4-5 courses deep and also contained rubble in its foundations. It was abutted by a flagstone surface (**1012** Plate 13) which was damaged and uneven in places. This was defined to the north by a fourth brick wall (**1011**, Fig. 4).

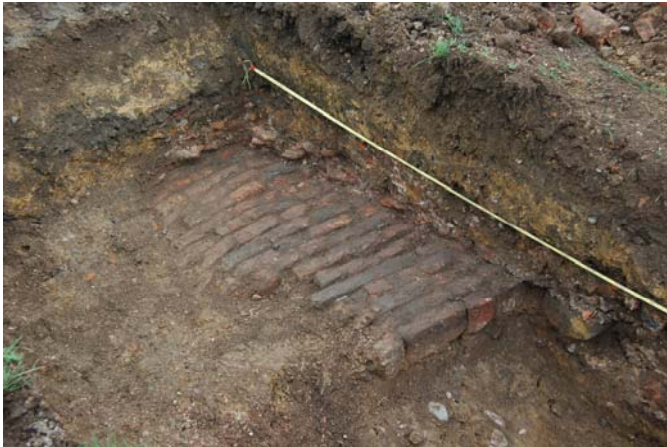
Plate 14 - **3003**

Although much of Trench 3 was truncated by the cut for a modern service, archaeological deposits were present on its southern edge. At the western end of Trench 3, a brick floor was identified (**3003**, Fig. 4 and Plate 14).

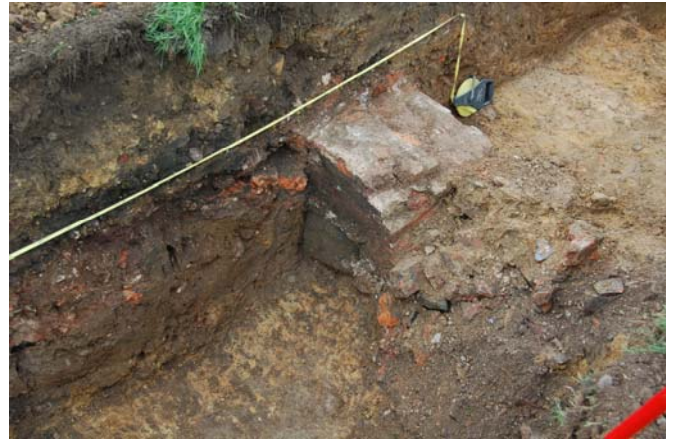
Plate 15 - **3004**

A brick and sandstone wall (**3004** Plate 15), aligned north-south was also identified at the eastern end of the trench. It comprised a foundation course of large faced sandstone blocks and rubble, with four courses of bricks constructed above it. A possible cut for wall **3004** was identified on the western side.

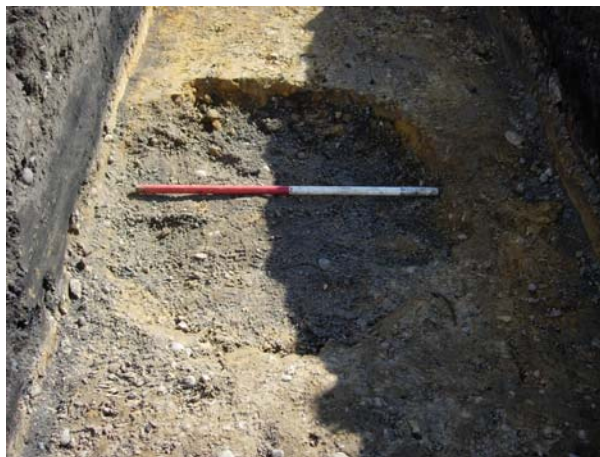
Plate 16 – **1010**

OTHER FEATURES AND DEPOSITS - In the centre of Trench 1 a shallow pit was identified (**1010**, Fig. 4 and Plate 16). This pit (**1010**) truncated the earlier ditch **1009** and layer **1003**, and contained late Post-medieval building rubble including brick fragments, tile and charcoal/coal.

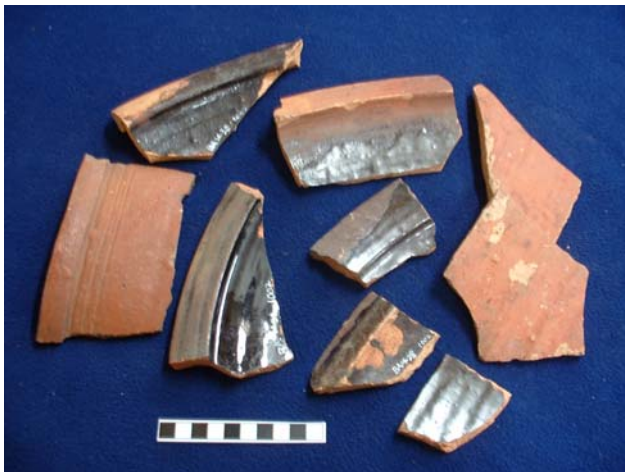
Plate 17 – Coursewares

The remainder of the pottery was of post-medieval date. It consisted primarily of dark brown or black glazed coarsewares (Plate 17). Bowls were the commonest form with storage jars much less well represented. These rather basic utilitarian wares were used throughout the post-medieval period and are associated with food preparation and storage. A few better quality wares are represented by single sherds of slip-coated ware, tin-glazed earthenware, yellow ware and three sherds (two vessels) of blackware. Formal dining and/or tea wares were represented by white salt-glazed stoneware and creamware sherds (Plate 18). However, the overall impression of the pottery is that it is mainly utilitarian in nature and may have derived from kitchens or storage areas.

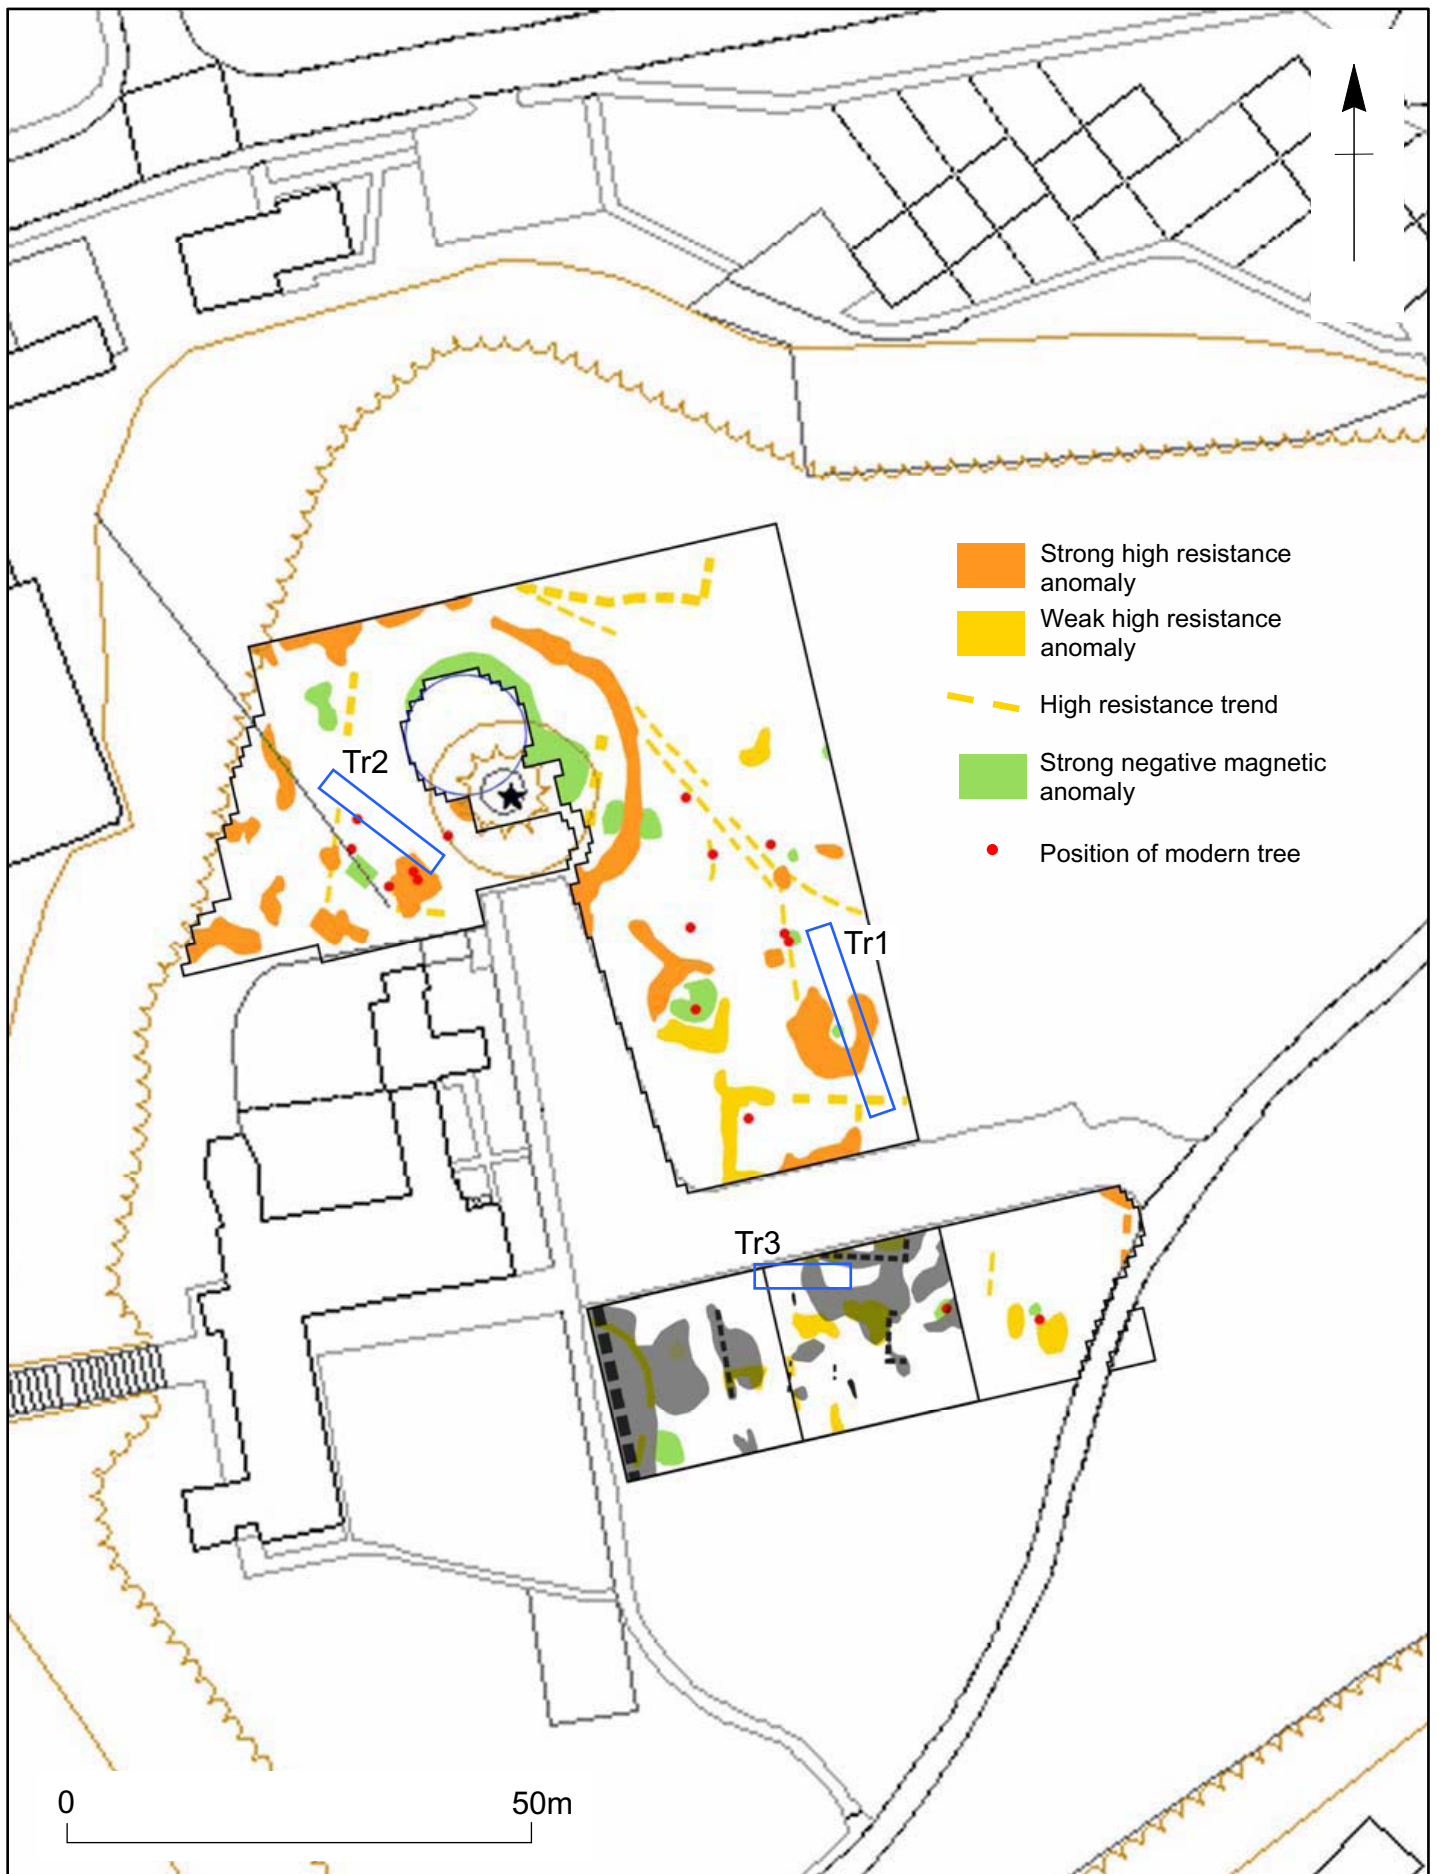
Fig.2

Trenches were located over anomalies identified by the geophysical survey, specifically targeting possible buildings in order to identify which phases of hall they belonged to (Fig. 2). A total of three trenches were excavated, totalling 50mX2m of trenching opened during the course of the evaluation.

The archaeological deposits correlate well with the results of the geophysical survey, and have served to enhance and aid interpretation of this evidence. The structures that have been identified also correlate well with the cartographic evidence. The walls in Trenches 1 and 2 can be plotted against walls shown on the Second Edition Ordnance Survey map, as can the flagstone surface in Trench 1. The wall and surfaces in Trench 3 are slightly more problematic, though it is likely that the wall and surface identified in this trench are related to the structures depicted on this map in this area, and it is difficulties in overlaying the older maps onto the modern ones, similar to the problems encountered during the geophysical survey, that has resulted in the mis-alignment of the structures and maps.

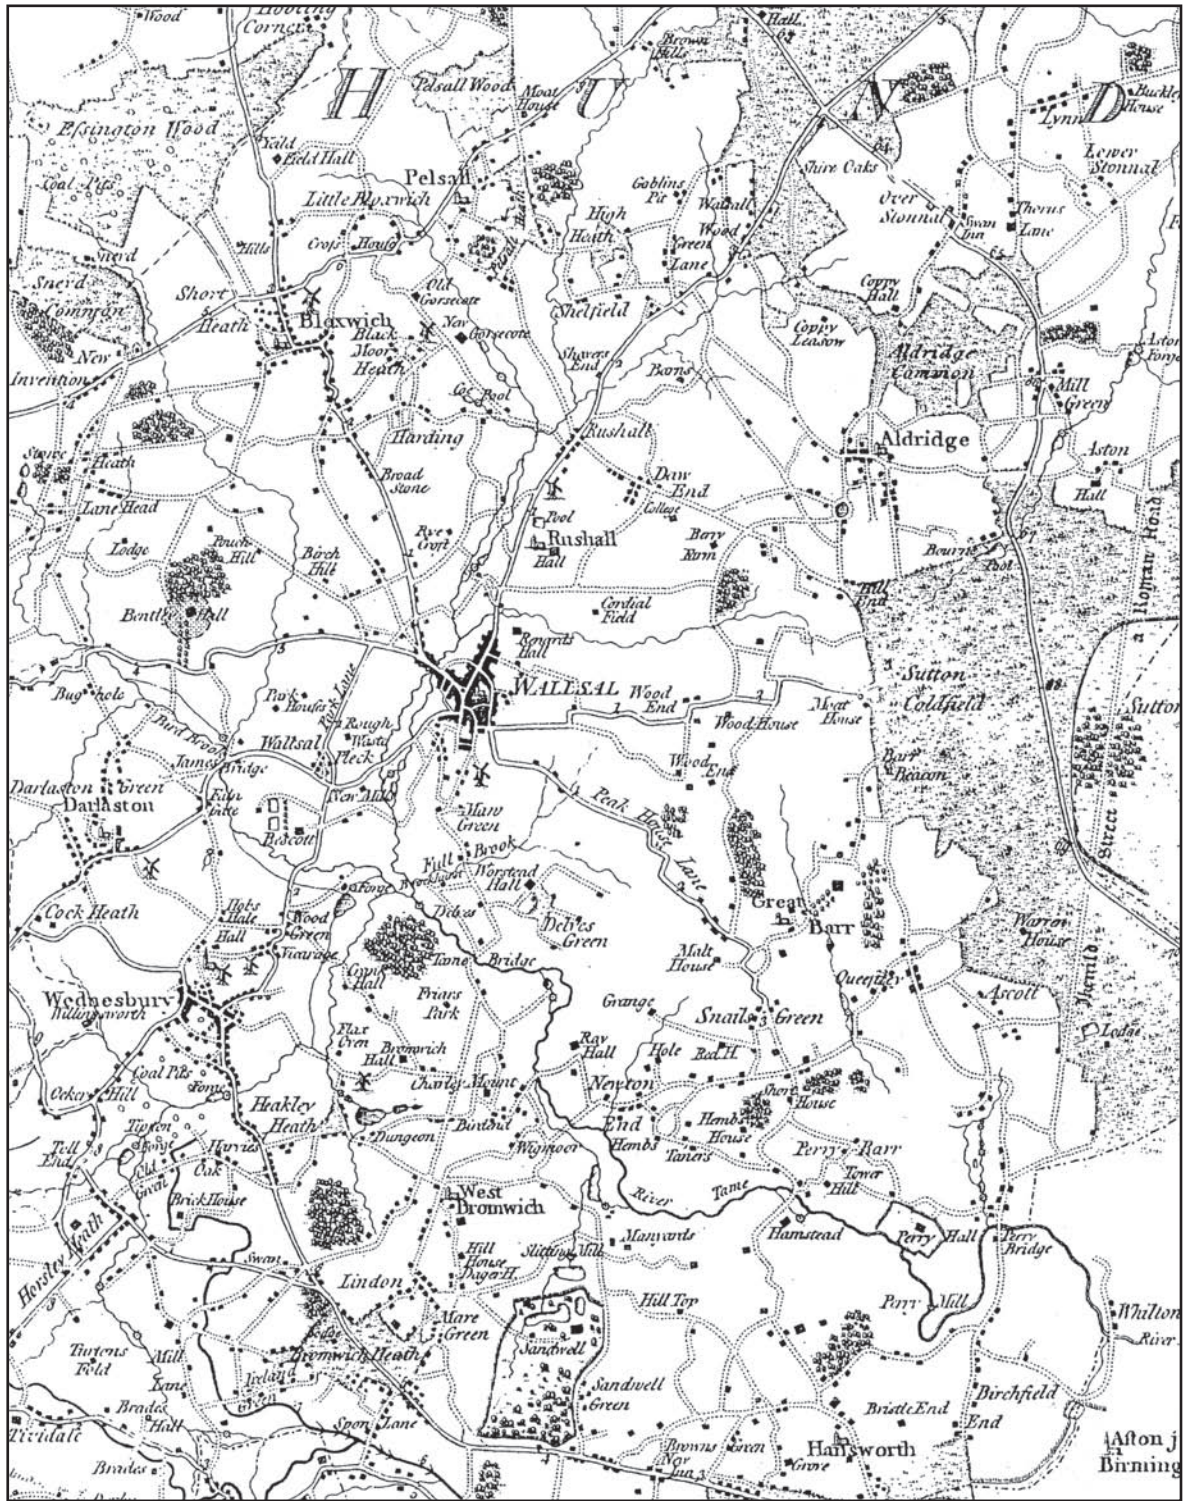
Fig.5

The location of the Jacobean Hall on top of the hill can be inferred from etchings (Plate 1) and from its depiction on Yate's map of Staffordshire 1775 (Fig. 5). On this map, Bentley Hall is shown as a comparatively large building, with woodland to the north, and a long tree lined avenue to the south. Unlike other halls and substantial buildings on this map, it is highlighted with a shaded circle, indicating its prominence and importance in the landscape.
