Former Adamant Co. Works 37-45 Commercial Street Birmingham

Building Recording and Documentary Record

# Building Recording and Documentary Research, 2006

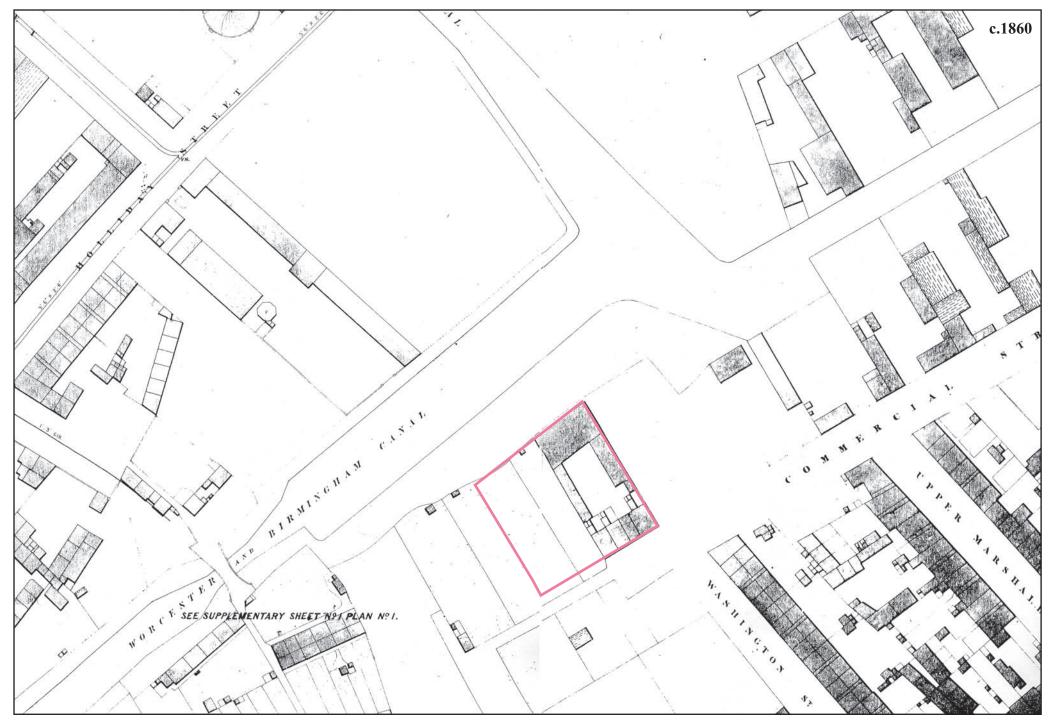
Fig.4

Commercial Street first appears in the cartographic record on the Piggott Smith's Board of Health map of 1848-62, by which time buildings had been erected in the study area (Fig. 4). The map shows a group of buildings arranged around a central courtyard, standing on their own and occupying the eastern half of the present site. The front (south) range was divided into four units, three of which had short rear wings within small rear (north) yards, and the appearance of a row of terraced houses. The fourth unit, which was slightly narrower and which had no appendages, may have been a covered entrance. Certainly, there is no other obvious access to the yard from Commercial Street. On the west side of the courtyard was a long narrow range, on the north side a much wider range, and on the east side a medium width range with a small annexe at the south end. The impression is of a collection of separate buildings rather than of a unified entity.

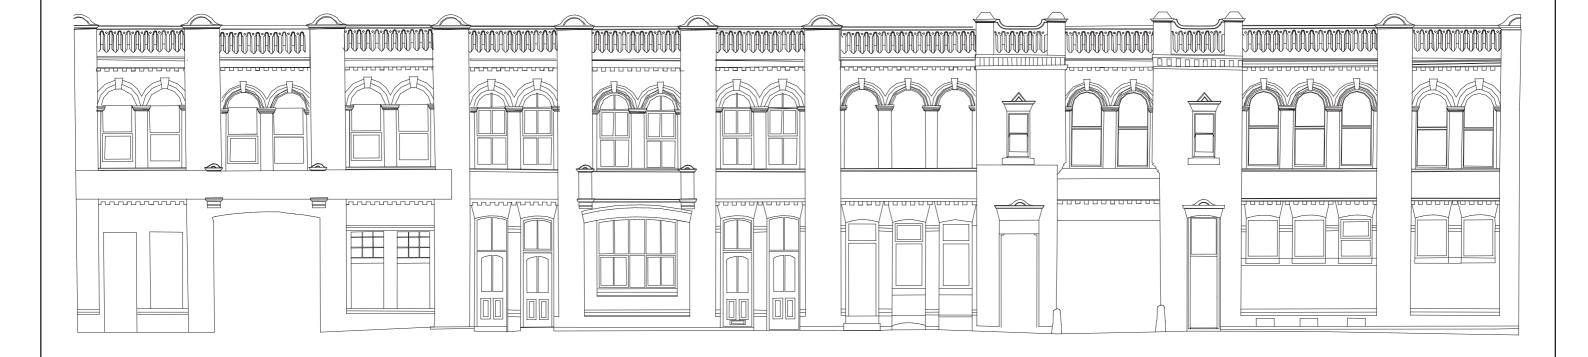
# South Elevation

The Commercial Street elevation, which is all part of Building A, dates from 1897 or immediately afterwards on the grounds that it does not correspond with Henman's plan of that year, yet belongs stylistically to the turn of the 19<sup>th</sup>/20<sup>th</sup> centuries. It is of two stories with blue brick-coped plinth, wide mid-height fascias defined by brick dentils and cyma-recta moulded strings, brick dentilled and moulded terracotta cornice, and stone openwork parapet. The front is articulated vertically by pedimented pilaster buttresses into ten bays containing semi-circular-arched windows, mostly two, but in some cases three to a bay. The 19<sup>th</sup>-century openings generally survive, with arches springing from moulded imposts, and either of moulded plasterwork, or of two tiers of red (inner) and brick (outer) voussoirs, depending on their position within the composition. Most of the original plate glass sashes, however, have been replaced.

Although first impressions are of a unified and regular composition, it soon becomes apparent that the elevation incorporates a number of separate and symmetrical elements, described here from left (west) to right (east).

Firstly, a three-bay block with central segmental-arched carriage entrance containing a late 19<sup>th</sup>/early 20<sup>th</sup>-century boarded two-leaf half-glazed door, modified by the insertion of a steel pedestrian door. The bays to either side have been remodelled in the mid to late 20<sup>th</sup> century. The fascia over the carriage entrance is highlighted by flanking pedimented pilasters on moulded imposts, and, at first floor level, the central windows have moulded plaster arches, whereas those to each side are plain.

Next, another three-bay block with central wide segmental-arched window flanked by two pairs of doorways, recessed under plastered segmental arches. Like the adjoining western block, the differentiation of the centre bay is continued above by the pedimented pilasters on moulded imposts that flank the fascia, and by the moulded plasterwork of the first-floor window heads.

Then, an arrangement of window bays in the rhythm of 3:1:2:1:3, the single windows piercing the pilasters. At ground level, a central vehicular entrance, now fitted with a late 20<sup>th</sup>-century roller shutter, is flanked by a pair of pedimented segmental-arched doorways set within the pilasters. In the left-hand (west) bay are a door and two windows, all with segmental arches, in the right-hand (east) bay three short windows, also with segmental arches.

Lastly, an odd two-window bay with half-pedimented corner pilaster.

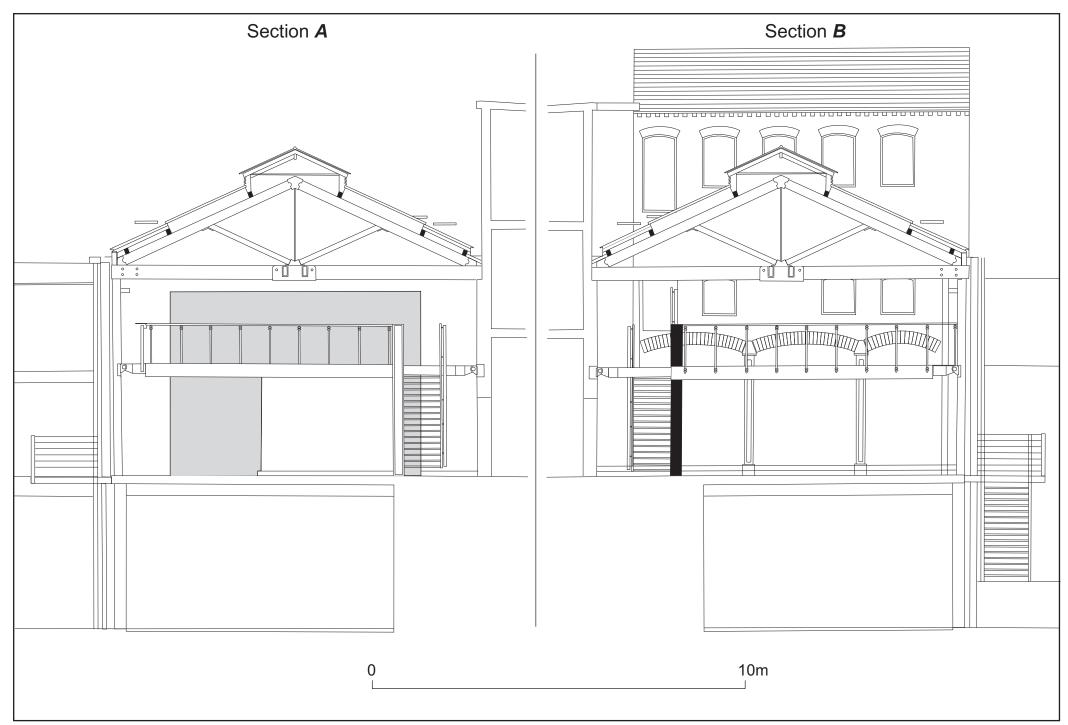
Fig.20

Also an open plan storey (S5/S6) lit by segmental-arched windows to the east (Plate 16), with wooden board floor and late 19<sup>th</sup>-century composite roof comprising iron rod tie beam, raking struts and king post, held in tension beneath timber principal rafters (Fig. 20, Plate 17).

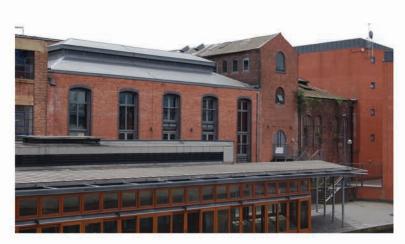
Plate 3

The north elevation towards the canal is divided into three elements: a two-storey, five bay range to the left (east) (Building D), a taller three-storey gabled wing to the centre (Building C), and a single-storey, four bay hipped roof wing to the right (west) with louvre extending back along the full length of the ridge (Building B).

<u>Building D</u>: The north elevation has been rebuilt in the late 20<sup>th</sup> century in red brick laid in English bond with blue brick dressings to the openings. Ground floor level was originally high above the wharf corresponding with the higher level of Commercial Street, but during the reconstruction of this side of the building, a wharf level storey was inserted below the former ground floor.

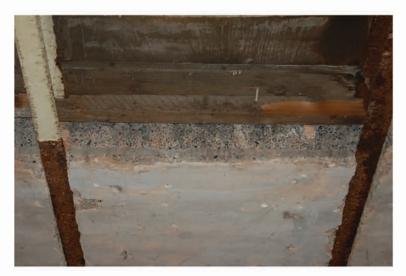
Plate 10

The first-floor offices were reached from the staircase adjacent to the ground floor office now entered directly from Commercial Street (G4). The stone staircase is rather plain, although the steps have moulded lips (Plate 9); over the landing (F12) there is a plaster ceiling with moulded surround. The office layout shown by Henman is still recognizable, with the board room (F14), office (F13) and spare office (F9) still distinct entities although there have been some alterations as a result of their conversion to sound studios, including the conversion of the lavatory on the east side of the office to a corridor. These rooms all seem to have concrete panel ceilings. Something of the nature of the structure is revealed by gaps in the ceiling. The concrete panels are slotted into a network of steel joists. Once the panels were in place, concrete was poured over the top and then sealed with asphalt. A sample of the concrete showed a rather crude concoction with a clinker-based aggregate (Plate 10).

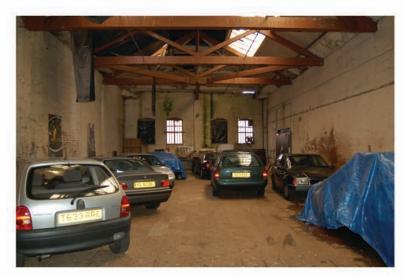
Plate 11

The packing warehouse of 1897, Building B contains a single room (G13) open to the roof, which is hipped at both ends. The painted brick walls are articulated on the west side by a series of piers dividing the wall into five bays corresponding with the roof bays, the trusses of which are supported on the piers, the east ends of the tie beams being embedded in the west wall of Building C, which predates it. The north wall is pierced by two pairs of segmental-arched windows, and has a central pier supporting the beam tying in the northernmost tie beam to the wall. The south wall also has a central buttress, serving a similar function, but this has been truncated by the insertion of a vehicular entrance. Otherwise, the wall was divided into three bays by two other piers. The eastern bay has also had a large opening inserted, but the western bay contains a blocked segmental-arched doorway. The roof is hipped at both ends and consists of a series of tie beam and principal rafter trusses with a pair of raking struts extending from the centre of the tie beam to the principals, and an iron rod in place of a king post (Fig. 21, Plate 12). A significant feature of the trusses is that the centres of the tie beams are fitted with iron collars which act as anchors for the struts and king post. The roof is of late 19<sup>th</sup>-century character, and the Ordnance Survey 1:500 map suggests that it might have been in existence by 1888.

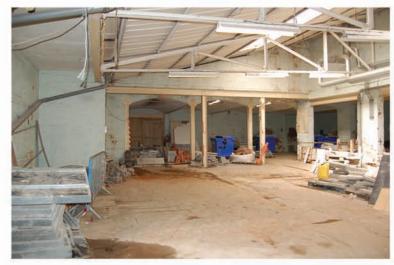
Plate 13

At ground level (G12/G22) the east elevation comprised nine bays of brick segmental arches (Plate 13) carried on iron square-sectioned panelled columns with square abaci, each supporting an iron *tas-de-charge* to meet the arches (Plate 14). The first and sixth arches from the south have been blocked with bricks. Inside, behind the brick arches is a series of tunnel vaults springing from iron joists bolted to flanges at the backs of the columns (Plate 15). The west ends of these are supported on brick piers with bullnose brick corners, ranged against the west wall. In the south wall is a blocked segmental-arched window (east) and a blocked full-height doorway (west), probably an insert. In the centre of the north wall is the former window, now a doorway.

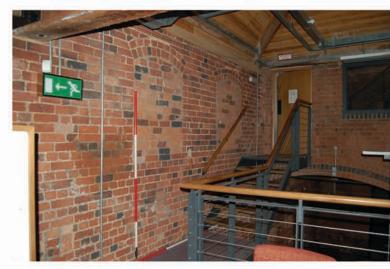
Plate 18

On Henman's plan this structure was divided into two areas, the boiler house to the south (G10) and the engine room to the north (G11), extending into Building C, through a now blocked archway. The walls of both the former engine room and the former boiler house abut Building C and must therefore be later. Both north and south walls of the boiler house have had two large full-height openings inserted into them leaving little in the way of details. The upper walls above these gaps are now supported by steel I-beams. At the east end of Building E the southeast corner of the engine room is executed in bullnose bricks. The north wall of the engine room retains blocked segmental-arched windows, visible from Building D (Plate 18).

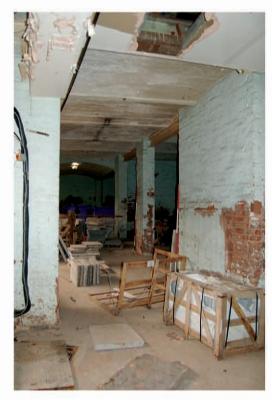
Plate 20

In 1897, this area was occupied by a large store room (G7) at ground level, which was provided with a pair of windows to the west. The whole of the west wall has now been removed at this level and the wall above is supported on an I-beam. The same is true of the south wall with Building A. Little detail, then, survives. A blocked doorway at the west end of the north wall is an insertion. On the Henman plan, the eastern half of the north wall was open to Building F but this opening has been closed with breeze blocks. The ceiling is largely covered over but where the plasterboard was fallen away it has revealed a timber first floor (Plate 20).

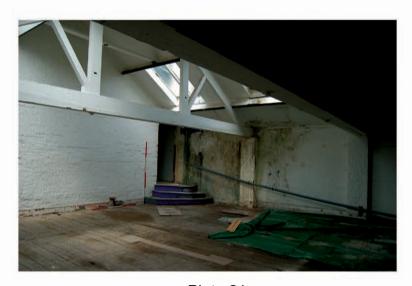
Plate 21

The upper storey of Building G (F11) was also lit towards the west by two windows, the southern one of which survives, while the northern one has been blocked with bricks. As shown in Henman's section (Fig. 10), they have segmental arches. The first floor itself comprises a single room, part of the modelling shop in 1897, but at a lower level than the first floor in Building A, and presumably from a different phase. The first floor room is open to the roof and has two later 19<sup>th</sup>-century timber roof trusses comprising tie beams, short principals carrying two pairs of plank purlins, and queen struts bolted to the tie beam and clasping a collar (Plate 21).
