**Former Corus
Steelworks, Bloomfield
Road, Tipton**

**Historic Building
Recording and Analysis
2006**

Project No. 1484

August 2006

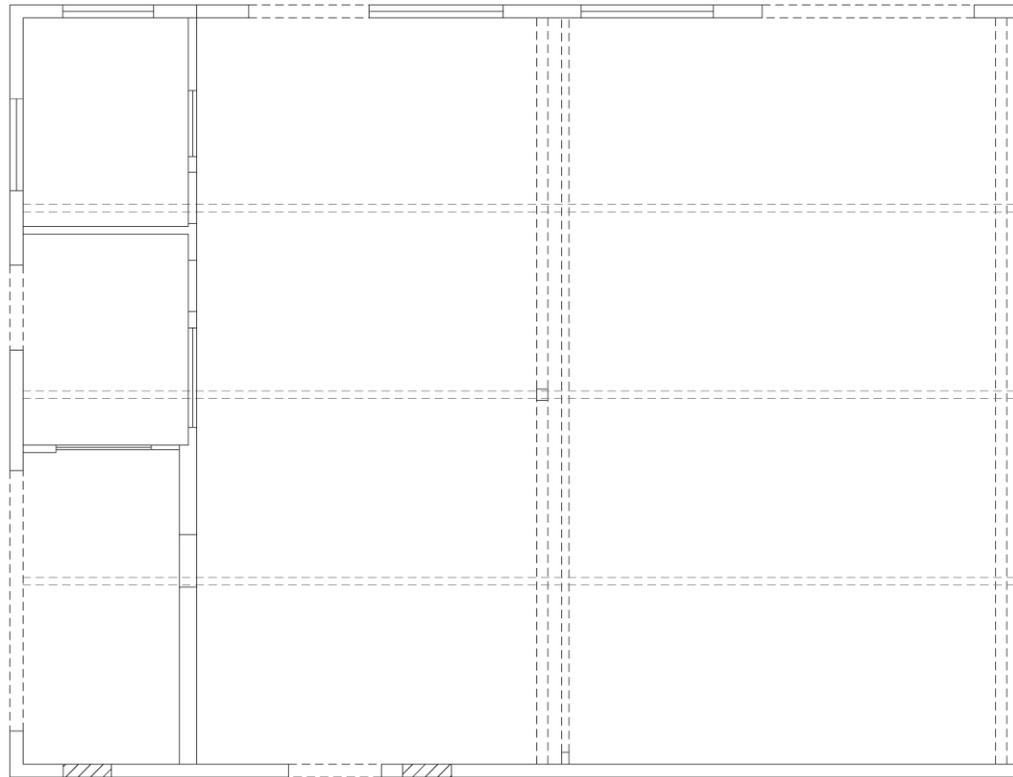
Fig.No.
Fig.4

Two-bay workshop of early-20th century date (Plate 10). The SW portion of the room has been partitioned off to form a small office/workshop. The floor of the room is concrete, covered by metal-topped tiles. The walls are composed of painted brick (9"x3"x4½") laid in Flemish stretcher bond. Central to the wall, and at the NW end is a steel I-post, supporting a steel I-beam running parallel to the wall. This supports an overhead travelling crane of mid to late-20th century date. The SE wall of the room has a large inserted double doorway with an I-beam lintel within the SW bay of the room. To the NE of this is a bricked-up doorway with a concrete lintel. At the SW end of the wall, contained within the partition is another bricked-up doorway with a concrete lintel. The SW wall has a large inserted opening with an I-beam lintel at its SE end leading to the exterior via the mid to late-20th century extension. To the NW of this, central to the wall is a doorway through to the extension. At the NW end of the wall is a timber-framed multi-light casement window. The NW wall has an identical window at its SW end. To the NE of this is a doorway of early to mid-20th century appearance. To the NE of this are two identical large, multi-light timber-framed windows. To the NE of those is a large metal roller shutter for vehicular entry.

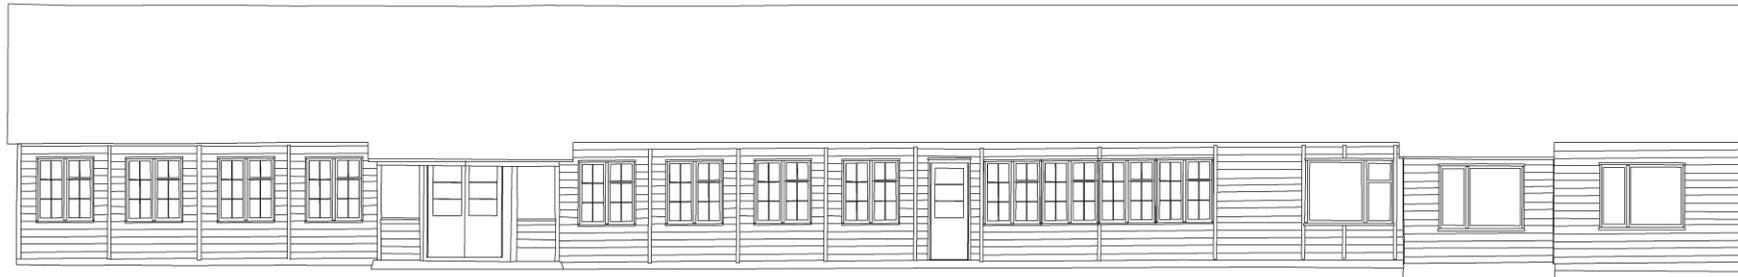
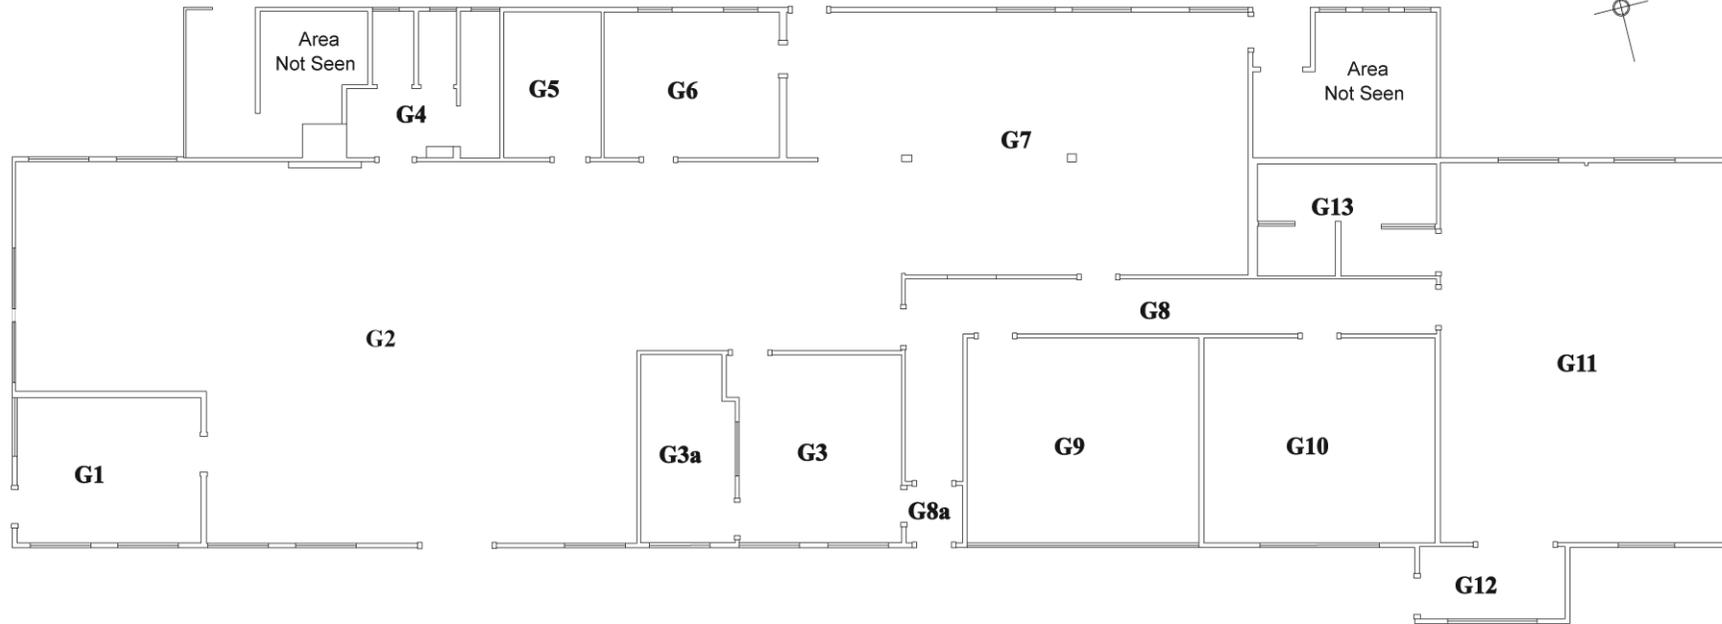
South Elevation

Main elevation of the building (Fig. 5). At ground level the building rests on a brick sill, faced with random sized, square-cut ashlar dressing at the E end (Plate 13). At the W end of the building are four evenly spaced 12-pane timber-framed windows, flush with the wall with a slightly projected chamfered timber label above, and a slightly projecting timber sill. To the E of this is a wide exterior porch with a central set of double doors of mid-20th century appearance with three glazed upper panels. To the E of this are four further evenly spaced 12-pane timber-framed windows. To the E of this is a single doorway filled by a door with of mid-20th century appearance with 3 glazed upper panels. E of this are four 12-pane timber-framed windows arranged immediately adjacent to each other to form one continuous glazed section. To the E of this is a large window with a large central fixed light, with side panes topped by top hung vents. E of this is a room projecting forward from the main body of the building to form a small porch. This has a large central window with a large fixed pane to the E with a narrow casement to the W. To the E of this projection is an identical window. The roof of the building is pitched and covered by felt.

Located in the SW corner of the building, SW of G2. Floored with wooden boards covered by lino. The walls are composed of stud, which has been panelled to mid-height, and papered and painted above. The E wall has a central doorway through to G2. The S wall of the room has two evenly spaced 12-pane, timber-framed casement windows with early-20th century latches. The W wall has a doorway at its S end of early-20th century date leading to the exterior. To the N of this is a 12-pane, timber-framed casement window identical to those on the S wall. The ceiling of the room is painted stud panelling, and pitches to the S from its central line.

Located at the W end of the building, the widest part of the room runs the full width of the main block (Plate 16). Floored with wooden boards covered by lino. The walls are composed of stud, which has been panelled to mid-height, and papered and painted above. The N wall has two identical 12-pane, timber-framed casement windows at its W end. To the E of this is a brick and tile fireplace (Plate 17). E of this is a 6-panelled wooden door of early-20th century appearance leading through to G4. This is to the W of a similar doorway leading through to G5. E of this is a mid to late-20th century door leading through to G6. At the E end of the wall the room is open through to G7. The E wall of the room is again open to G7 at the N end of the wall. To the S of this is a doorway leading through to G8. The S wall of the room steps forwards at the E end to allow for G3 behind, central to this projecting section is a doorway through to G3. To the W of this is a 12-pane, timber-framed casement window. W of this, central to the length of the room is a set of glazed doors leading to the exterior. This is to the E of two further 12-pane, timber-framed casement windows. The W end of the wall again steps forward, this time to allow for G1 behind. The W wall has two 12-pane, timber-framed casement windows located to the N of G1. The ceiling of the room is composed of five bays separated by wooden trusses supported by metal struts.

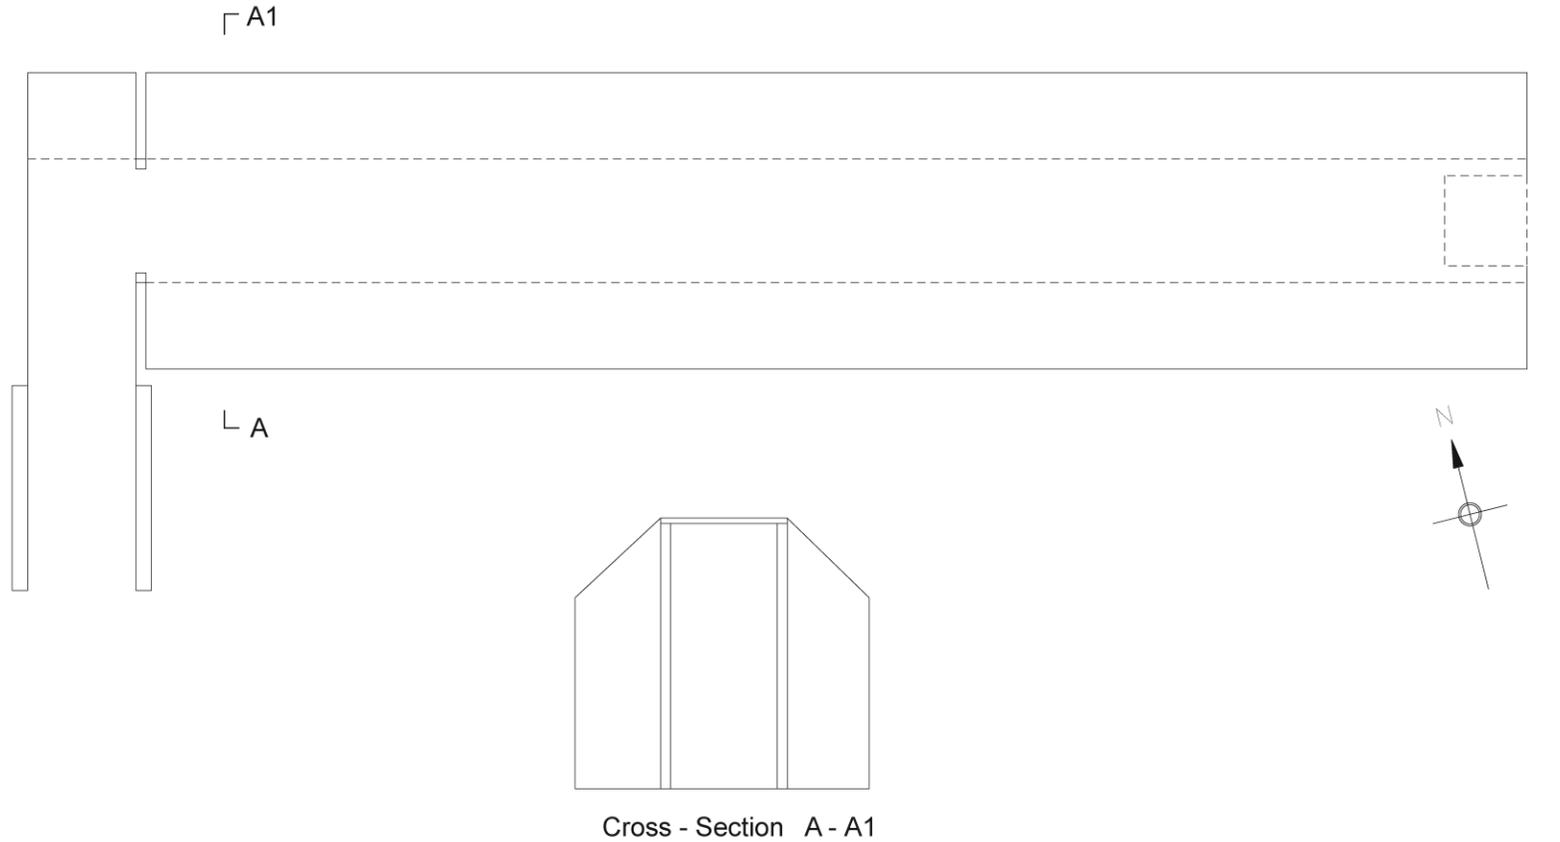
Building N

The interior of the shelter has a floor composed of concrete. The walls are composed of concrete rendered with plaster. The north and south walls are pitched from mid-height. The W wall has a central doorway through to the porch area (Plate 21). The door has a substantial timber frame, containing a large timber door. The E wall has an iron ladder rising central to the wall leading to a small, square hatch in the ceiling leading to the exterior.

The 1937 Air Raid Precautions Act required the provision of adequate shelter for workers at sites such as the Brymill Steel Works. Although passed in 1937, the Act did not become law until January 1st 1938 (Dobinson 2000, p25), with most factories not beginning construction until the first wave of bombing began in 1939-40 (Nichol, K 2006, *pers. comm.*). This explains the absence of the structure from the 1938 O.S. map of the works (Fig. 3). The structure is a semi-sunken shelter, and is unusual in having a pitched roof profile rather than a parabolic cross-section (Lowry 1996, p71).

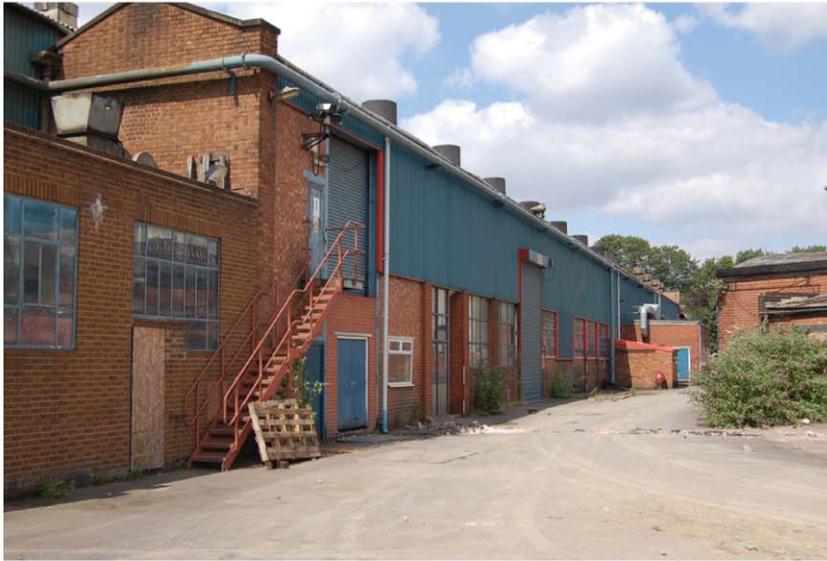
Plate 1

Mid-20th century factory shed (Plate 1). The structure is composed of a large steel framework, infilled to a height of c.2m with red/brown brick (9"x3"x4½") laid in Flemish Stretcher bond. Above this the walls are constructed of corrugated steel sheeting. The walls are cut by large openings covered by steel roller shutters to allow vehicular access. The walls are perforate by large steel-framed multi-pane windows. The roof is composed of the same corrugated steel sheeting with large outlet flues.

Buildings B1 and B3 were recommended for Level 1 recording to establish if earlier industrial fabric was contained within the structure. Although earlier material is present, it is of early-20th century date and does not form a coherent pattern.

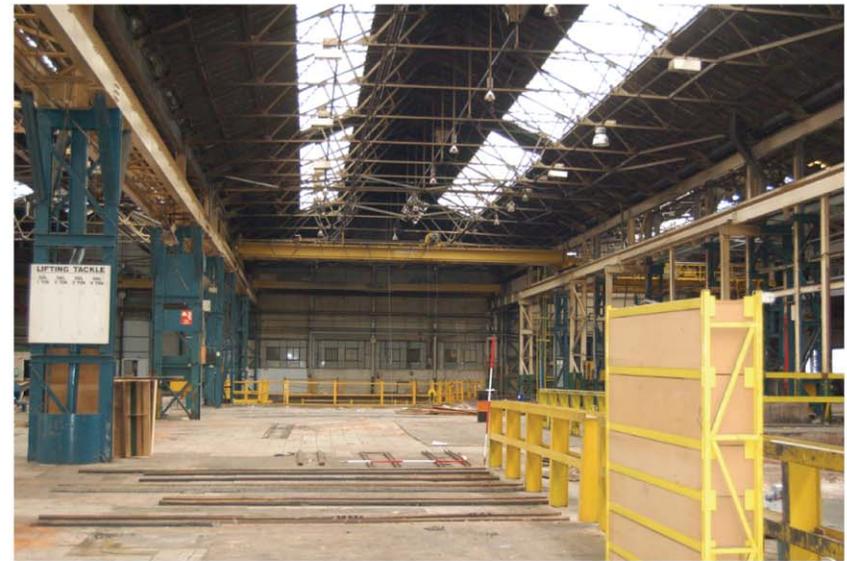
Plate 2

Large factory shed composed of four bays running N-S with a further bay at the S end running east-west. The interior space is approximately 2-3 stories in height (Plate 2). The floor is composed of steel-topped tiles laid over concrete. At the S end of the building are a series of sunken pits, which appear to be large moulds for steel. The building is supported by a large steel frame composed of bolted steel I-beams, open between bays (Plate 3). The exterior walls are composed of brick to a height of c.2m. Above this are large metal-framed, multi-pane windows. The interior contains several smaller buildings, built as offices, all of late-20th century date. Each bay of the interior has an overhead travelling crane. The roof of the building is composed of steel I-beams supporting corrugated steel sheeting (Plate 4).

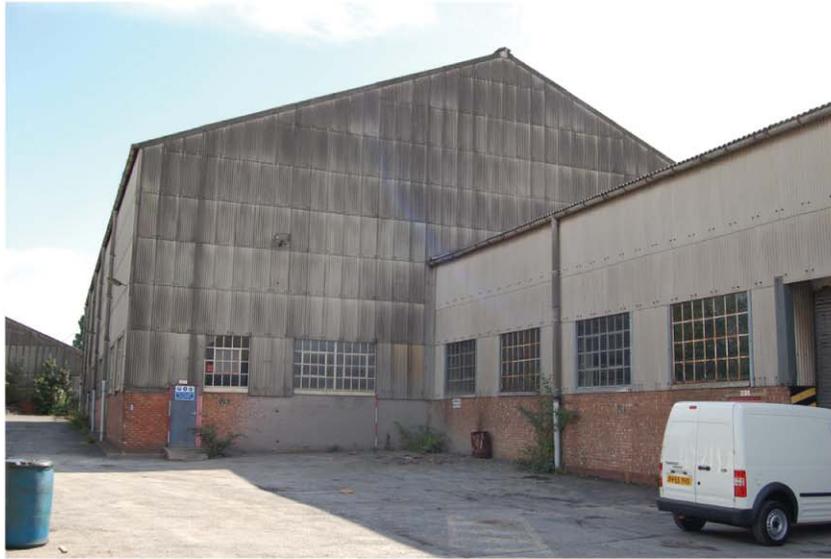
Plate 5

Mid-20th century factory shed (Plate 5). The structure is composed of a large steel framework, infilled to a height of c.1.6m with red/brown brick (9"x3"x4½") laid in Flemish Stretcher bond. Above this the walls are constructed of corrugated asbestos sheeting, covered by steel sheeting on the exterior. The walls are cut by large openings covered by steel roller shutters to allow vehicular access. The walls are perforated by large steel-framed multi-pane windows. The roof is composed of corrugated asbestos sheeting with clear corrugated sheets to allow light to enter. A few patches of seemingly earlier brickwork exist, measuring 8½"x2½"x4¼" but these are again only 1.6m high and of no discernible pattern. They appear instead to be re-used Victorian brick, as they are machine-cut and early 20th-century in appearance.

Building G was recommended for Level 1 recording to establish if earlier industrial fabric was contained within the structure. Although earlier material is present, it is of early-20th century date and does not form a coherent pattern.

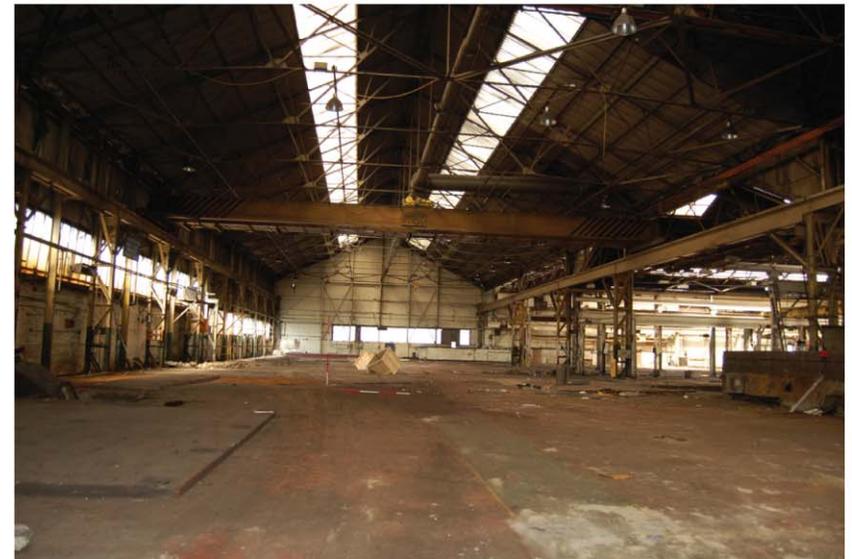
Plate 6

Large factory shed composed of five bays running NE-SW with a further three bays at the S end running SE-NW. The interior space is approximately 2-3 stories in height (Plate 6). The floor is composed of concrete. Throughout the building are a series of sunken pits (Plate 7). The building is supported by a large steel frame composed of bolted steel I-beams, open between bays. The exterior walls are composed of brick to a height of c.2m. Above this are large metal-framed, multi-pane windows. Each bay of the interior has an overhead travelling crane. The roof of the building is composed of steel I-beams supporting corrugated steel sheeting.

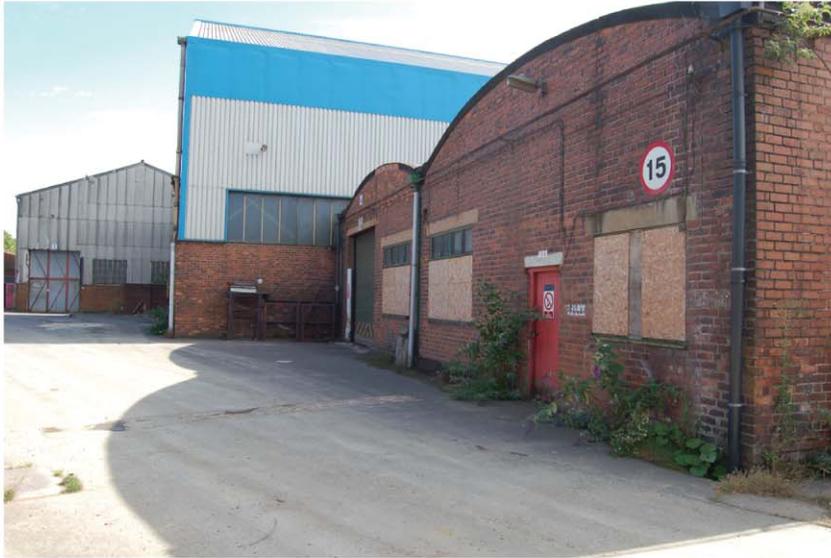
Plate 9

Single-storey building with two segmental-arched bays (Plate 9). The walls are composed of red/brown brick (9"x3"x4½") laid in Flemish stretcher bond. At the NE end is a large opening with a concrete lintel covered by a steel roller shutter. To the SW of this is a large timber-framed, multi-light window with a concrete lintel. To the SW of this, central to the façade, is a steel I-post. To the SW of this is an identical window. To the SW of this is a doorway of early to mid-20th century appearance with a concrete lintel. At the SW end of the elevation is a small window whose features are obscured by wooden boarding.

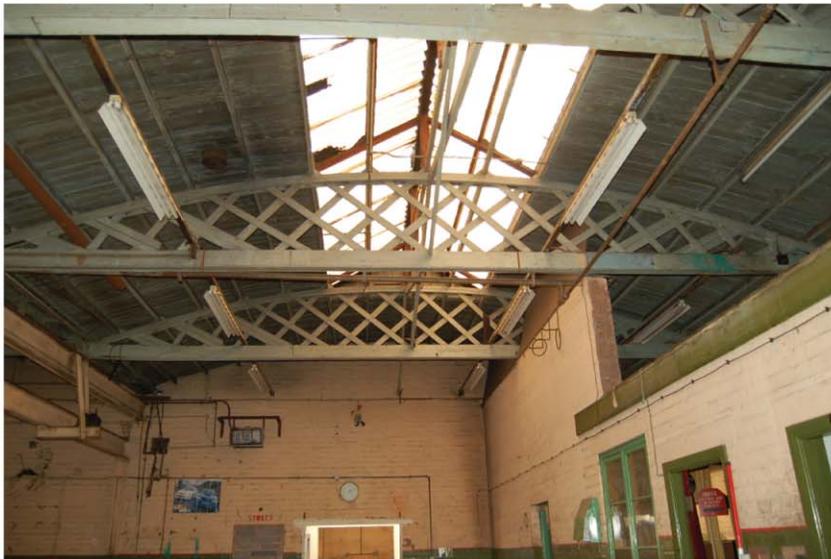
Plate 11

Building I is a small industrial workshop of early-20th century date. Although it possesses a Belfast truss roof (Plate 11), it is of no great architectural significance or importance.

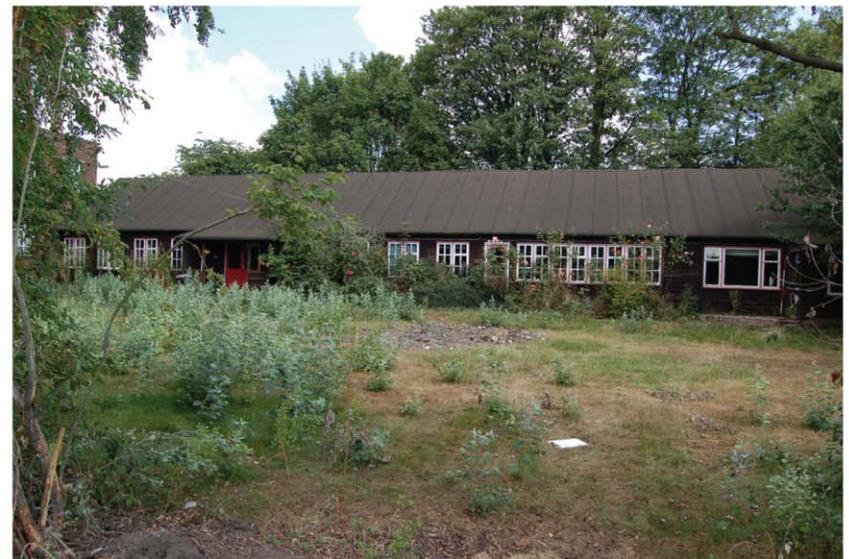
Plate 12

Single-storey building of early-20th century date. Constructed primarily of timber with weatherboarded walls and timber-framed windows (Plate 12). The roof is pitched and covered by felt.

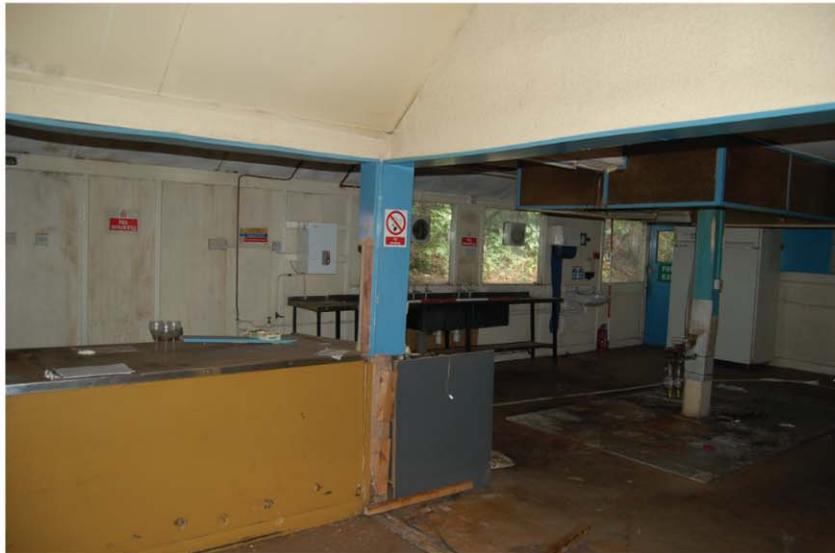
Plate 18

Kitchens (Plate 18). Located to the N and E of G2, E of G6, N of G8. The floor is composed of wooden boards covered by lino. The walls are composed of painted stud. The N wall has an early-20th century door at its W end leading to the exterior. Central to the wall are two large, single-paned windows, with a further identical window at the E end of the wall. The E wall has a doorway at its N end leading to the exterior. This is filled by a mid-20th century door with a glazed upper section. The S wall has a central doorway leading through to G8, filled by a plain mid-20th century door. To the W of this is a hatchway opening into G8. The W wall of the room is open at its S end to G2 to the W. To the N of this is a doorway filled by a door of early to mid-20th century date which leads through to G6. The ceiling of the room is composed of painted stud and pitches downward to the N.

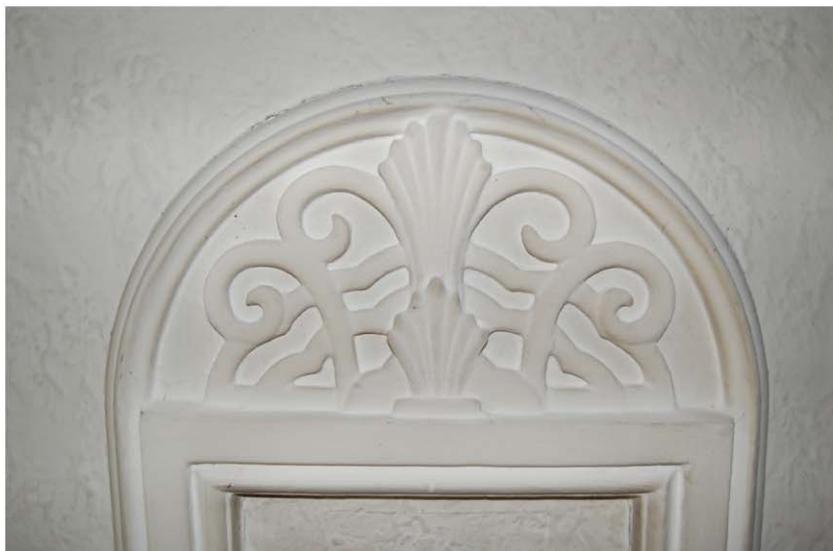
Plate 19

Located S of G8, W of G9, E of G11. The floor is composed of wooden boarding covered by carpet. The walls are composed of stud covered by wallpaper. The N wall has a central doorway leading to G8, filled by a door of mid-20th century appearance. The S wall of the room has a large central window with a central fixed pane, with a side pane to either side topped by a top-hung vent. The ceiling of the room is composed of stud covered by paper. Around the central light fixture is an ornamental wooden surround of Art Deco style (Plate 19).

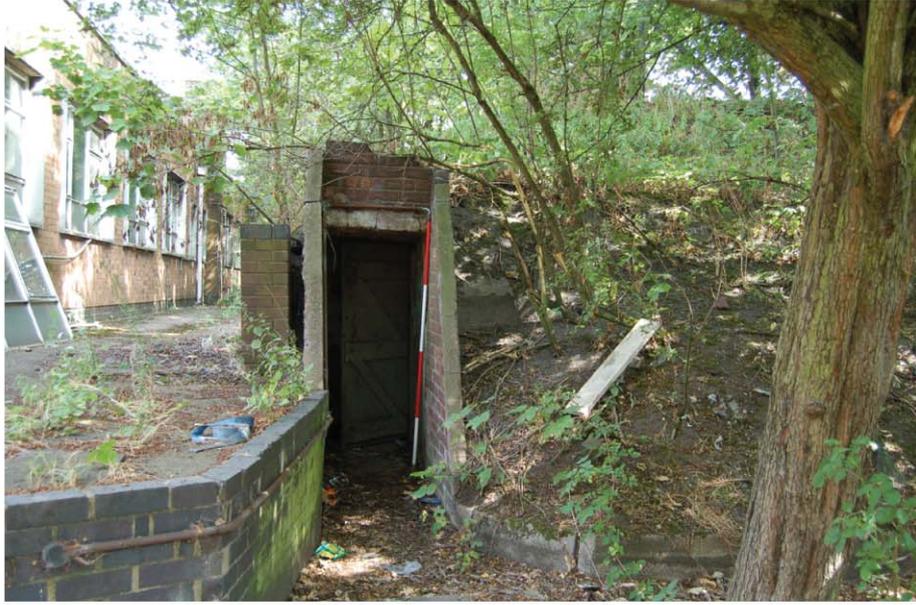
Plate 20

Second World War air-raid shelter. The bulk of the structure is composed of concrete, and covered by a low mound of earth (Plate 20). The entrance to the shelter, at the W end of the S elevation is framed on either side by a sloping brick wall, composed of red/brown brick (9¼"x3"x4½") laid in stretcher bond and capped by concrete. This leads to a small porch-like area with concrete walls and ceiling covered by a layer of plaster held to the surface using a metal mesh.
