Westgate, Wakefield:  
An Archaeological  
Evaluation 2006

Project No. 1534

By Kristina Krawiec and Matt Edgeworth

### AN ARCHAEOLOGICAL EVALUATION 2006: AREAS A, C and D FINAL REPORT

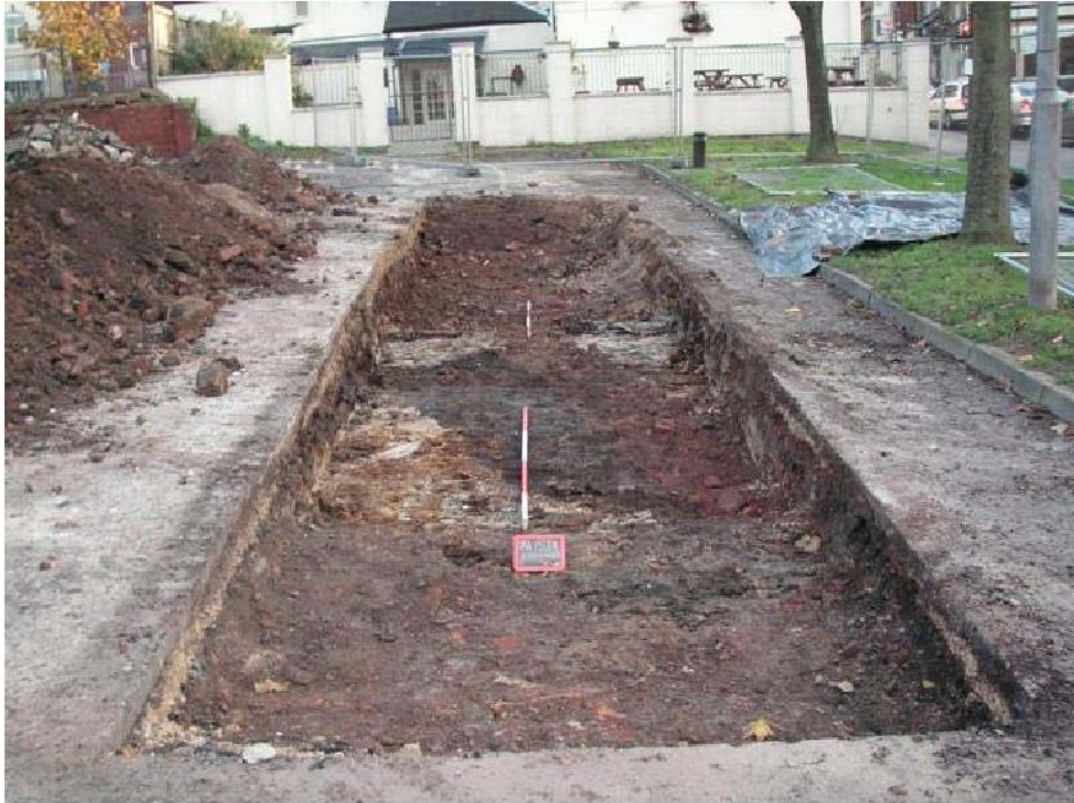
**Plate 1**

Trench 1 (Plate 1) was aligned east-west in the area identified as the former Westgate street frontage. The natural subsoil was a yellow grey silt clay [1007] which was reached at a depth of 38.20m AOD.

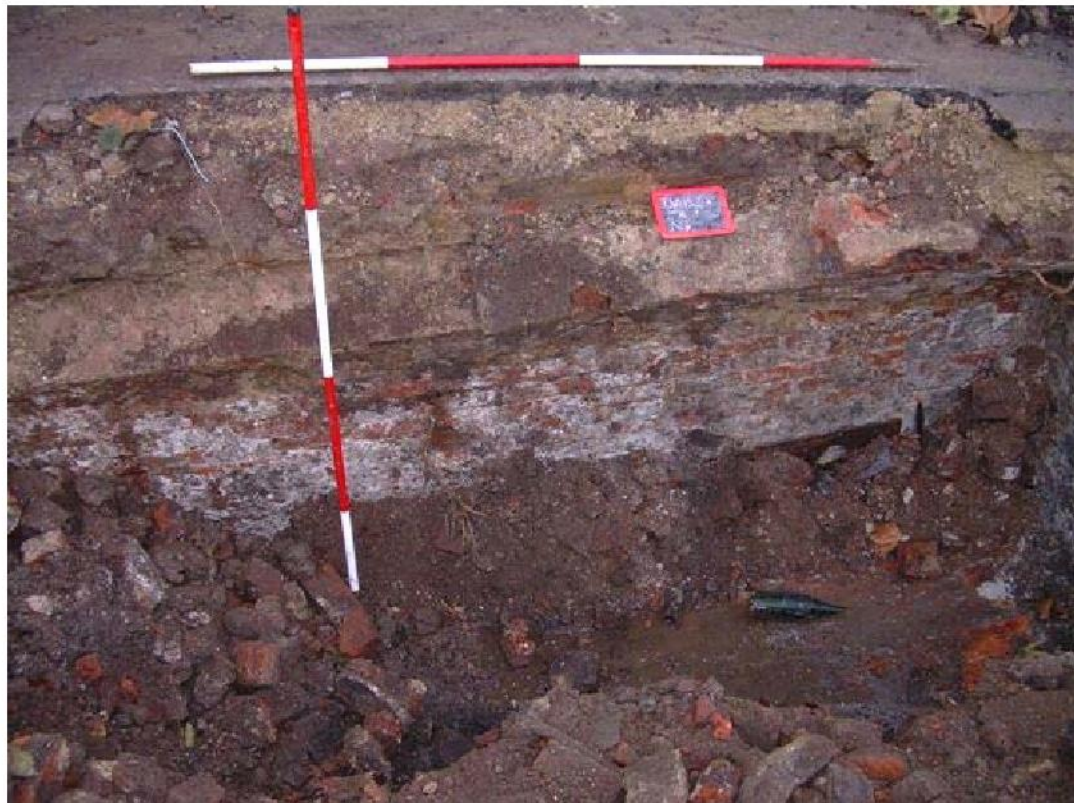
**Plate 2**

At the eastern end of the trench the natural [1007] was cut by a large barrel vaulted cellar [1004] (Plate 2). The floor (evident at 36.80m AOD) and walls [1005] of the cellar were constructed using machine-cut brick. The cellar [1004] was filled with brick demolition-rubble [1006]. This rubble and the sandstone wall [1003] were sealed by a layer of rubble [1002], which was evident along the entire trench. The demolition rubble [1002] was truncated by a large southwest-northeast orientated modern storm drain, which was in turn sealed by the hardcore [1001] and [1000] tarmac car park surface.

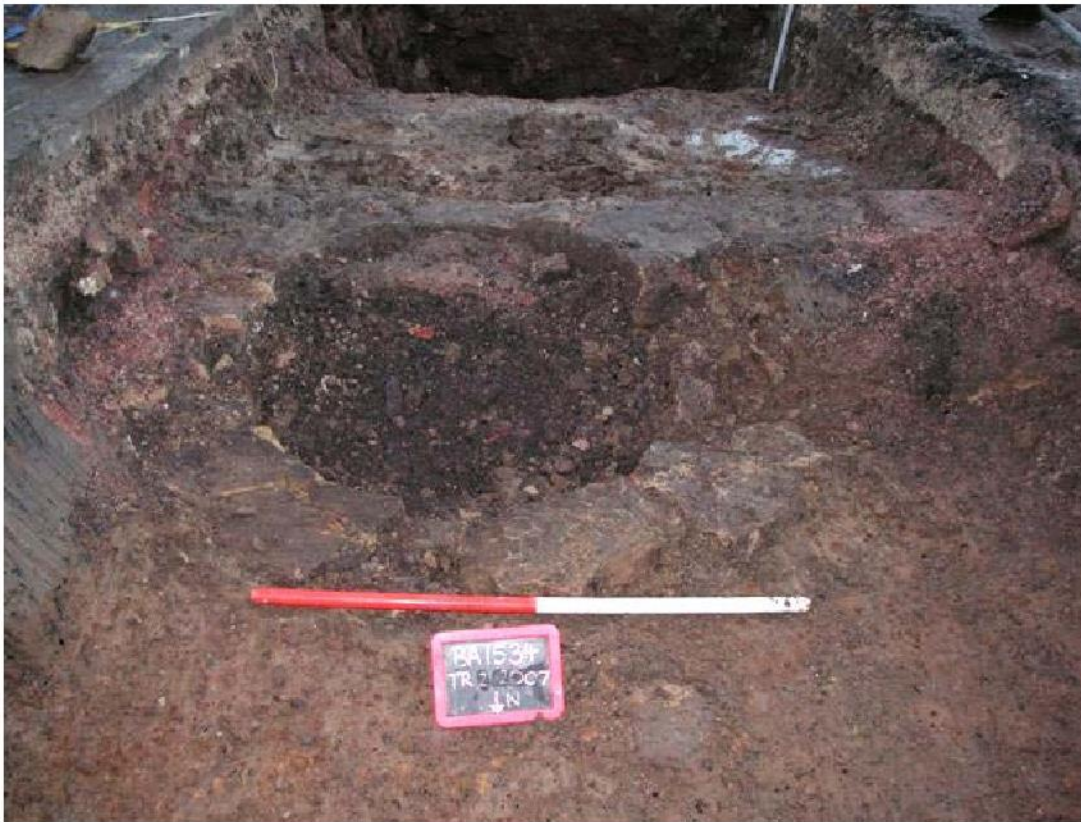
**Plate 3**

To the north was a sandstone well [2007] which was filled with compacted brick rubble [2018] containing late 17<sup>th</sup>-18<sup>th</sup> century pottery (Plate 3). A 20 litre soil sample was taken from this context but again no charred plant remains were present. The upper fill of the well comprised a very hard crushed brick deposit [2017].

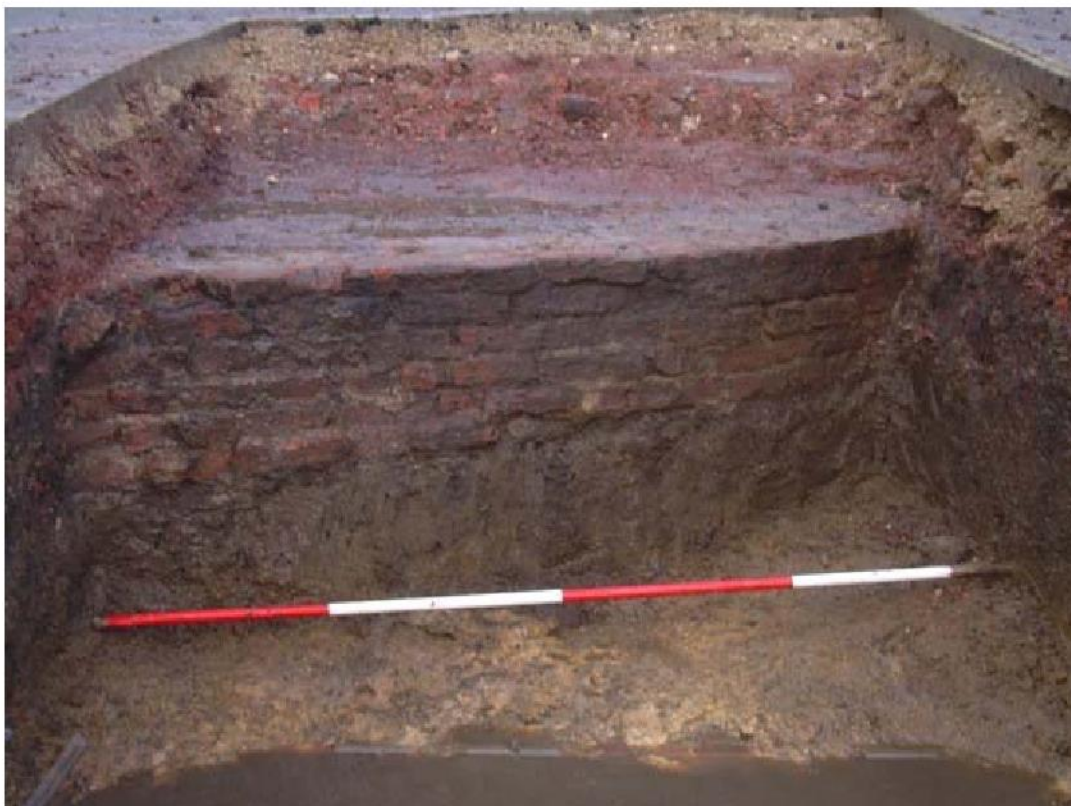
**Plate 4**

At the northern end of the trench layer [2011] was cut by a curving brick wall [2002], which survived to a height of 40.24m AOD and is possibly a garden feature (Plate 4). This was not seen in section partly due to the curvature of the wall, but it also because the wall butt ended close to the section edge. Near the middle of the trench layer [2011] was overlain by a post-medieval black-grey silt clay flecked with charcoal [2004]. This layer was in turn overlain by a brick floor [2010], made of handmade bricks in poor condition, which may have formed part of an alleyway.

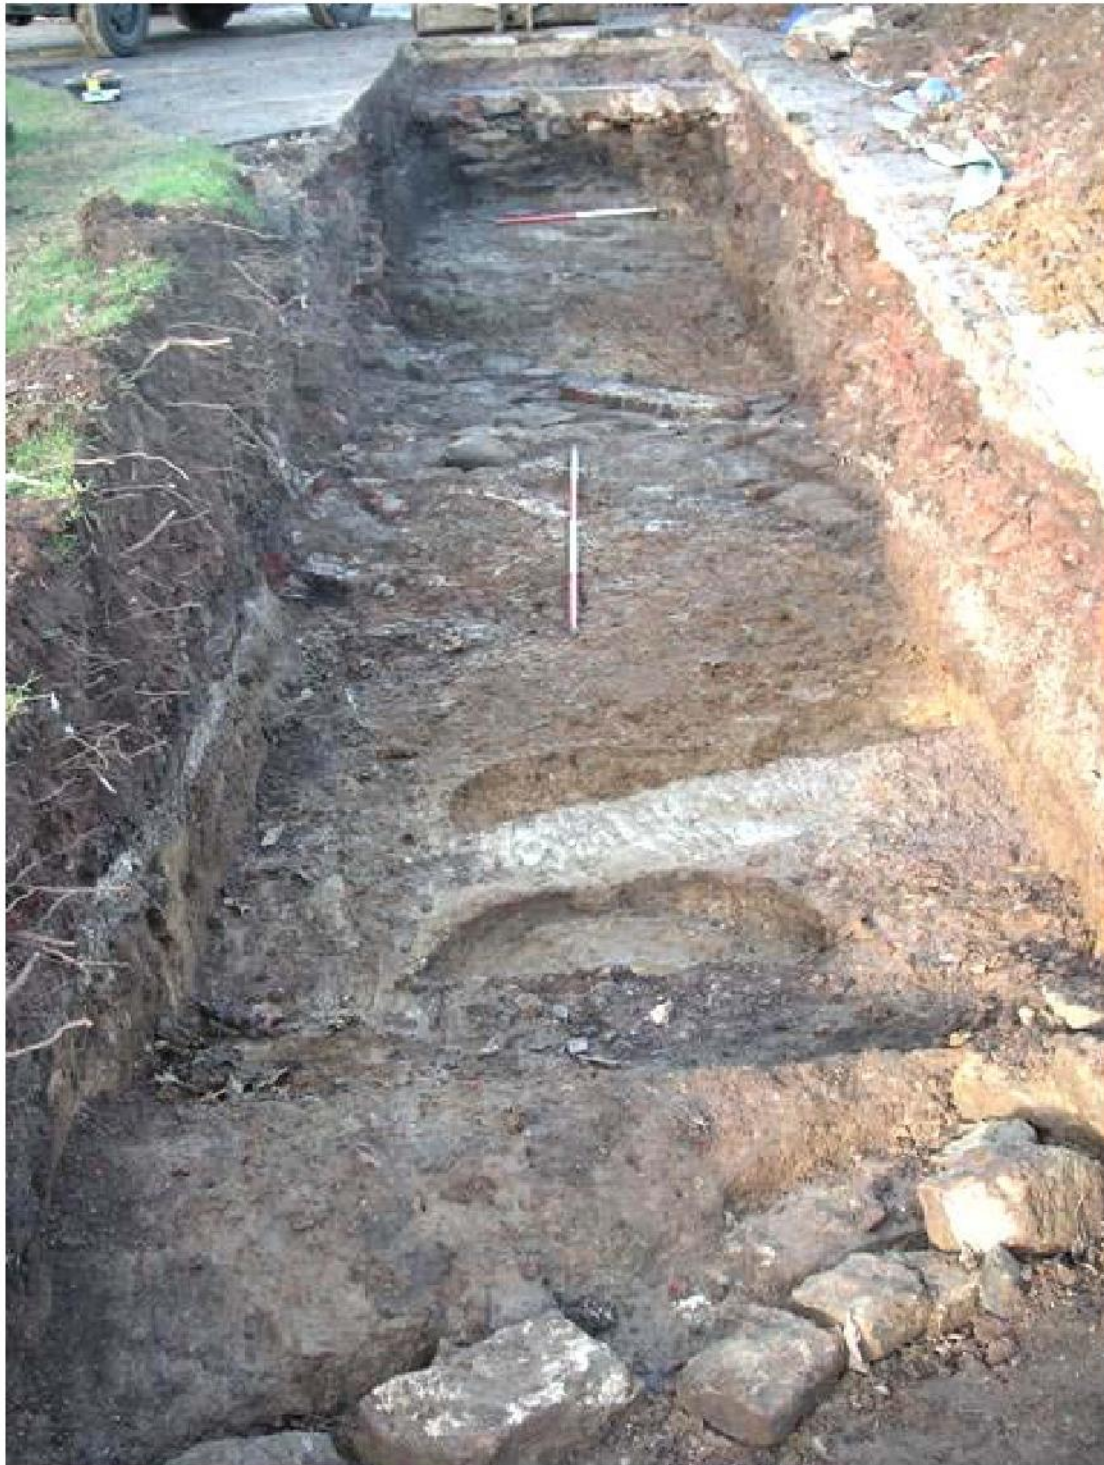
**Plate 5**

At the southern end of the trench the natural was cut by a southwest-northeast orientated sandstone wall [3004] which returned to the southeast [3045] (Plate 5). Only one course of the wall survived. The wall was built of roughly cut sandstone with brick insertions and one sherd of medieval pottery was retrieved from the top of the wall. To the north of this wall were three clay lined pits, [3009], [3012] and [3041], one of which [3009] produced a sherd of medieval pottery. Two of the pits [3012] [3041] were heavily truncated leaving only the clay lining at the base. The relationship between them was unclear and they may represent a double pit. These pits were similar to pit [2019] recorded in Trench 2.

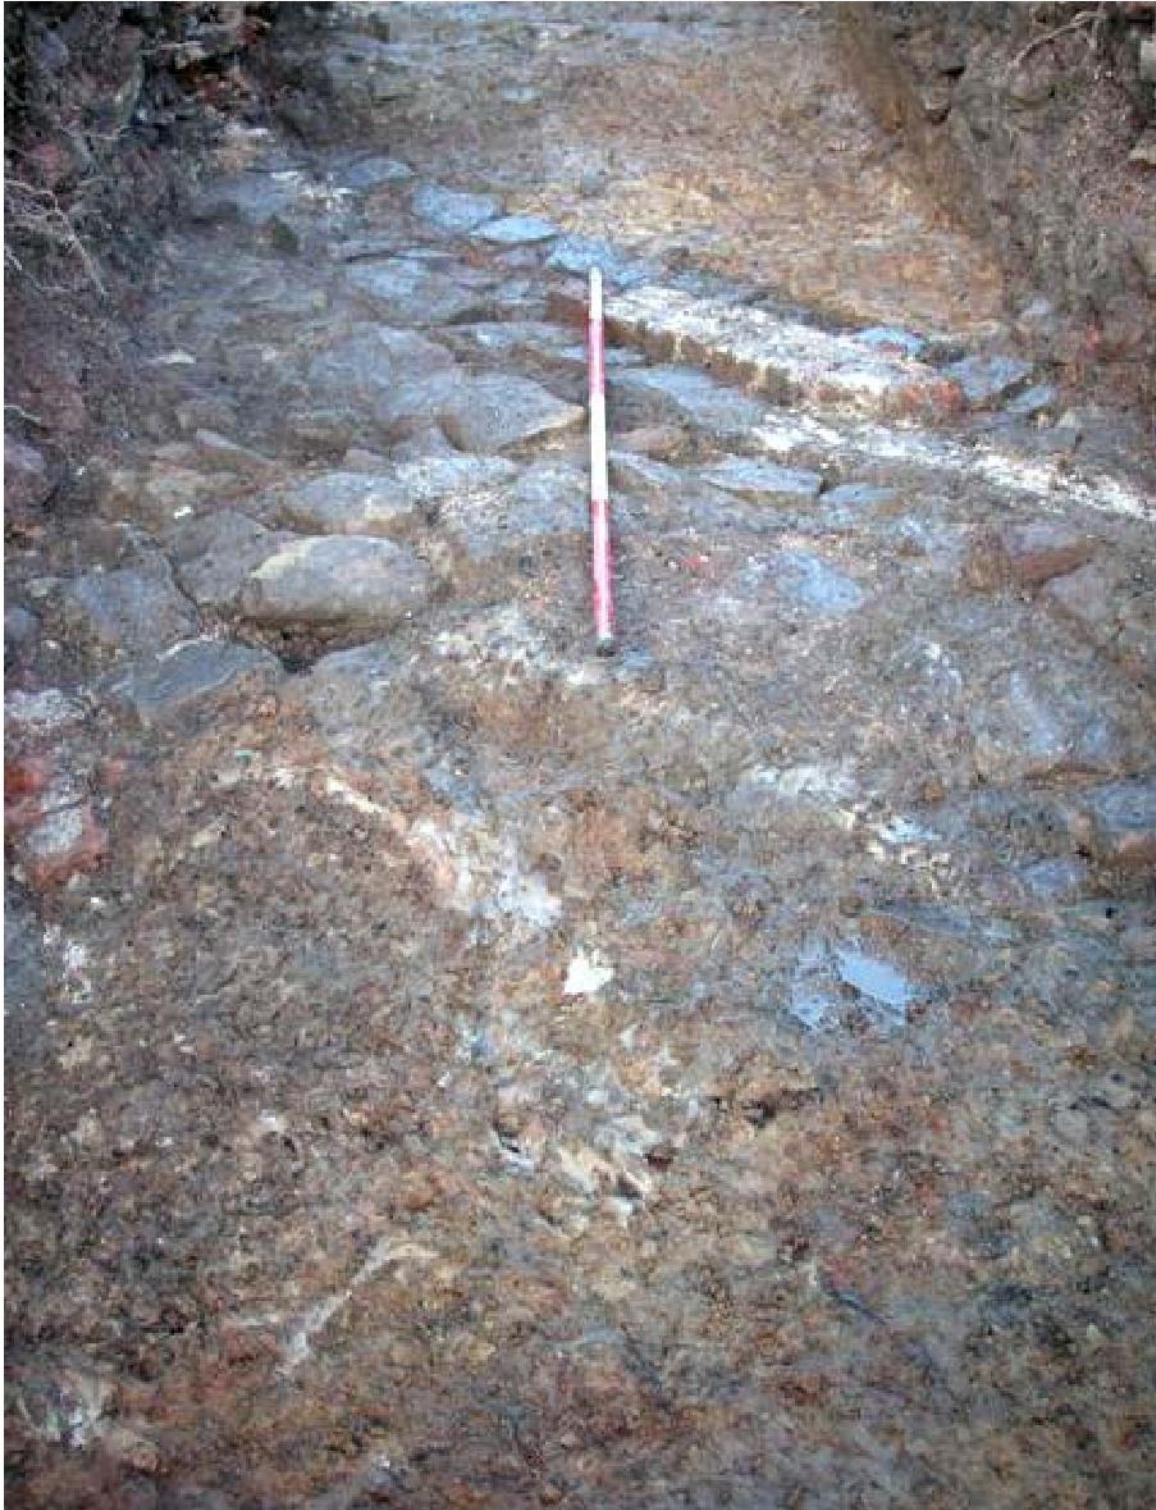
**Plate 6**

To the north of the pits [3009], [3012] and [3041], was a northwest-southeast orientated sandstone wall [3028], 0.80m wide, which had been reused as a foundation course for a brick wall [3026] (Plate 6). Another sandstone wall [3034] at right-angles to wall [3028] may represent an internal wall as it had an associated sandstone floor [3031] made up of large rough sandstone slabs.

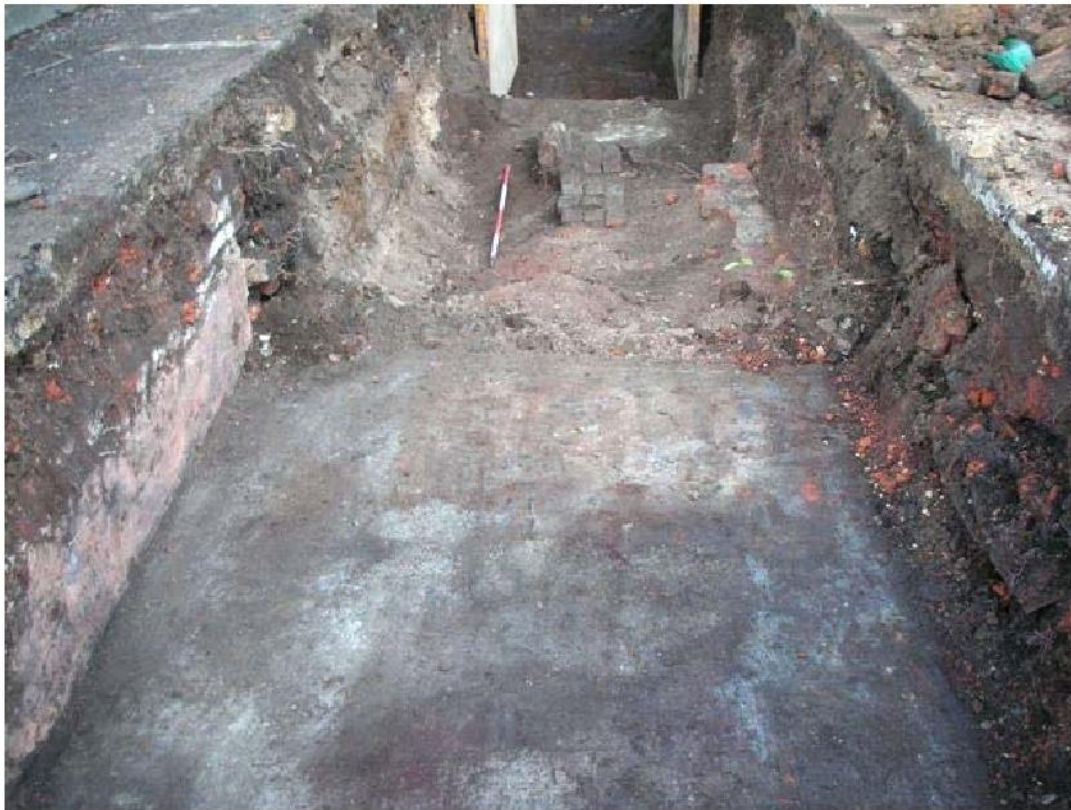
- Plate 6 Trench 3 [3029] looking south-west
- Plate 7 Trench 4 looking south-east
- Plate 8 Trench 4 looking north-west
- Plate 9 Trench 5 looking north-east

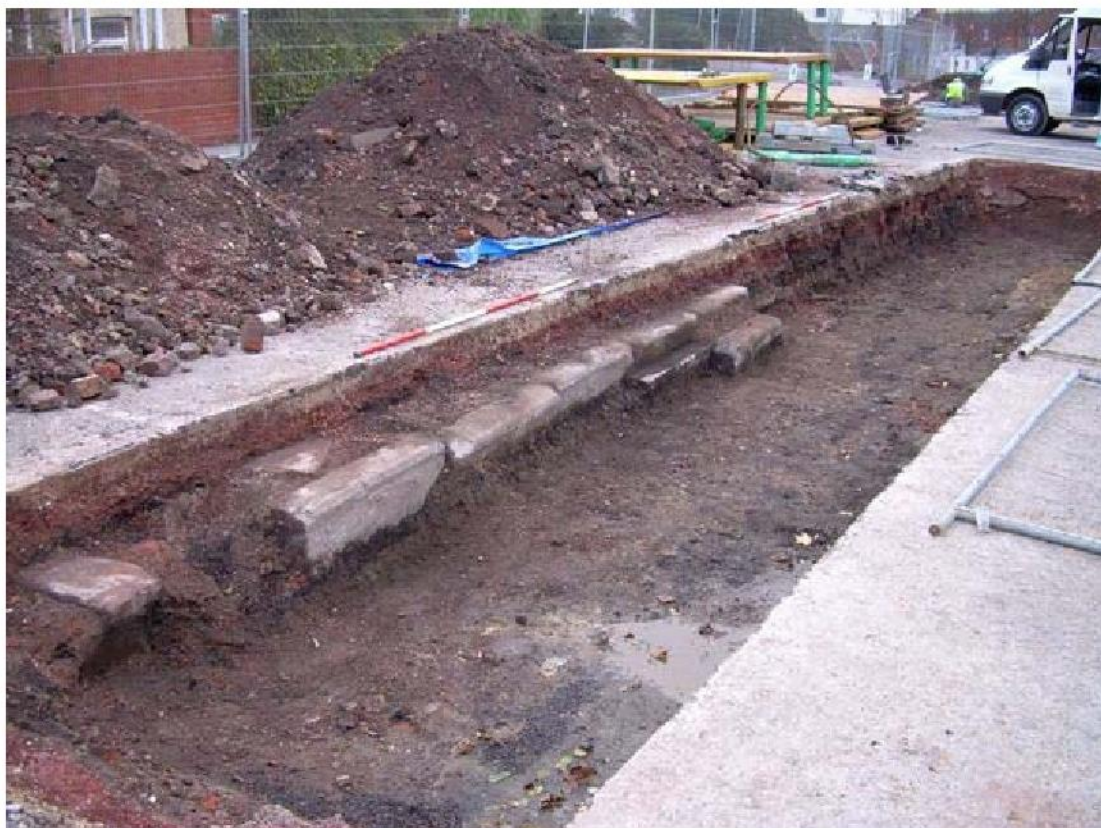
**Plate 10**

- Plate 10 Trench 5 looking west (second machine)
- Plate 11 Trench 6 looking south-east
- Plate 12 Trench 6 [6009] looking south
- Plate 13 Trench 7 looking north-east

A large north-south orientated culvert **[5017]**, evident in the northern half of Trench 7 and through the centre of Trench 6, truncated layers **[5016/5019]** in the middle of the trench (Plate 10). Another narrow culvert **[5007]** fed into it from the east. The culvert was constructed of machine cut bricks and sandstone tiles of 18-19<sup>th</sup> century date. These features were sealed by a layer of silt clay **[5005]**.

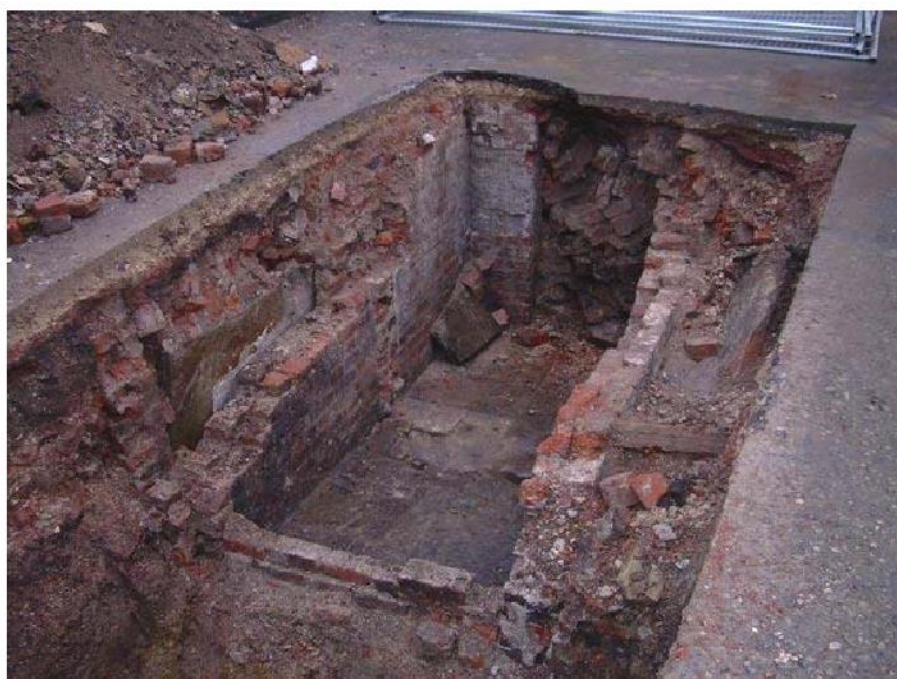
**Plate 14**

At the northeast end of the trench the layers sealing the natural were cut by a large 18<sup>th</sup>-19<sup>th</sup> century cellar [7010] with a flagstone floor [7012] (Plate 14). There were no features beneath the cellar floor. A blocked doorway was evident in the north-east wall of the cellar [7010]. The wall observed in the south facing section had a scar running through the centre probably as a result of the removal of an internal wall. There was also the remains of a coat of whitewash. To the southwest of the cellar [7010] part of another possible cellar [7006] of similar date was recorded. Both cellars were filled by the same rubble infill [7011/7013] which was derived from the demolition of the upper floors of the building. A large sandstone slab was recorded behind the cellar wall in the south facing section. Cellar [7006] had a possible wooden beam or brace inside it visible in the southern side of the trench. Several modern, late 20<sup>th</sup> century finds were retrieved from this rubble context, including nails, window glass and fragments of wood.

The post-medieval phase of Area A is characterised by building foundations, floors and large barrel vaulted cellars. One cellar in Trench 7 with a flagstone floor, which was infilled with the rubble derived from the demolition of the upper floors of the 18<sup>th</sup>-19<sup>th</sup> century buildings. It is possible that this cellar relates to a building seen on the 1805 tithe map. The culvert aligned north-south across the site had been constructed from reused sandstone roof tiles and is considered to be contemporary with the cellars. The cellar and floor surface seen in trench 5 may relate to two separate buildings in the centre of the Area A seen on the tithe map. The quality of the maps makes interpretation a best fit model and is open to interpretation.

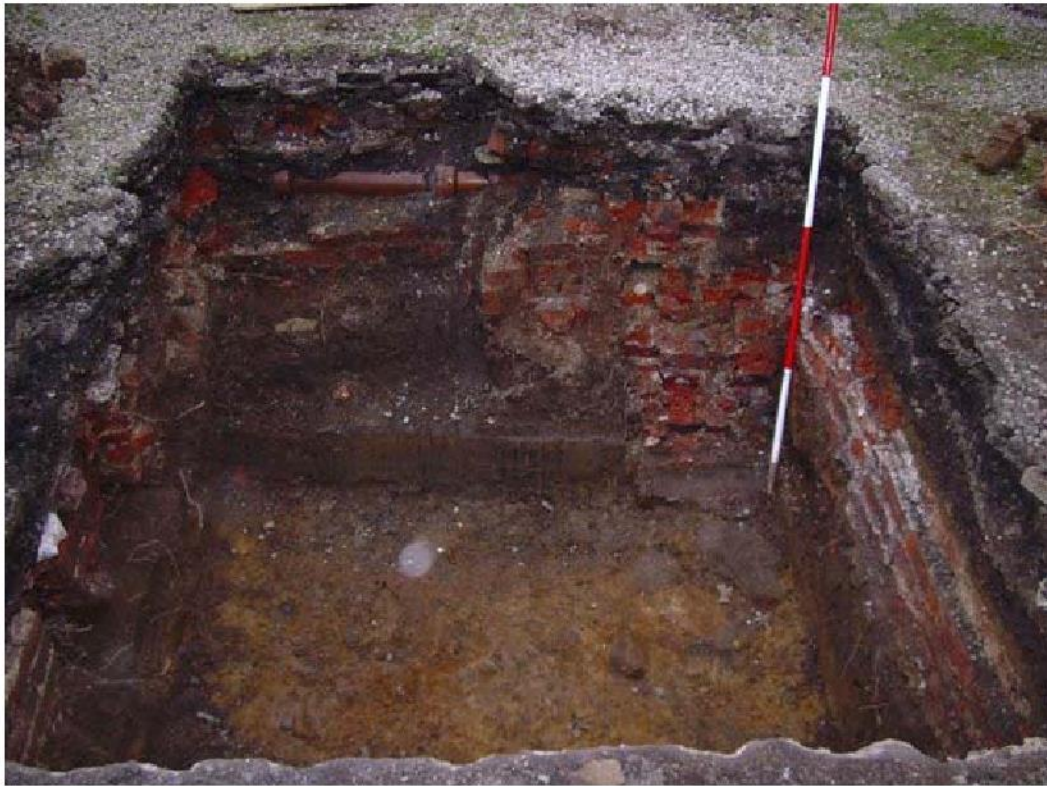
- Plate 14 Trench 7 cellar [7010]
- Plate 15 Trench 14 looking north
- Plate 16 Trench 14 north end looking east
- Plate 17 Trench 17 looking south-west
- Plate 18 Trench 17 [7009] wall

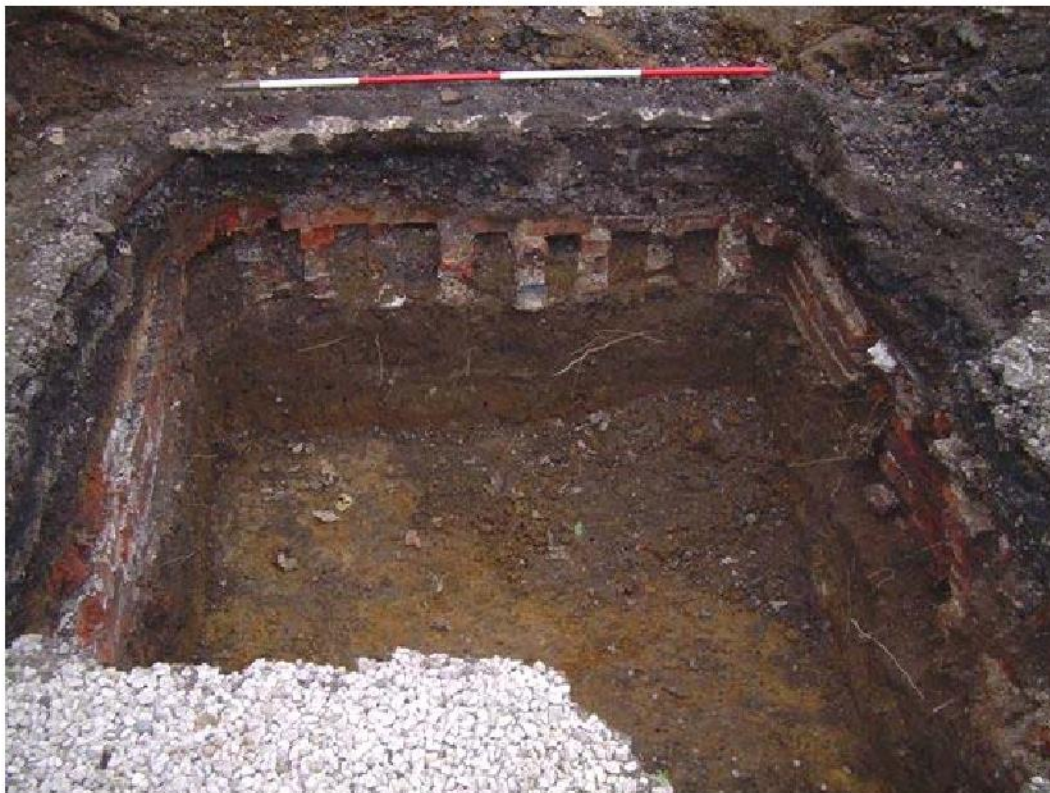
**Plate 16**

In the middle and north of the trench brick foundations **[14022]** and **[14019]** consisted in part of rows of bricks aligned north-south and spaced about 0.2m apart, overlying layer **[14010]** below (Plate 16). A domino was found in the fill **[14008]** of the spaces between the rows. These foundations were cut by the modern drain **[14021]**.

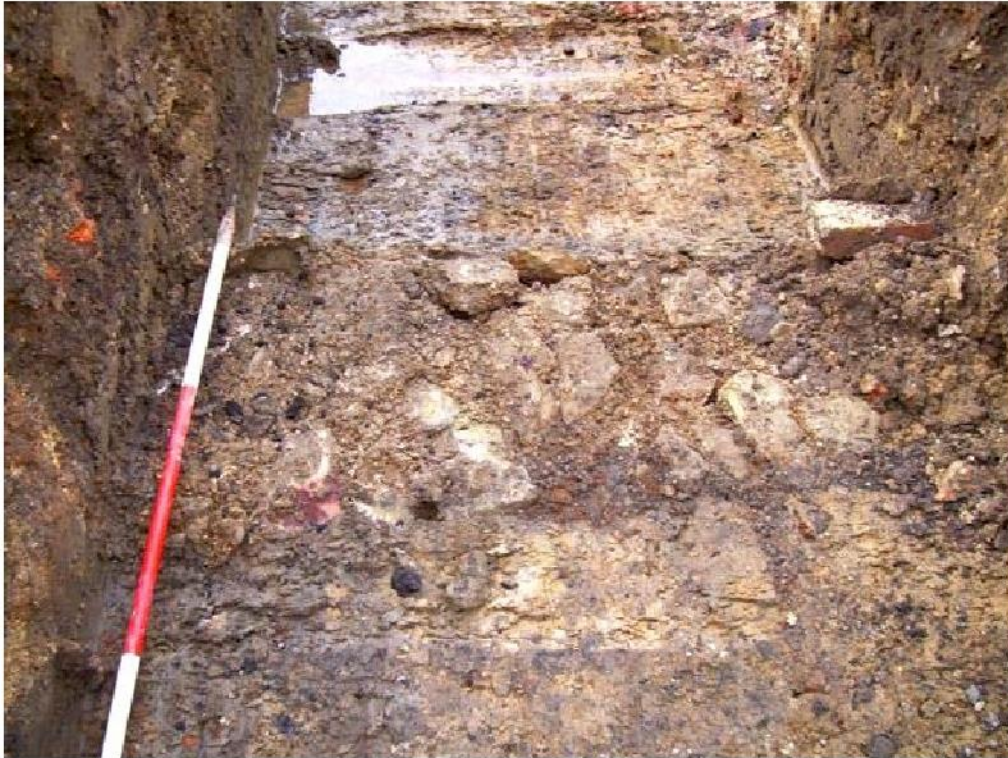
**Plate 18**

Cutting **[17003]** was the wall trench **[17009]** containing the north-south orientated sandstone wall **[17007]** (Plate 18). The wall consisted of two courses of sandstone and brick waster material. The latter comprised large blocks formed from red hand-made bricks that had been fired and fused together in stacks, presumably deriving from a brickyard kiln nearby. The wall is thought to be 18<sup>th</sup> or early 19<sup>th</sup> century in date. The sandstone wall was used as a foundation for a later brick wall **[17005]**.

The character of the upper stratigraphy in Trenches 14 and 17 is unsurprisingly related to the development of the railway in the 19<sup>th</sup> century. In Trench 14 a cellar was associated with several railway sleepers and Trench 17 revealed the remains of a 19<sup>th</sup> century building. The walls in Trench 7 were interesting in that it appears brick waster stacks were being reused for foundation material.

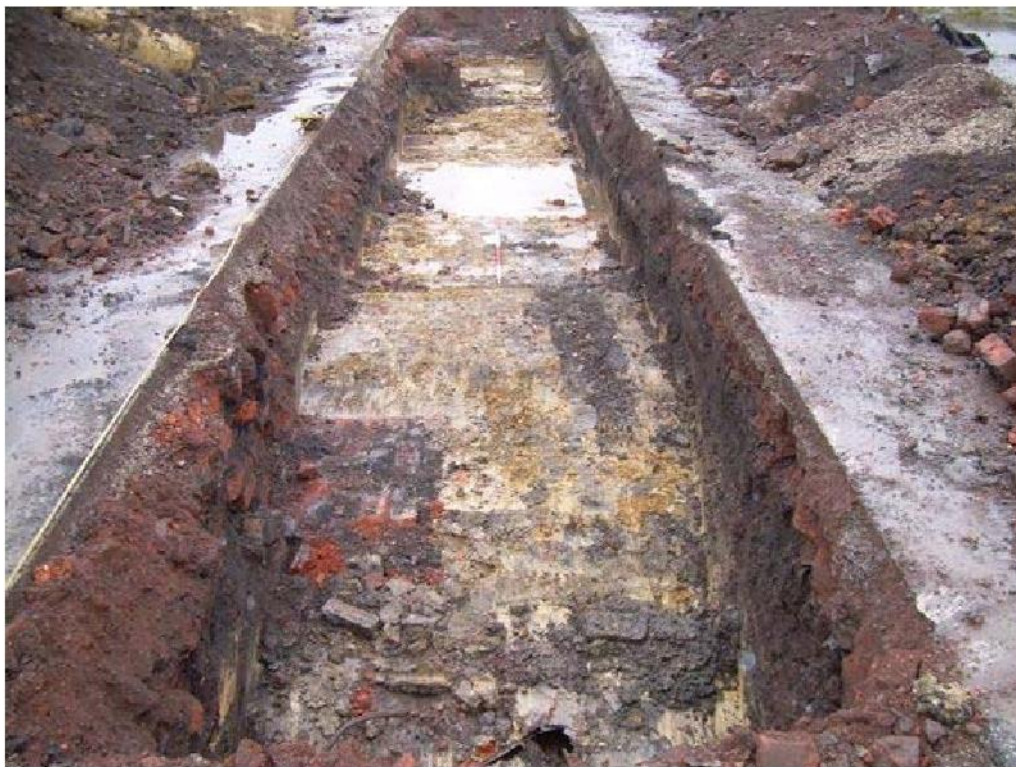
- Plate 19 Trench 18 looking north-west
- Plate 20 Trench 18 [18006] brick plinth
- Plate 21 Trench 19 looking north-east
- Plate 22 Trench 19 railway lines

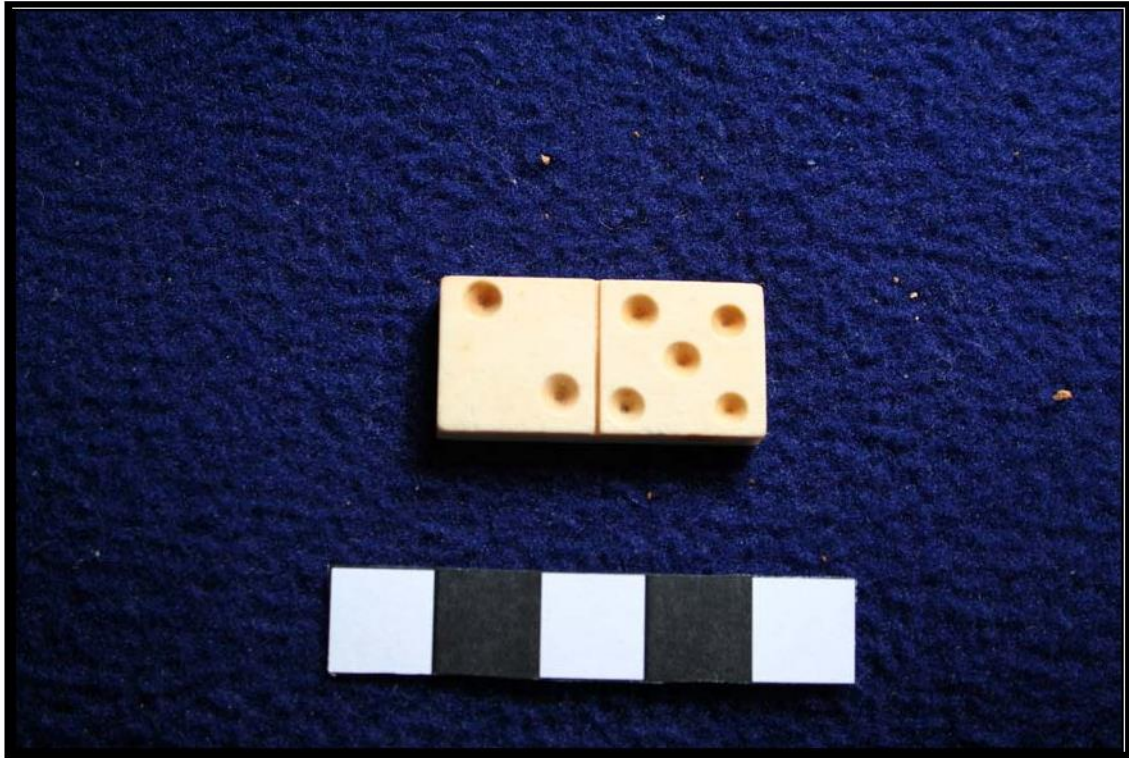
Plate 23

A carved bone domino of unknown date was found in [14008] (Plate 23). The only other items recovered from the site were fragments of clay pipe. Most of these fragments were from pipe stems, although one complete pipe bowl, and six fragments from other bowls were recovered from Trench 4 [4005]. The complete bowl dates to the early 17<sup>th</sup> century (Ayto, 1999, 2 & 5), whilst two of the bowl fragments may well be of later 17<sup>th</sup> / early 18<sup>th</sup> century date (Ayto, 7).
