The Walker Building
58 Oxford Street
Digbeth
Birmingham

Archaeological Watching Brief
2007

THE WALKER BUILDING, 58 OXFORD STREET, DIGBETH
ARCHAEOLOGICAL WATCHING BRIEF

Project No. 1636
June 2007

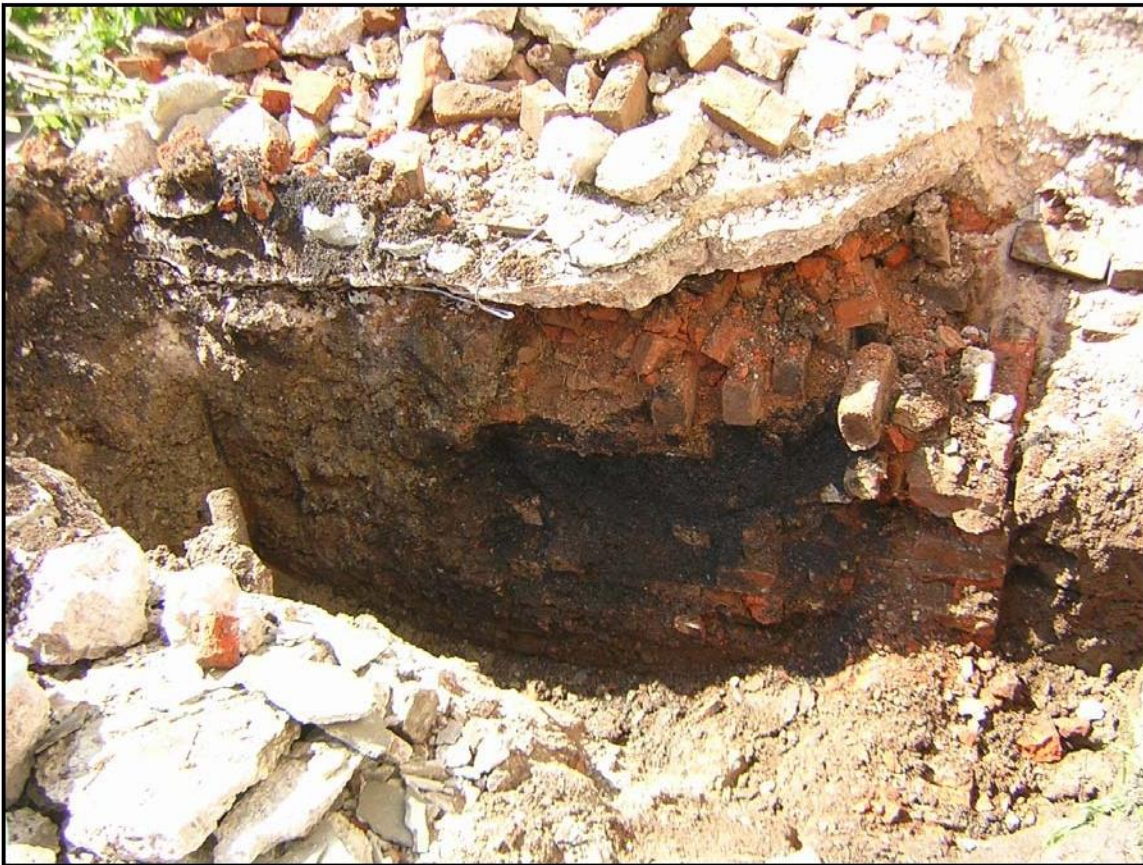
Plate 1 - Pit 4 showing wall foundation 1007

The pit was excavated against the existing wall at the base support for the railway viaduct above. Natural clay 1010 was identified at a depth of 1.8m below current ground level. Wall foundation 1007 was recorded bisecting the pit on an east west alignment. With the base course sitting on the natural clay, the wall consisted on a total of 8 courses of 19th century bricks. Either side of 1007 was demolition rubble 1006. All the above was sealed by modern concrete forming the existing yard surface.

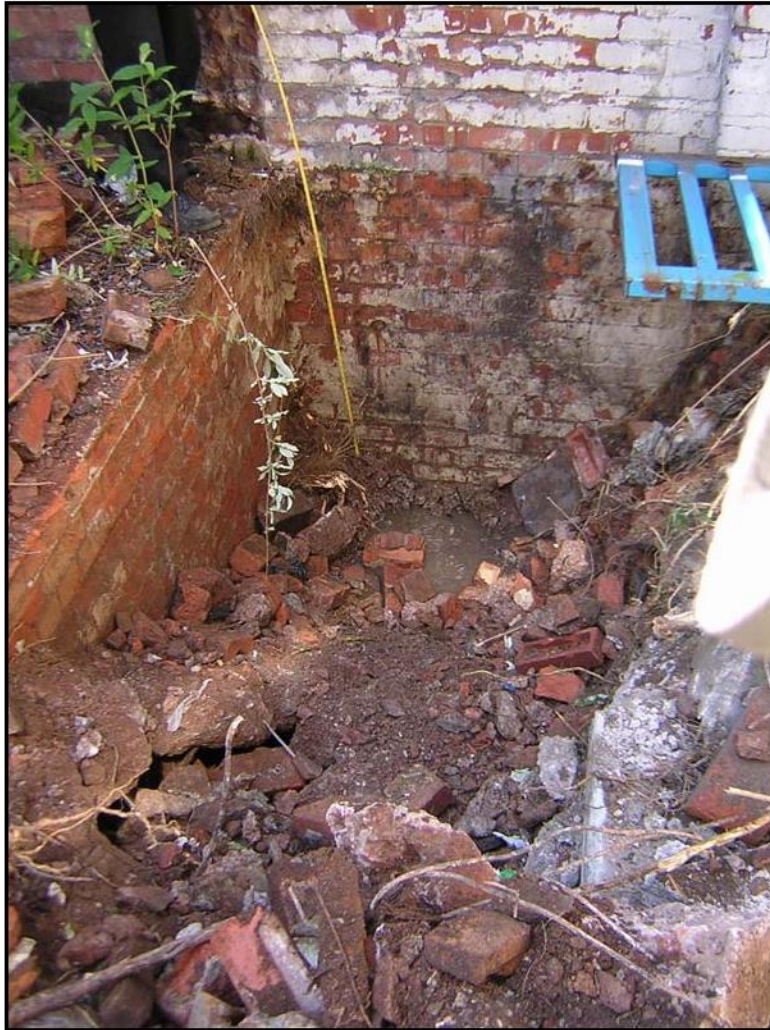
Plate 2 - Pit 5 showing possible cellar wall 1008

Brick surface 1008 formed the base of the trench at a depth of 2.3m below current ground level. This test pit was thought to lie over a 'void'. Once excavated it became apparent that it was a cellar type structure from a pre-existing building. The base (at 2.3m) was formed from mid 19th century brick (1008), as were the walls. There was a continuation of the concrete coated pipe seen in pit 3. This cut through the brickwork. Brick and other debris filled the pit. Again, a concrete layer covered this pit. It formed a thin crust on this test pit of only a few centimetres.

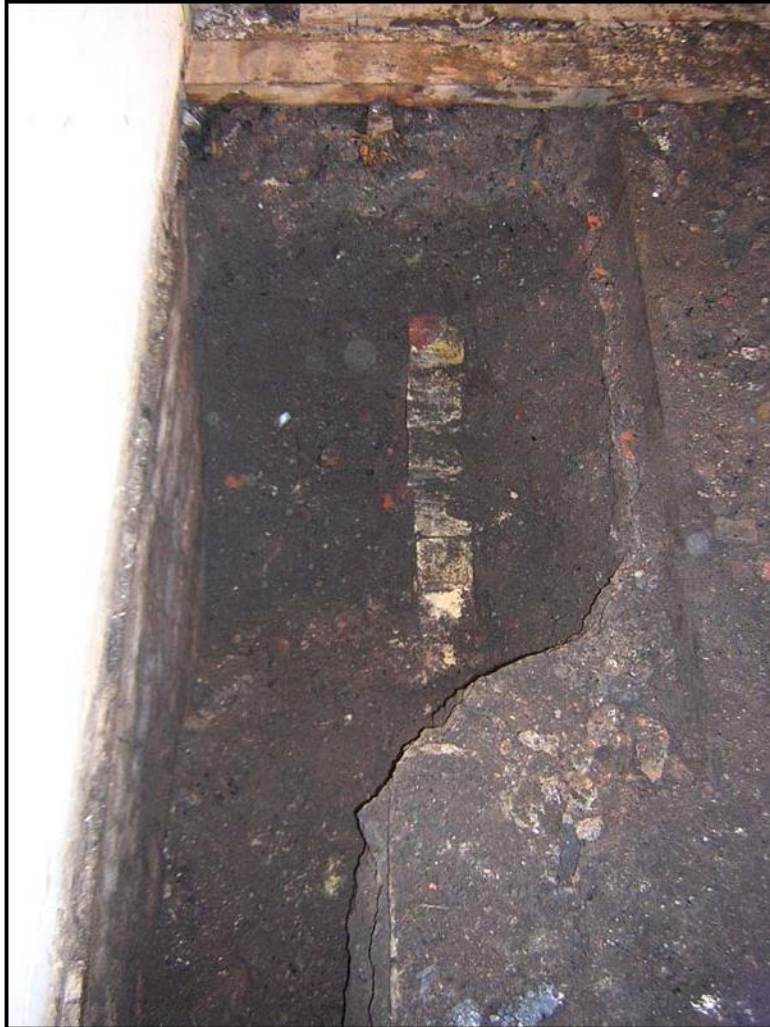
Plate 3 - Showing the uppermost course of wall 1013

This pit was hand dug in the interior of the main existing 1910 building. It was dug against an existing wall to a depth of 1.2 metres. At the base of the pit were the truncated remains of brick wall 1013, consisting of two courses. Aligned east-west, it was constructed from two types of early 19th century bricks. This may represent the earliest structural evidence identified on the site during this project.

Wall 1013 was sealed by a layer of sandy silt and debris (1012) similar to the rest of the site, containing post medieval-pottery, tile and shell. The uppermost surface of the pit consisted of wooden boards, which in turn were covered by floorboards.

The structural remains in Pit 6, dating to the early 19th century, may be the earliest evidence on site. It seems likely that this feature predates the later, more substantial brick foundations recorded in several other pits. Cartographic evidence suggests a similar sequence of development with the site shown as open land until the late 19th century.

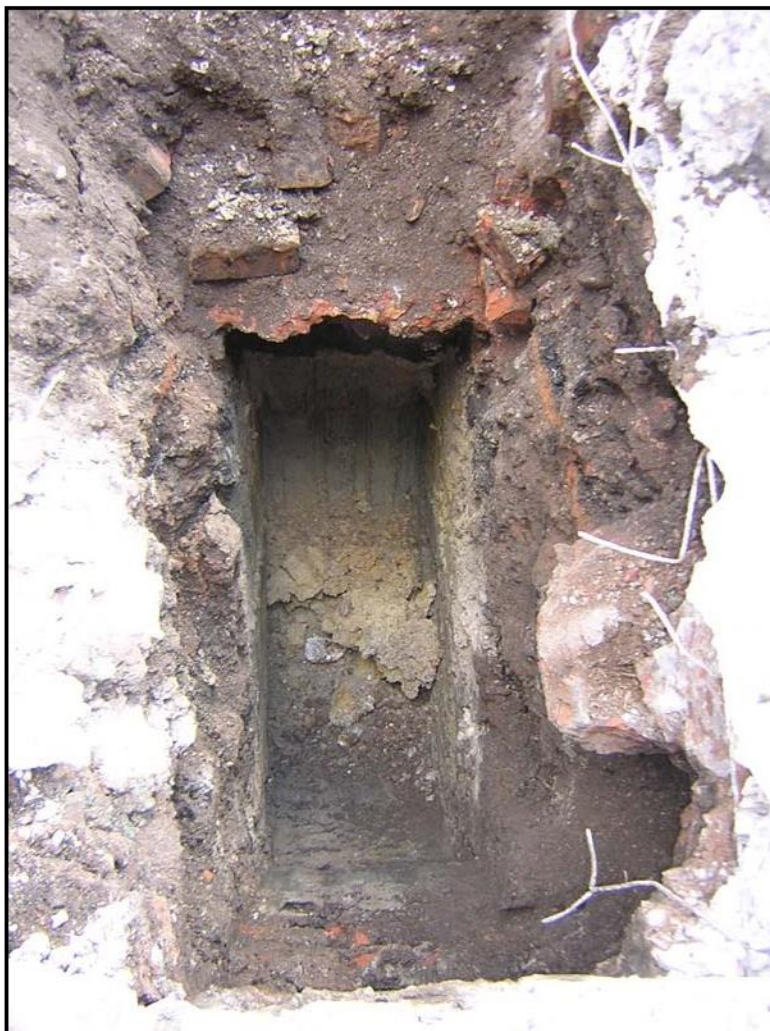
Plate 4 - Pit 7 showing natural clay 1010

Natural clay 1010 was encountered at a depth of 1.5m below current ground level. The truncated remains of a modern foundation wall, consisting of bricks and concrete, was recorded in the south-eastern corner of the trench. This was sealed by demolition rubble 1009, consisting of brick and concrete rubble, that in turn was overlain by a modern concrete surface.
