**Former Chance Brothers Glassworks,  
Spon Lane, Smethwick, West Midlands**

**Historic Building Recording**

BUILDINGS A, B, D, E and K

Ric Tyler AIFA  
(Birmingham Archaeology)

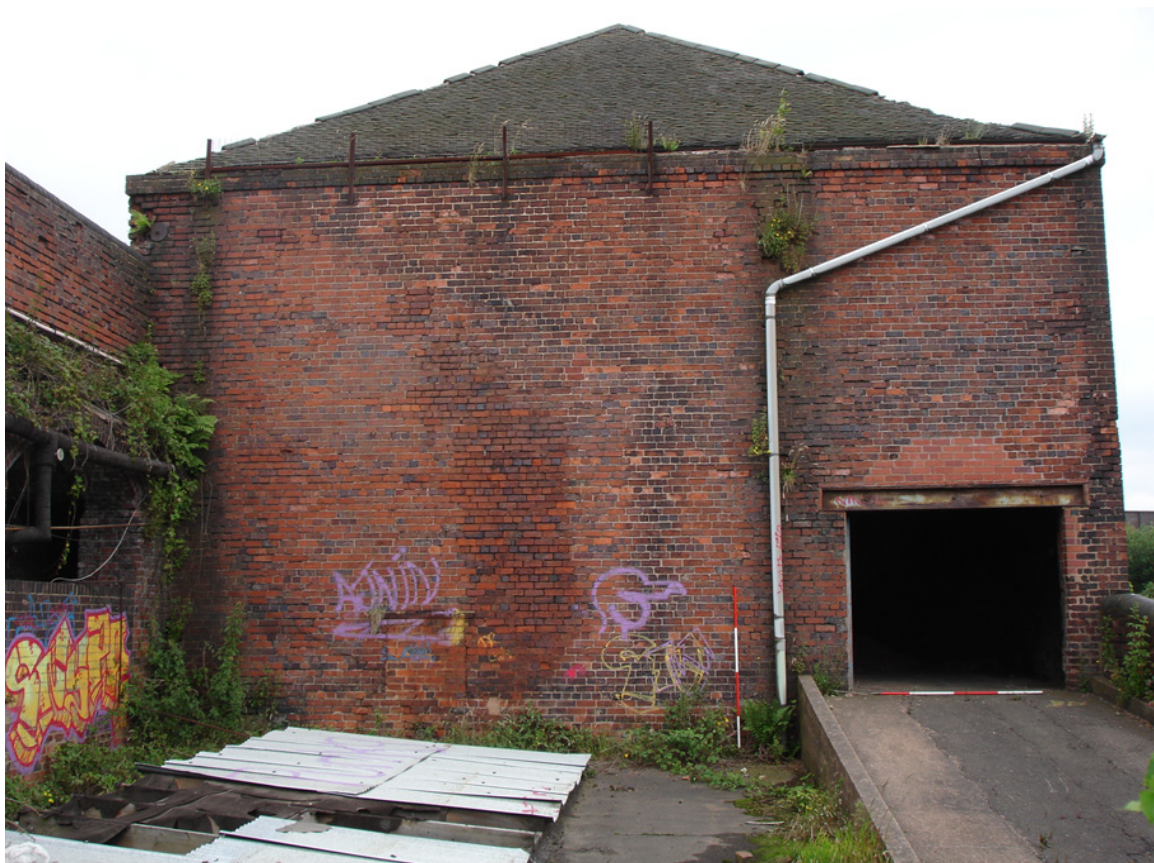
**Plate 6:** Building A, west elevation. Note shadow of former infill block (see Figure 14c).

- 4.1.4 The building is accessed via a wide, inserted doorway in the west wall (Plate 6), approached via a short ramp. A blocked doorway in the eastern end of the north wall (Plate 10) formerly gave access to the barrel-vaulted tunnel which runs the full length of the building, linking up with a further tunnel to the north of Building B.<sup>1</sup> Two further blocked doors and a blocked window in

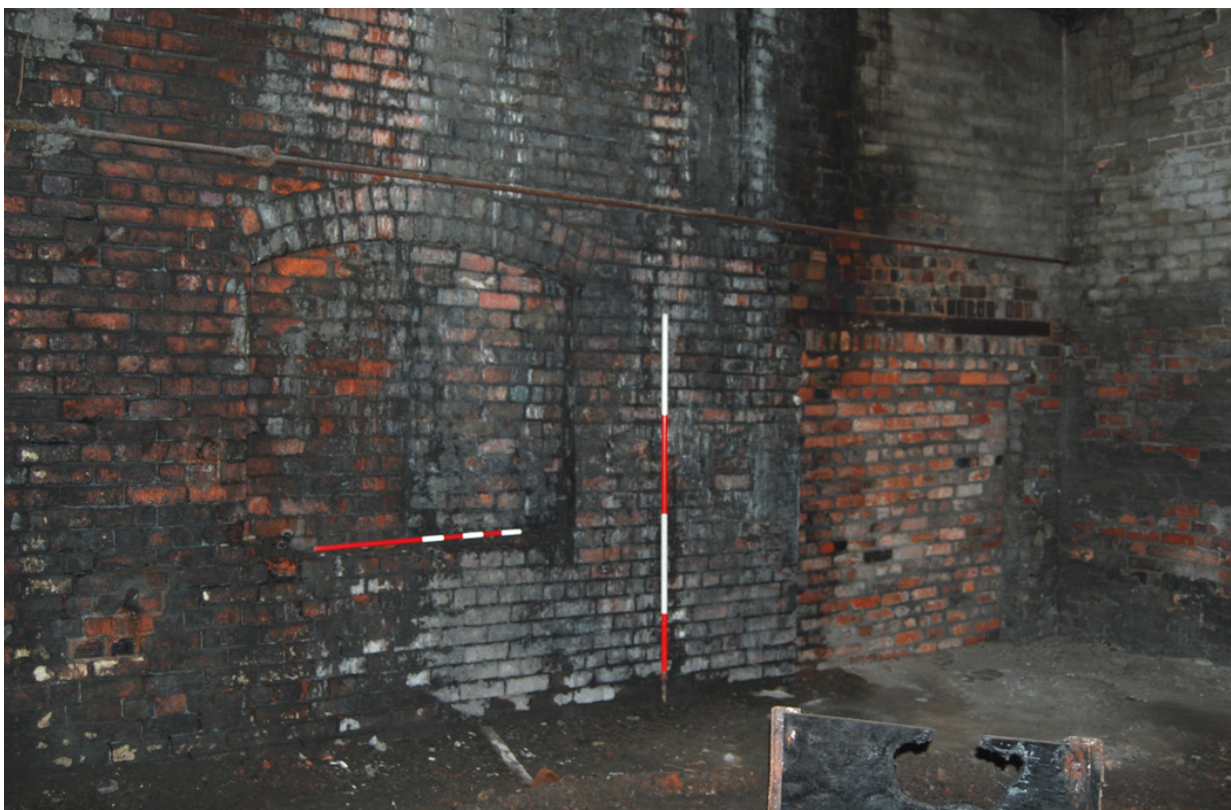
**Plate 9:** Building A: interior east wall; blocked window (left) and door (right).

the east wall (Figure 13; Plates 9 & 11) indicate that this range of buildings formerly extended further to the east (see below).

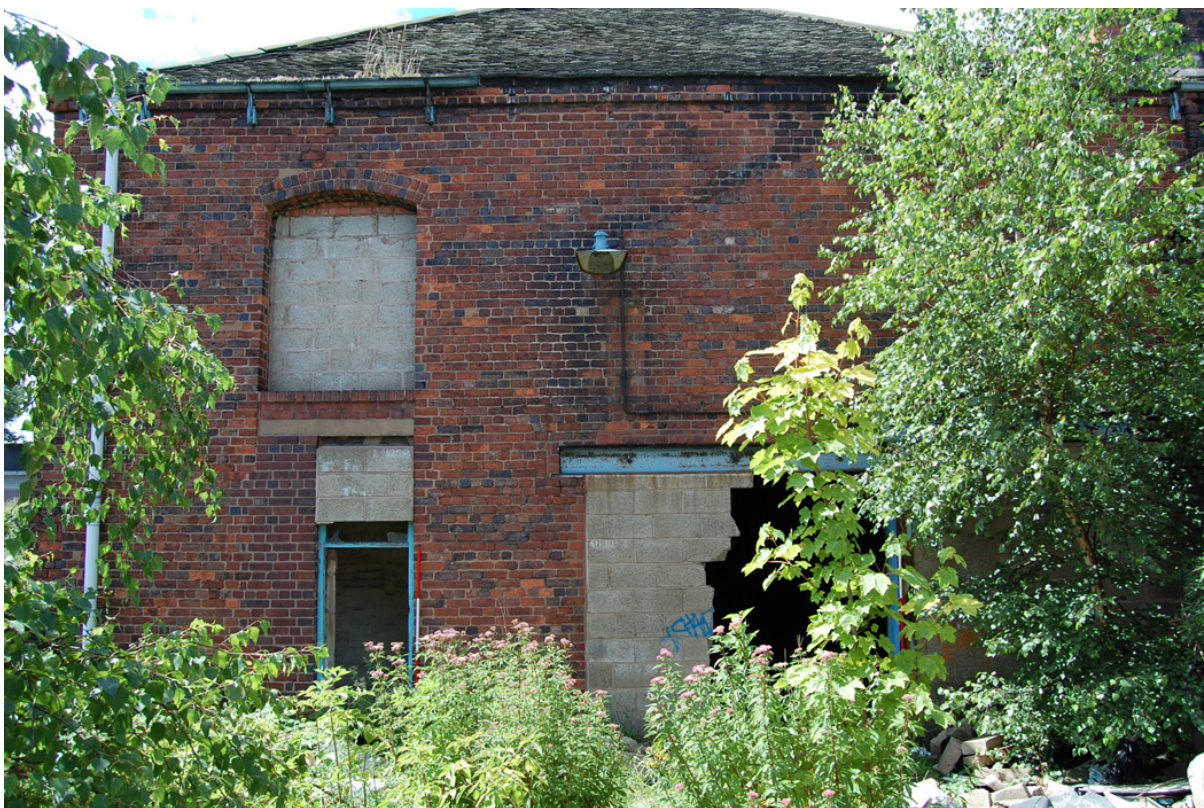
**Plate 17:** Building B, east elevation. Note shadow of former infill block (see Figure 17d).

- 4.2.4 The southern, canal elevation includes four tall segmental-headed openings, blocked in brick and split vertically (Figure 17a; Plate 4) suggesting they originally lit separate floor levels internally. The eastern elevation also suggests two original interior storeys, with three regularly spaced, segmental-headed window openings at high level, the central opening having been truncated and blocked when the ground level doorway was extended upwards (Figure 17c; Plate 16). The western elevation has been significantly modified with a large inserted opening to the north, though superimposed doorways to the south (Figure 17d; Plate 17) again imply an original two-storey internal division.

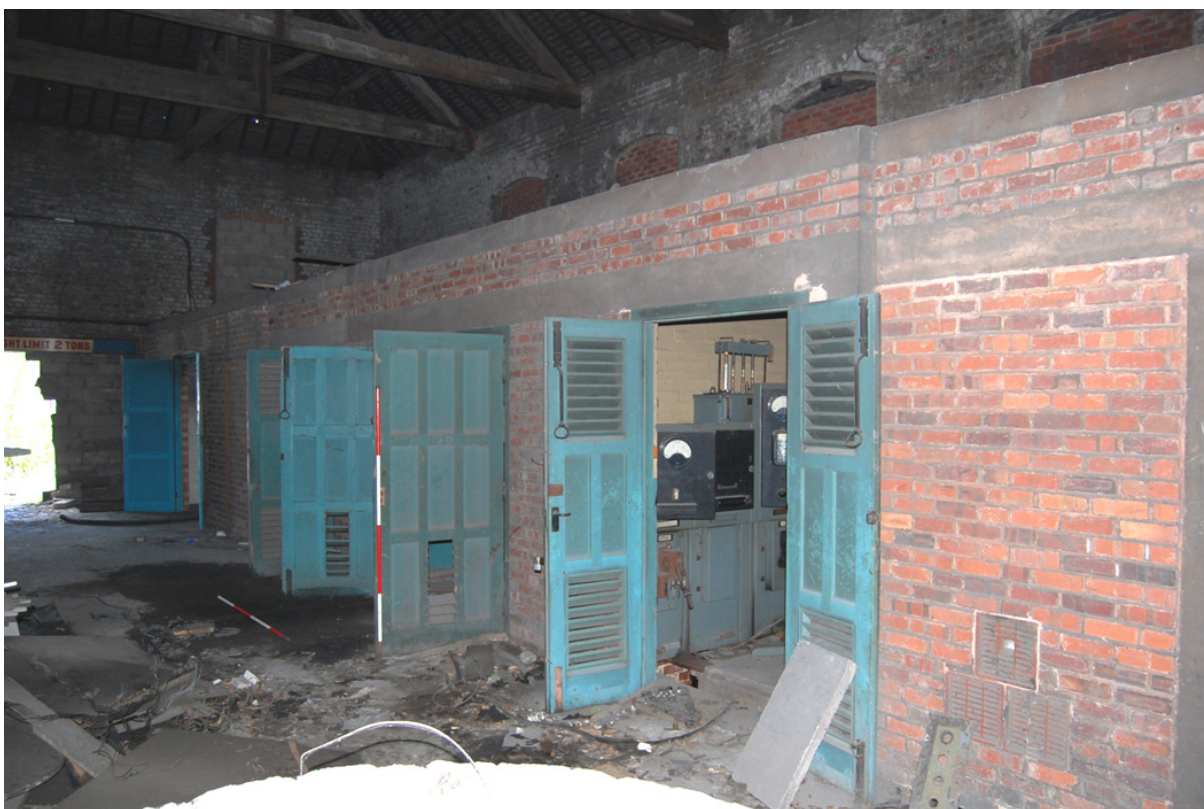
**Plate 19:** Building B, interior view looking east, note blocked windows visible above plant rooms.

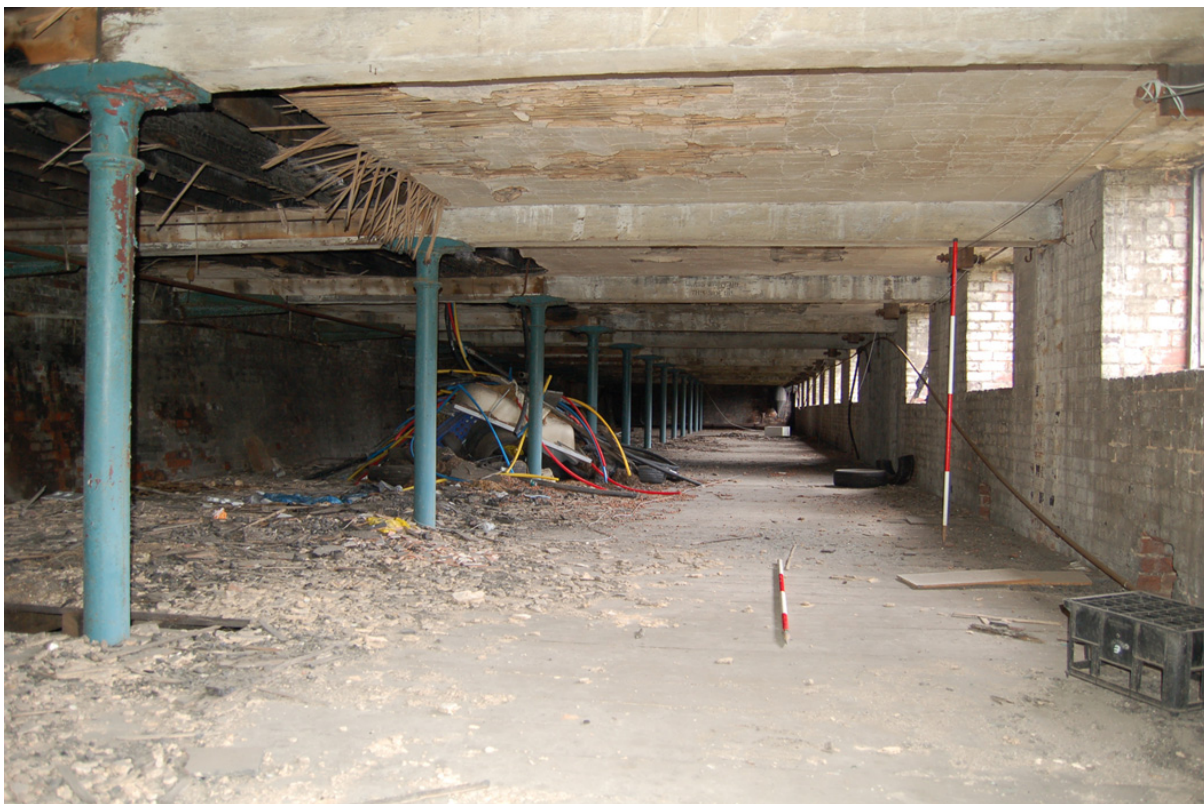
**Plate 25:** Building D; Level 1, looking east.

- 4.3.2 The lower level (level 1) of the range comprises a single open space, standing 2.25m tall from the timber floor to the underside of the lath and plaster ceiling (Plate 25). There is no primary internal access to the lower level from the upper levels of the range, and the sole access would appear to have originally been via a passage and straight stair, descending at Bay 5 from the series of former buildings located to the north and illustrated in historic plans. The fenestration of the south wall is uniform with each bay (save Bay 9) having a rectangular window opening with flat soffit (segmental arch externally) and perpendicular reveals, housing two-light timber casements. A small vent is located at floor level below each window. Bay 9 displays a wide (3.35m, 11ft) doorway with semi-circular brick, double-header arch, blocked in brick (Plate 29). This archway is mirrored by a similar blocked opening within Bay 9 of the north wall (Plate 28). A further, rectangular doorway within Bay 5 of the north wall formerly gave access to the lower level of the range from within the buildings to the north, possibly serving a furnace base similar to that recorded to the north of Building C (see Upson 2004, fig. 14). The lower section of the north wall is slightly battered to both east and west. The west wall includes a single, semi-circular arched doorway, blocked in brick (Plate 27), offset slightly to the south of centre while to the east, a flat-headed doorway with iron lintel, blocked in sandstone blocks, is offset slightly to the north. The principal joists of the ceiling structure are embedded in the brickwork of the north and south walls; to the south, additional support is provided by 1.35m long projecting iron brackets. Each beam is supported mid-span by a circular-section cast-iron column (head-plate detail A1; Figure 36), identical to those within Building E and Building K. The southern end of each principal beam has a softwood block attached, with paired pulley wheels forming two lines running the full length of the range (Plate 31). The function of these remains unclear.

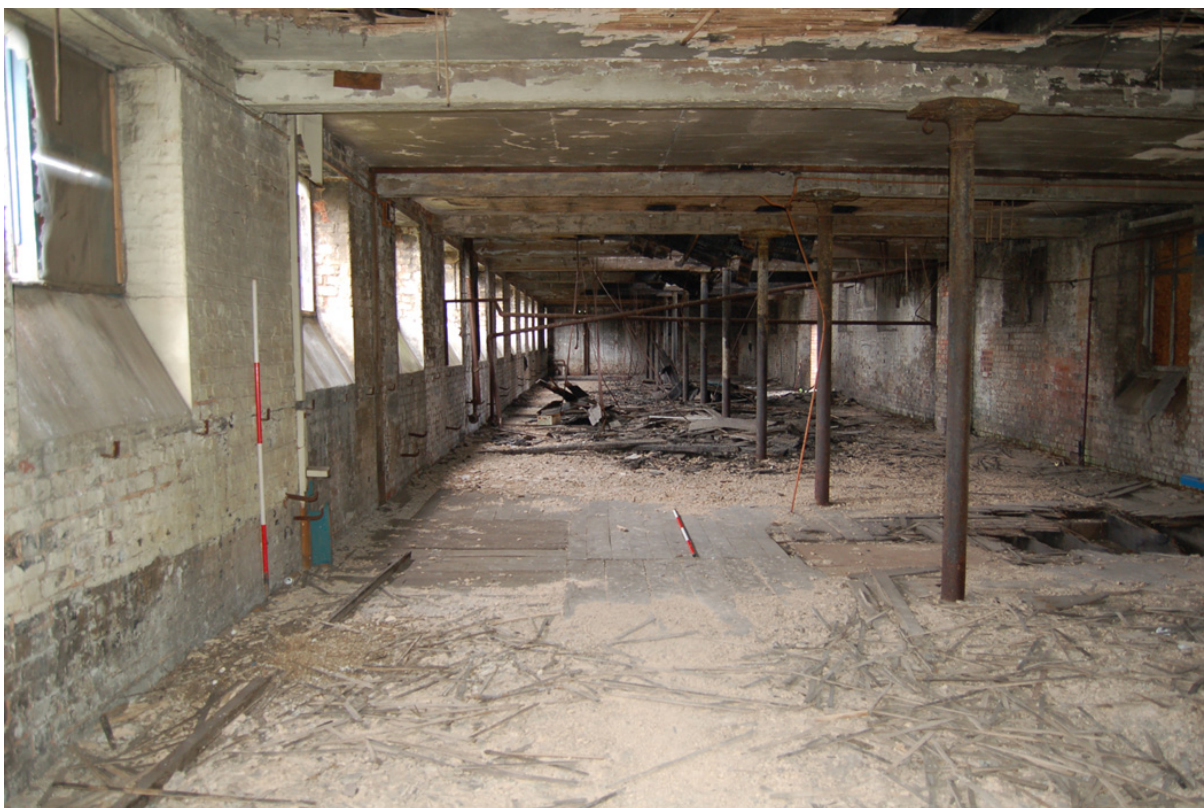
**Plate 32:** Building D; Level 2 looking west.

- 4.3.4 The middle level (Level 2) of the range formerly comprised a single open space (Plate 32), though Bays 1 and 2 have subsequently been partitioned off and a raised floor level introduced at the eastern end of the building (Plate 33). It is accessed from the yard to the north via doorways within Bays 4, 5 and 11; there is no primary internal access to Level 1 below. The south wall displays regular fenestration of one segmental-arched opening per bay, set high in the wall with splayed reveals and sloping cills. The northern wall displays a similar pattern of fenestration, though many of the windows have here been blocked (see Figure 20a) and Bay 1 is unlit to this elevation. Openings within Bays 5 and 11 have been converted to form doors, while a further doorway within Bay 4 appears to be primary. The principal joists of the ceiling structure are embedded in the brickwork of the north and south walls, each being supported mid-span by a circular-section cast-iron column (Plate 34) identical to those recorded at Level 1.

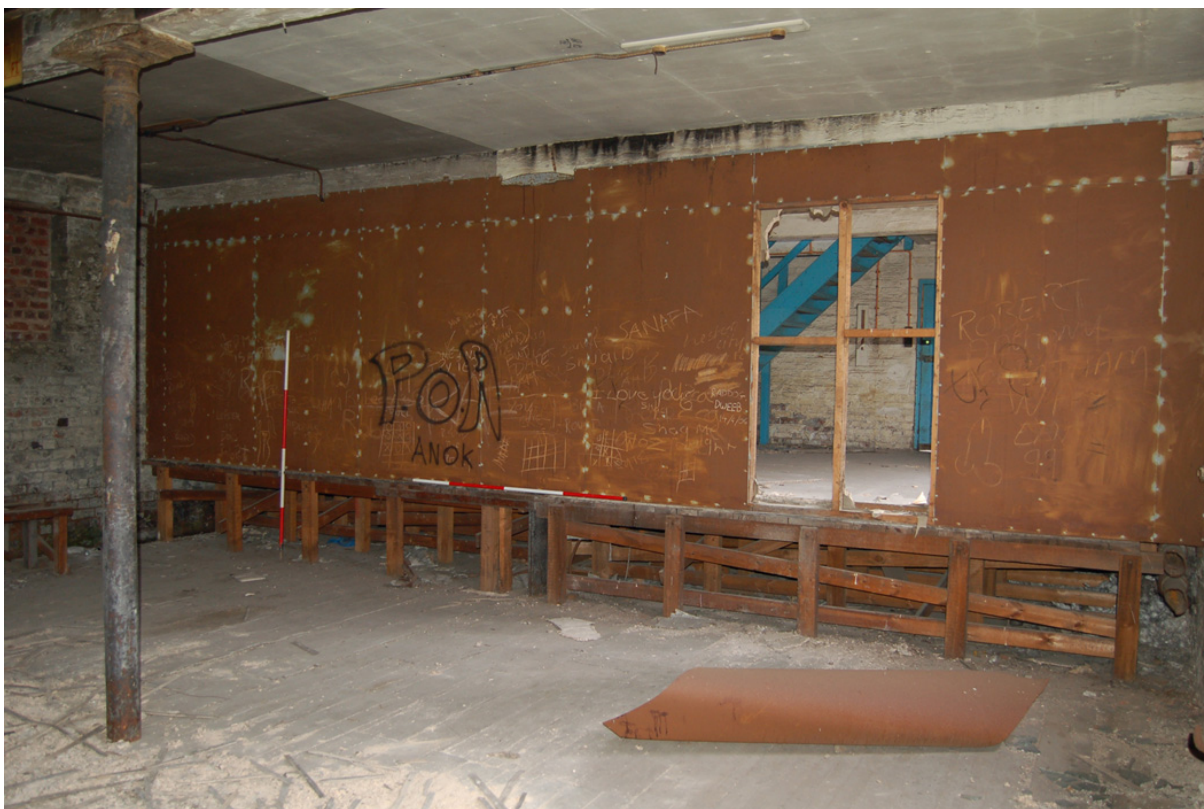
**Plate 33:** Building D; Level 2, raised floor level at east end (Bays 1 and 2).

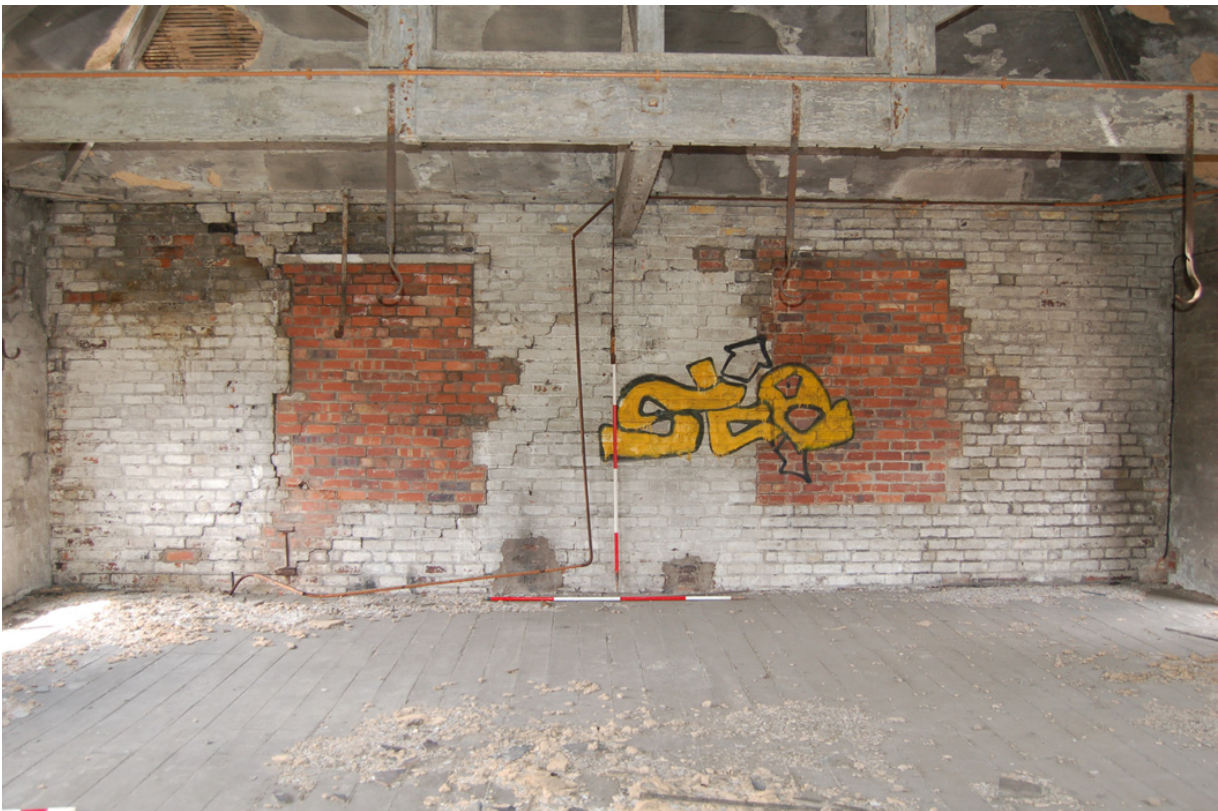
**Plate 41:** Building D; Level 3, blocked windows in west wall.

regularly fenestrated with one window per bay with segmental brick heads and splayed reveals. The north wall is somewhat more complex (Figure 20a), with regular openings, one per bay, but including a number of doorways (now blocked) within Bays 4 (Plate 37), 8, 9, 10 (Plate 38), 11 and 13, which must relate to former links with the (now demolished) structures to the north, visible on historic mapping (Figures 7-11). Paired openings within the west elevation have been infilled in brick (Plate 41).

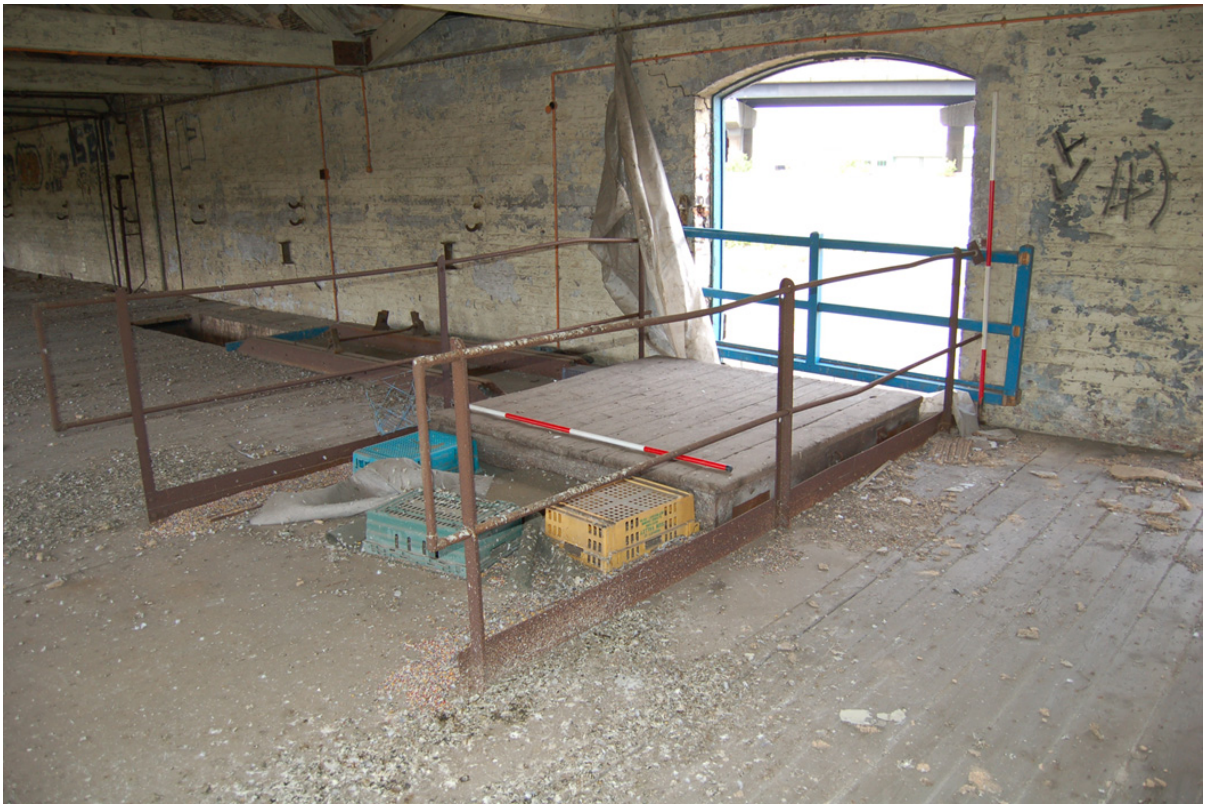
**Plate 52:** Building E; Level 3 hoist at Bay 3.

- 4.4.4 The upper level (Level 3) comprises a single open space (Plate 51). It has no primary internal means of access from Level 2, communication between the levels formerly being at Bay 2 by means of an external stair, the scar of which is visible within the exterior elevation at Bay 1 (Figure 23a; Plate 46). A wide doorway with segmental arch at Bay 3 (N) appears original; the eastern and western walls are featureless. The floor of level 3 comprises 7 in. softwood boards aligned north-south resting on east-west aligned joists (11 in. x 3 in. @ 18 in. centres) which span between principal beams aligned on the line of the bay divisions. A hatch is located within Bay 12, while adjacent to the doorway in the north wall of Bay 3 is a c.2 m square opening with sliding cover (Plate 52), set below a hoist wheel supported at tie level.

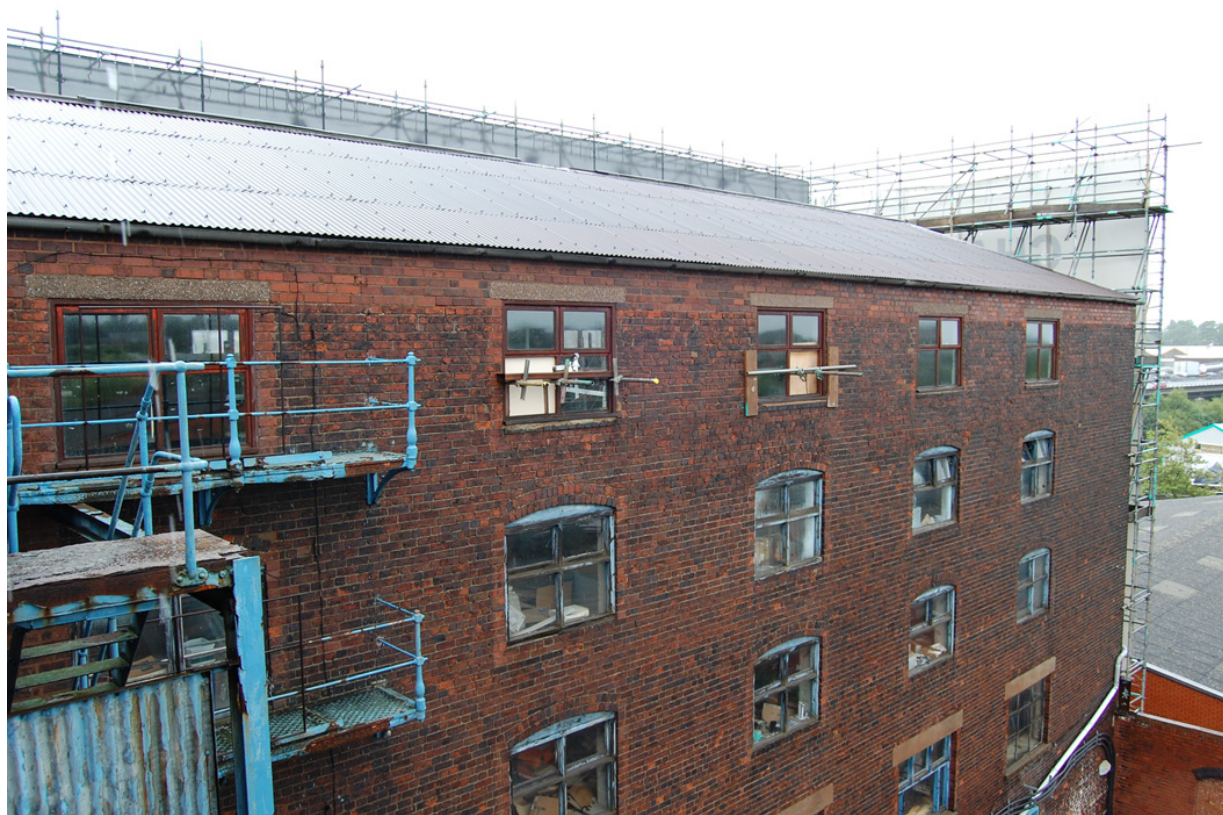
**Plate 60:** Building K, North Range; note rebuild of upper wall and alteration of windows.

- 4.5.20 The roofs of both ranges have been replaced, a process which entailed the renewal of the upper six courses of brickwork of the exterior walls (Plate 60). Both roofs comprise simple, lightweight steel trusses of double-fan form respecting the original bay divisions (Plates 71/2). It is unclear at what date the new roofs were introduced (1950s?), though it is possible that records of such a major undertaking would survive within the company archives.
