Chance Brothers Glassworks,  
Smethwick, West Midlands  
Historic Building Record  
Building C and Associated  
Features

**Former Chance Brothers Glassworks,  
Spon Lane, Smethwick, West Midlands**

**Historic Building Recording**

**BUILDING C AND ASSOCIATED FEATURES**

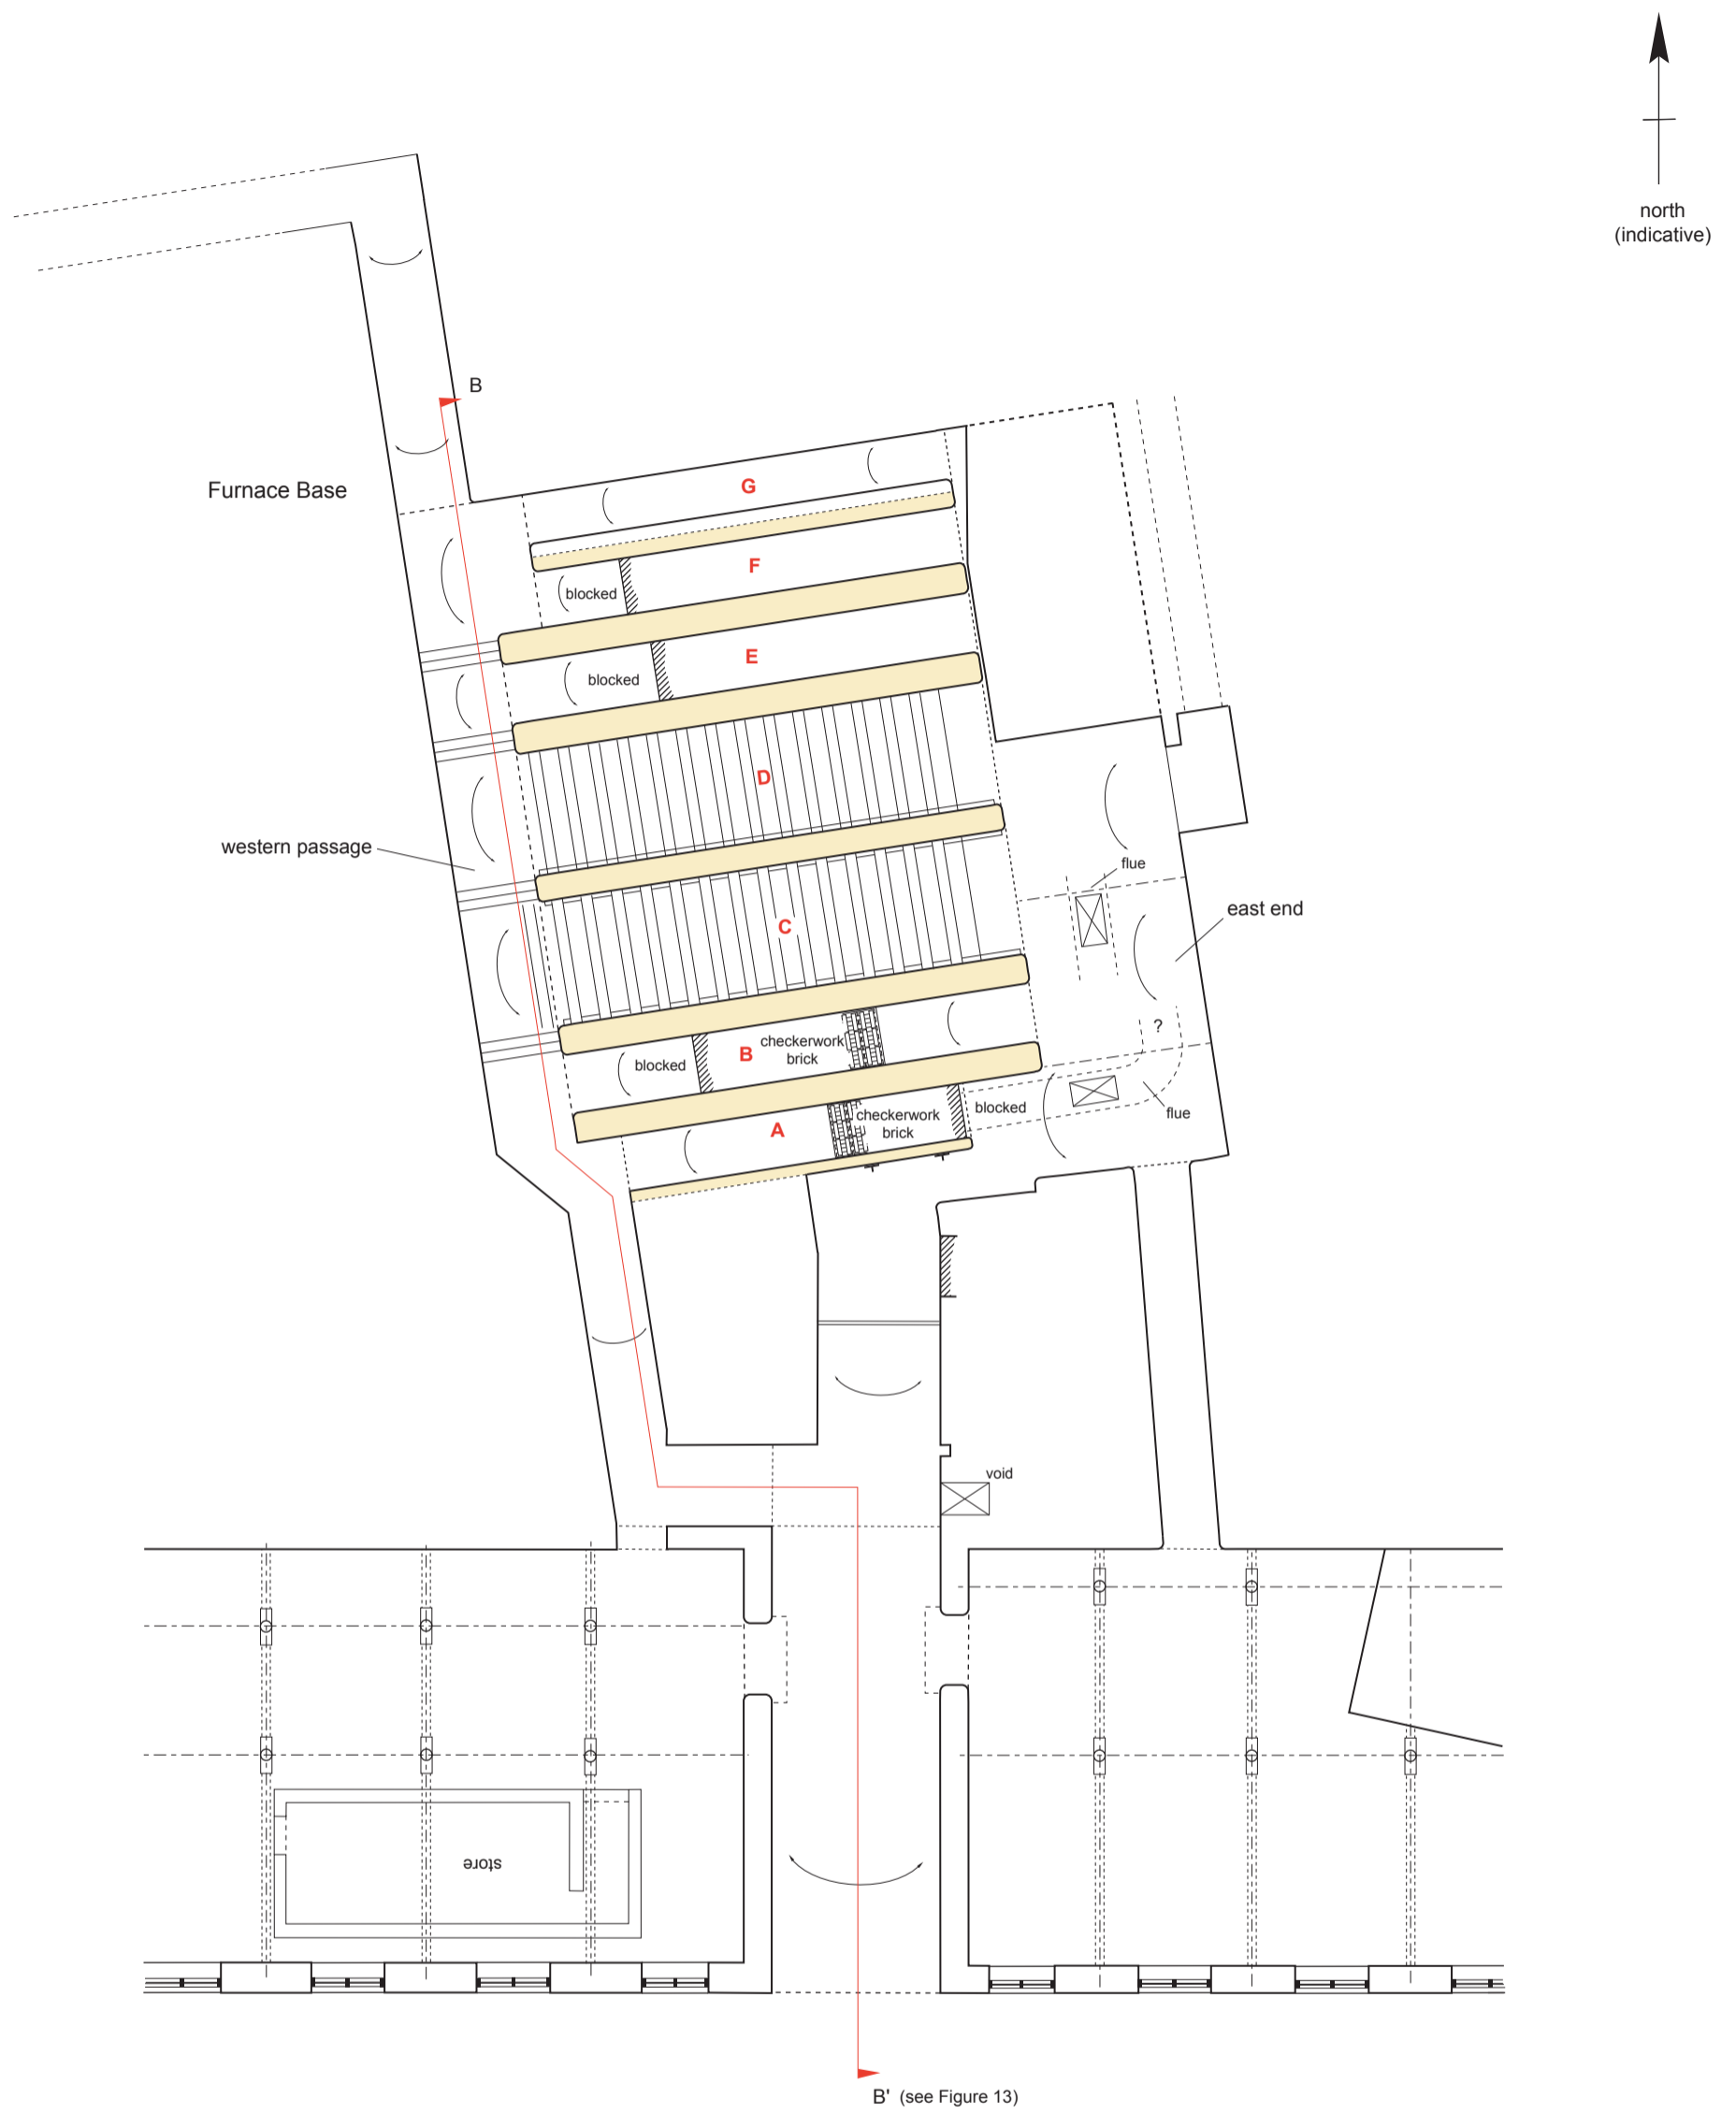
Figure 11: Furnace base north of Building C

refractory brick

6.4.2 The structure comprises a total of seven parallel tunnels (A-G from south to north, Figures 11/13), aligned approximately east-west, the southern six of which are constructed entirely in refractory brick. To the west of the tunnels, accessed via the door in Bay 10 of Building C, is a longitudinal passage running approximately north-south giving access to each of the tunnels (Plates 18/19). The ceiling of the western passage is formed of a series of shallow jack-arches supported on transverse RSJs. Beyond Tunnel G at the northern end of the passage, the western passage continues as a red-brick barrel-vaulted passage for a further *c.*7 m before turning westwards; access to the westward extension was not possible because of accumulated spoil, though it was noted to extend for at least 10m before veering gradually to the north. Upson (2004; Fig. 14), based upon a combination of previous studies and historical maps, indicates that this tunnel extends further to the west and serves a second furnace base.<sup>1</sup>

6.4.3 The southern two tunnels (A and B) are narrow (1.15m and 1.20m respectively), Tunnel A standing slightly taller than tunnel B.<sup>2</sup> Both are constructed of refractory brick and have semi-circular barrel vaults terminating in an arch of stretchers. Tunnel A retains a packing of checkerwork refractory brick, laid to a 'pigeon-hole' setting with horizontally disposed passages (Plate 20). At 7.5m long, Tunnel A is somewhat shorter than the remaining tunnels; the north flanking wall of the tunnel extending beyond the body of the tunnel to both east and west to form the southern wall of Tunnel B (Figure 11). Tunnel A is blocked off to the east (Plate 29).

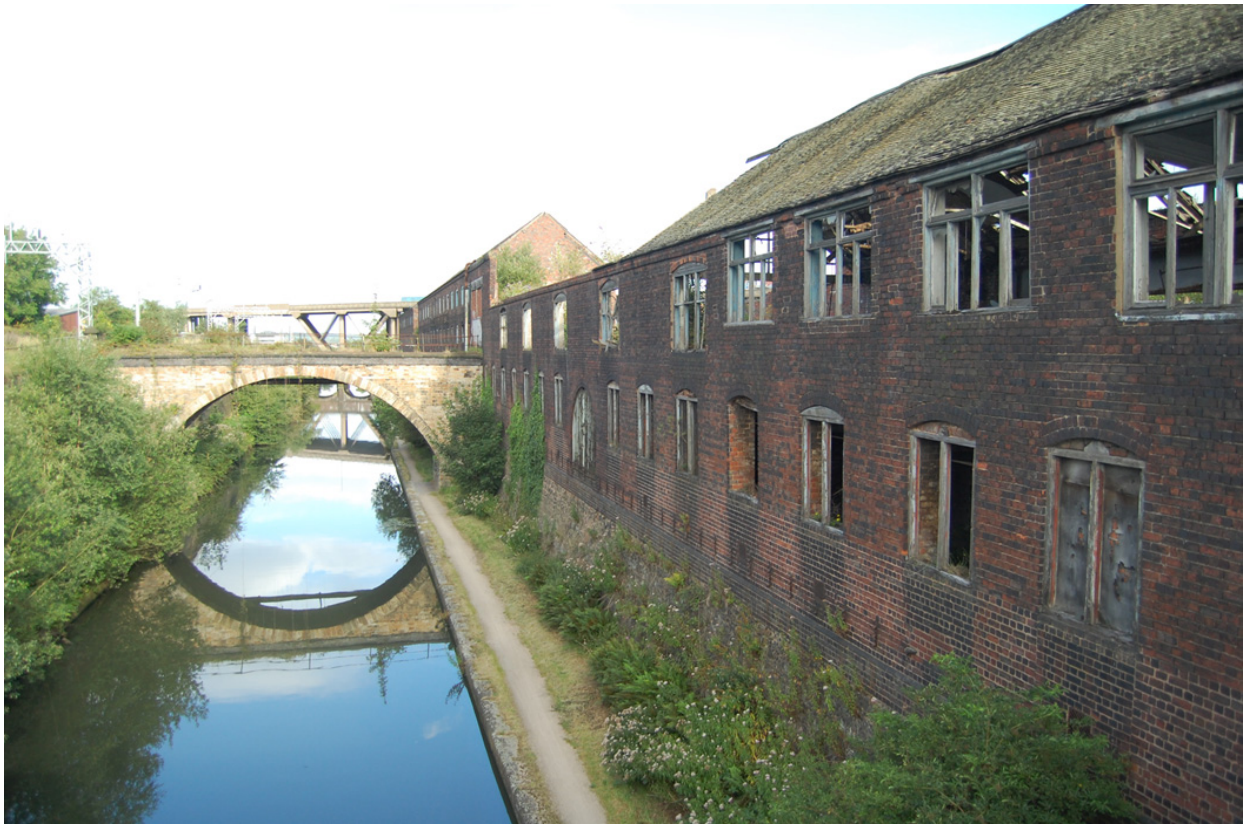
**Plate 1:** Building C, oblique view looking west from Canal Bridge.

embankment such that the southern (canal) elevation is of two storeys above a battered clinker plinth, while the northern elevation, facing the main site, is of single storey height. It is brick built of purple-red brick laid in English bond to the cill level of the lower storey windows, in English garden wall above this level, with three courses of stretchers between header courses (Plate 1).

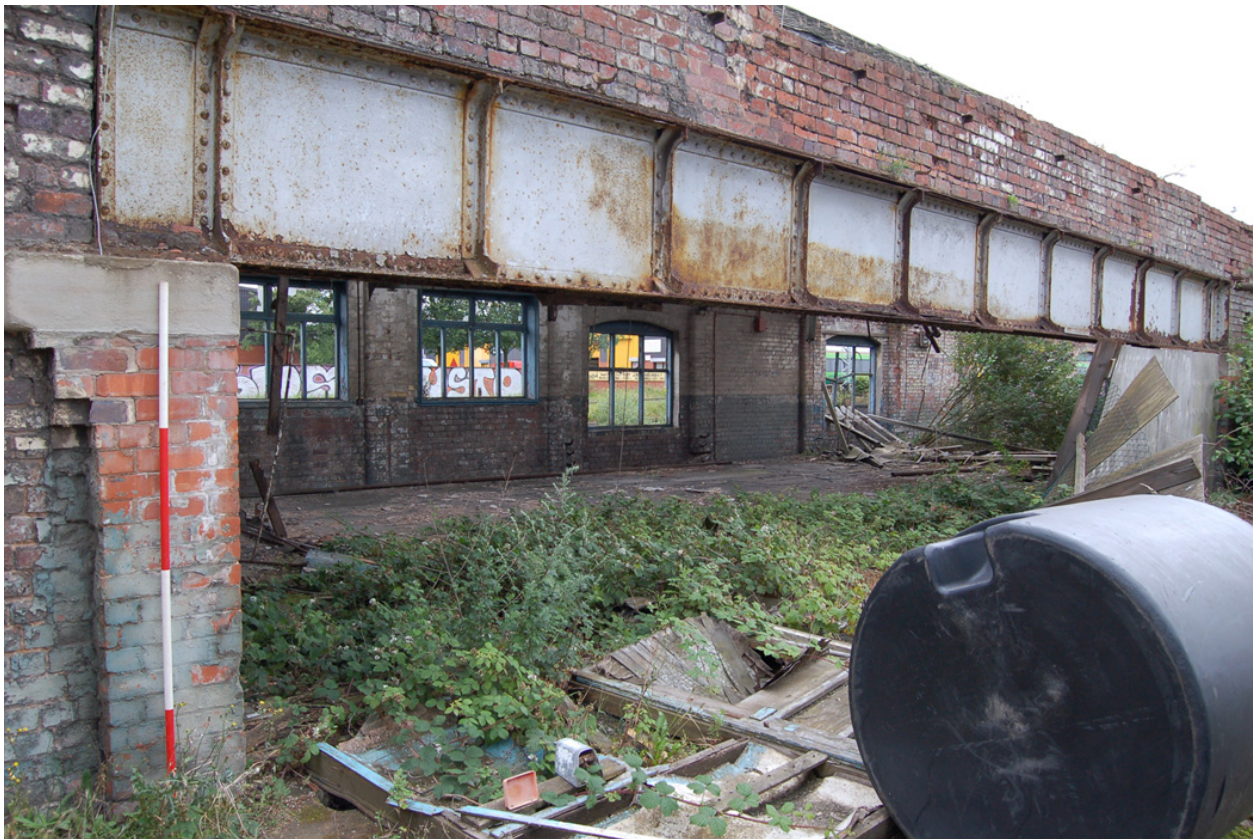
**Plate 4:** Building C, north elevation, inserted iron girder over wide opening.

- 6.2.3 Bays 3-6 of the north elevation are open at floor level, the upper section of wall being supported by a substantial, inserted webbed steel girder supported to east and west by inserted piers of brickwork (Plate 4). This girder supports the northern end of trusses T3-T7.

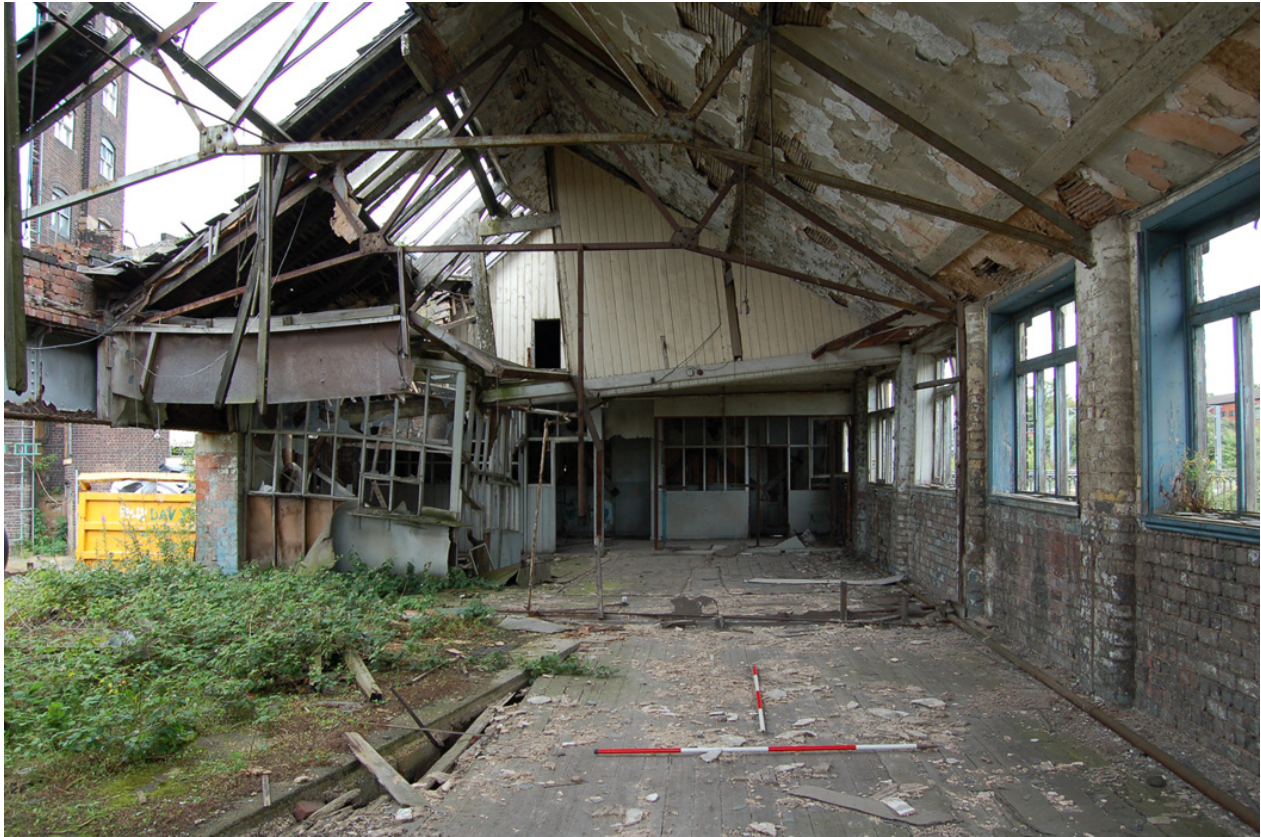
**Plate 5:** Building C, Level 2 interior looking east; office sub-divisions, note collapsed roof.

- 6.2.5 To the far east end of the range, the building is subdivided to form a series of offices by studwork partition walls with glazed upper panels (Plates 5/6). The partition walls retain, in part, vertical tongue and groove cladding also recorded at the upper, attic level (Plate 5).

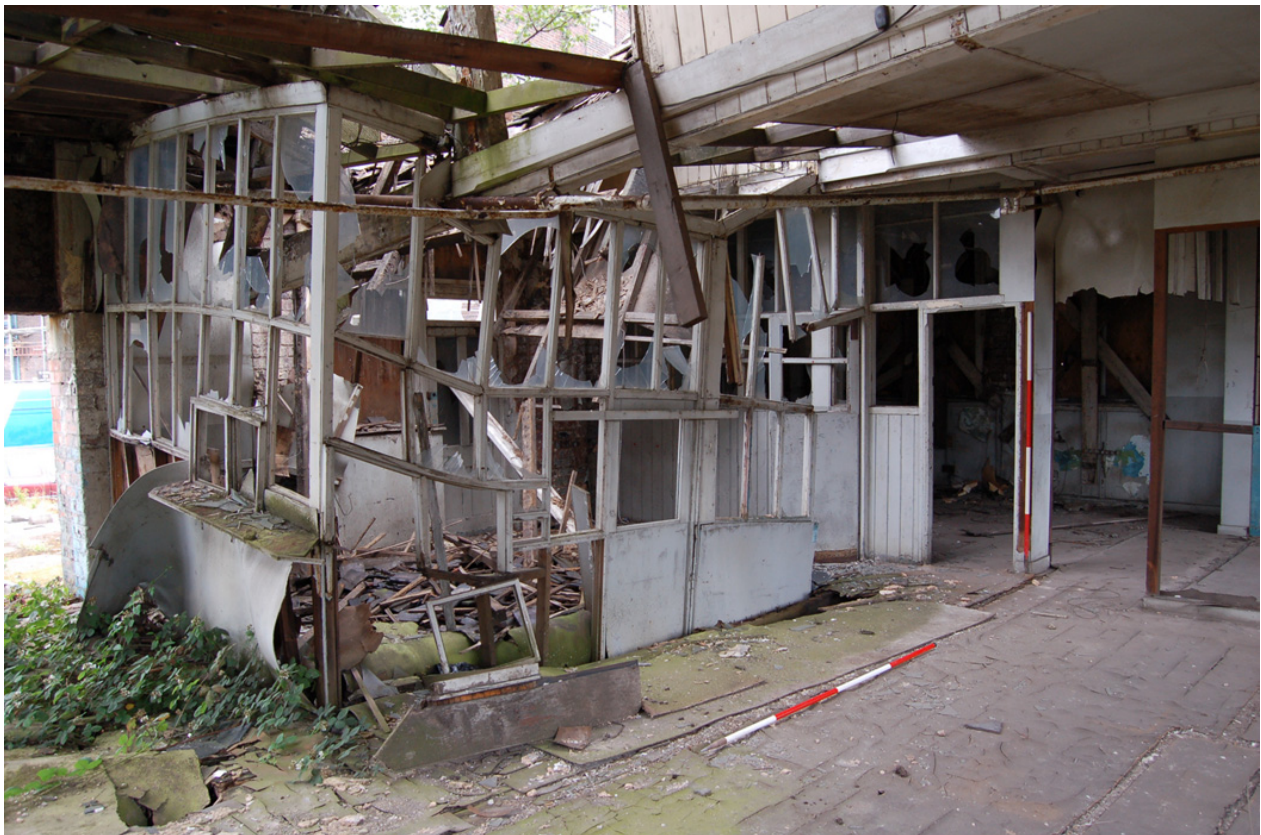
**Plate 6:** Building C, Level 2, east end; detail of office partitions.

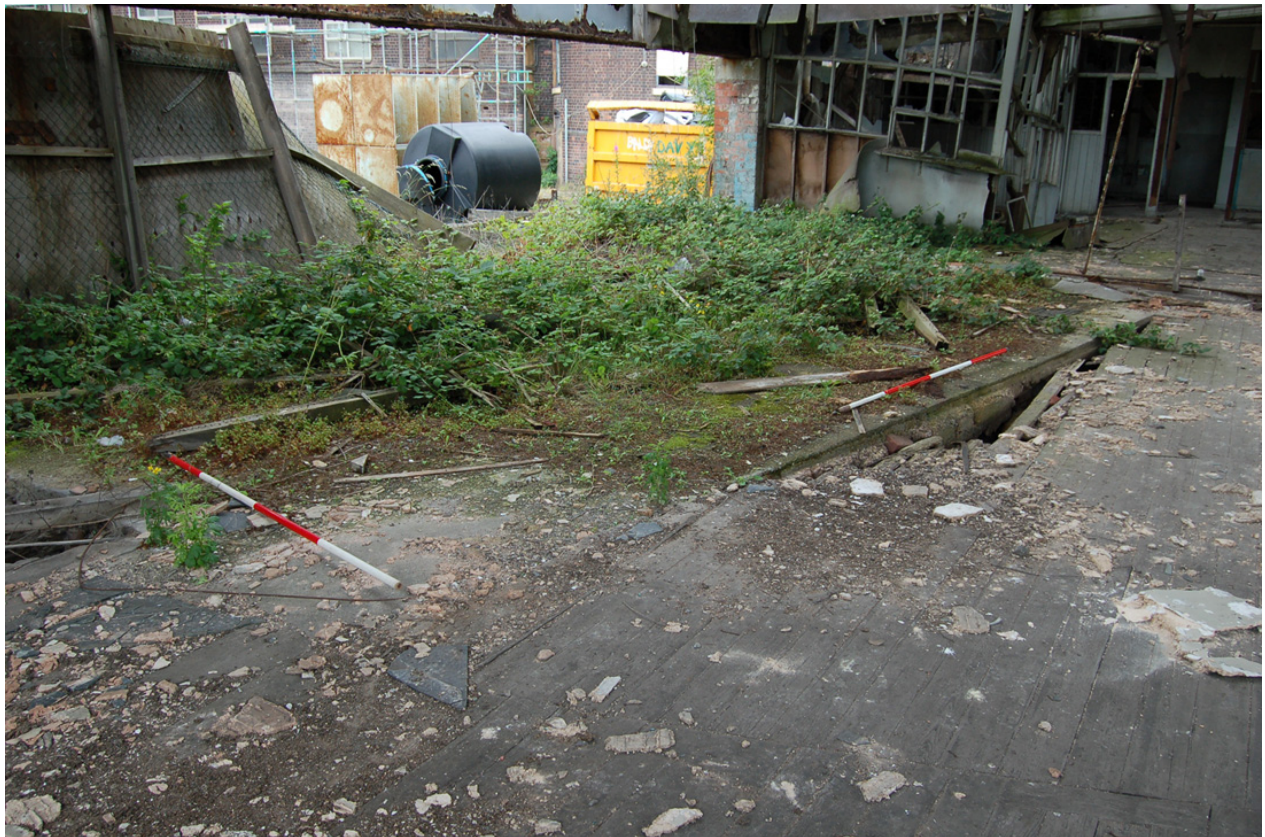
**Plate 8:** Building C, Level 2; concrete top of inserted Level 1 structure.

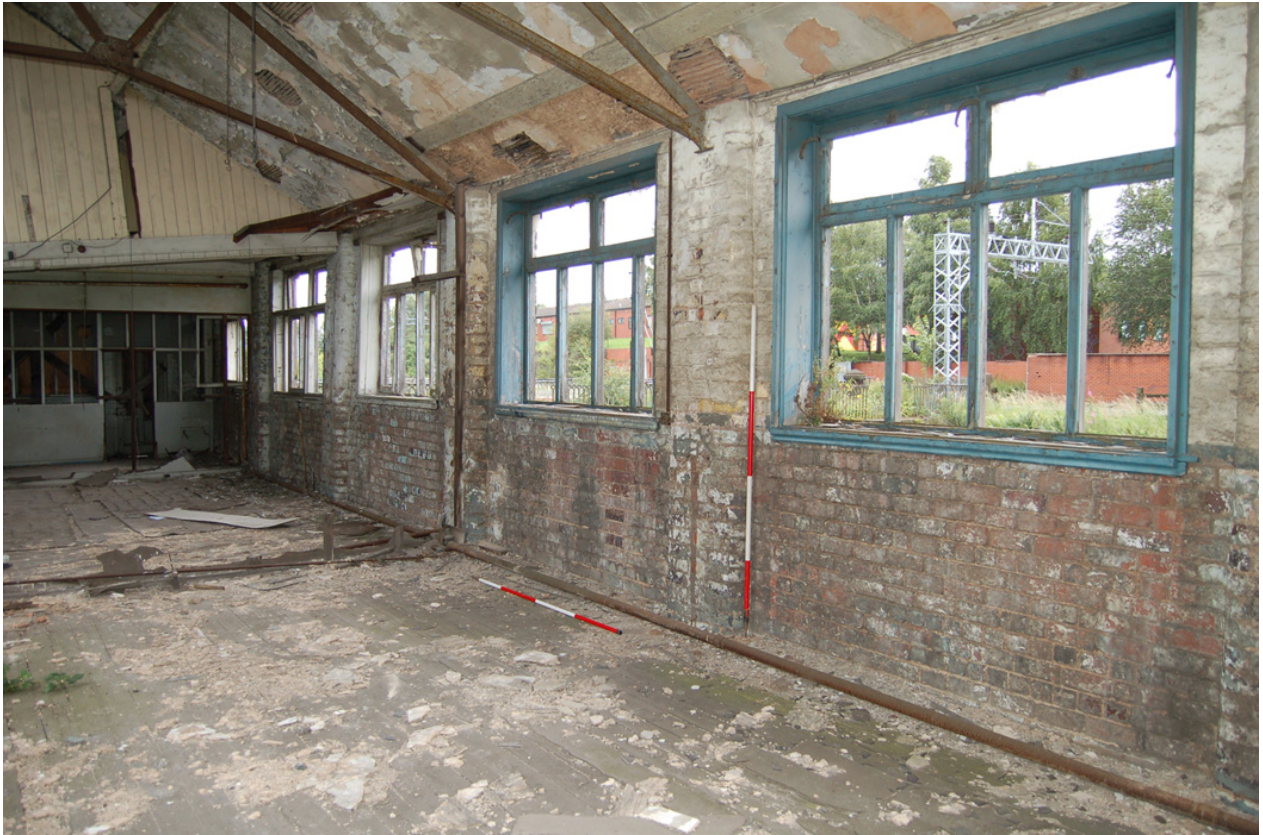
**Plate 9:** Building C, Level 2; fenestration of south elevation (E).

- 6.2.2 Fenestration of the south wall can be divided into two sections. To the east, Bays 1-5 each display rectangular openings housing timber casements of four vertical lights with two double-width, bottom hinged panels over (Plate 9). The window within Bay 1 is somewhat narrower than those within Bays 2-5. Bay 6 displays a large window opening with segmental-head (double-header arch) with perpendicular reveals housing a three-light, transomed timber casement (Plate 10). Beyond Bay 6, alternate bays (8, 10, 12, 14) are lit by similar, segmental headed windows, Bays 7, 9, 11 and 13 being unlit. Reference to the view of 1857 (Figure 5) indicates that all fenestration at this level is secondary, an observation that is verified by evidence of insertion within exterior brickwork of the elevation.

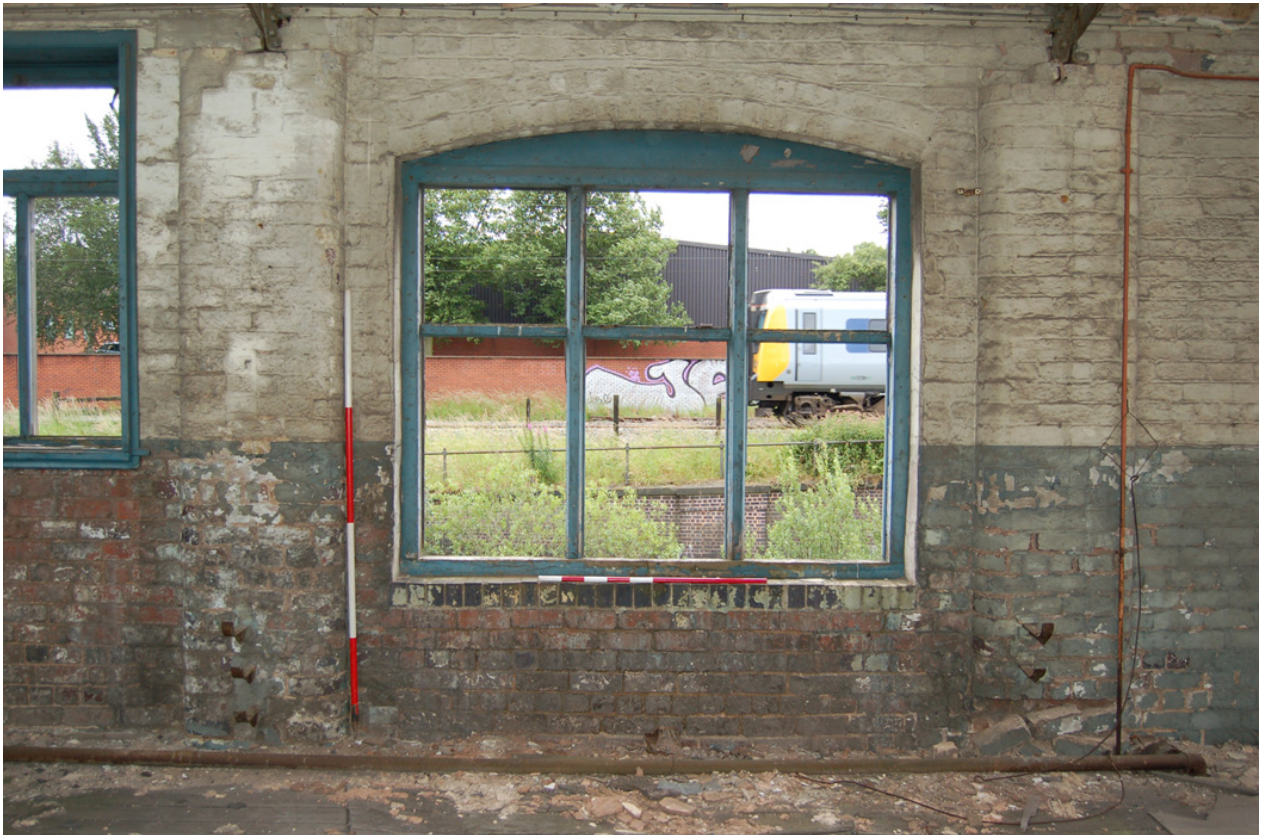
**Plate 10:** Building C, Level 2; fenestration of south elevation (W).

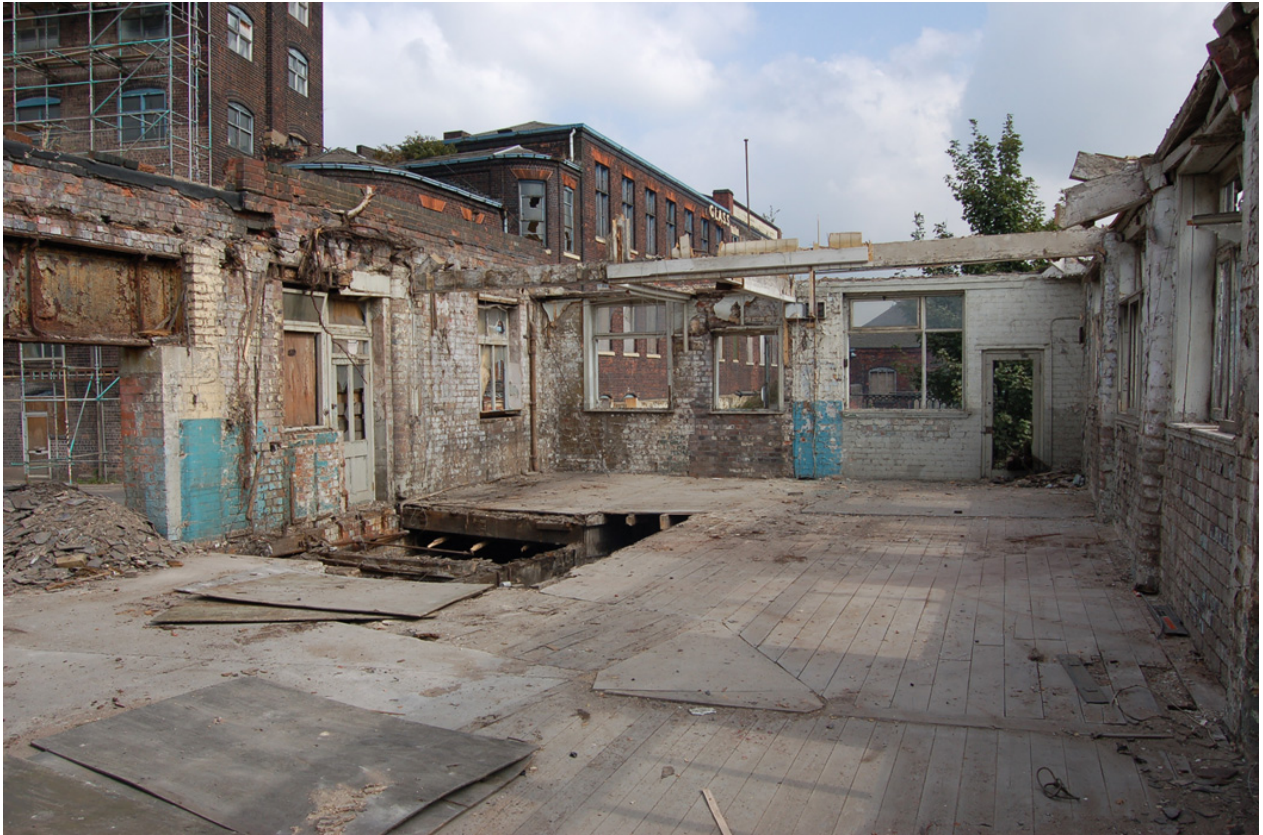
**Plate 11:** Building C, Level 2 looking east after removal of office partitions and unsafe roof structure.

- 6.2.6 As a part of remedial works to stabilise the building, the unstable eastern section of the roof and the studwork office partition walls were removed in September 2007 (Plate 11). Removal of the partition walls exposed the remains of a former ramp, aligned longitudinally on the axis of the range, sloping down towards the eastern elevation (Plate 12). This ramp had been converted to a shallow pitched stair before being boarded over in north-south aligned softwood boards.

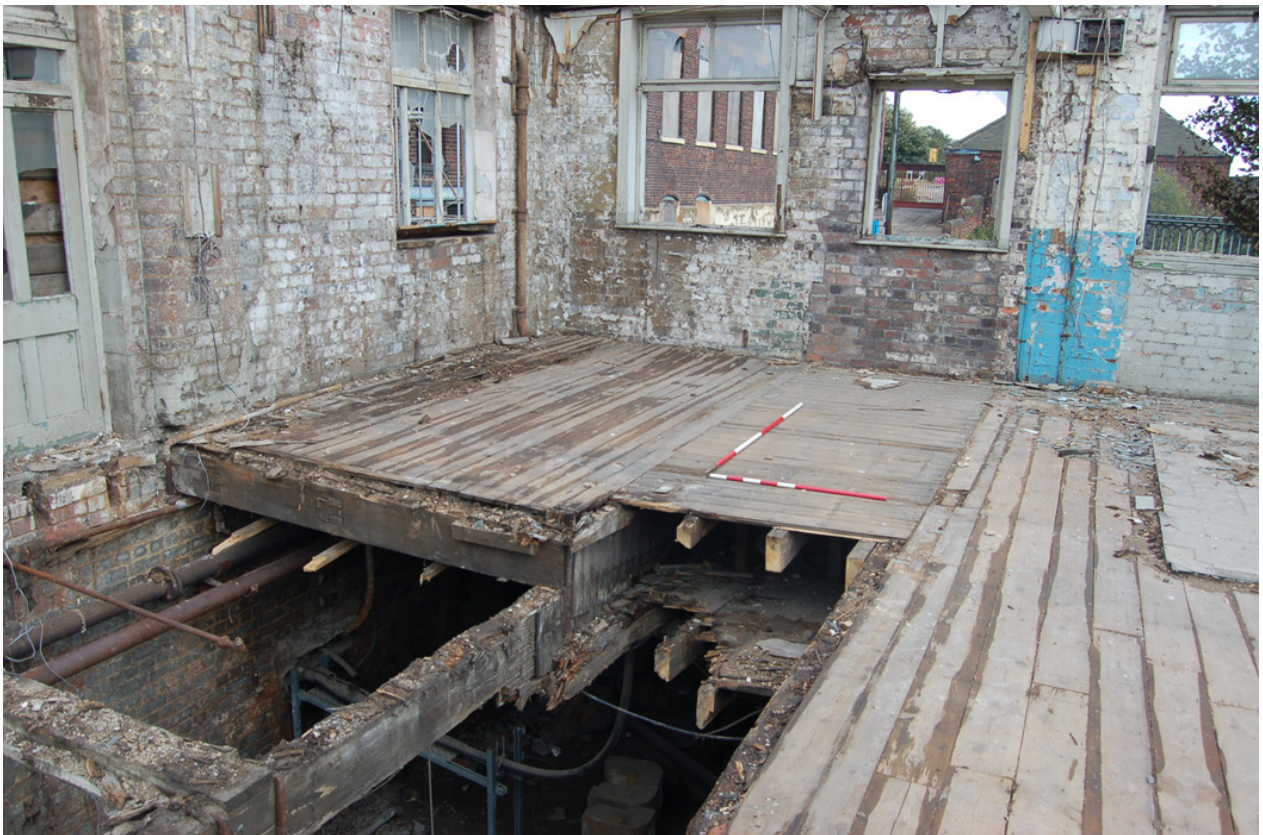
**Plate 12:** Building C, Level 2; evidence of former ramp (centre) exposed beneath office partitions.

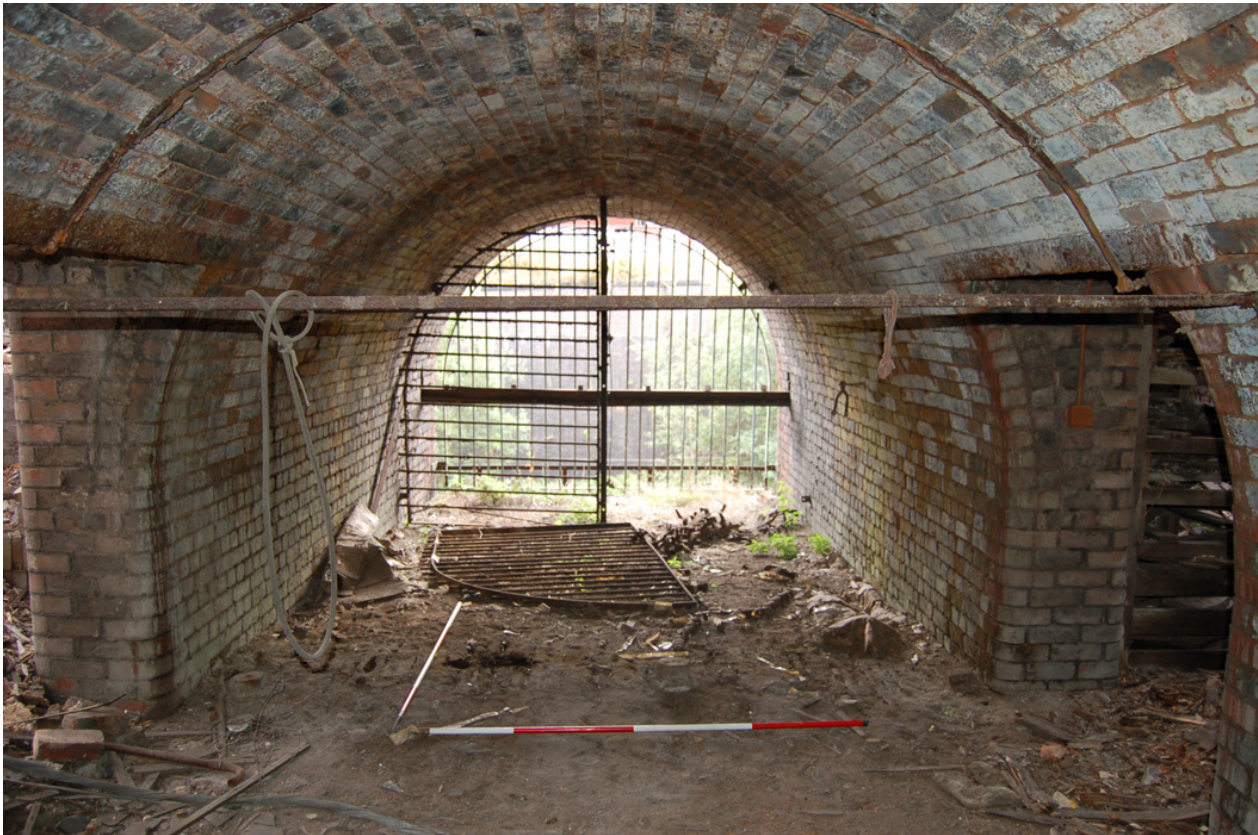
Plate 14: Building C, Level 1; central entrance tunnel looking south.

6.3.6 The central transverse passage occupying Bay 9 is brick built with a semi-circular vault (Plate 14). Through access is provided by simple rectangular doorways in the northern end of the eastern and western walls. The tunnel opens out to the south above the battered plinth overlooking the NML canal, and to the north provides access to the furnace base (see §.6.4).

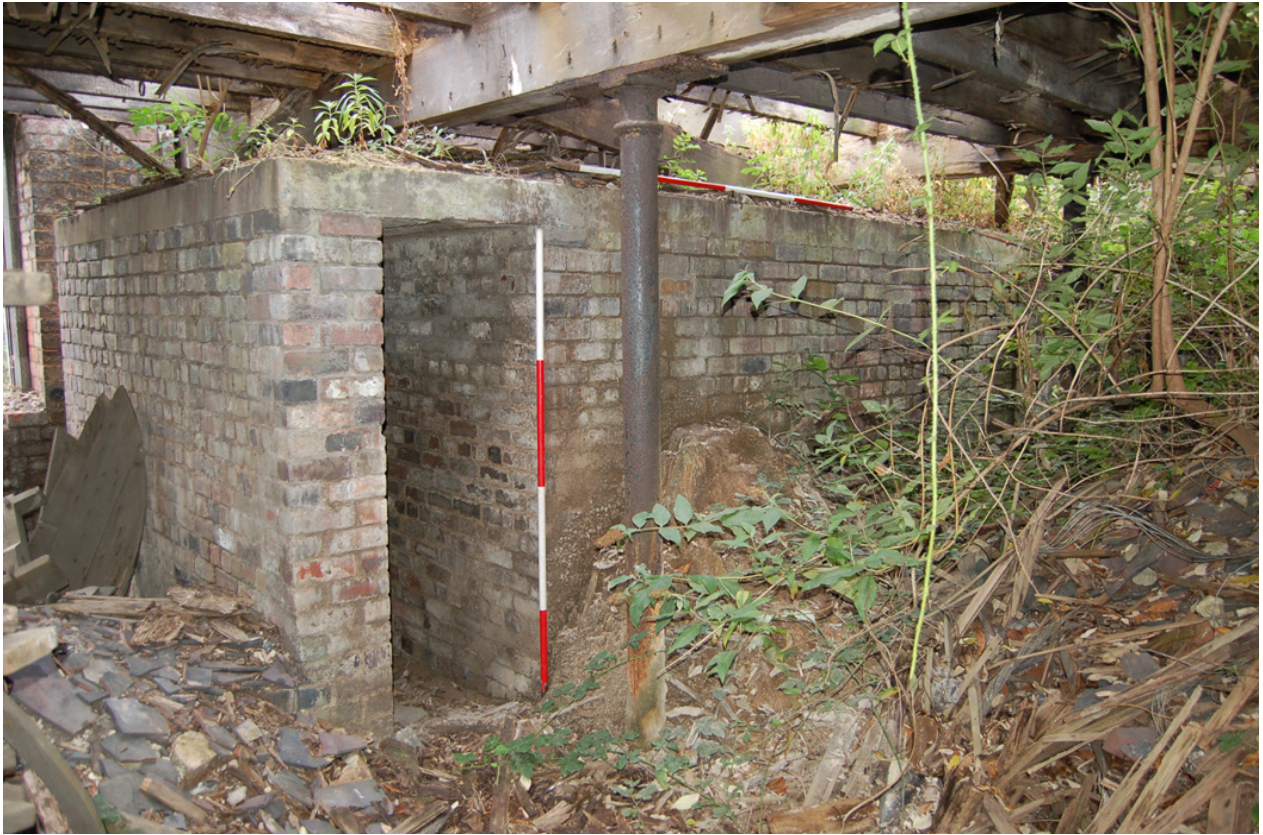
**Plate 15:** Building C, Level 1 (W); inserted store.

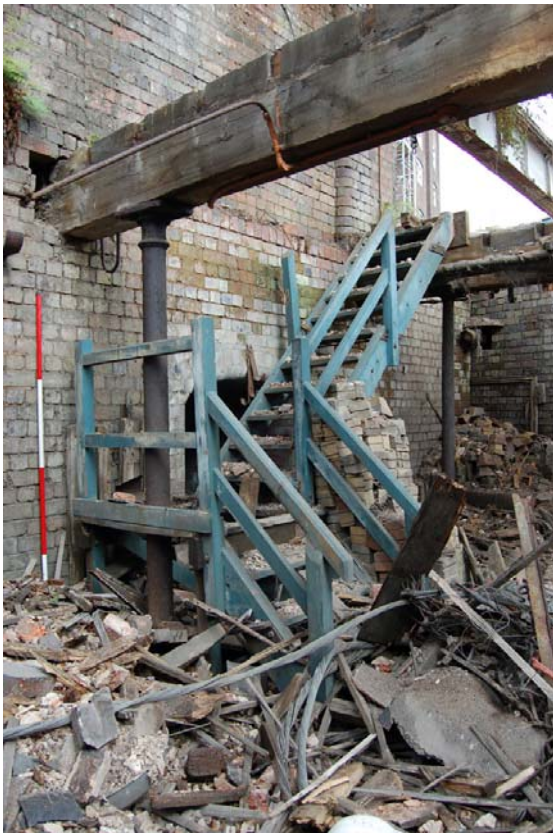
**Plate 16:** Stair against north wall.

6.3.5 A wooden, quarter-turn stair rises against the north wall of Bay 7 (Plate 16); this stair does not emerge into the upper level of the range, being floored over with two layers of floor boards suggesting a considerable time has elapsed since it was in use. A segmental-headed doorway with bull nose brick jambs in the north wall of Bay 7 (inserted), is partially blocked by the stair (Plate 17).

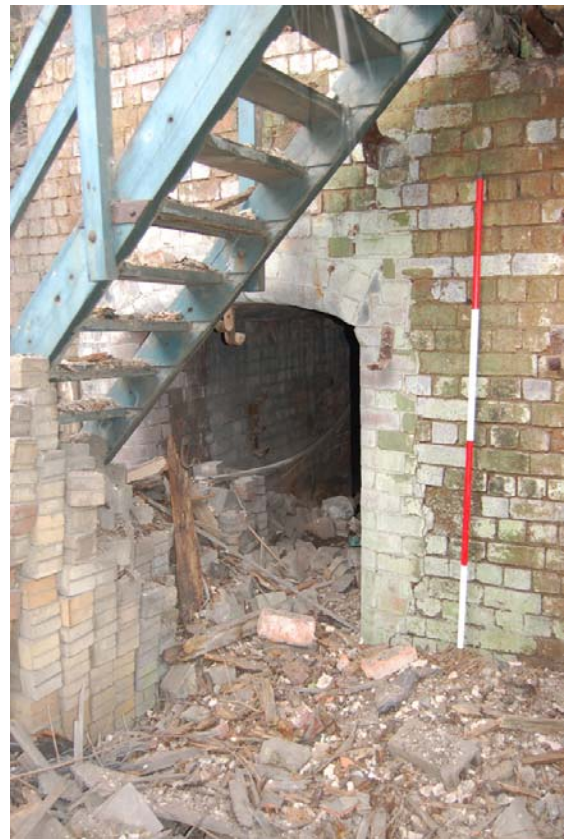
**Plate 17:** Entrance to furnace base (inserted).

6.4.1 A series of three tunnels leading off the north side of Level 1 (Bays 7, 9 and 10) give access to the well preserved structural remains, here provisionally interpreted as the base of a regenerative furnace. Both the eastern and western entrance passage doors display clear evidence of having been inserted into the pre-existing brickwork of the north wall (Plate 17).

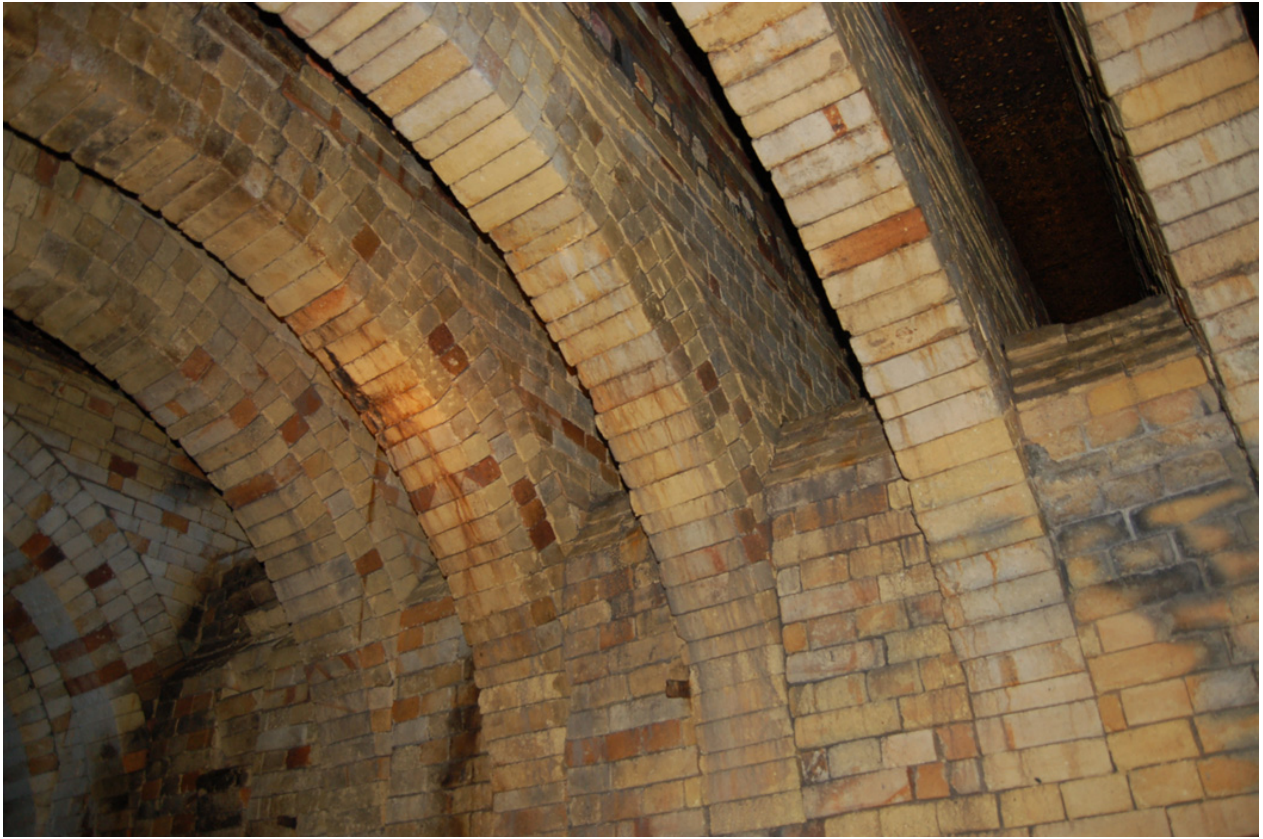
**Plate 22:** Tunnel C, detail of brick ribs.

6.4.5 The central tunnels (C and D) are significantly wider (2.53m) and taller than the flanking tunnels (A, B, E and F) and vary structurally in that, rather than tunnels *per se*, they comprise a series of arched brick ribs (Plate 22), separated by *c.*0.4m wide voids which extend to the underside of a perforated iron plate (Plate 23), and are interconnected at high level.

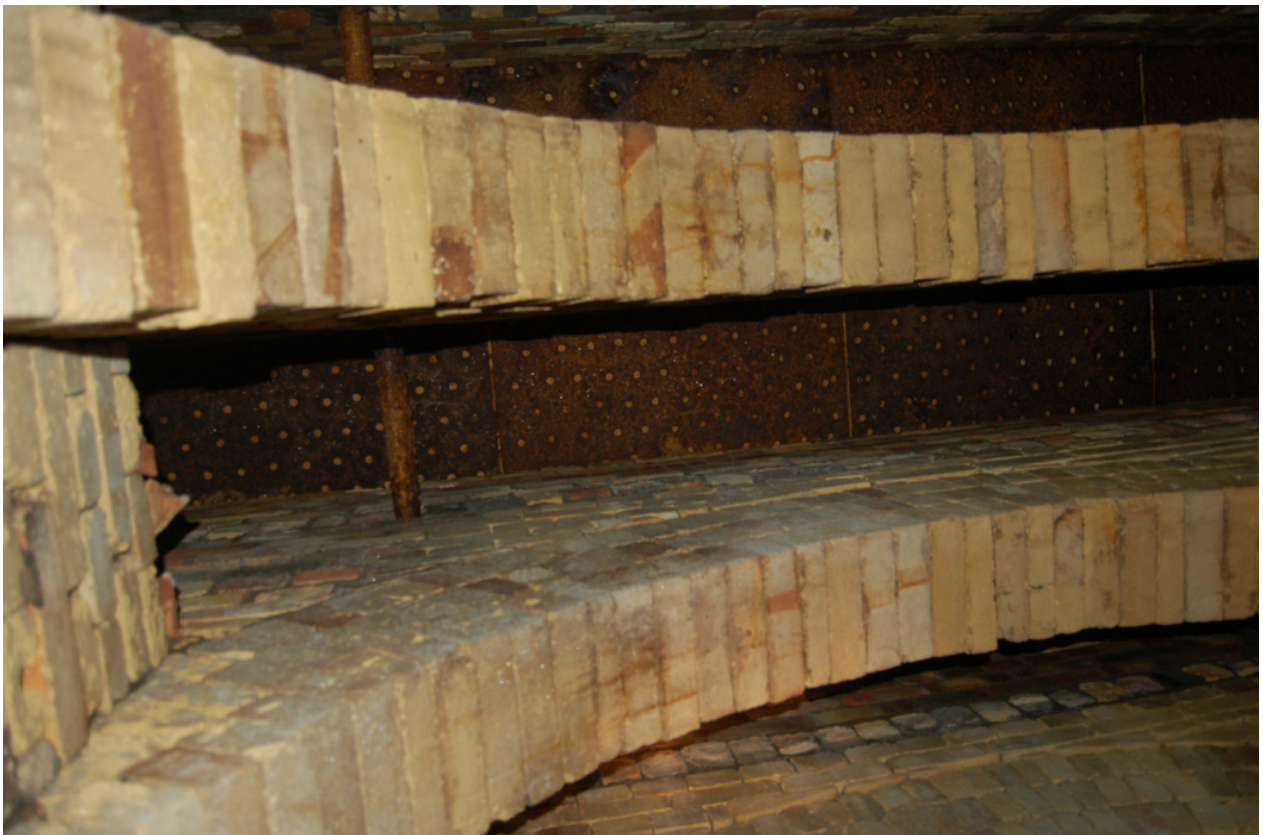
**Plate 23:** Tunnel C, detail of voids extending upwards to soffit of perforated iron plate. Note iron tie rod.

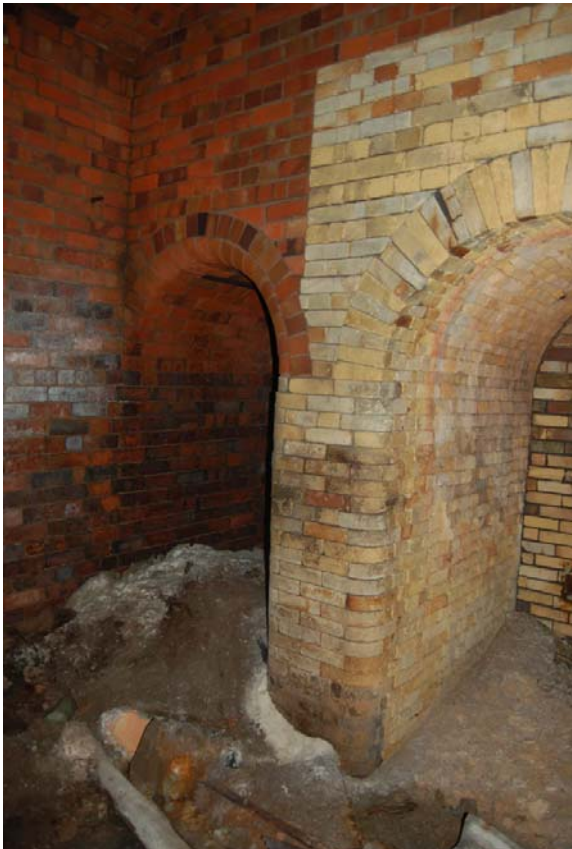
Plate 26: Tunnels F (right) and G (left).

- 6.4.7 At the far north end, Tunnel G probably forms some form of access tunnel. Only the southern wall is in refractory brick (being the north wall of Tunnel F; Plate 26), the remainder of the structure is in red-brick with rounded, bull-nose arch and two alignments of grey engineering brick which run the length of the barrel vault (Plate 27).

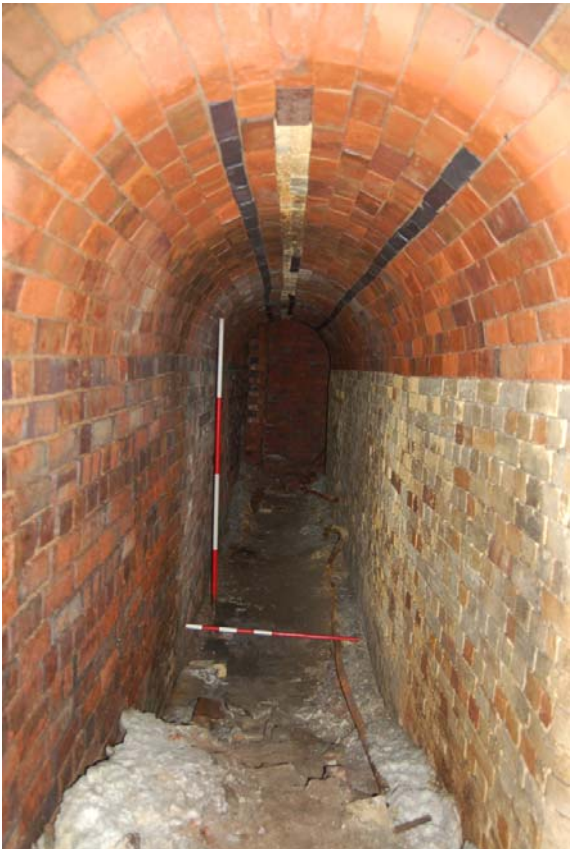
Plate 27: Tunnel G looking east.

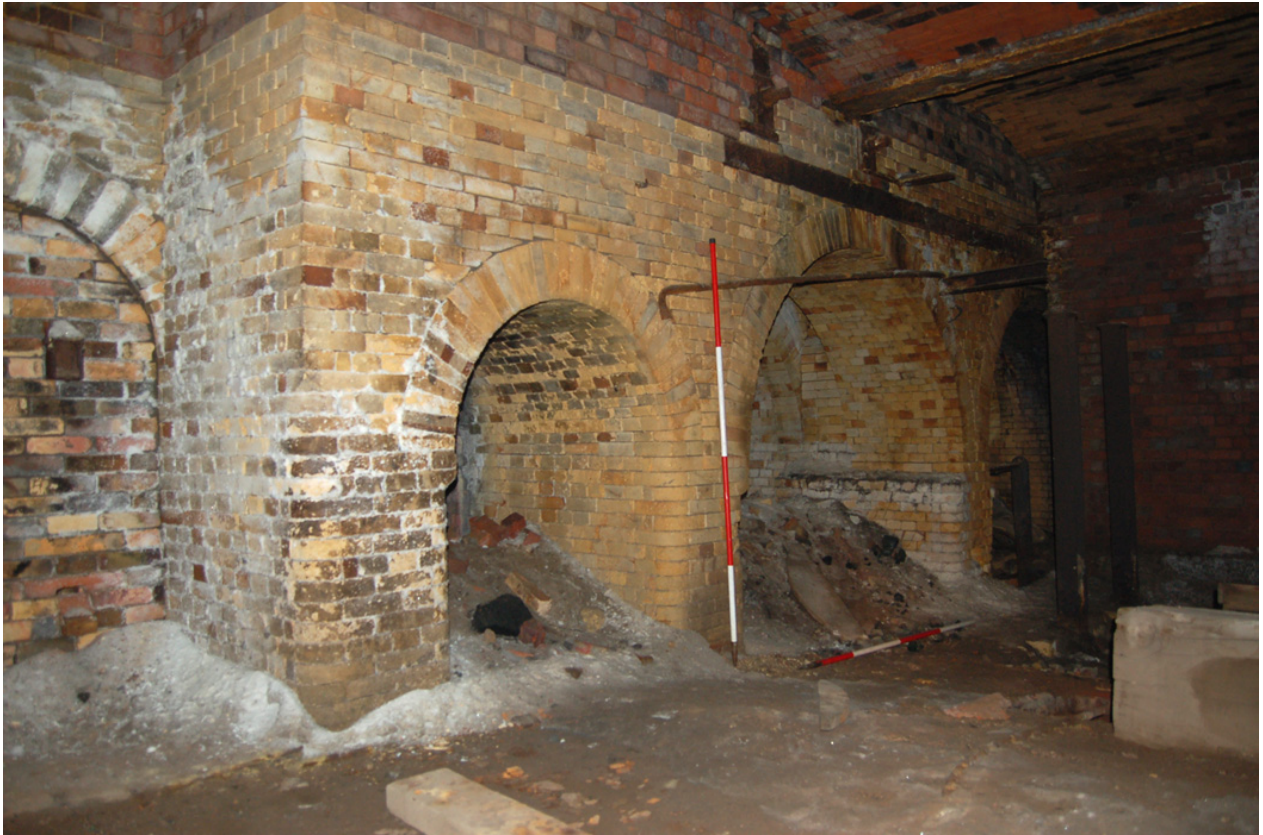
**Plate 28:** Furnace base, east end; tunnels A (left; blocked), B and C (middle), and D (far right).

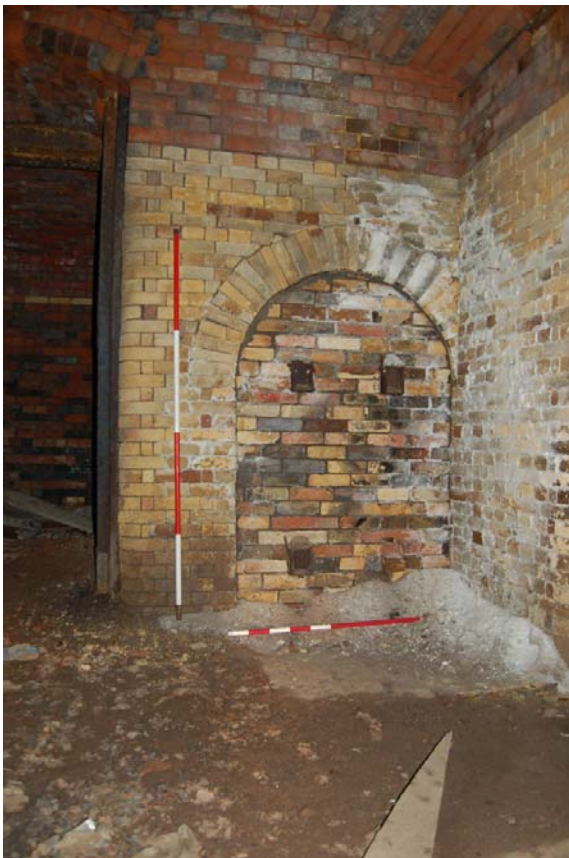
**Plate 29:** Tunnel A, east end; blocked.
