Chance Brothers Glassworks,  
Smethwick, West Midlands  
Historic Building Record  
Building C and Associated  
Features

**Former Chance Brothers Glassworks,  
Spon Lane, Smethwick, West Midlands**

**Historic Building Recording**

**BUILDING C AND ASSOCIATED FEATURES**

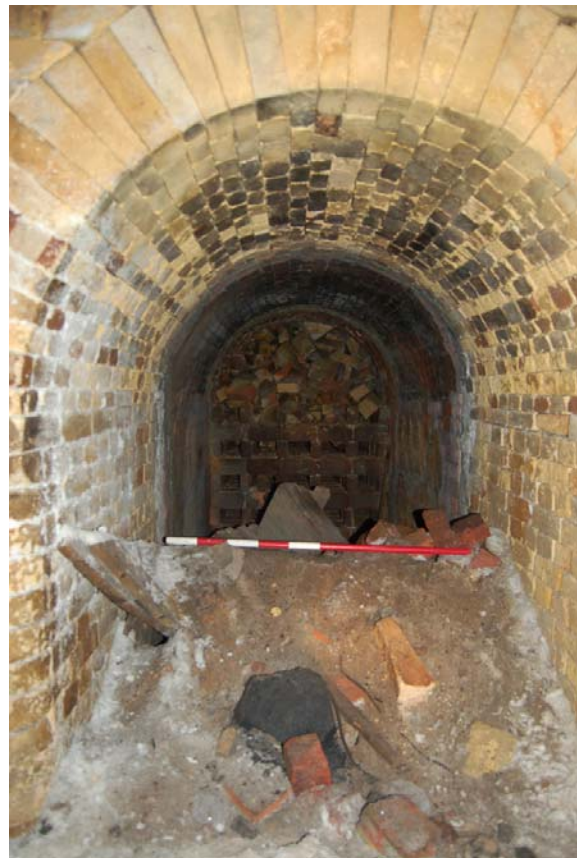
**Plate 30:** Tunnel B looking west, note packing.

6.4.4 Tunnel B slightly wider and shorter than Tunnel A, and longer at 10m in length. The tunnel is blocked off 2.75m from its western end. From the east, it is seen to retain checkerwork brick packing (Plate 30) of a similar nature to that recorded within Tunnel A.

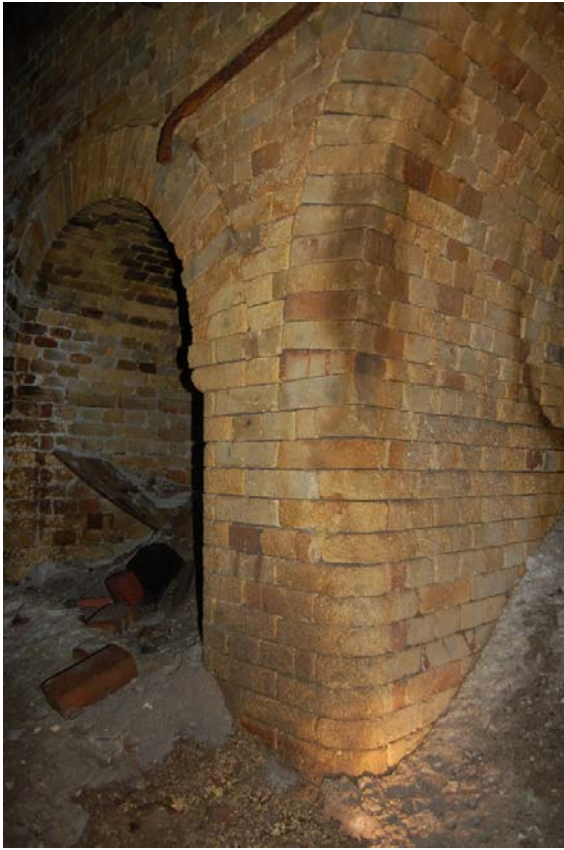
**Plate 31:** Brick detailing to east end arches.

- 6.4.8 The brickwork of all the tunnels is of high quality, with rounded and stopped jambs (Plate 31).
- 6.4.9 At the eastern end of the tunnels, accessed via a passageway from Bay 7 of Building C, is a rectangular area, 3.5m wide and ceiled by three low brick jack-arches, allowing access to the eastern end of the tunnels (Plate 28). To the north, an inserted redbrick structure obscures the eastern end of tunnels E- G. Two voids in the floor provide access to sub-surface, brick-built flues, one of which extends below Tunnel A returning to the east to run approximately north-south, parallel to the eastern wall. The second flue, accessed immediately east of Tunnel C seems to run on a north-south alignment (?possibly returning westwards to run beneath Tunnel B?), though it has been blocked internally.

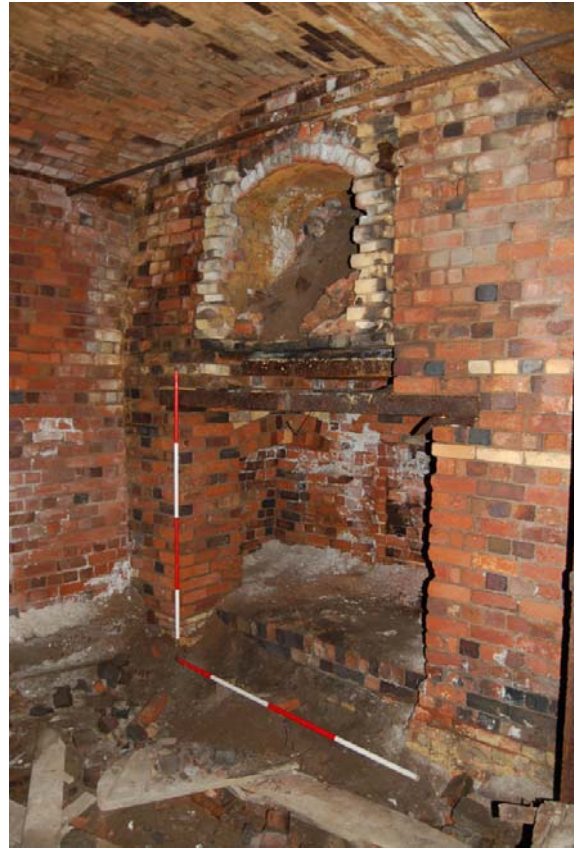
**Plate 32:** East end, openings in east wall.

- 6.4.10 The exterior walls of the 'east end' space are in red brick and include a pair of superimposed openings in the eastern wall (Plate 32); reference to Upson (2004, Fig.14) indicates that these tunnels may serve a further furnace base to the north. The doorway in the south wall of the east end is clearly inserted (Plate 33).

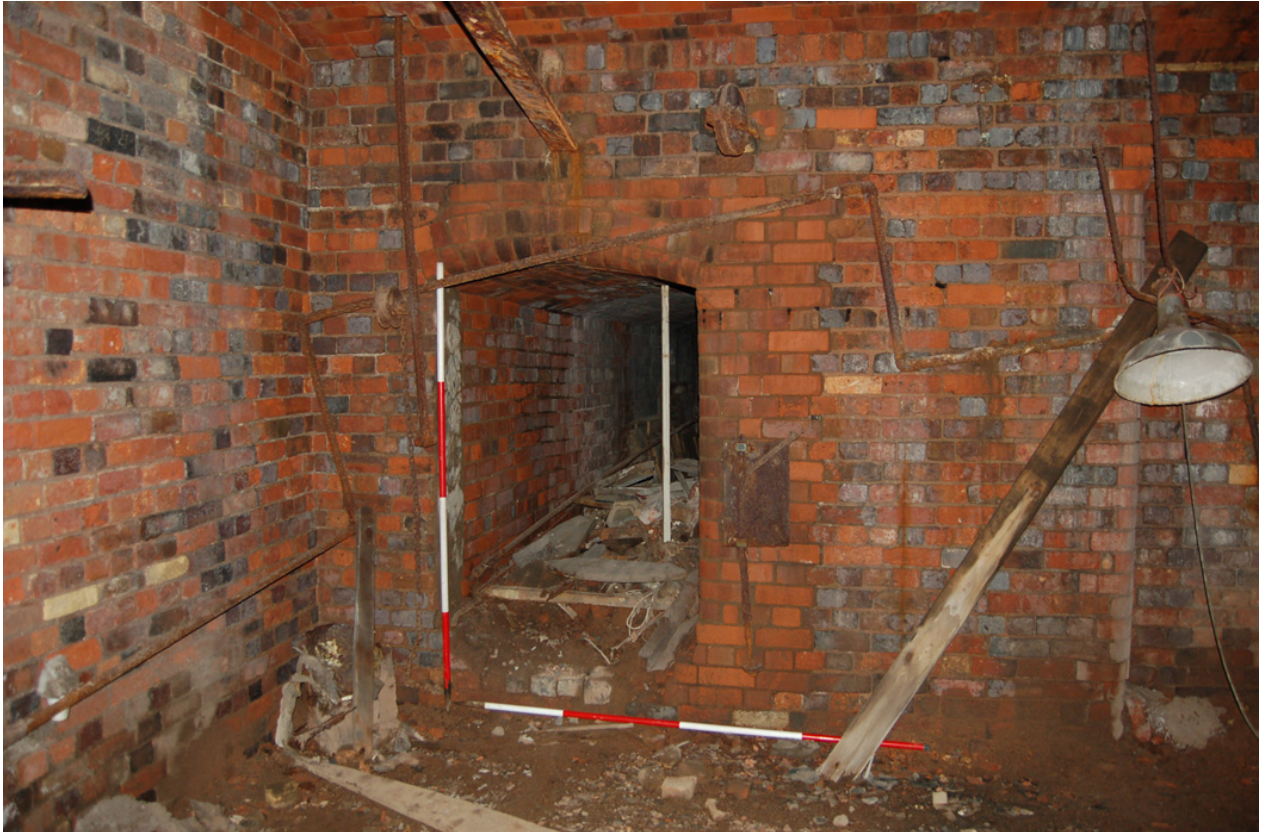
**Plate 33:** East end, south wall, (eastern passageway leading to Building C, Level 1; inserted).
