**Colsterworth Railway Bridge,  
Lincolnshire**

**Historic Building Recording**

Project No. 1660  
July 2007

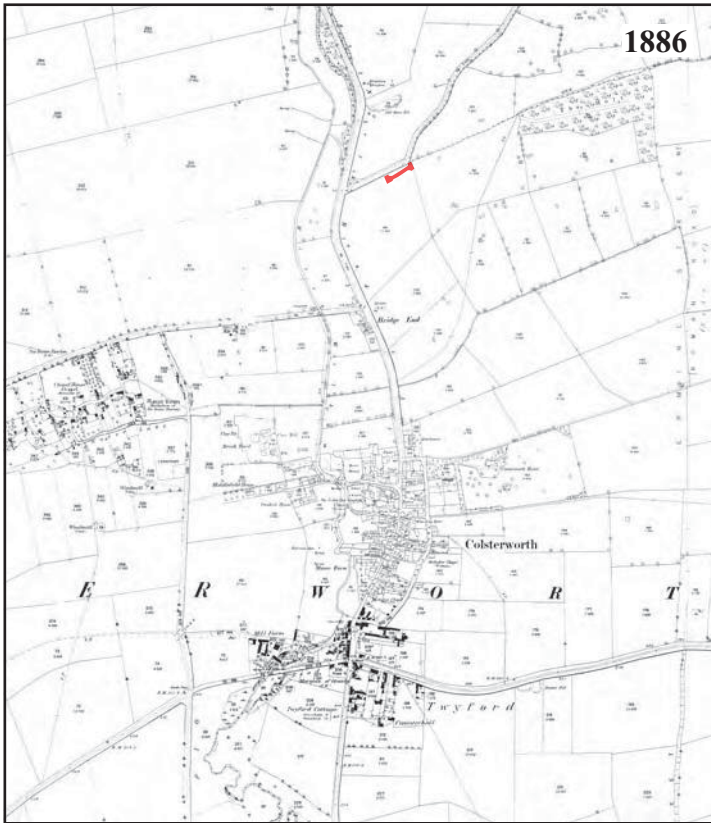
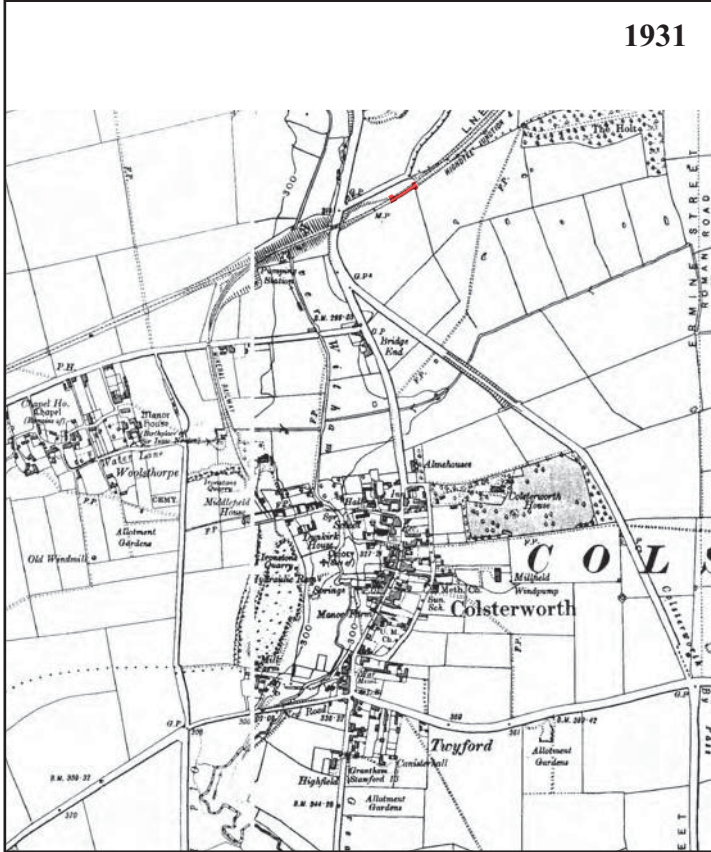
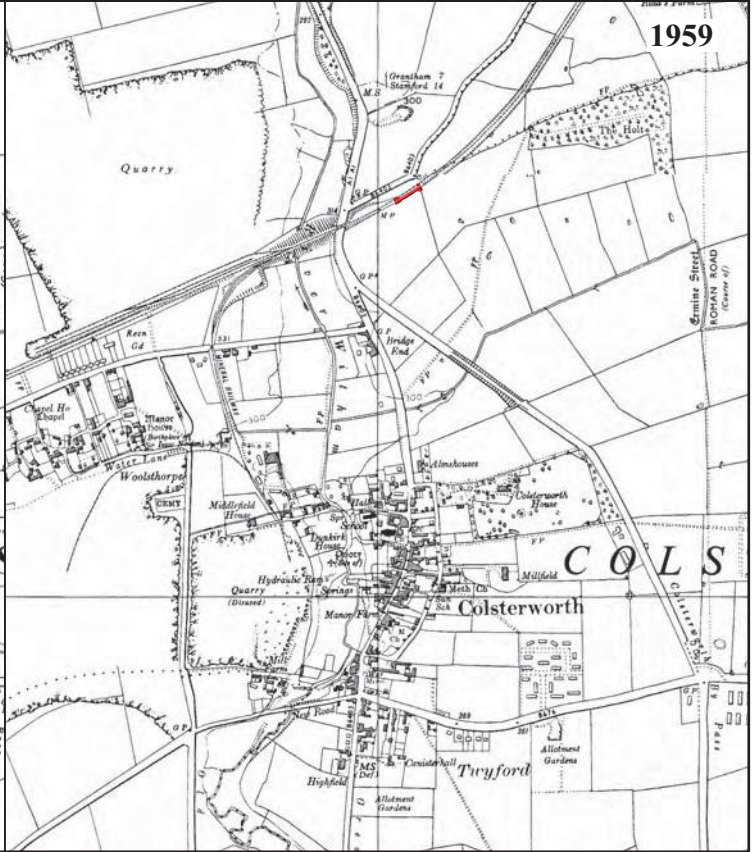
Fig.5

Following the site visit it was decided to consult historic map evidence in order to aid an understanding of the chronological development of the bridge and the railway it conveyed (Figs. 5 and 6). The historic Ordnance Survey maps show that the railway bridge had not been constructed by the time of the 1959 map. There is no evidence of the railway on the 1886 or 1904 maps. The 1931 map shows the railway which appears to have been part of the LNER or London and Northeast Railways line which was constructed after an Act of Parliament in 1921. This is carried over the now B 6403 by the now partially demolished railway bridge to the west of the current site. In addition a line running from an ironstone quarry in Colsterworth meets the track to the west of the site. The section of A1 spanned by the extant bridge had not been constructed by the 1959 map.

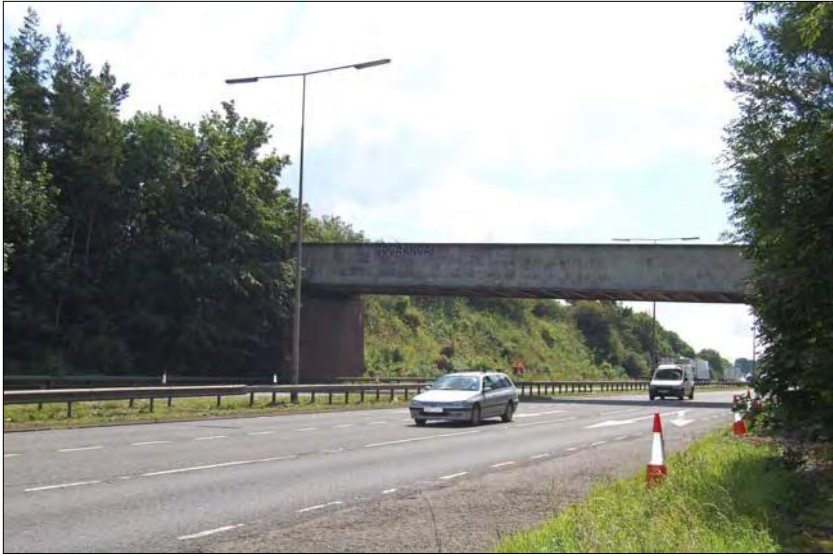
plate 1

- Plate 1. Colsterworth Railway Bridge from northwest.
- Plate 2. Colsterworth Railway Bridge from southeast.
- Plate 3. Example of brick abutment from south.
- Plate 4. Underside of bridge.
- Plate 5. Brick abutment from southwest.
- Plate 6. Deck of bridge from southwest.
- Plate 7. Deck of bridge from northeast.
- Plate 8. Bridge wall or 'web' from northeast.
- Plate 9. Abutment bolts from above.
- Plate 10. Bridge wall or 'web' from southwest.
- Plate 11. Fixture on southwest side of bridge.
- Plate 12. Example of concrete footing.

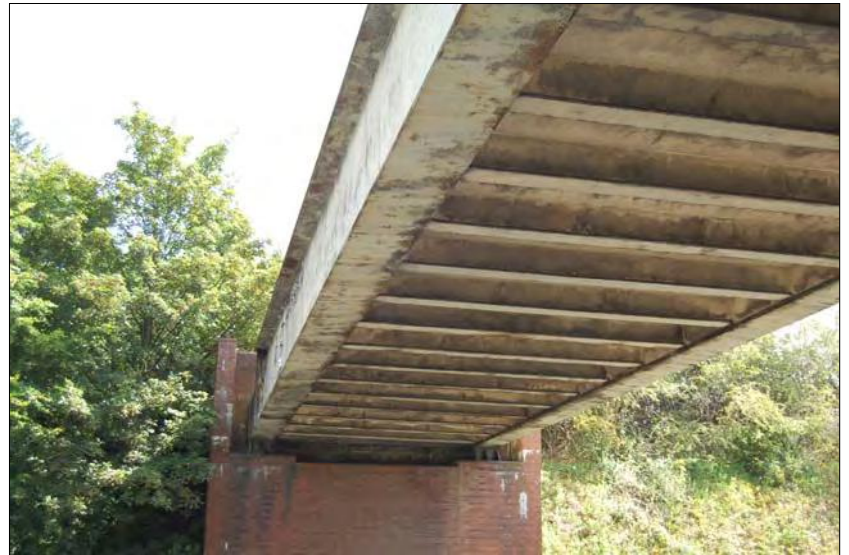
plate 4

From the roadside the bridge gives the appearance of a large steel girder spanning the highway, which is essentially what it is. The structure is utilitarian in appearance, and no attempt at embellishment or decoration has been made. From underneath it is possible to gain an understanding of the construction of the bridge. It comprises two steel I-beams with c.1.5m high webs and projecting flanges. The inner flanges support and are welded to cross-running steel joists which support the deck above (Plate 4). The bridge is raised on a red brick abutment.

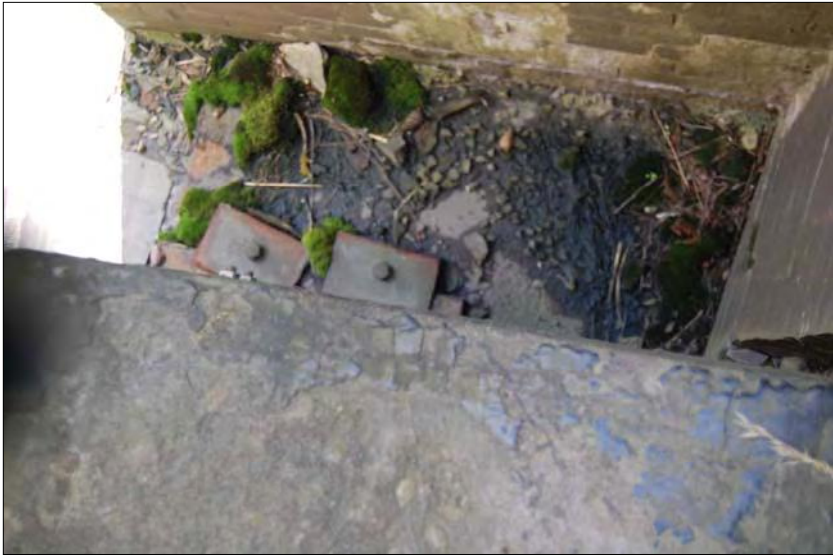
plate 9

made in Riddings, Derbyshire, where there was an extensive pottery works. The bridge appears to be tied to the abutment from above with large bolts (Plate 9). As noted above a number of stiffeners line the interior of the bridge. These thin strips of steel have been welded to the structure to provide further support. On the south side some of these stiffeners have projecting supports which may have been used to raise planking so workers could walk along the bridge without having to walk on the track (Plate 11). Some of the stiffeners are thicker, have flanges, and are set in concrete footings. The bottom flange at each side of the interior of the bridge appears to have been covered in concrete. As noted above the deck of the bridge is of earth and pebble, and there is no railway track remaining in-situ.
