Evaluation of Land adjacent  
to Seymour Road/  
Birmingham Road, Oldbury,  
Sandwell

**Project No 1719**

Bryant Homes North Midlands

**LAND ADJACENT TO SEYMOUR ROAD/BIRMINGHAM ROAD, OLDBURY,  
SANDWELL  
AN ARCHAEOLOGICAL EVALUATION, 2007.**

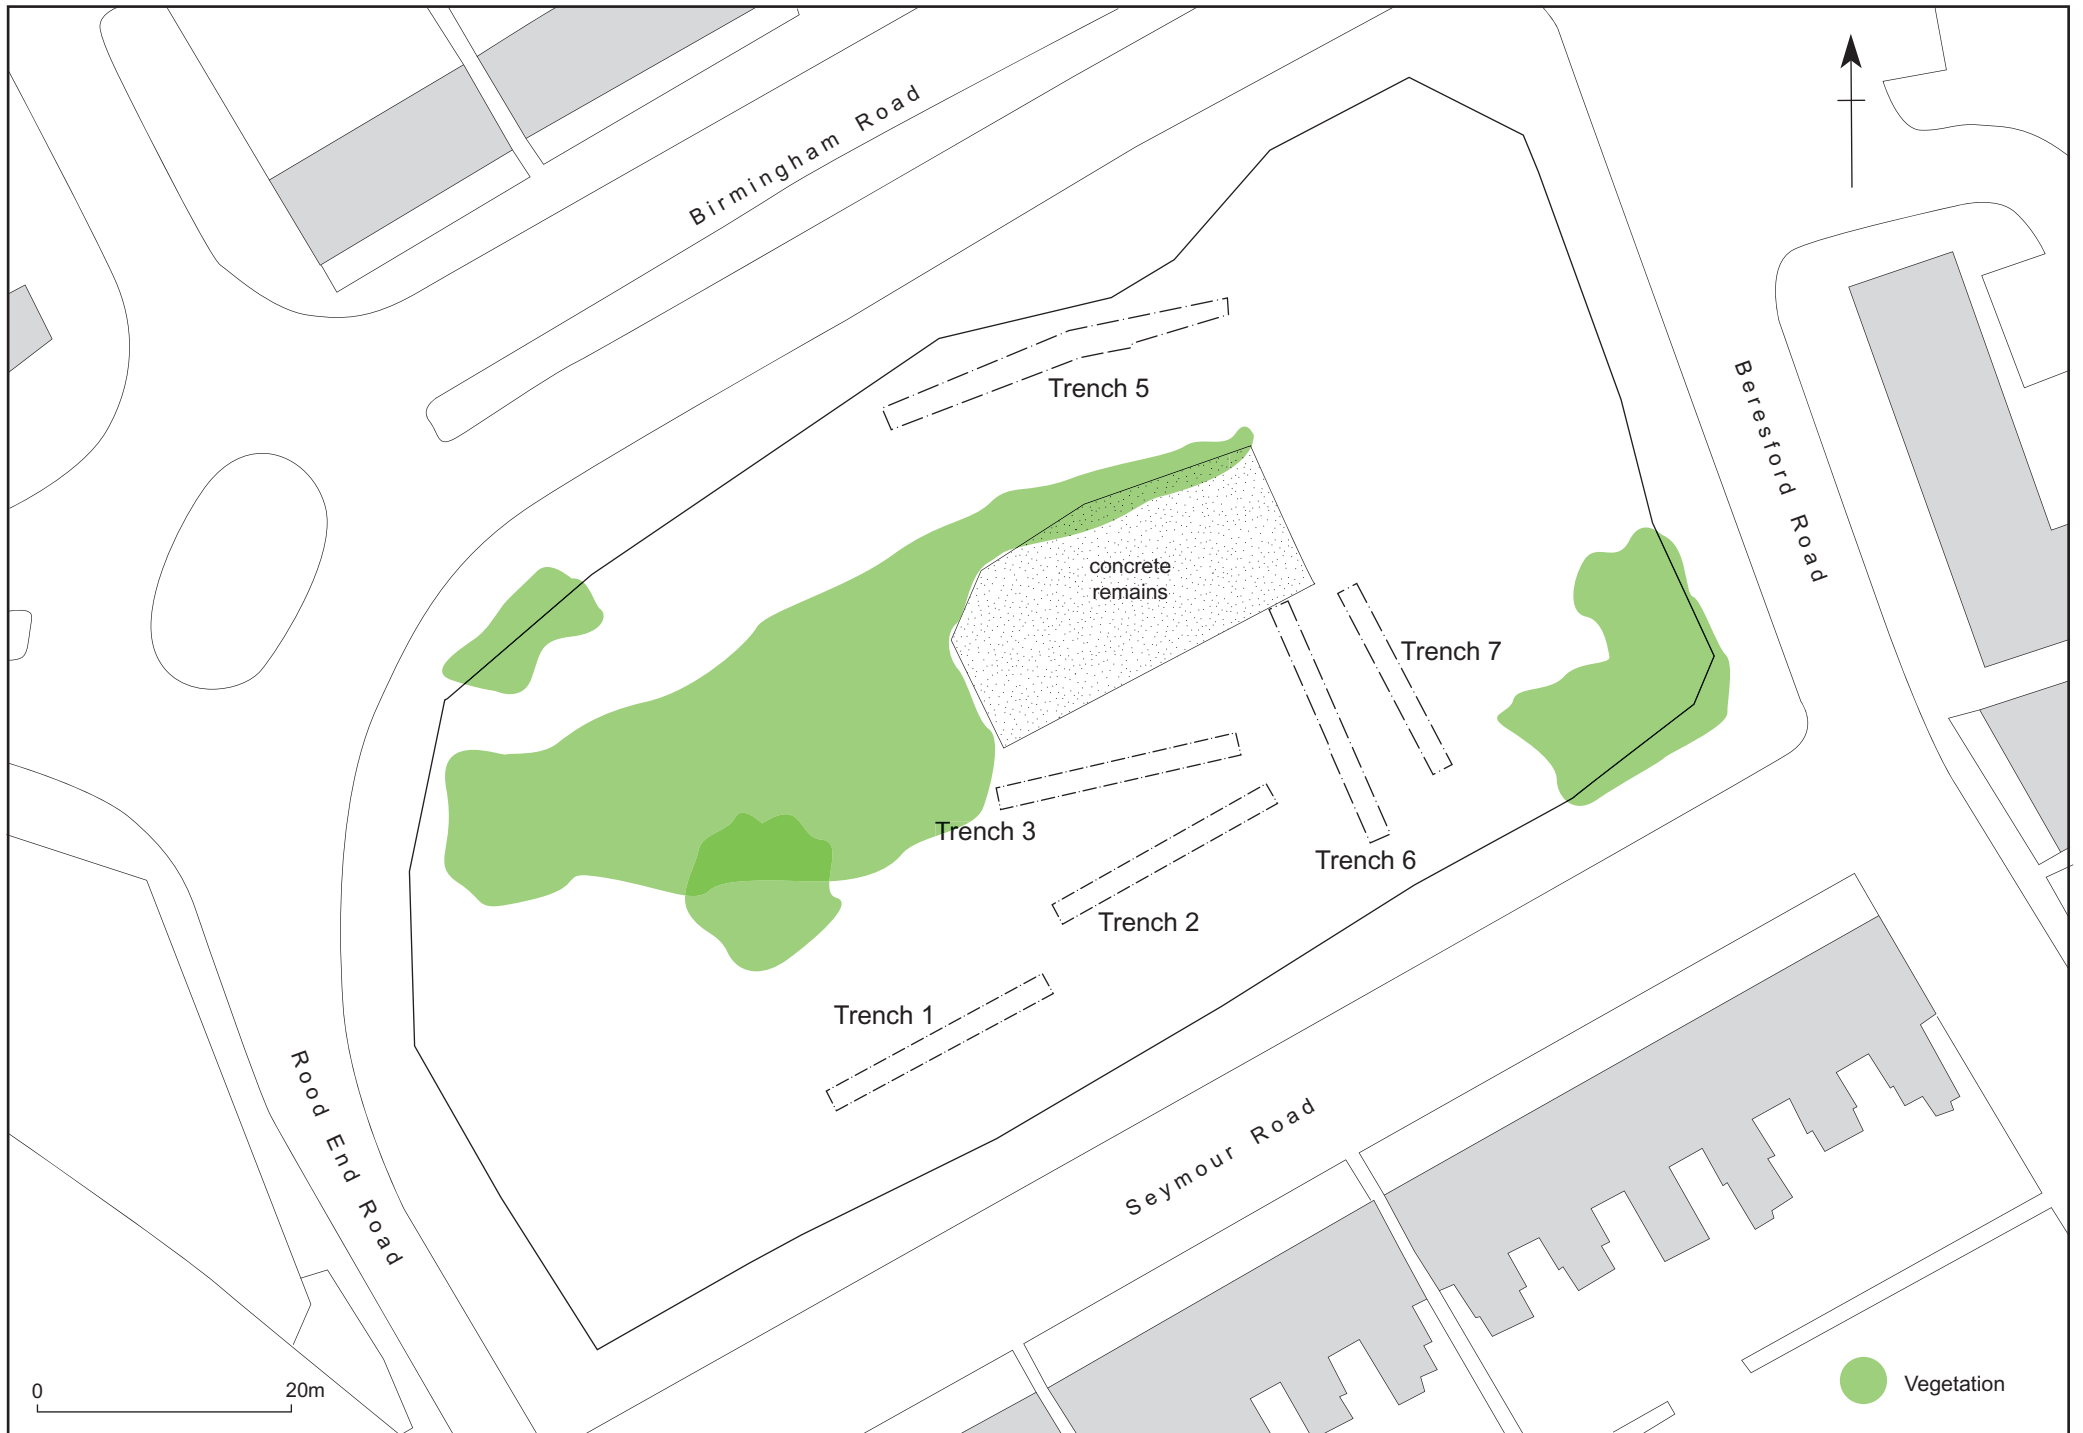
Fig.1

The site was located approximately 800m to the east of Oldbury town centre and was centred on Ordnance Survey NGR SP 0011 8934 (Fig. 1). The site occupied a currently undeveloped plot of land that was generally rectangular in plan and which comprised approximately 0.7 hectares. The northwestern boundary of site was formed by the Birmingham road, and the southeastern site boundary was defined by Seymour road.

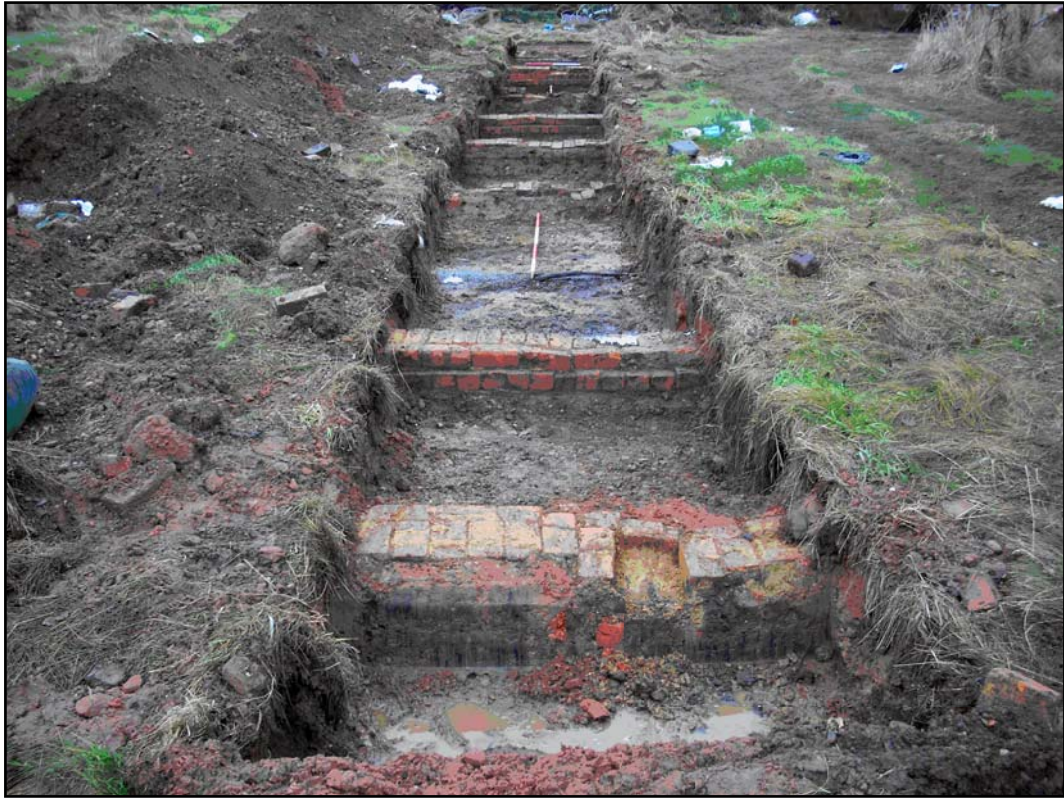
Plate 1: Trench 1, facing Southwest

Trench 1 was located at the southwestern corner of site and was aligned northeast to southwest. The trench was 20.2m in length and 1.6m in width and was excavated to a depth of 0.75m. A group of parallel early-20<sup>th</sup> century walls, aligned northwest to southeast, were exposed within this trench. These walls were the foundation walls of the rear of the properties fronting on to Seymour Road, first evident on the 3<sup>rd</sup> edition Ordnance survey map (Fig. 4).

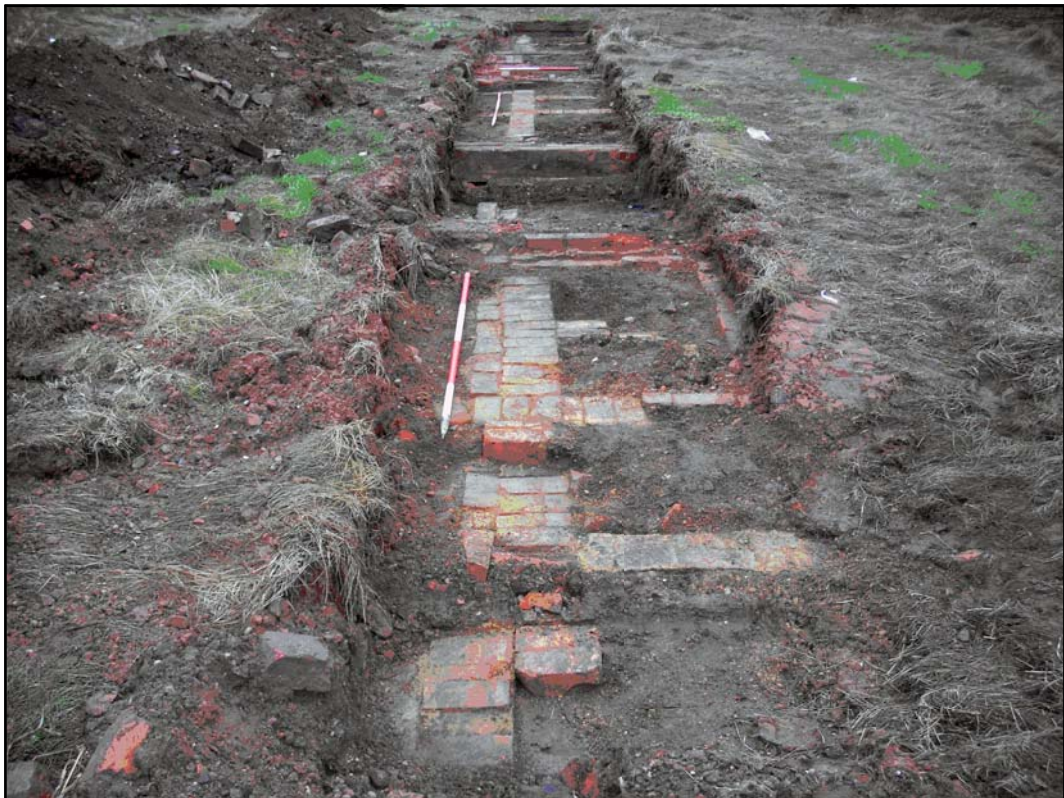
Plate 2: Trench, facing Southwest

Trench 1 was located at the southern half of site and was aligned northeast to southwest. The trench was 20m in length and 1.6m in width and was excavated to a depth of 0.35–0.7m. A collection of early-20<sup>th</sup> century walls comprising two phases of construction were exposed within this trench. These walls were on the same alignment as those exposed within trench 1 and represent the foundation walls of the rear of the properties fronting on to Seymour Road, first evident on the 3<sup>rd</sup> edition Ordnance survey map (Fig. 5). The structures include ceramic drainage pipes and truncated concrete flooring.

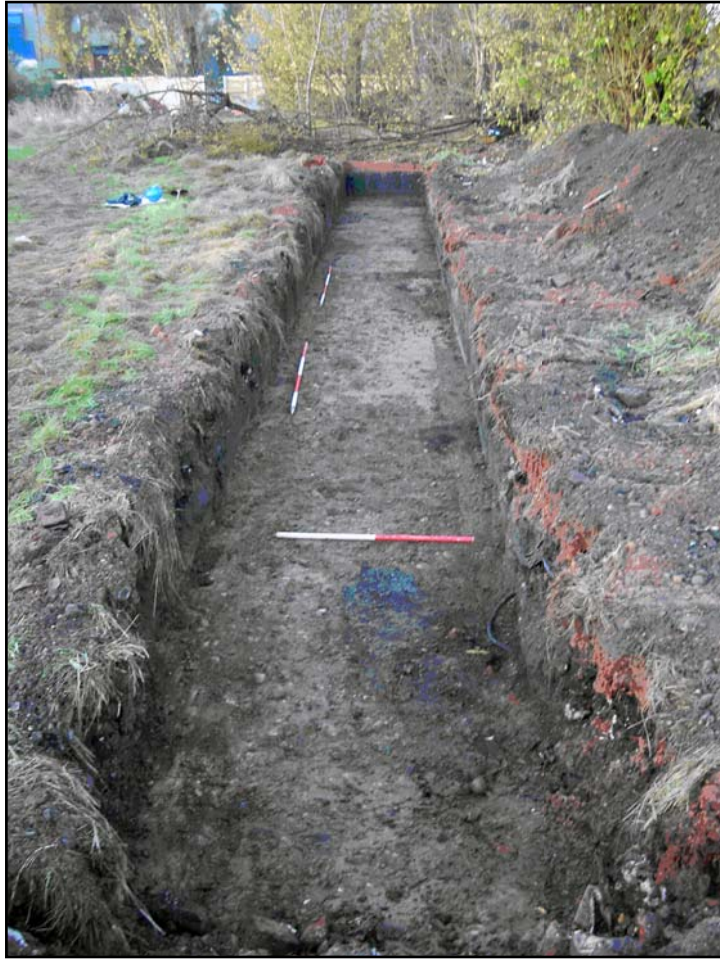
Plate 3: Trench 3, facing West

Trench 3 was located just west of the centre of site and was aligned northwest to southeast. The trench was 19.5m in length and 1.6m in width and was excavated to a depth of 0.8m. The trench was devoid of any structural deposits as it was situated within an area of relatively undeveloped land identified in the historic mapping. This area was between the boundaries of the back gardens of the residential properties and was therefore the most promising location for identifying earlier deposits. A group of modern intrusions were identified beneath the northern section of the trench. One residual sherd of medieval pottery was recovered.

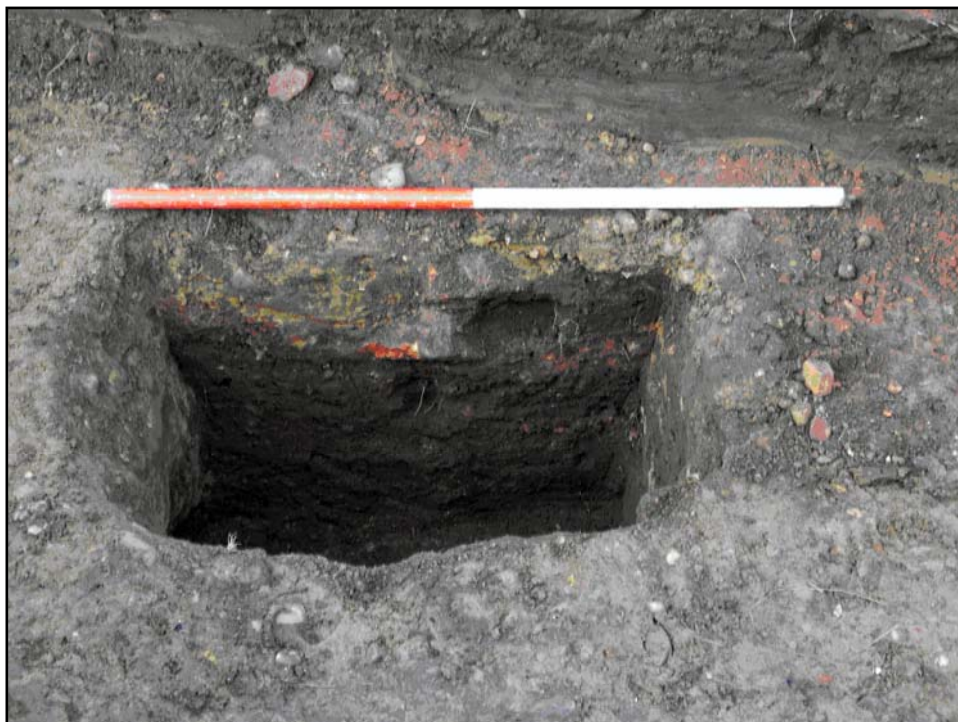
Plate 4: Trench 3, Pit 3006 facing North

At the northwestern end of the trench, beneath the northern section was a sub-square shaped cut (**3004**) which was filled with blackish brown sandy silt (**3003**). This irregularity of this feature makes it likely that this was a deeper stratified patch of subsoil. Further towards the centre of the trench was a regular rectangular cut (**3006**), with steep vertical sides. It was excavated to a depth of 0.6m but the base was not reached. The primary fill was mixed orange and dark brown silty sand (**3011**) and included 19<sup>th</sup>-century ceramics and a residual sherd of medieval pottery. The upper fill level (**3005**) was more mixed and included large amounts of building rubble. The purpose of the pit remained unknown. A further sub-square shallow pit (**3008**) was exposed further to the southeast along the trench. The fill contained degraded fabric and small animal bones covered by a black silty fill (**3007**). This probably represented a pet burial. A further rectangular cut (**3010**) was exposed at the southeast end of the trench. This was similar in form to that of pit **3006** but was filled by 20<sup>th</sup>-century domestic waste such as plastics, ceramics and building rubble within a mixed black silt (**3009**).

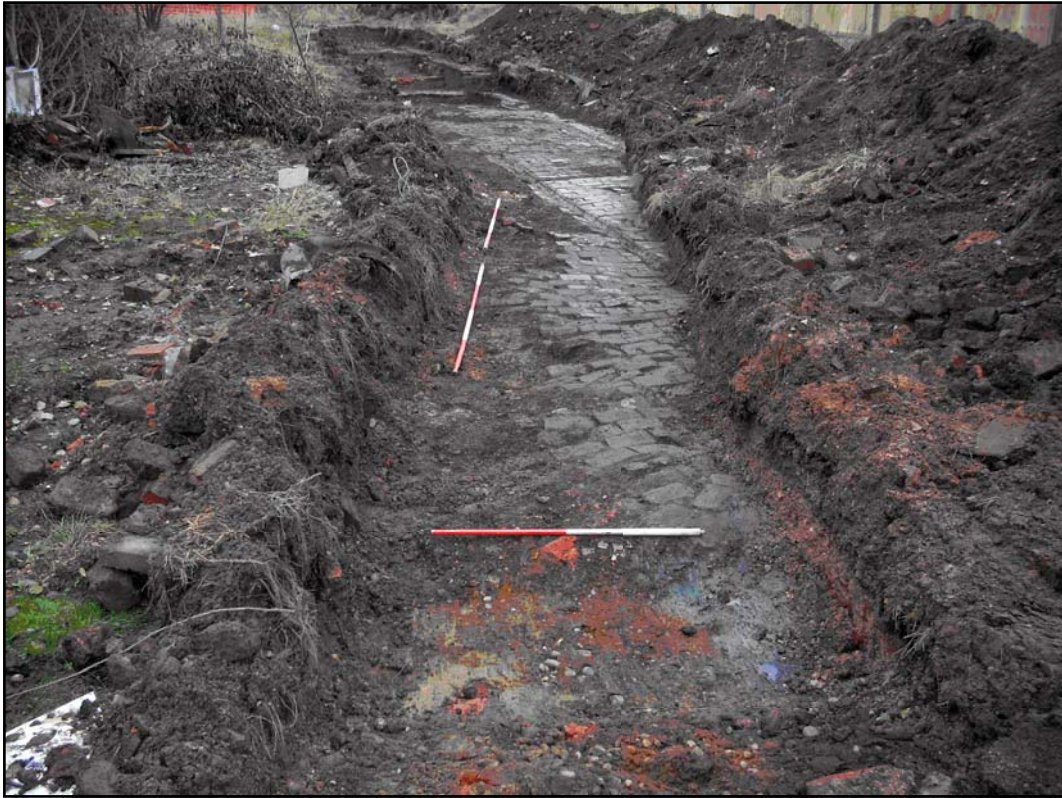
Plate 5: Trench 5, facing Northwest

Trench 5 was located on the northern side of site and was aligned northeast to southwest. The trench was 28.5m in length and 1.6–2m in length and was excavated to a depth of 1.2m. A group of late-19<sup>th</sup> century walls and brick yard surfaces northeast to southwest and northwest to southeast were exposed within this trench. These structures represented the foundation walls and associated yard surfaces of the properties fronting on to Birmingham Road first evident on the 1<sup>st</sup> edition Ordnance Survey map (Fig. 3).

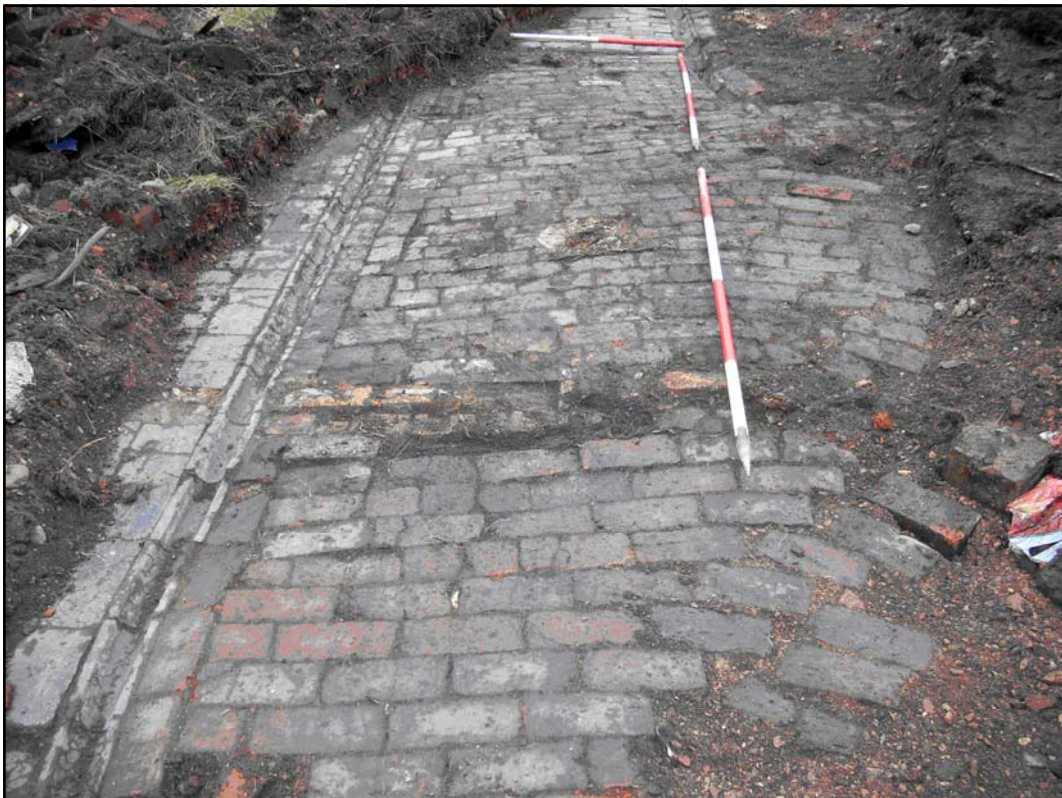
Plate 6: Trench 5, Yard surface 5001/5002/5003 detail, facing Northeast

Trench 5 provided evidence of structures dated to the late-19<sup>th</sup> century which were related to the residential properties fronting on to Birmingham Road. These structures took the form of foundation walls, regularly laid engineering brick yard surfaces with inlaid drainage channels. Salt glazed ceramic drains were also associated with these structures.

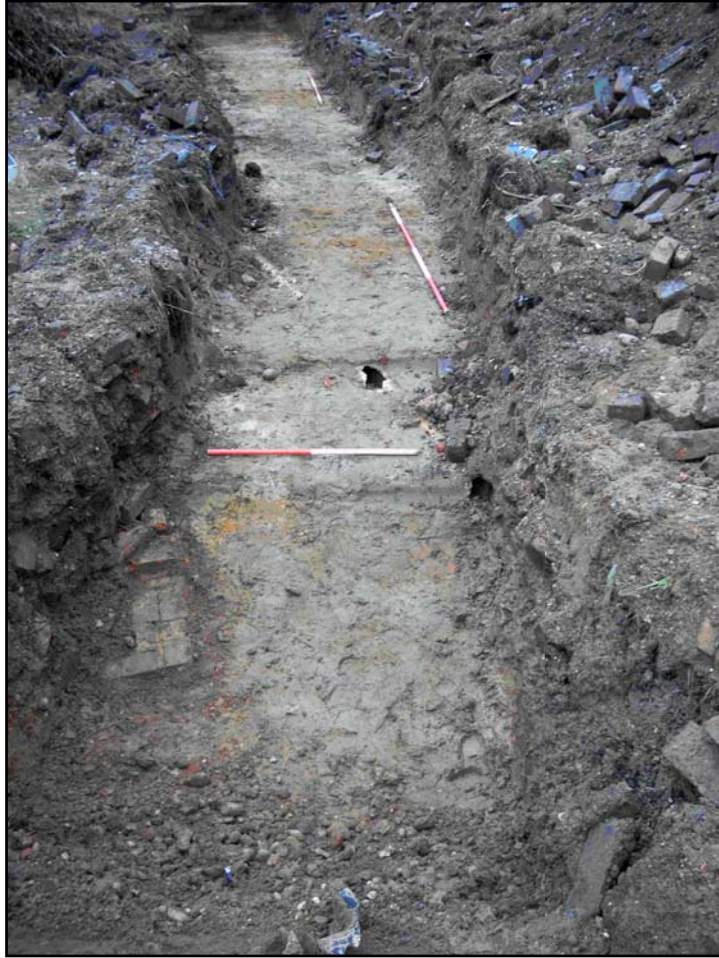
Plate 7: Trench 5, Northeast end of trench post removal of yard surface, facing Southeast

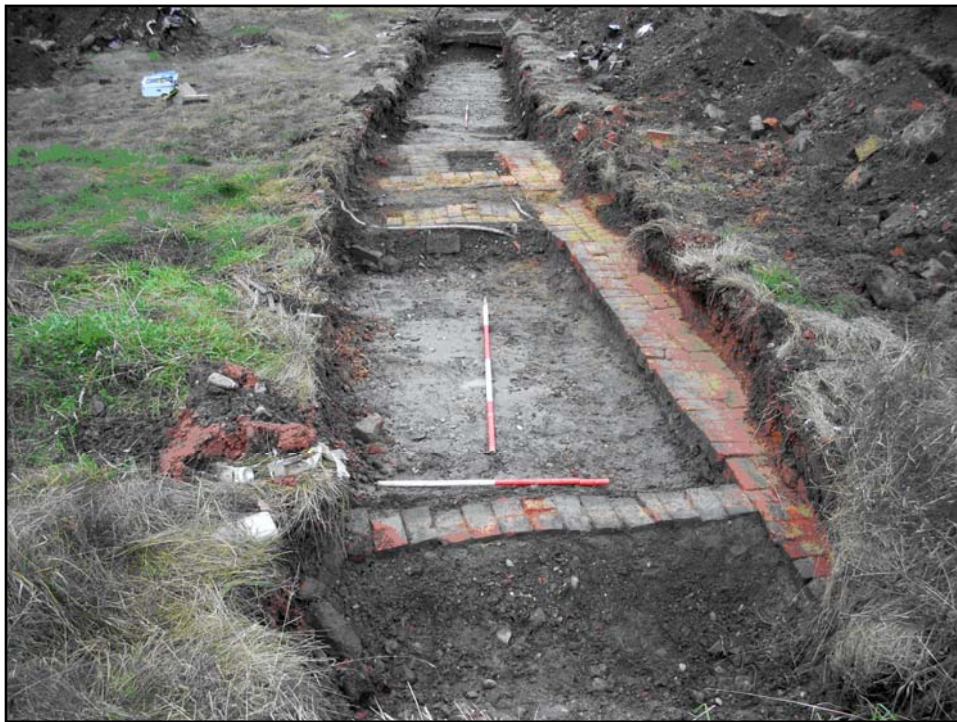
Plate 8: Trench 6, facing Northwest

Trench 6 was located towards the southeast corner of site and was aligned north to south. The trench was 20m in length and 1.6m in width and was excavated to a depth of 0.35–0.7m. A group of early-20<sup>th</sup> century walls, aligned northwest to southeast and northeast to southwest, were exposed within this trench. These walls were the foundation walls of the rear of the properties fronting on to Seymour Road, first evident on the 3<sup>rd</sup> edition Ordnance survey map (Fig. 5) and relate to the walls exposed in both trench 1 and 2.

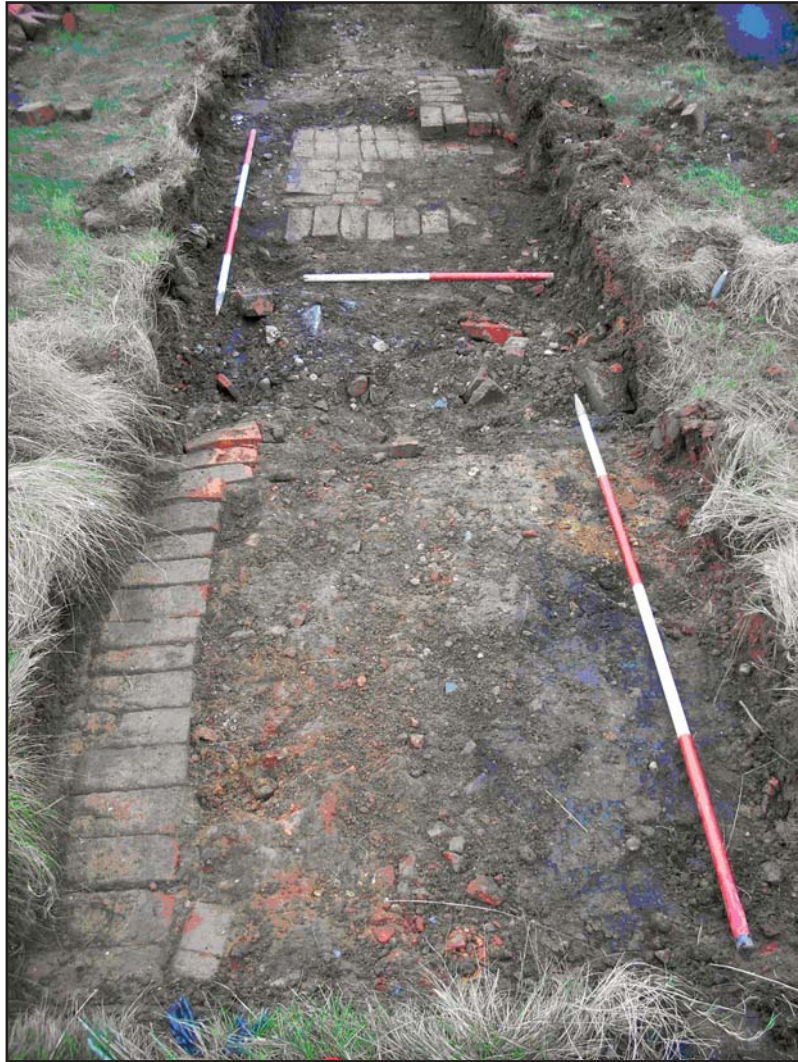
Plate 9: Trench 7, Southeast end of trench facing Northwest

A series of heavily truncated walls (**7004/7005/7006**) were situated at the northern end of the trench. These walls were aligned both northwest to southeast and northeast to southwest and were constructed of machine-cut unfrosted dark orange 3in bricks set in a cement base mortar within an English bond. At the northern end of the trench natural was overlain by a 0.2m thick layer of yellowish brown silty sand (**7013**). Several modern features cut into this and the natural layers. Pit (**7008**) was sub-circular, 1.5m in width and excavated to a depth of 0.7m. A post hole was noted in the southern edge. The pit was filled with modern garden soil and red sand (**7007**) with inclusions of modern domestic waste. A circular steel tank (**7010**) was situated north of this pit and was filled with a black silt (**7009**). A further linear feature (**7012**) was situated at the far northern end of the trench. This was again filled with modern domestic waste and rubble (**7011**). These features probably all relate to modern garden features and waste pits at the end of the gardens or possibly with the burial of waste after demolition and levelling.
