**Evaluation of Land to the  
West of Walsall Road,  
Great Wyrley, Cannock,  
Staffordshire**

**Project No. 1733**

## LAND TO THE WEST OF WALSALL ROAD, GREAT WYRLEY, CANNOCK, STAFFORDSHIRE

### AN ARCHAEOLOGICAL EVALUATION, 2007

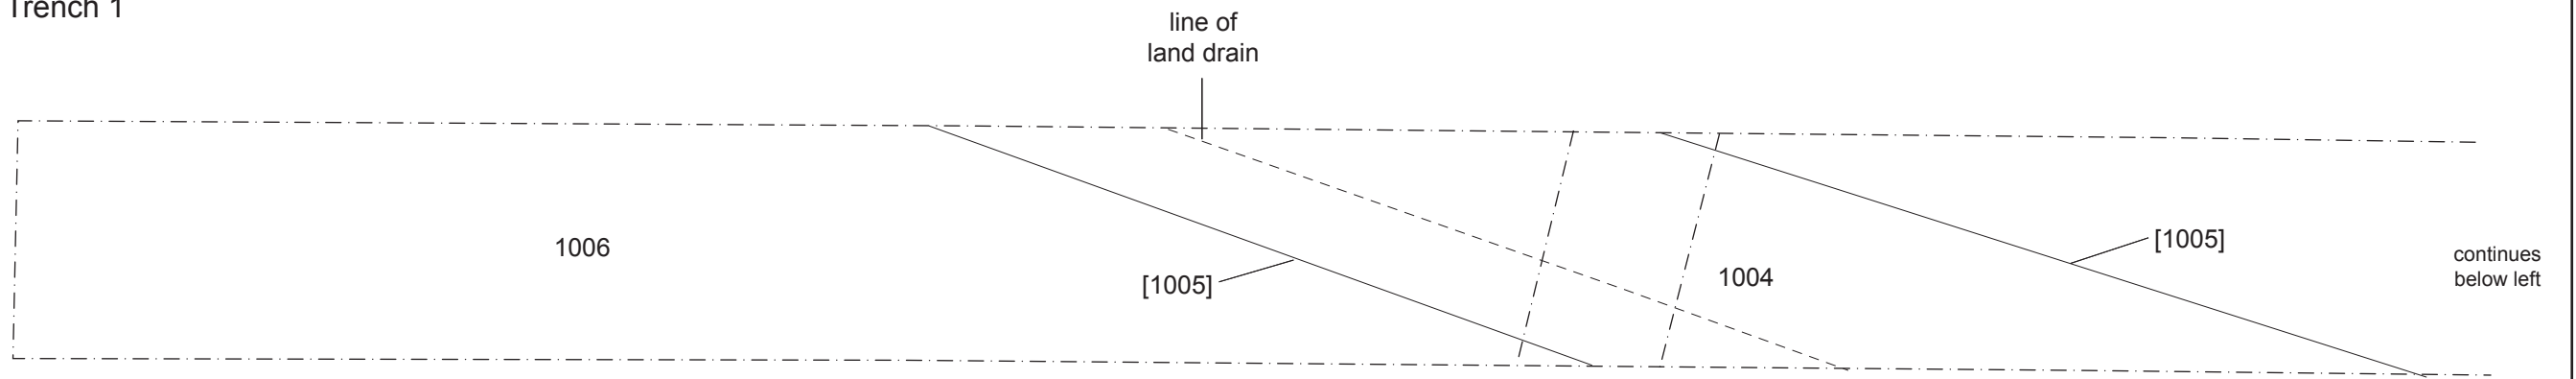
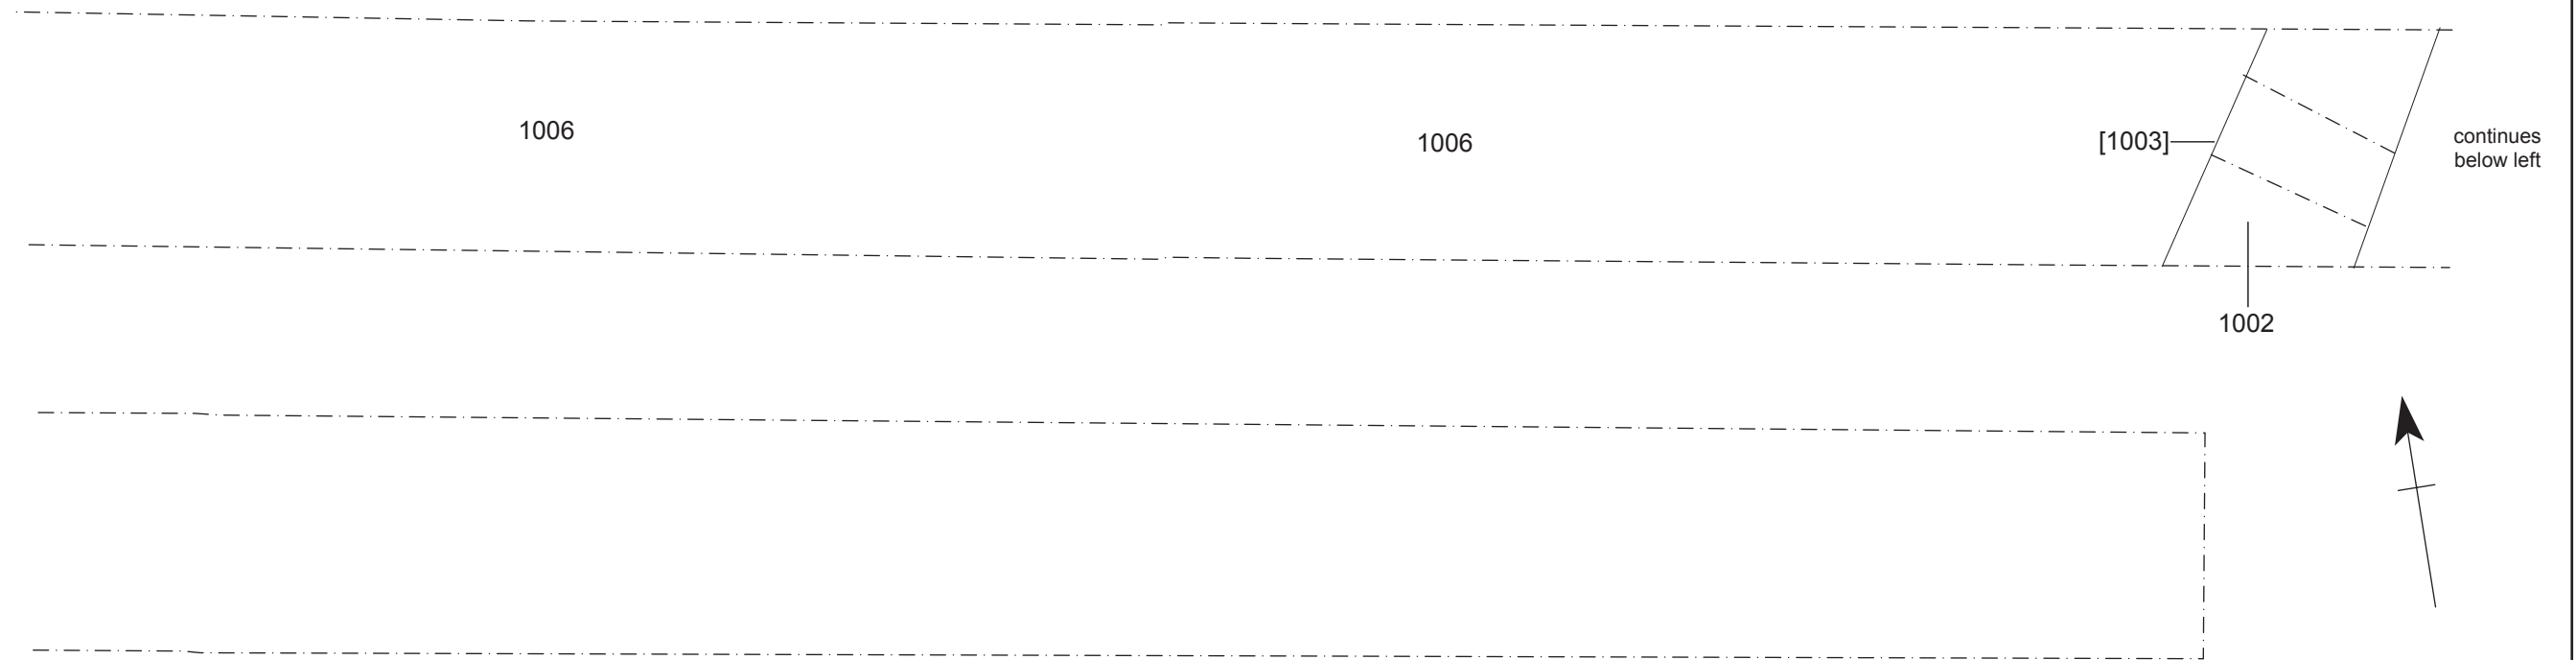
Fig.8

The trench contained two archaeological features both of which were associated with field irrigation. Towards the centre of the trench was a shallow linear gully **1003** orientated northeast to southwest, the fill of which was an orangey-brown, silty clay **1002**. A further linear drainage cut **1005** orientated northwest to southeast was present at the northwestern end of the trench. An arched ceramic field drain sat within the cut upon a base composed of flat slate and was surrounded by an orangey-brown, silty clay backfill deposit **1004**.

The features were covered by 0.2m of mid-dark brown, silt **1001**. There was a shallow lens of re-deposited coal and clinker between the silt subsoil **1001** and the topsoil **1000**, which was probably the result of dumping of material from the edge tool works. The trench was sealed by 0.25m of dark brown, silt topsoil **1000**.

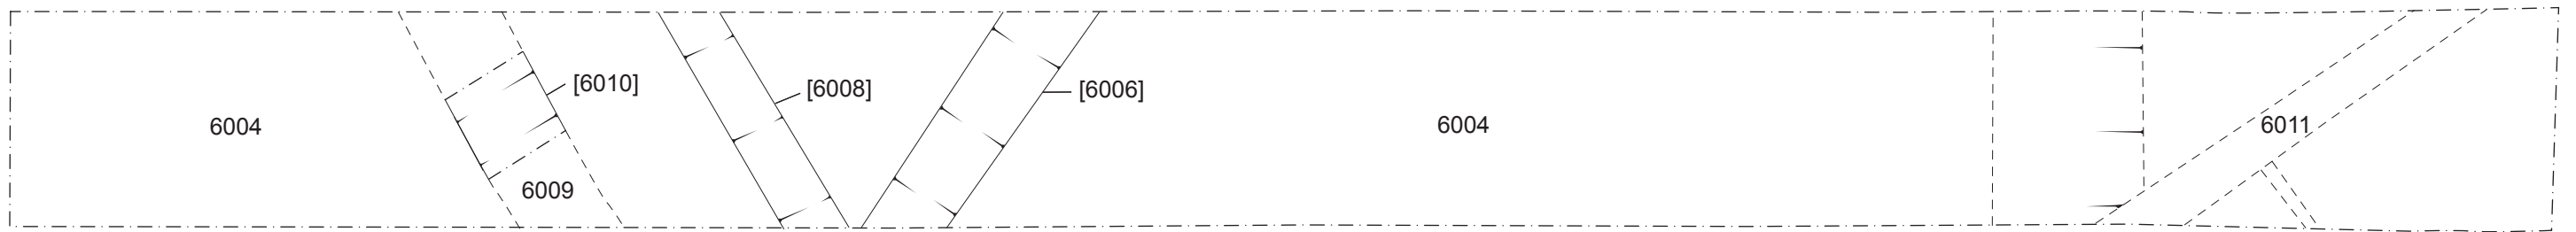
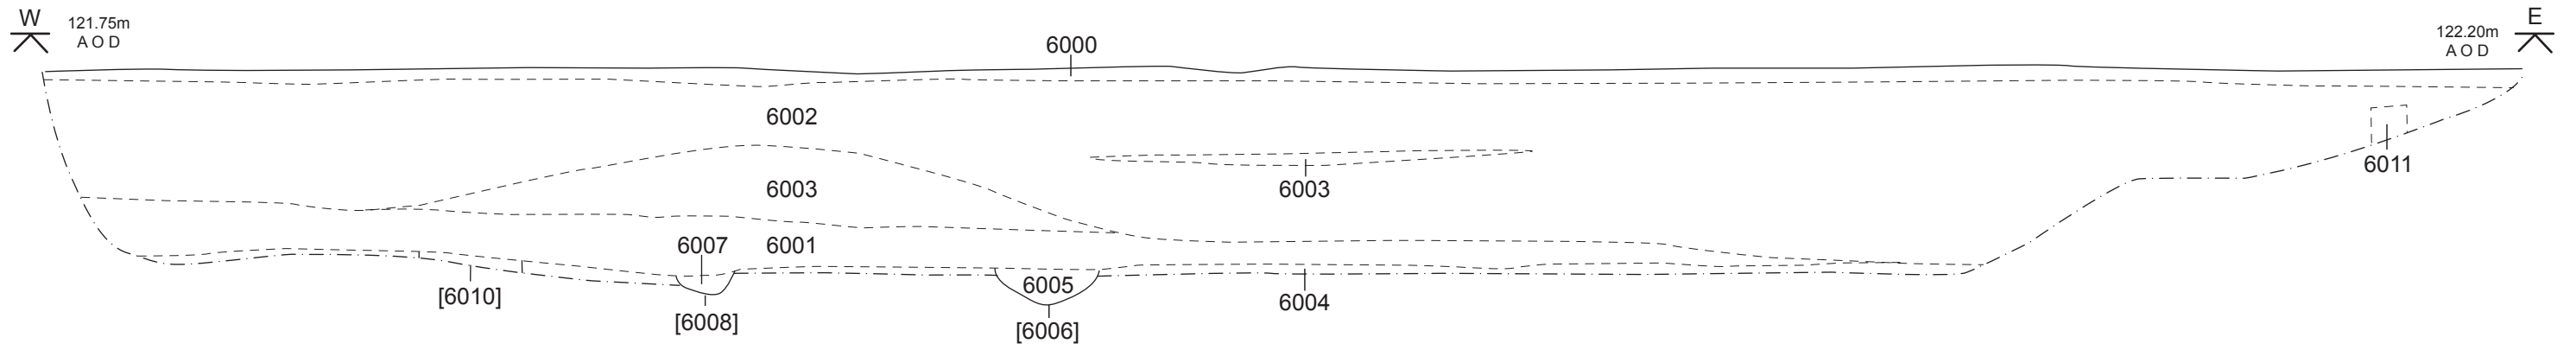
Fig.10

Cut into the natural sandy clay were three irregularly cut ditches, the purpose and date of which remained elusive. At the western end of the trench were two parallel ditches orientated northwest to southeast. Ditch **6008** was a linear ditch which was moderately sloped on the western side. It was filled with an accumulated deposit of mid-dark brown, sandy silt. Located parallel to this was ditch **6010**. This was a linear ditch which was moderately sloped on the eastern side. It was filled with a similarly accumulated deposit of light brown, silty sand **6009**.

Taken together these ditches may have been part of the same feature, between which may have been a shallow bank. A further u-shaped ditch **6006** was orientated northeast to southwest. This was again filled with an accumulated deposit of mid-dark brown sandy silt **6007**. None of the ditch fills contained any material evidence.

The natural clay was covered with an approximately 0.6m thick layer of orangey-brown, silty sand subsoil **6001**, upon which were successive layers of dark blackish brown silt, slag and demolition material overburden **6002**. This layer also contained a distinct, dumped layer of pale creamy orange degraded brick and limestone **6003**. Set into the levelling deposits at the eastern end of trench was a wall **6011** orientated northeast to southwest. The wall was constructed of machine-cut, unfrogged 3 inch bricks set in a stretcher bond within a cement based mortar.

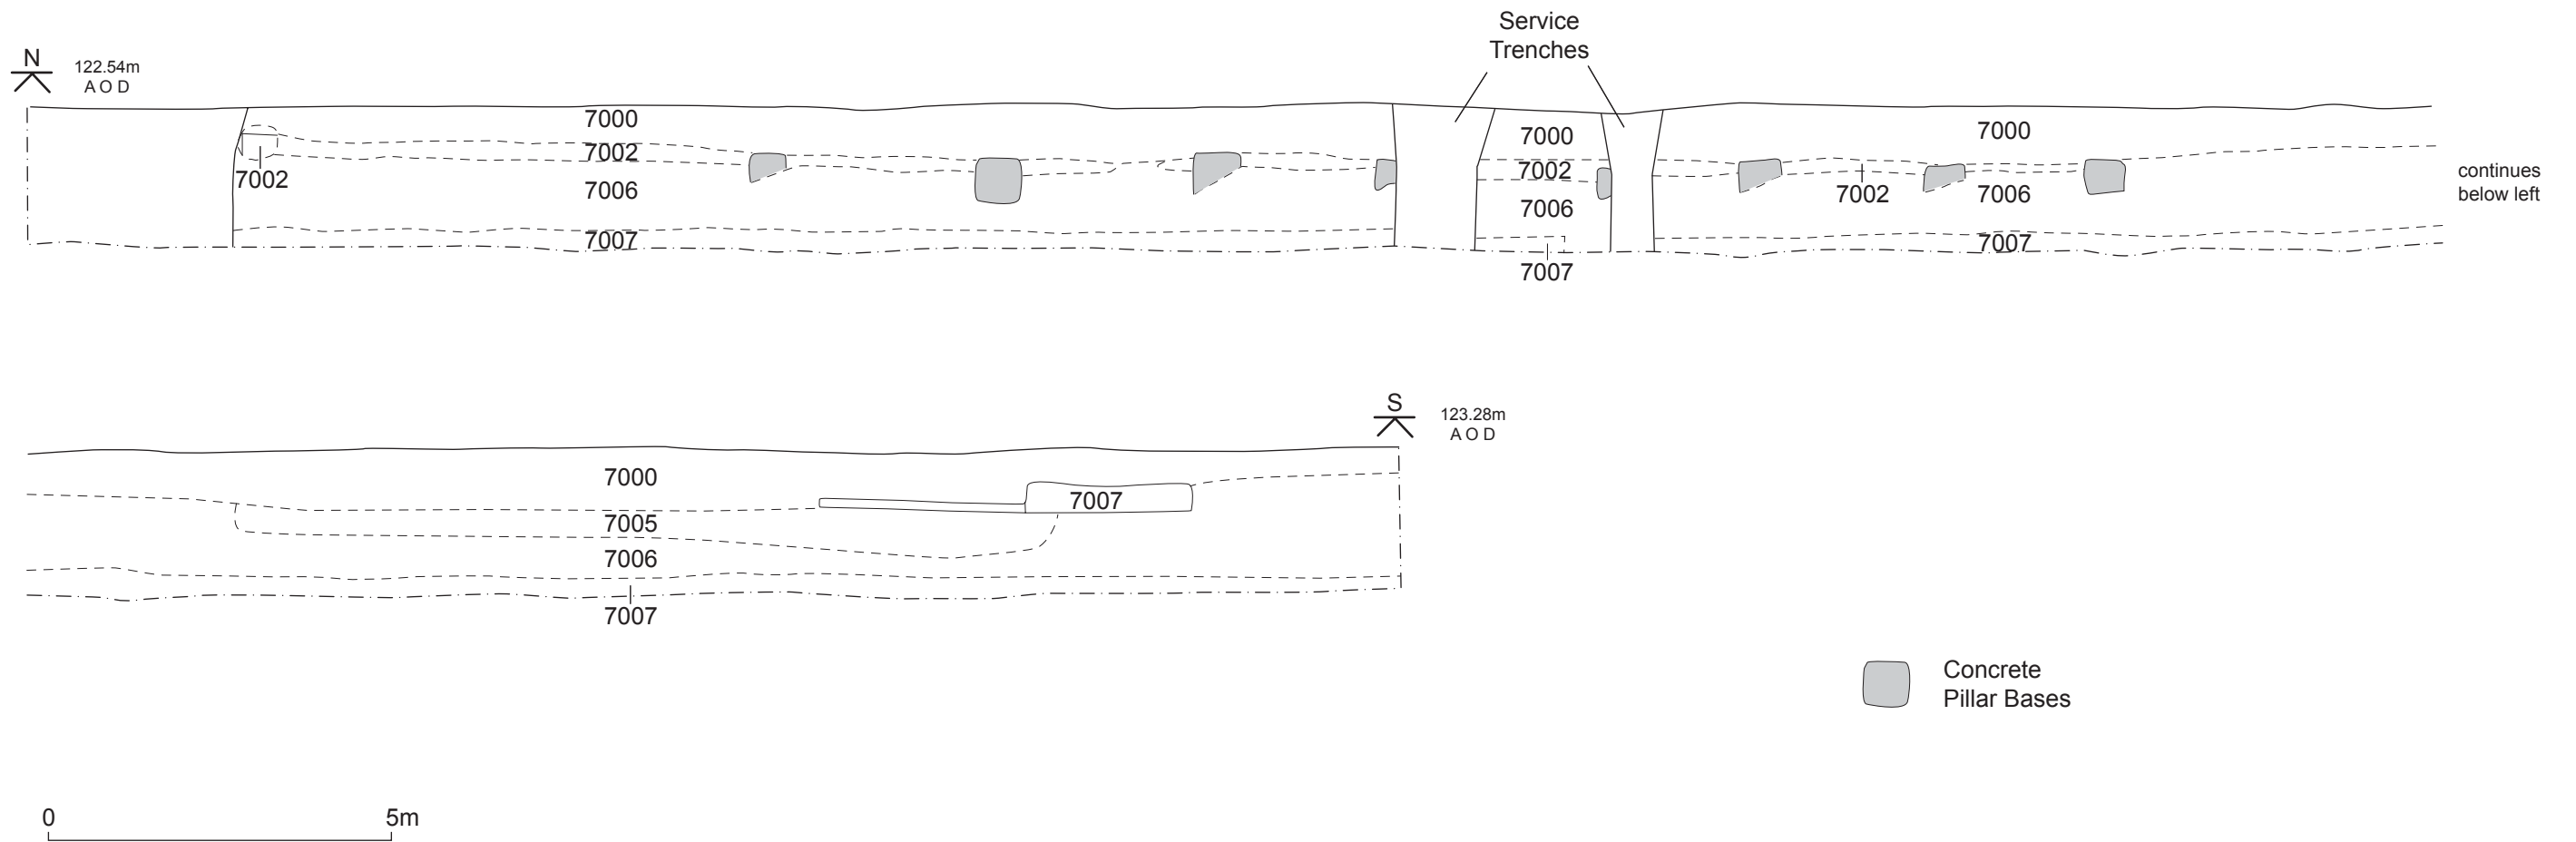
Fig.11

Above the natural clay was a 0.2m thick layer of mid brownish-grey, silty clay alluvium **7007**. This was overlain by a dark black silt and coal levelling layer **7006**. This was primarily composed of waste from the edge tool works situated in this area. This was then overlain by thick lens deposits of mixed orange and grey demolition rubbles **7003/7005** composed of crushed brick, mortar and silt. A fragment of sandstone grindstone was found within this deposit (See 7.2, plate 10) which was directly related to the functioning of the edge tool manufactory. Constructed above these demolition horizons was a truncated wall orientated north to south **7004**. It was constructed of machine-cut, unfrogged 3 inch red bricks set within a cement based mortar. A series of concrete foundation pads **7002** aligned north to south were set into deposit **7006**. Associated with these foundations was a thin concrete floor surface **7001**. This demolition layer and construction of a building with concrete foundations and floor relate to a secondary period of construction post-dating the main period of manufactory construction.

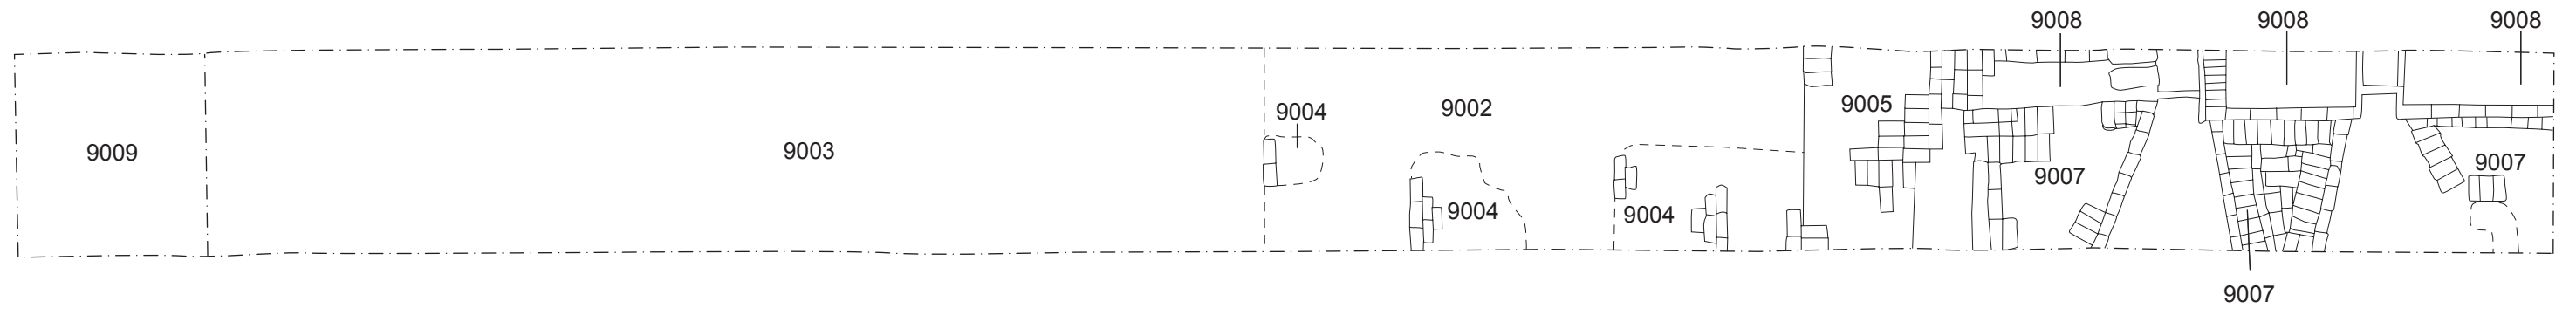
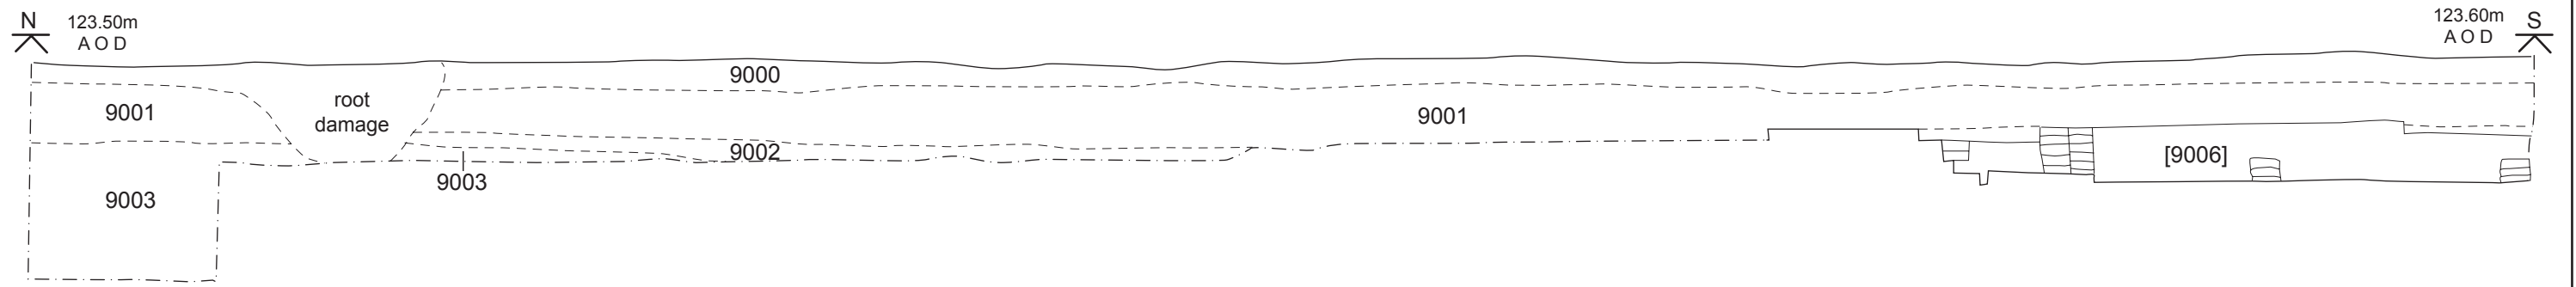
Fig.12

In the northern half of the trench, natural was overlain by a black, sandy clay **9003** contaminated by coal and industrial waste. This constituted a levelling layer after the demolition of the edge-tool manufactory. Part of this structure was observed at the southern end of the trench arranged in a series of triangular brick walls **9007**. These walls had been truncated down to the foundations and only 2-4 courses remained. These walls were constructed of machine-cut, unfrosted 2¼ inch red bricks set in a cement based mortar within a random foundation bond, the date of which can be speculated at early to mid-19<sup>th</sup> century. These walls were bonded in to an L-shaped section of wall **9005/9006** which was composed of the same materials. Inserted vertically into wall **9006** were two iron I-bar type structures, situated at the meeting point between the triangular sections of walls. The base of these walls was composed of a 0.03m thick level of compacted mortar **9008**. Taken together these walls made up what appeared to be the possible location of forging hearth flues. The northern wall of this structure **9005** had the remains of an external yard surface on its northern side. The surface was constructed upon a thin (0.15m), layer of crushed rubble and cement **9002** and was composed of machine-cut, unfrosted 3¼ inch red bricks **9004** laid in a simple stretcher pattern.

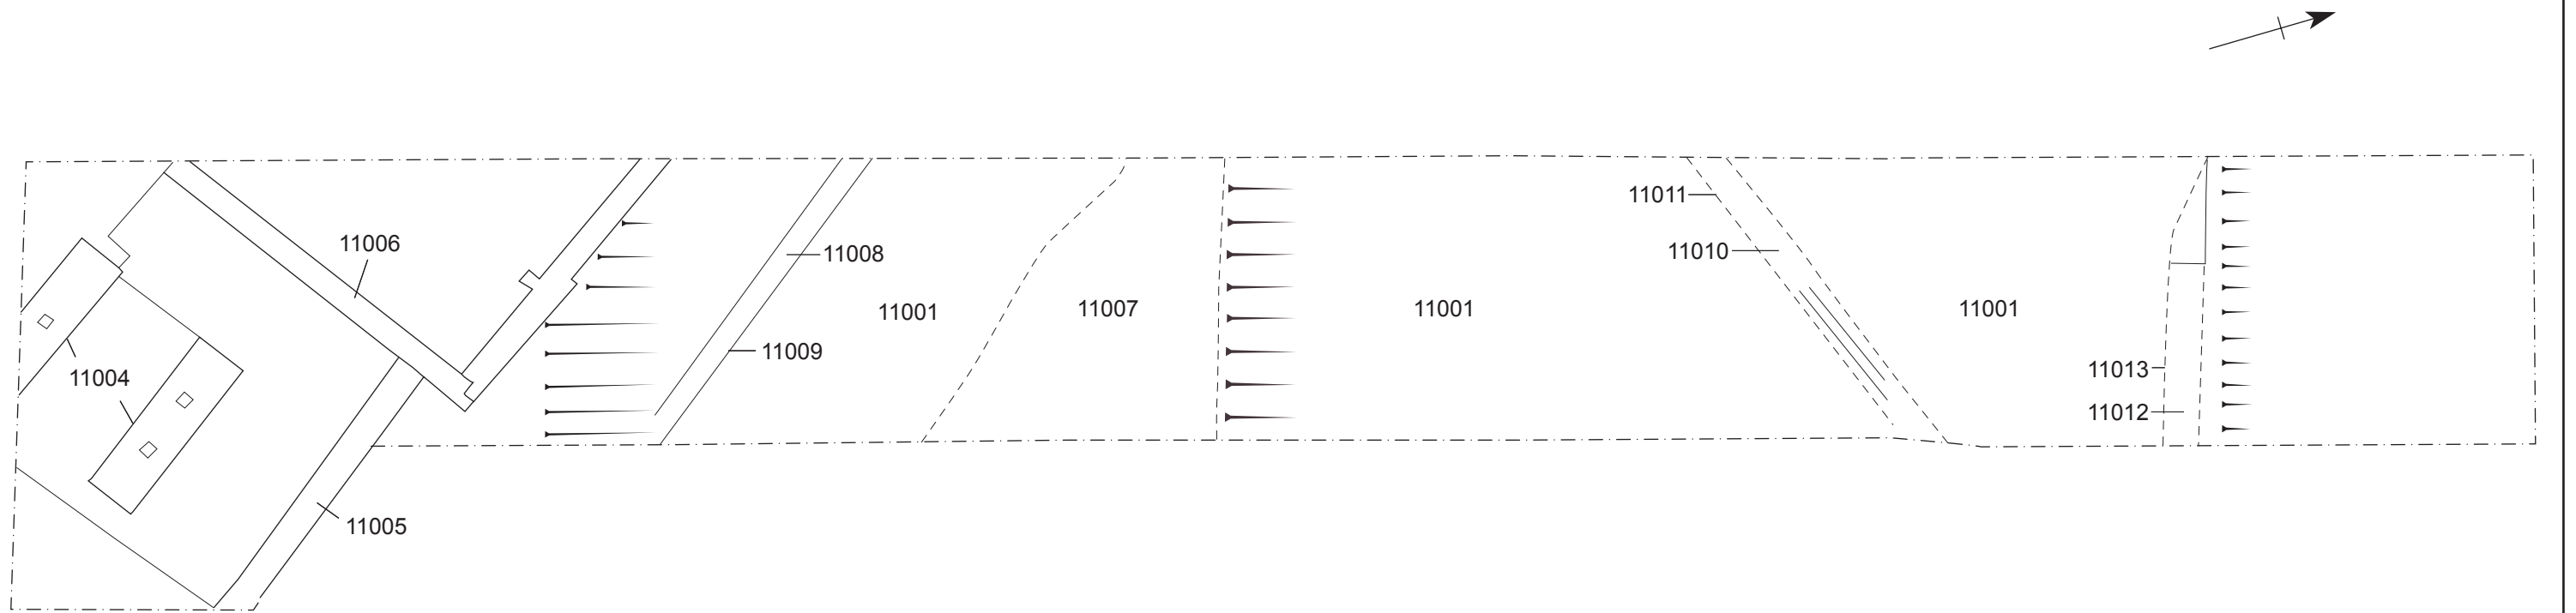
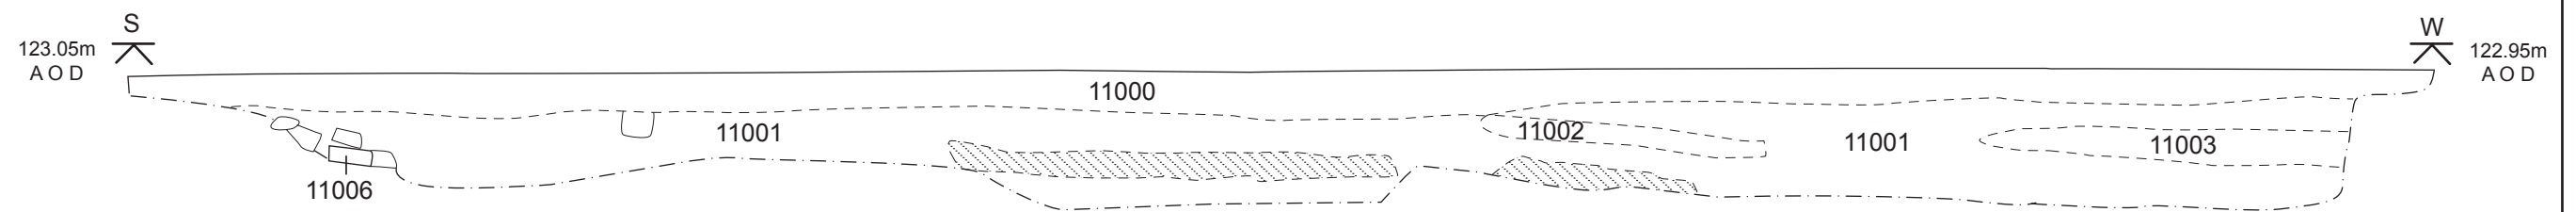
Fig.13

reconstruction and site development was identified in trenches 9, 10 and 11. This predominantly consisted of replacement of brick with concrete (such as the floors within trench 11). Evidence of various phases of building were also apparent and different periods of brick build were clearly evident.

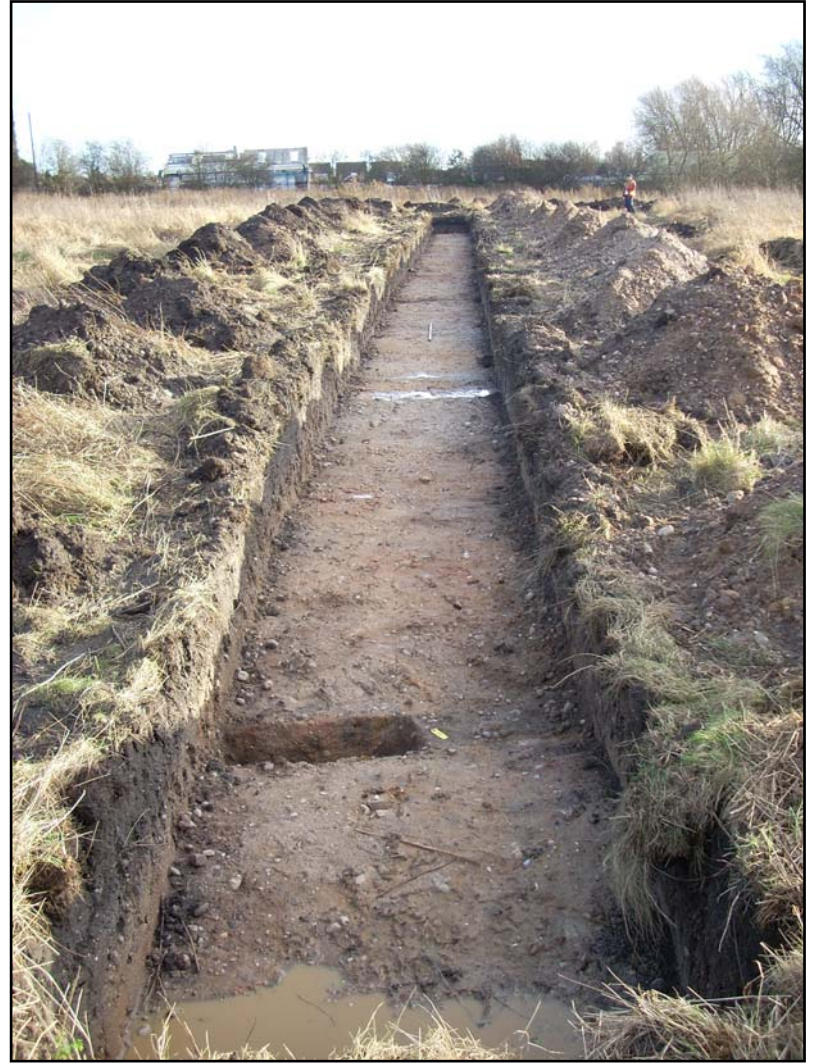
Plate 4

The trench contained three archaeological features, all of which functioned as field irrigation. These three features were ceramic field drains; each was constructed in a similar way, from identical materials. At the north end of trench was a northeast to southwest orientated field drain, set within a vertically sided linear cut **2003** and covered by light brown sandy silt **2002**. A further land drain situated in the centre of the trench was orientated northeast to southwest and was set into a vertically sided linear cut **2005** and covered by light brown, sandy silt **2004**. At the southern end of the trench was an east to west orientated, vertically sided linear cut **2007** into which was set a ceramic field drain. This had been covered by a light brown, sandy silt fill **2006**.

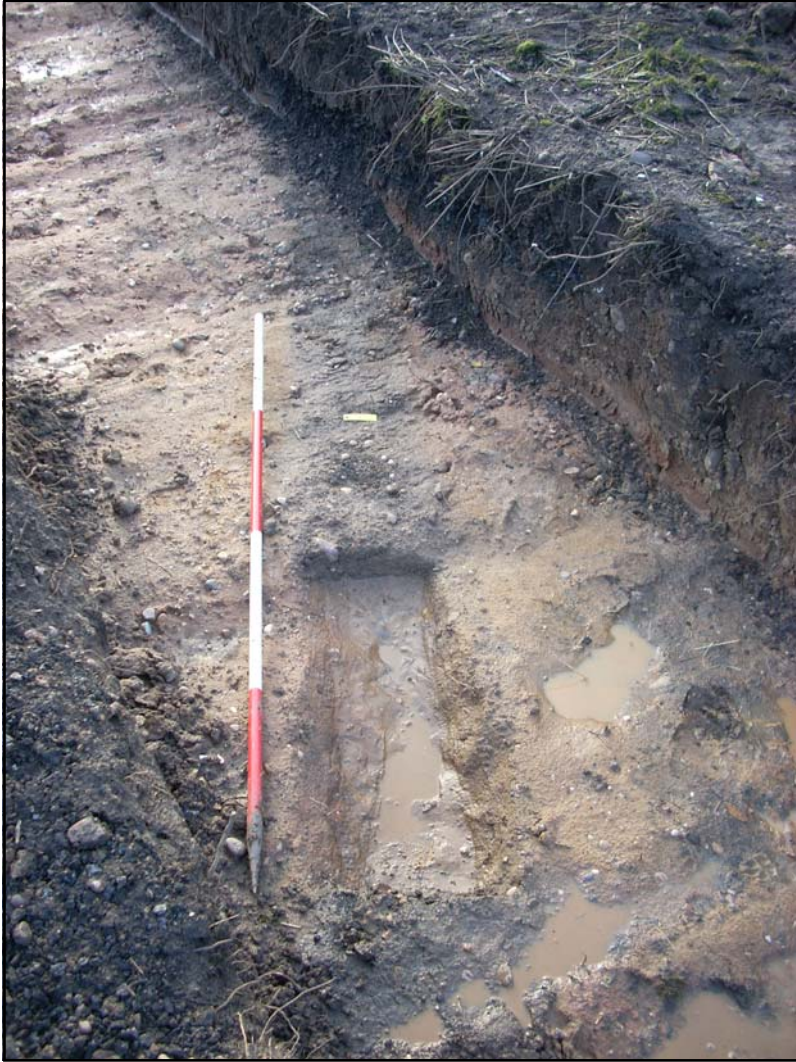
Plate 5

Only one archaeological feature was exposed within this trench. Situated within the centre of the trench was a northeast to southwest orientated vertically sided linear gully cut **3003** within which was set a ceramic field drain. The cut had been backfilled by a deposit of light brown, sandy silt **3002**. An assemblage of 19<sup>th</sup> century ceramics dated the construction of this feature (See 7.1).

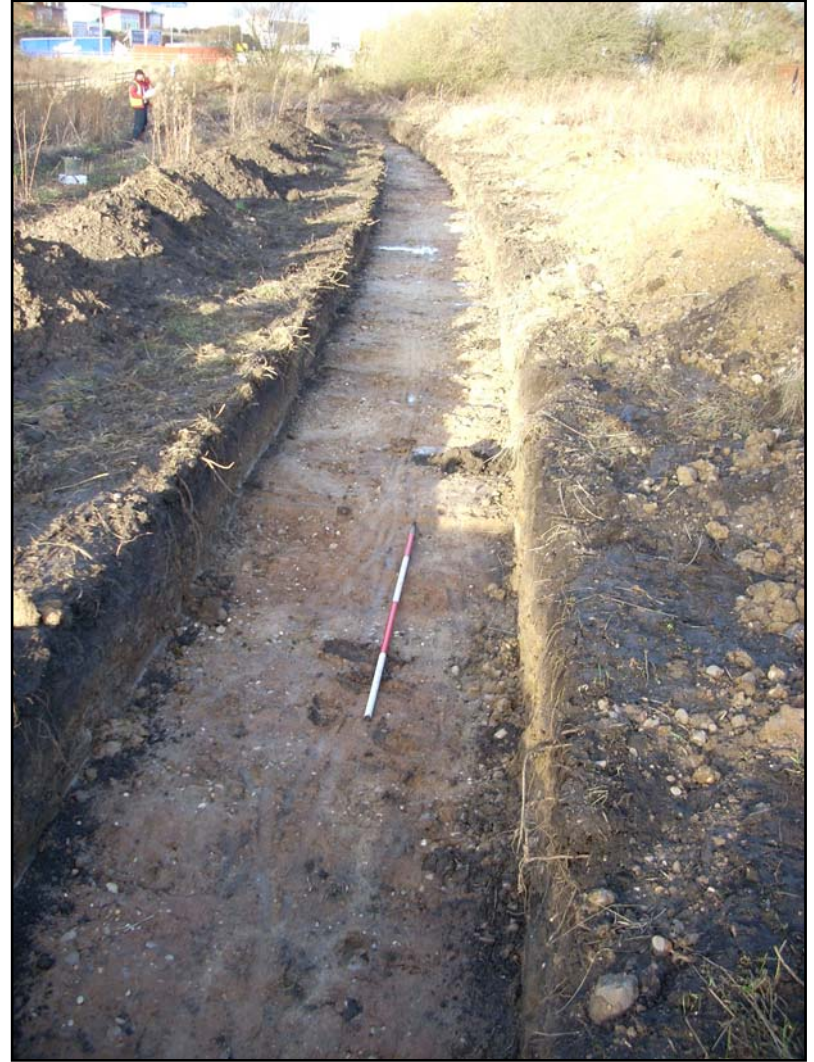
Plate 6

The trench was devoid of any archaeological features or cultural inclusions. The trench deposits consisted of a 0.15m thick mid brown, silt subsoil layer **4001** beneath a dark brown, organic silt topsoil **4000**. Two sherds of un-stratified ceramics were found associated with this trench (see 7.1).

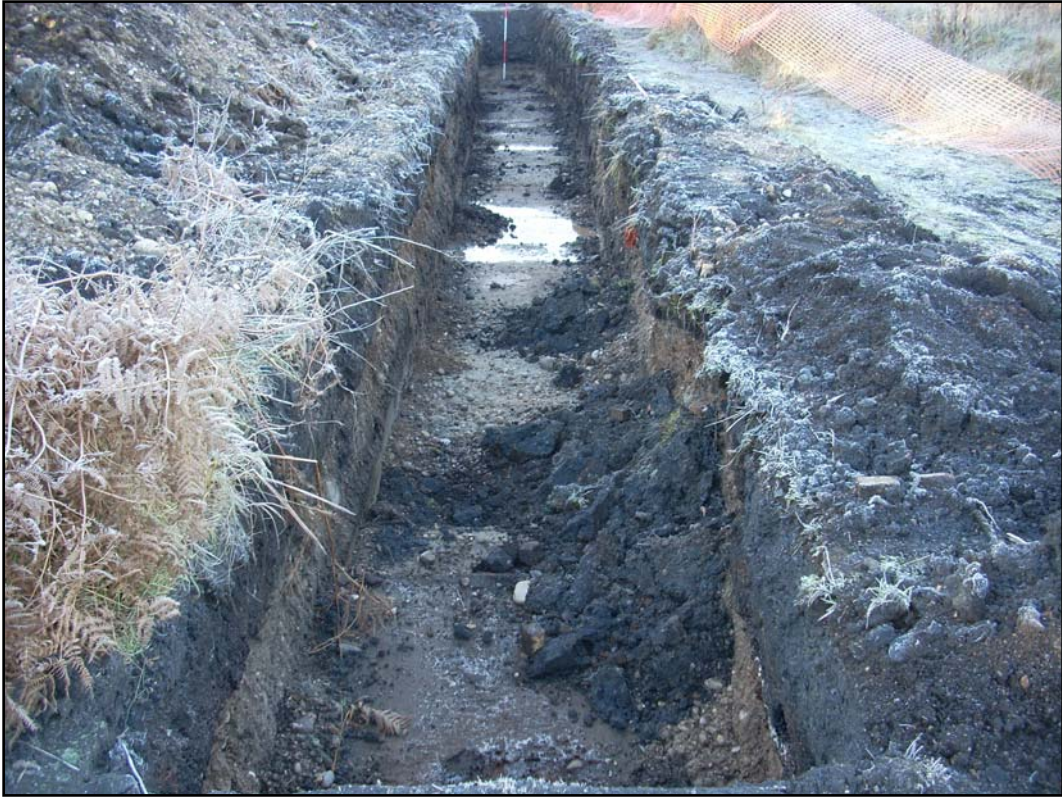
Plate 7

Only one tentative archaeological feature was identified this was a small circular patch of burning **5003**, possibly the location of a small bonfire. This patch had been burnt into the subsoil layer. This was a 0.6m thick deposit of pale orangey-brown, silty sand **5001**. The trench was sealed by a thick (0.6m) layer of topsoil **5000** which was mixed with successive layers of overburden dating to the period of the edge-tool manufactory.

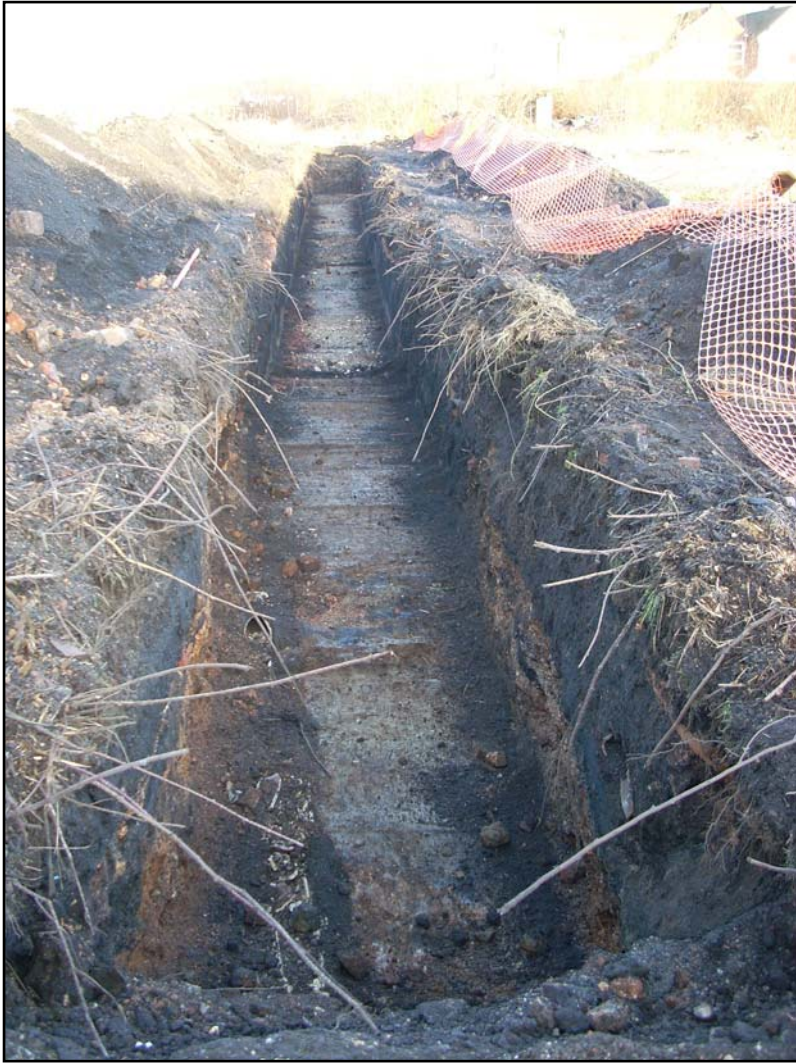
Plate 11

Above the natural clay was a dark black silt layer with coal inclusions **8001**. This was spread across the entire trench. Cut into the natural aligned northeast to southwest was a ceramic salt glazed drain set into a linear cut **8008** and surrounded by a dark black, silt and clay deposit **8007**. At the western end of the trench above the natural was a yellowish-orange demolition layer **8003** which was composed of brick fragments and gravel. Two further smaller lenses of demolition material were exposed towards the centre and eastern ends of the trench **8002/8004/8005**. Again these were composed of brick fragments, gravel and silty-sand. A section of steel drive shaft was found within these demolition layers (see 7.2, plate 15)
