**Wellesley Court,  
Wellington, Somerset**

**Built Heritage  
Assessment**

**Project No. 1737.1  
March 2008**

**Wellesley Court, Wellington, Somerset  
Built Heritage Assessment**

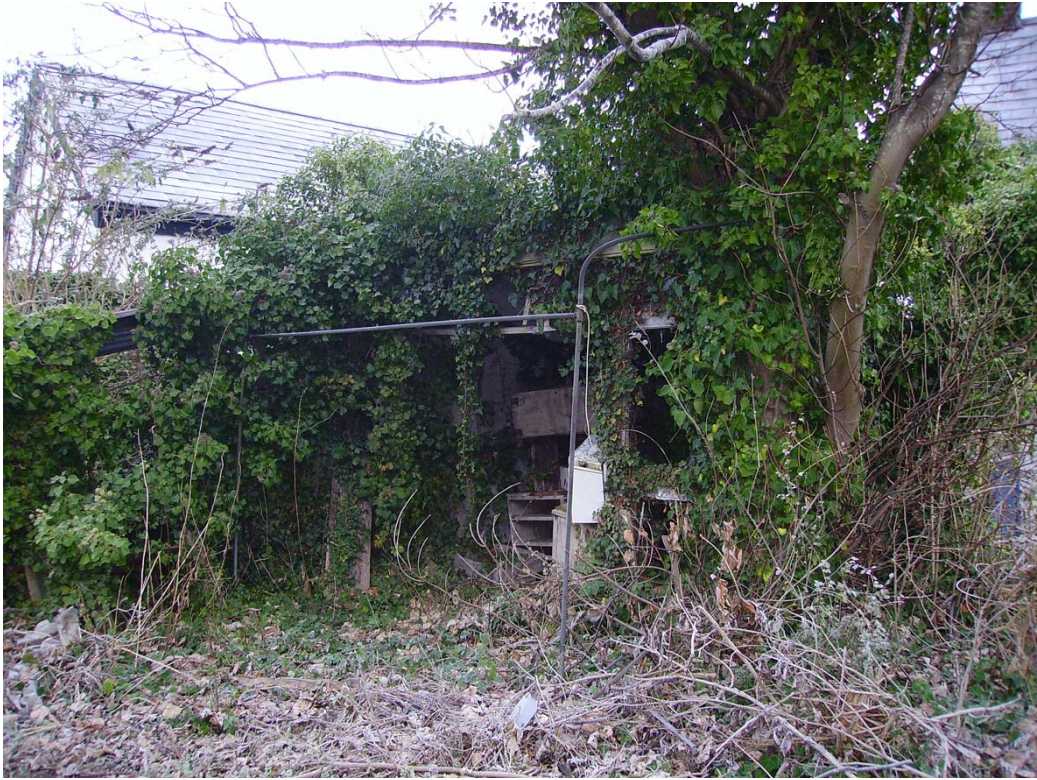
Fig.2

Mid-20<sup>th</sup>-century single-storey shed. Timber framed with corrugated asbestos wall cladding and roof. Aligned northwest-southeast facing southwest and open fronted.

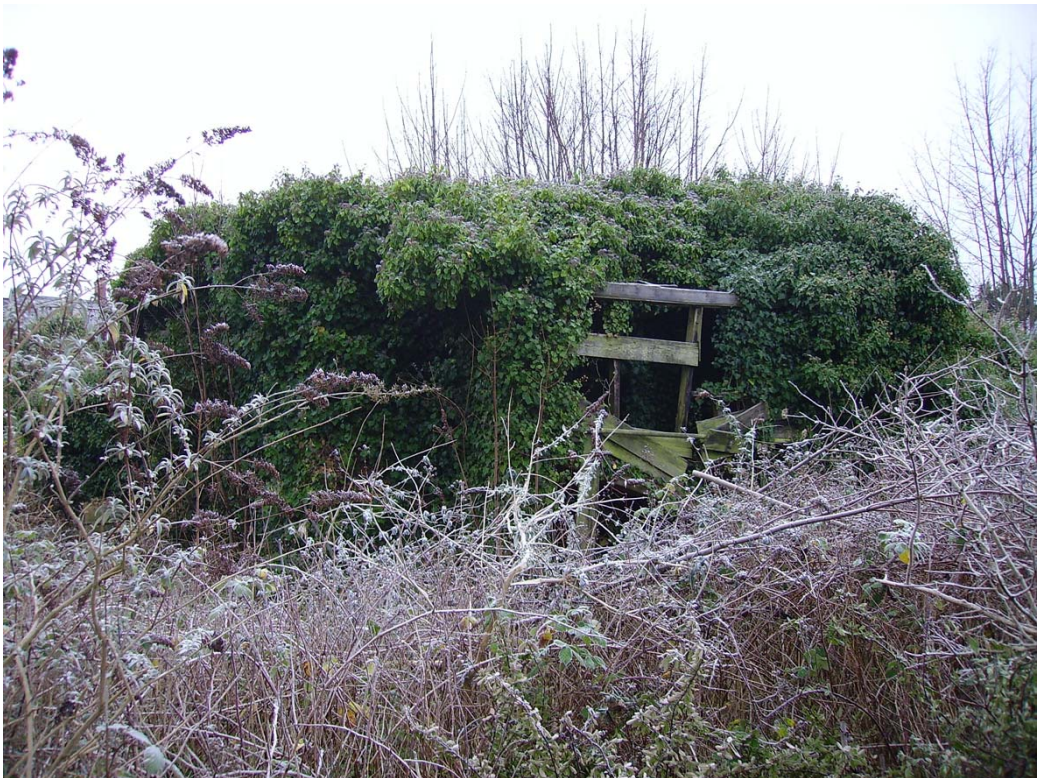
Fig.3

Row of early to mid-20<sup>th</sup>-century single-storey lean-to outbuildings aligned northeast-southwest facing northwest and set within the angle formed by two garden walls. Timber framed with corrugated iron wall cladding.

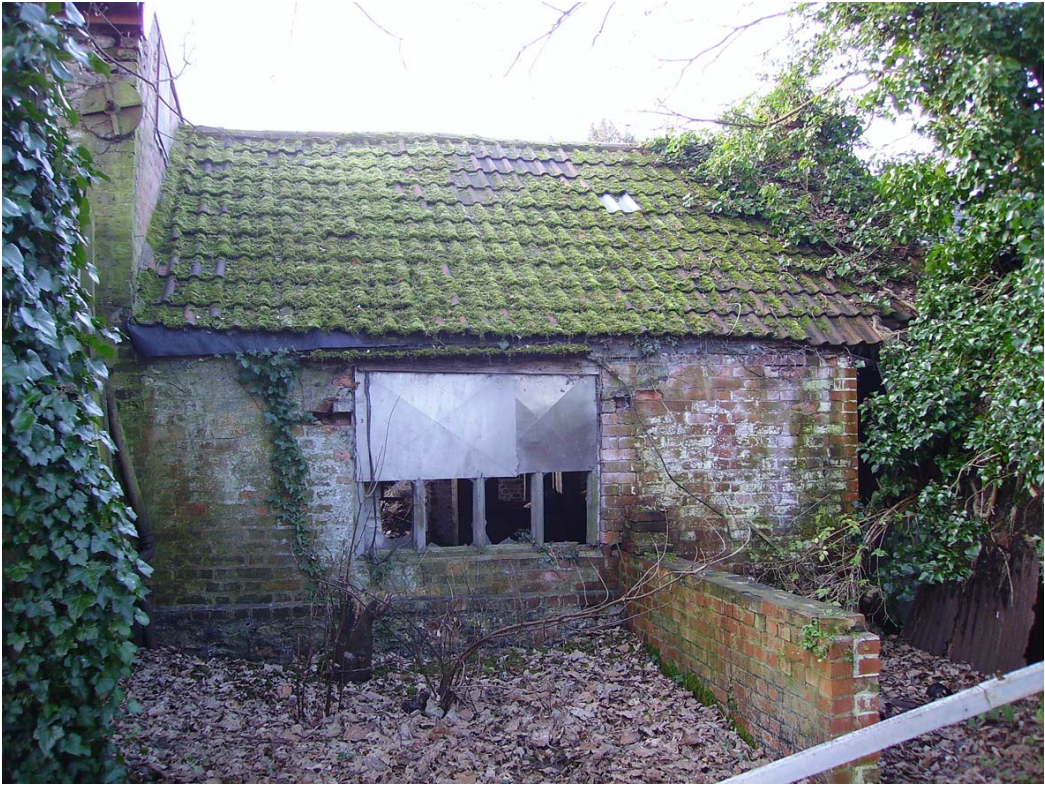
Fig.6

Later 20<sup>th</sup>-century outbuildings of brick laid in stretcher bond, with corrugated iron roof and extension wing. The principal alignment is northwest-southeast facing southwest. Central brick-fronted section with central 6-panel door and a pair of flanking casement windows is framed by a pair of wide bays the left-hand one now open and the other partially closed with corrugated iron sheeting. At the

left-hand end of the range a corrugated iron clad wing breaks forward from the main frontage.

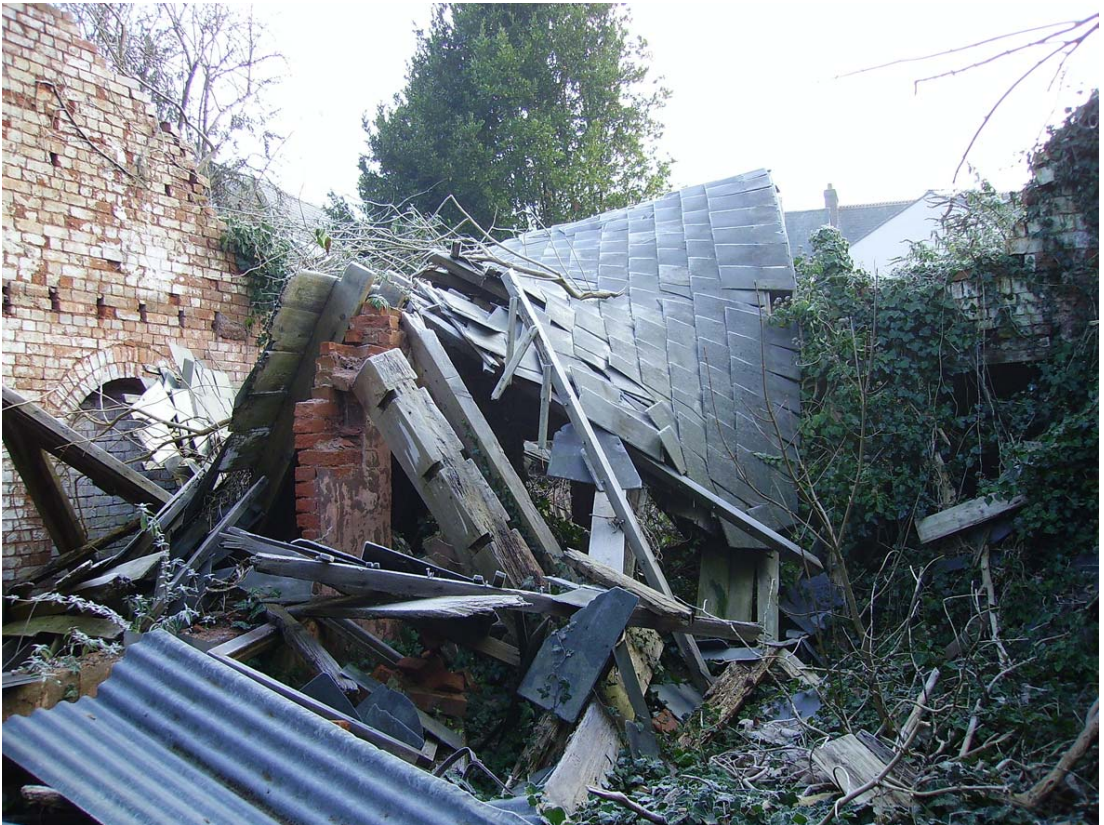
Fig.9

Probably early 19<sup>th</sup> century with later alterations, built largely of chert rubble and some red brick with a corrugated iron roof. 19<sup>th</sup>-century brick segmental-arched windows to the southwest. There is a 20<sup>th</sup>-century doorway in the southeast end within a low segmental-arched former carriage entrance, and a blocked doorway, now a window, to the southeast end of the northeast front.

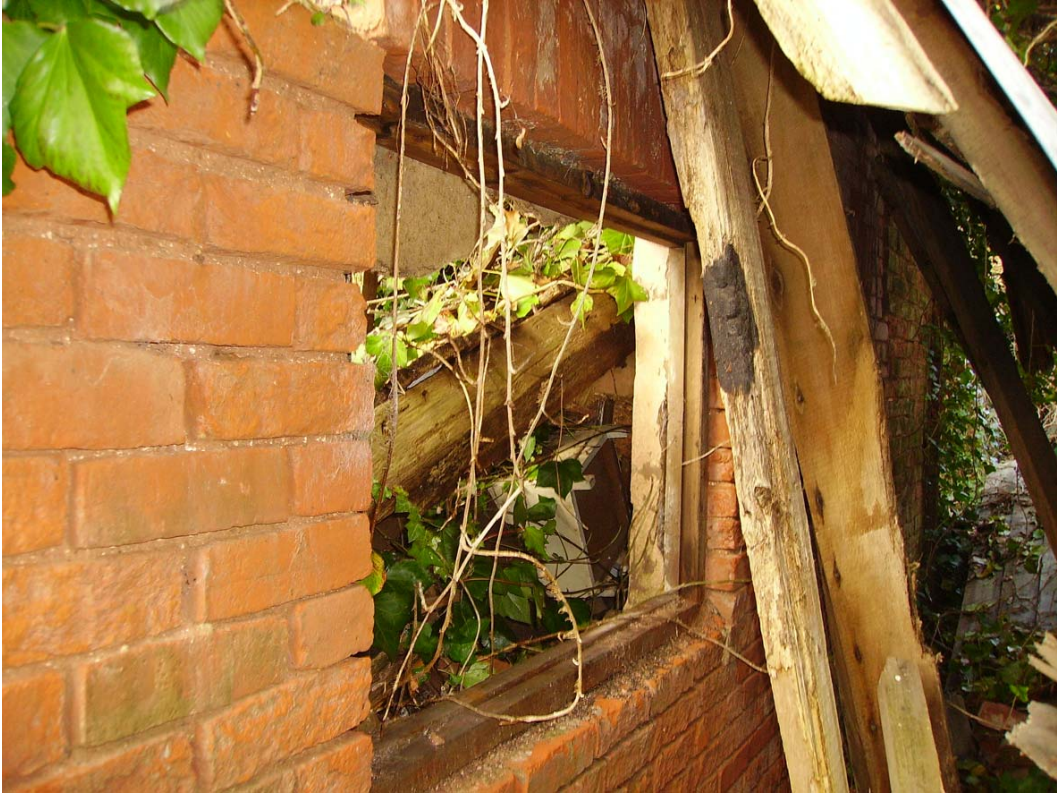
Fig.10

Dating from the mid-19<sup>th</sup> century, Structure 9b is a single-storey, single-cell structure northeast built of red brick (9ins x 4¼ins x 2¾ins) on a chert rubble plinth, and a roof covering of clay double Roman tiles. The building is aligned northwest-southeast, now facing northeast, although there was originally a southwest front too.

The entrance is to the right (northeast), and there is a central wooden-framed four-light chamfer mullioned window (Fig. 10). Anomalies in the brickwork suggest that both these openings may be inserted. The southwest front (now inside Structure 10) is similar, with a central 4-light chamfer mullioned window and a doorway to the right (southeast) (Fig. 11).

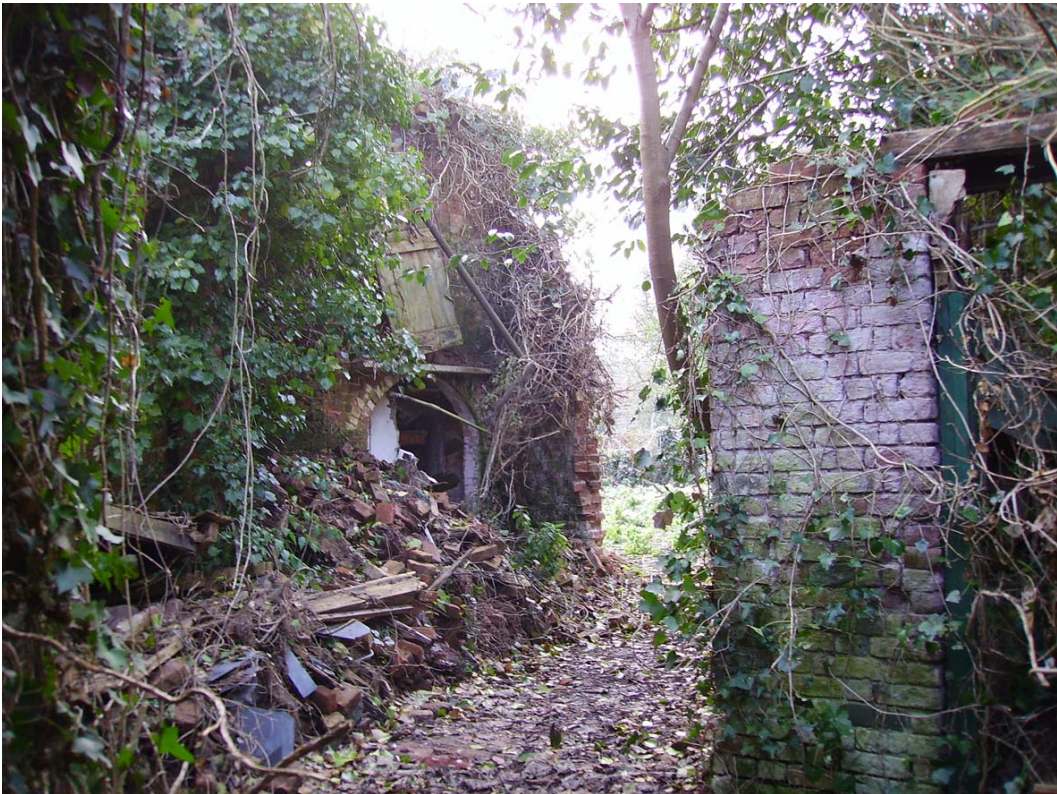
Fig.11

Structure 10 represents a yard roofed over in the mid-20th century. It has a concrete floor, a wooden boarded wall to the northwest, full height sliding door to the southeast, and a roof of corrugated iron and corrugated asbestos sheeting.

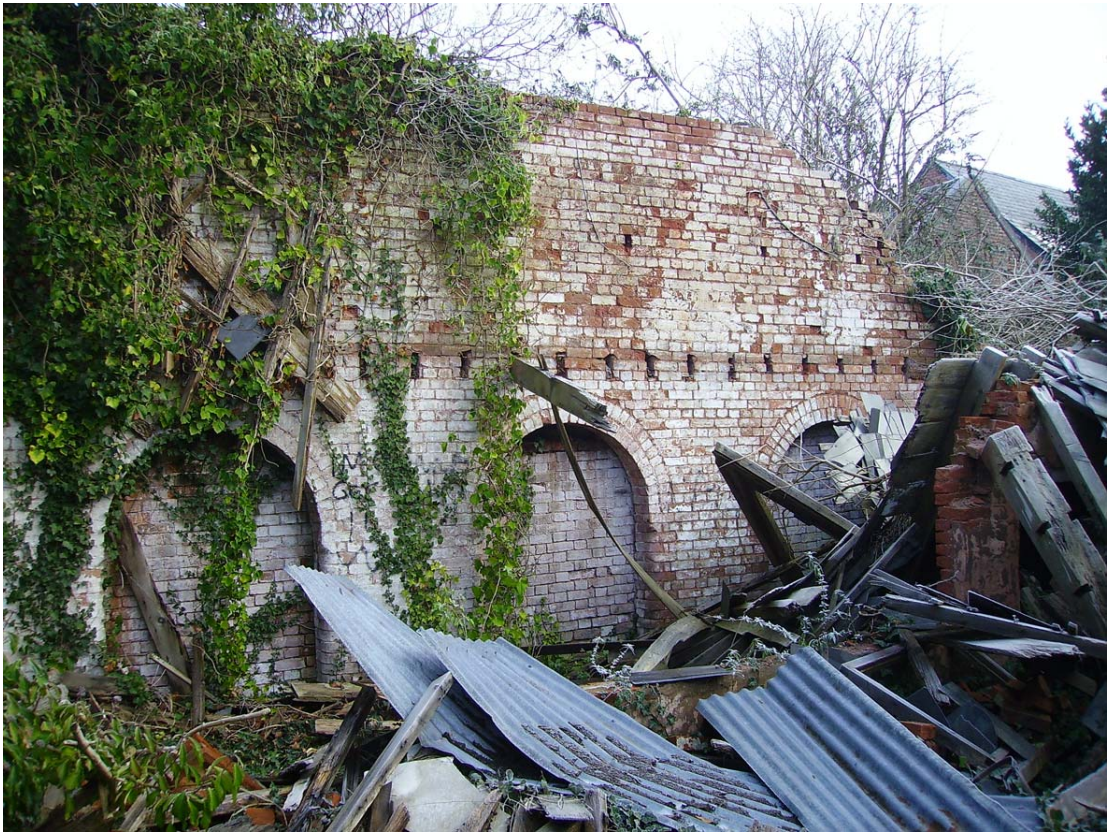
Fig.12

Inside, the floor is of poured concrete, and the lower parts of the front and rear walls of rubblestone (Fig. 12). In the southeast wall is a blocked doorway to the parent building. Plain machine-cut floor joists carry the floor boards of a loft.
