Queen Square, Wolverhampton Archaeological Watching Brief 2008

Project No. 1749

QUEEN SQUARE

ARCHAEOLOGICAL WATCHING BRIEF

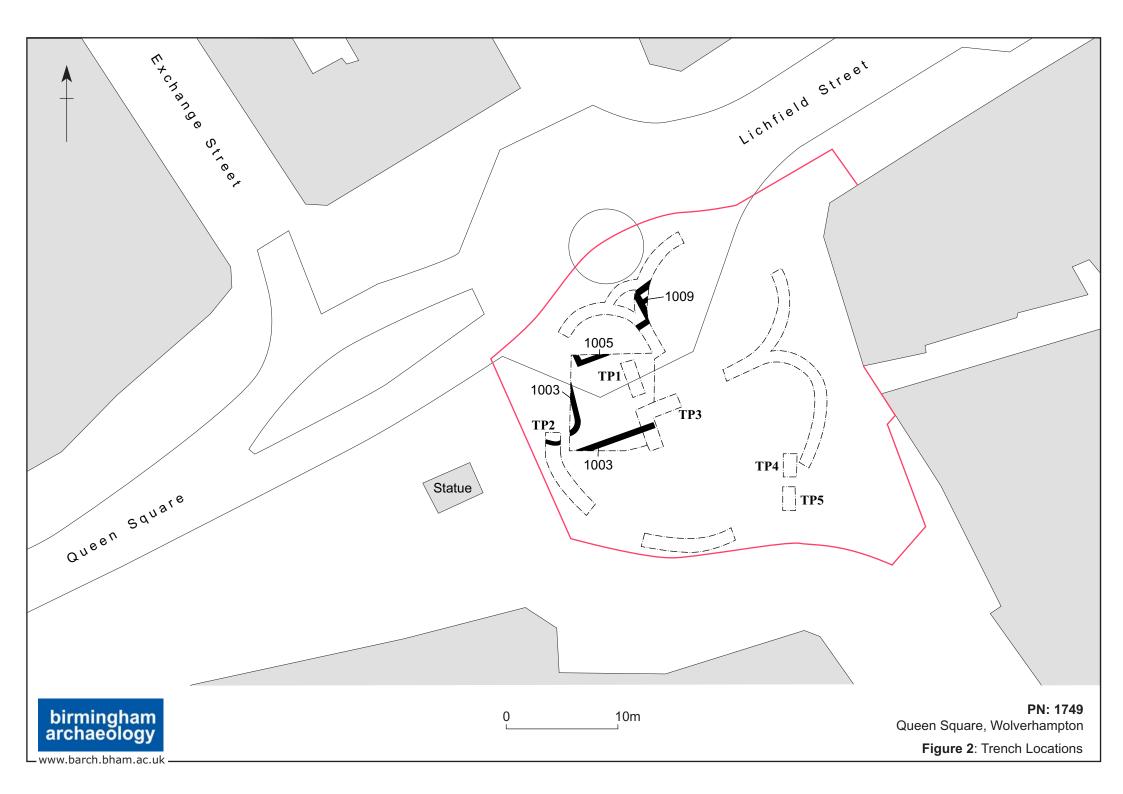
- 6.1.1. The areas that were monitored for archaeological features are illustrated in Fig. 2. The results of the watching brief are described together below.

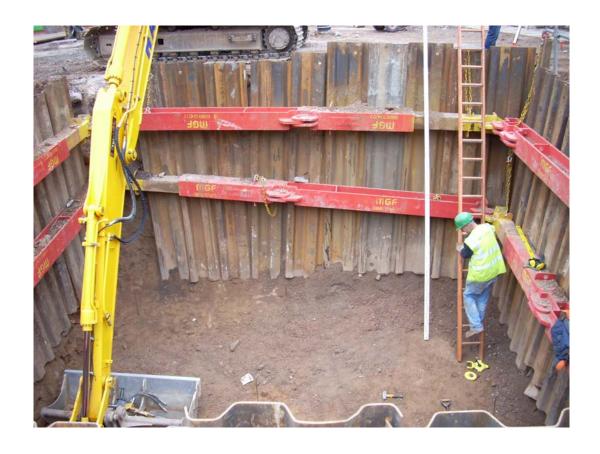
- 6.1.2. The bedrock (**1006**) was encountered 1.2m below the modern ground surface, during the excavations for the installation of the water tank (Plate 1). This consisted of pink sandstone. This was overlaid by pink mixed sandy clay (**1008**), the result of glacial activity. This was encounter over the area of the site, ranging between 0.55m and 0.8m below the modern ground surface (Plate 2).

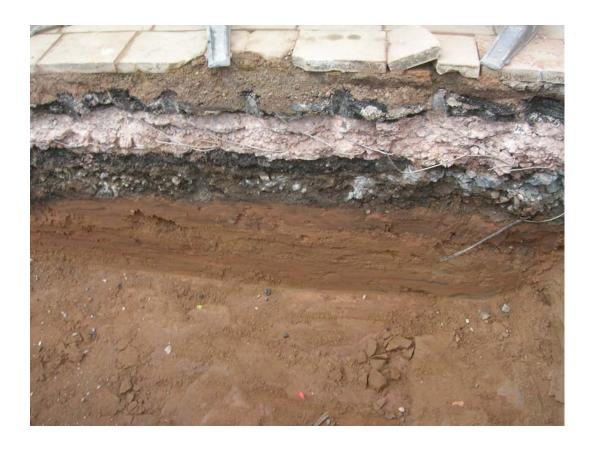
- 6.1.4. Overlying these and much of the eastern side of the site was a layer (**1007**) of black silt and sand with coal and clinker type material throughout up to 0.3m deep (Plate 2).

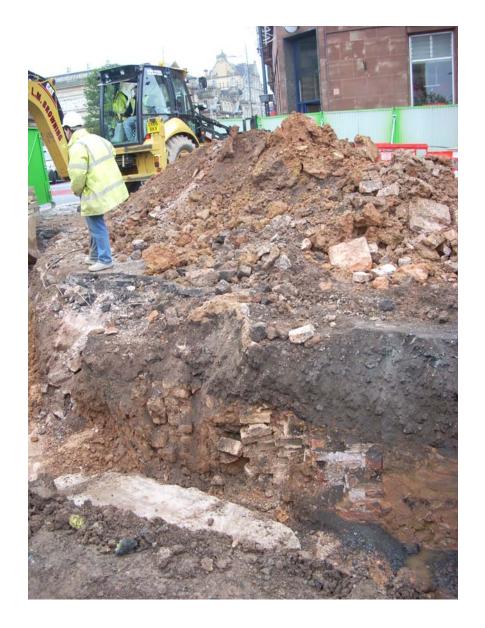
- 6.1.3. Cut through this horizon to the north of the site was a small section of quite substantial brick built footings (**1009** Plate 3). Aligned with the frontage of Lichfield Street, these were 0.5m wide and were survived to a height of 0.6m (located 1.3m below the modern ground surface), although it was apparent that this was not the full extent. The hand-made red bricks measuring 2¾ inches by 9¾ inches by 4½ inches. These were set in a hard lime mortar. No sign of the associated floor surface was evident.

- 7.1.1. Part of the line of wall/ structure **1009** follows the line of Dudley Street and Lichfield Street. This may relate to an earlier structure aligned along these streets. However it does not correspond with the Charity School depicted on the 1750/1 map and no evidence to the Charity School was found during monitoring of ground work.

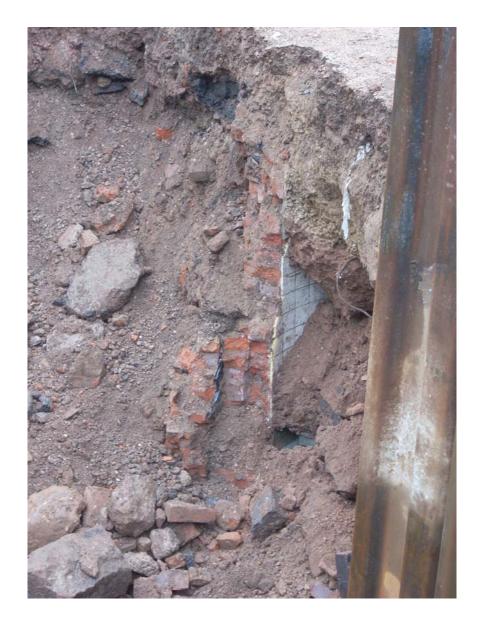
- 6.1.5. In the area of the water tank, brick-built structure **1003** was the remnants of the old underground public toilet block, identified during excavation by the ceramic tile lined walls (Plate 4). This structure is clearly illustrated on the 1919 Ordnance Survey map (Figure 6). This structure had been back filled with loose brick rubble (**1004**). Possibly associated with this at the northern extent of the area of the tank were the remnants of a plinth for an earlier statue (**1005**).

- 7.1.3. Other brick built features identified during the course of the watching brief can be easily identified with structures illustrated on the early Ordnance Survey Maps. This Includes the brick built-structure **1005** identified with the 'Prince Consort Statue' illustrated on the 1889 map (Figure 5). Also structure **1003** with the distinctive white tiled wall treatment can be identified as the 'Latrines' illustrated on the 1919 map (Figure 6).
