**St. Thomas á Becket  
House, Ettington,  
Warwickshire**

**Archaeological Evaluation  
and Watching Brief.**

**Final Report**

Project No. 1783

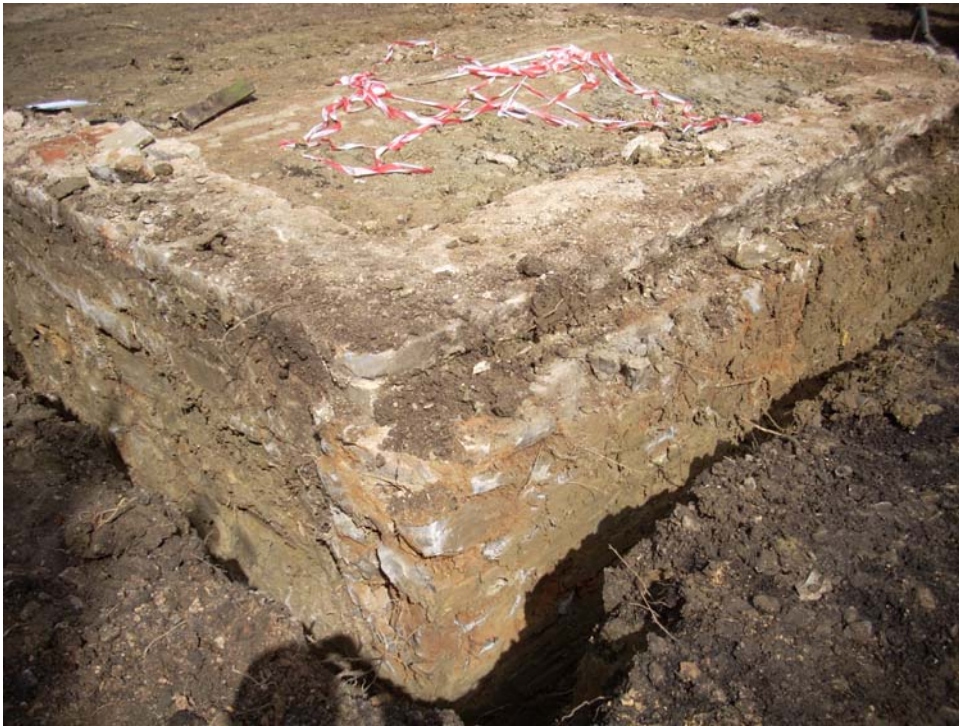
Plate 2: The south west corner of the mausoleum

The exterior walls were constructed from the same blue sandstone as the rest of the church, but the interior structure (including the arched roof, supports and ledges) were constructed of unfrogged red brick (Plates 2 and 3).

Exterior dimensions were measured as length 6.6m, width 5.5m, depth below ground 1.8m. The internal dimensions were measured as length 5.0m, width at base 3.8m, height at centre 2.15m. The interior of the crypt was formed by an arched roof running along the length of the structure. A central brick column on each side of the structure supported the roof and the coffin ledges. There were eight ledges in total in addition to four spaces on the floor for coffins to be placed. No remains were present. The ledges were 2.2m long, 1.25m wide, and were 0.11m thick at the centre (one brick depth). The top of the lower ledge was 0.55m from the present floor level, whilst the top of the upper ledge was 1.23m from the floor. The stairwell leading down into the crypt was in a state of disrepair. The wall retaining earth on each side of the stairway was not bonded into the main structure. It was built from similar stone, but the workmanship appeared different, the blocks were smaller, and was capped by three courses of red 19<sup>th</sup> century unfrogged brick. It is likely that this was a later addition, or possibly part of later repair work on the crypt.

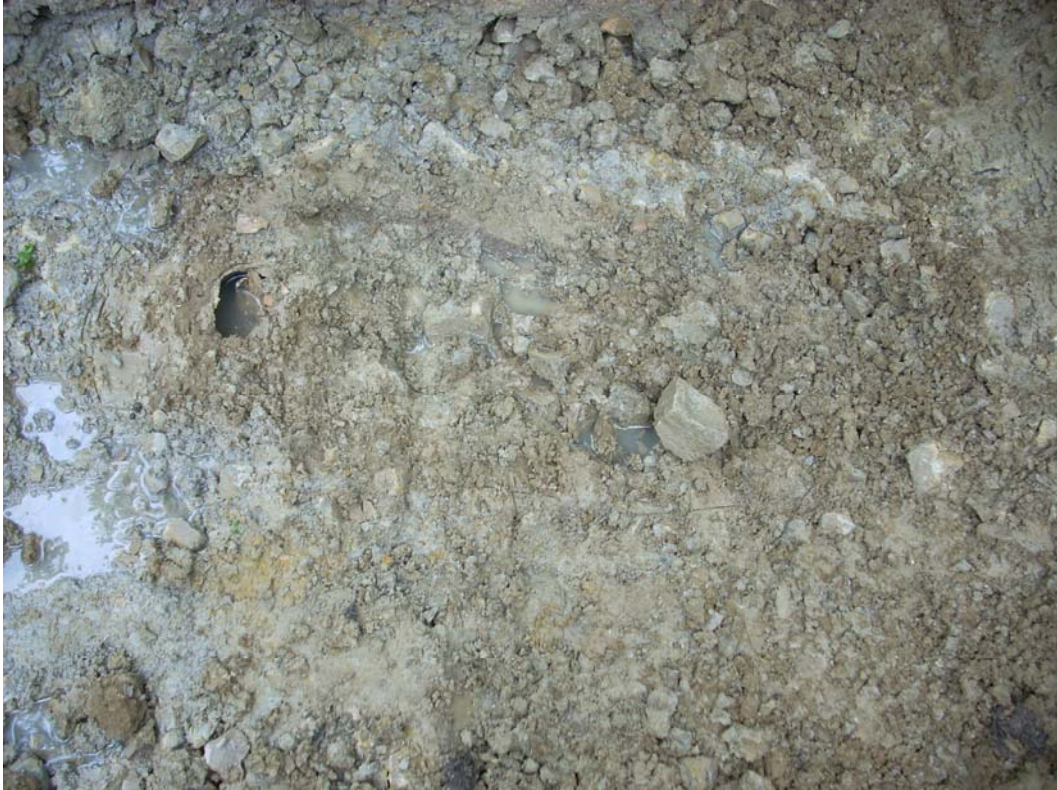
Plate 4: Possible human skull remains

The pit for the septic tank was also located within the area of the pathway, at the eastern end of Trench F. An initial 2 x 2m square pit was excavated to a depth of 1.4m. At a depth of approximately 1.3m below the ground surface a skull was found. The size and shape were consistent with that of a small human skull (Plate 4). The skull appeared to lie at the end of a shallow grave shaped cut (**1013**). Once the skull was uncovered, no further excavation was undertaken and it was therefore impossible to tell if this was part of an articulated skeleton or just charnel remains. The standing gravestones in the cemetery indicate a direction of burial aligned towards the northeast (as with the nave of the church), however the position of the skull within the cut would suggest that the skeleton was aligned generally towards the southwest, suggesting a different burial phase to the main graveyard.

The location of the septic tank was moved to the south in order to avoid disturbing this potential burial. No further remains were encountered. The trench was sealed by a layer of subsoil (**1008**).

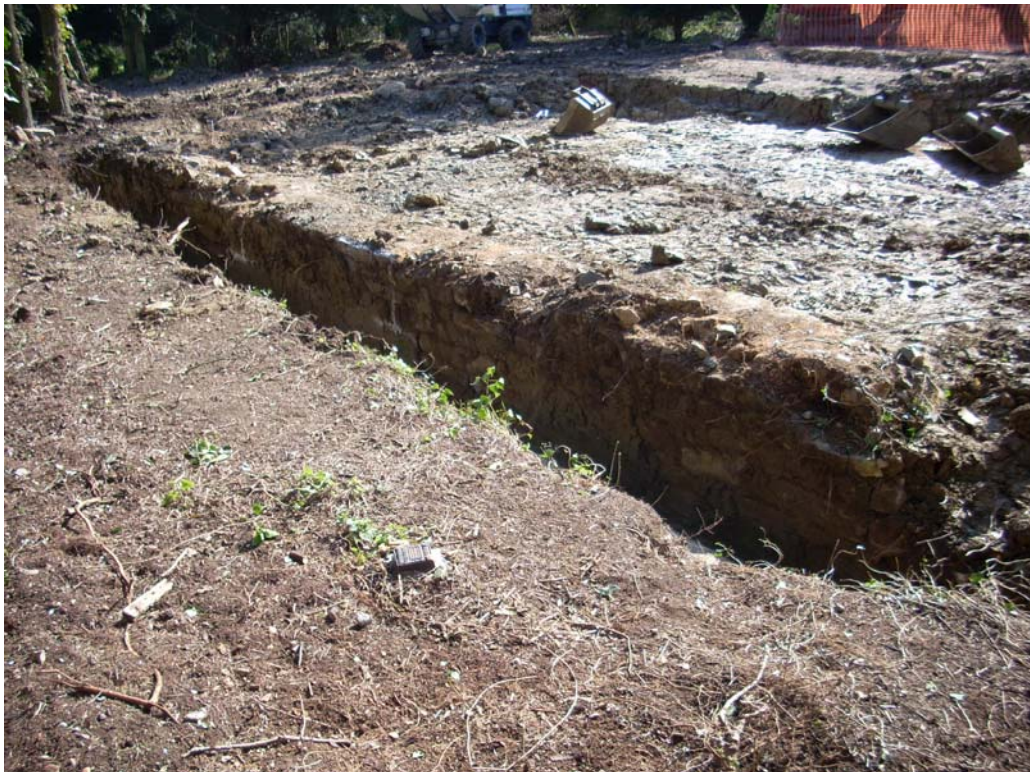
Plate 5: Foundation trench along northwest side of church footprint

This trench was continued from the end of Trench C along the northwest side of the church (Fig. 3) all the way to the existing tower structure at the west corner of the church (Plate 5). It was stepped from 2.7m to 2.5m, then to 2.0m, and finally to 1.5m as it reached the tower. No features were seen in this stretch of trench. One piece of late 18<sup>th</sup> / early 19<sup>th</sup> century glazed pottery was recovered from (**1001**) The final 5m of trench was along an area previously disturbed in modern times. A quantity of concrete had been placed into the ground disturbing it, but the trench was able to be dug. The depth of the wall and the natural was consistent with that of the south wall, on the opposite side of the structure, remaining at a depth of 0.9m throughout the trench. The natural, subsoil and topsoil levels remained consistent.
