Cambridge Street, Birmingham  
Archaeological Evaluation  
2008

**Project No. 1788**

New Library Site, Cambridge Street, Birmingham  
An Archaeological Evaluation, 2008

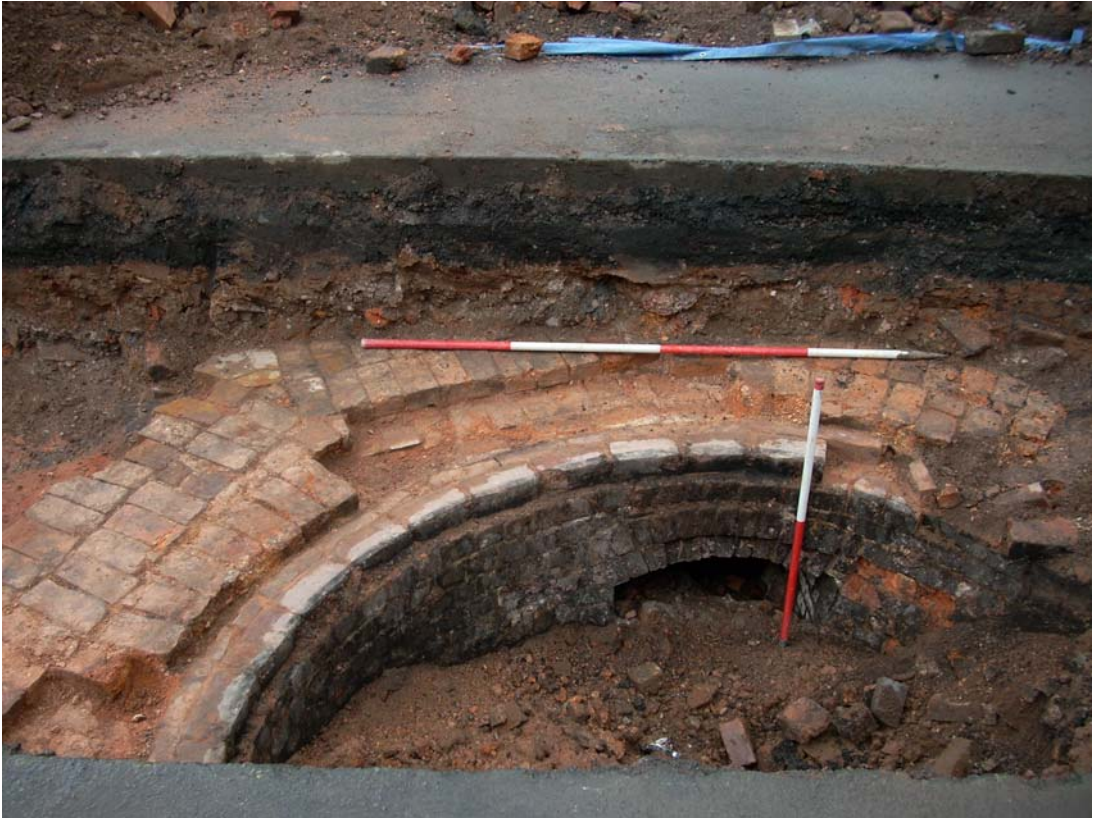
Plate 1

- 5.4.3 10m to the north of the canal in Trench 1 the base of a chimney was identified (**1016** Plate 1), with a flue present heading off to the east. The outer structure was octagonal, and approximately 10m in diameter, with a circular internal face constructed in English bond that had been exposed to heat and smoke. The octagonal corners of the external face were formed by terracotta or brick specials.

- 5.4.1 The earliest structures identified on the site were the canal, present in Trench 1 (**1021** **1022**) and Trench 2 (**2015**), and the base of a chimney in Trench 1 (**1016** Plate 1).

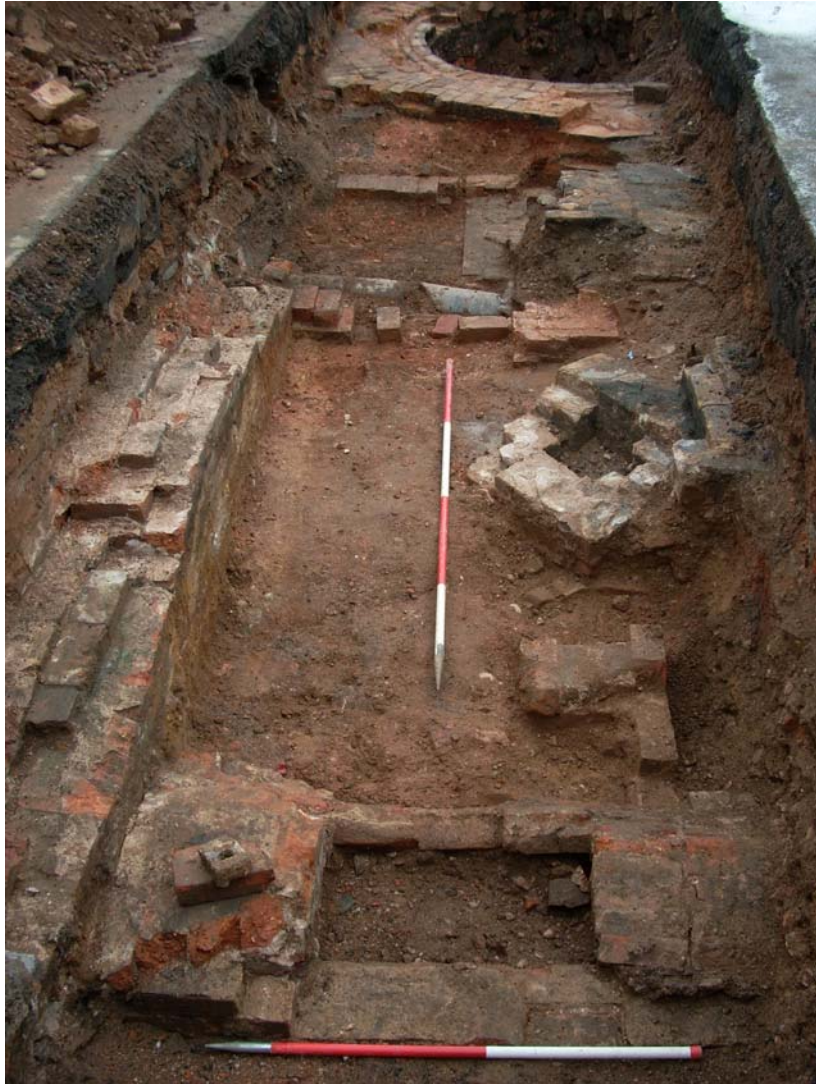
Plate 2

- 5.5.2 Within Trench 1, a culvert (**1010**, Plate 2) was identified abutting wall **1009**. Between the culvert and the chimney were a series of different phased but essentially undiagnostic structures, including the truncated remains of walls and drains (**1011**, **1015**). To the south of the chimney a small amount of brick surface was identified **1017** that overlay a yellow brown sand with mortar fragments **1003**. A discrete deposit of black-grey silt-sand with ash was identified in the vicinity of this surface (**1004**). This area was not fully investigated due to the proximity of modern services.

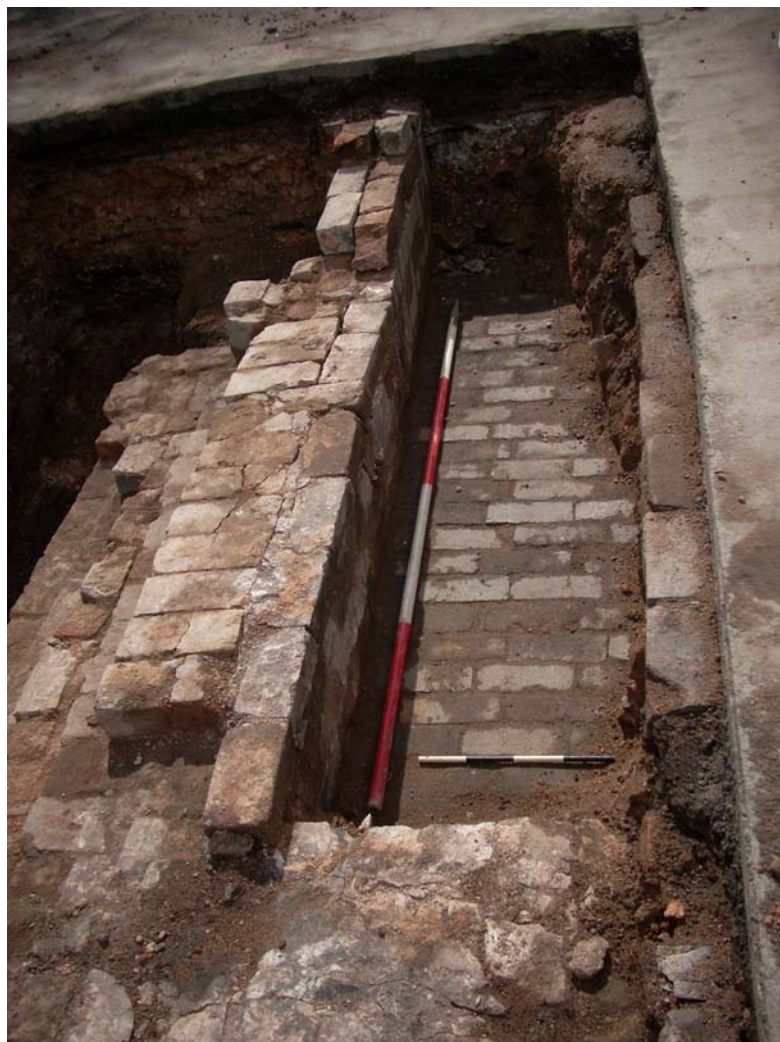
Plate 4

- 5.5.4 At the southern end of Trench 2, a series of walls was identified (**2011**, **2016**, Plate 4) with part of another possible floor surface (**2010**) abutting the canal wall and **2011**. This surface overlay deposits **2003** and **2004**, which contained inclusions of broken brick, slag and crucible. These may constitute primary deposits for the levelling of the surface.

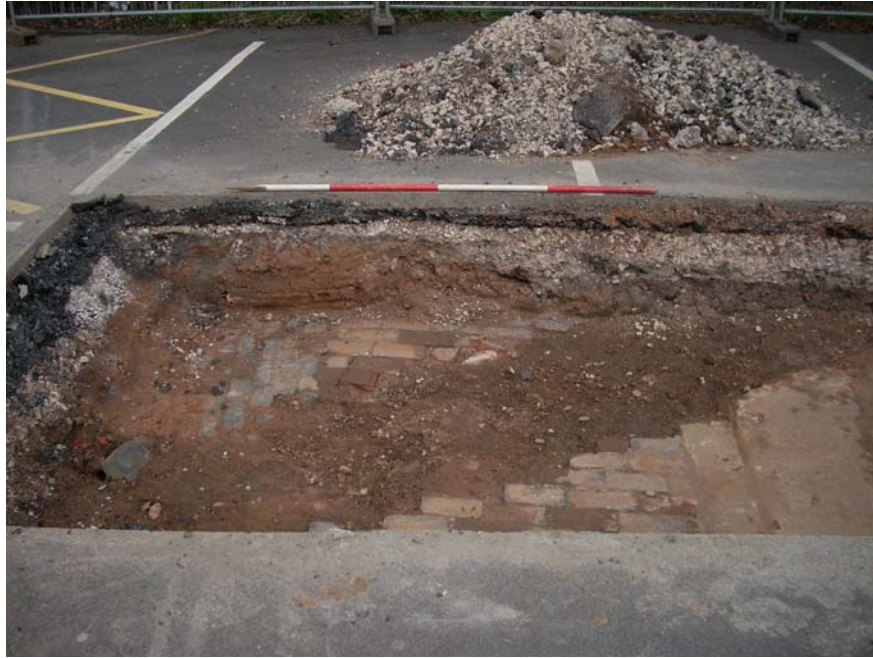
Plate 5

- 5.5.5 A brick surface was identified at the northern end of Trench 3 that is likely to have been from this phase (**3010**, Plate 5).
- 5.5.6 Several parallel northeast - southwest aligned walls were identified in Trench 4 (**4016**, **4018**, **4019**, **4020** and **4021**, Plate 6). These were constructed in blue brick, and were predominantly laid in English bond where it was discernable. Within these walls iron fittings, tubing and superstructure were present, suggesting these were to support machinery rather than representing the foundations of internal walls. A grey ashy rubble deposit (**4007**) was identified between walls **4016** and **4018**.

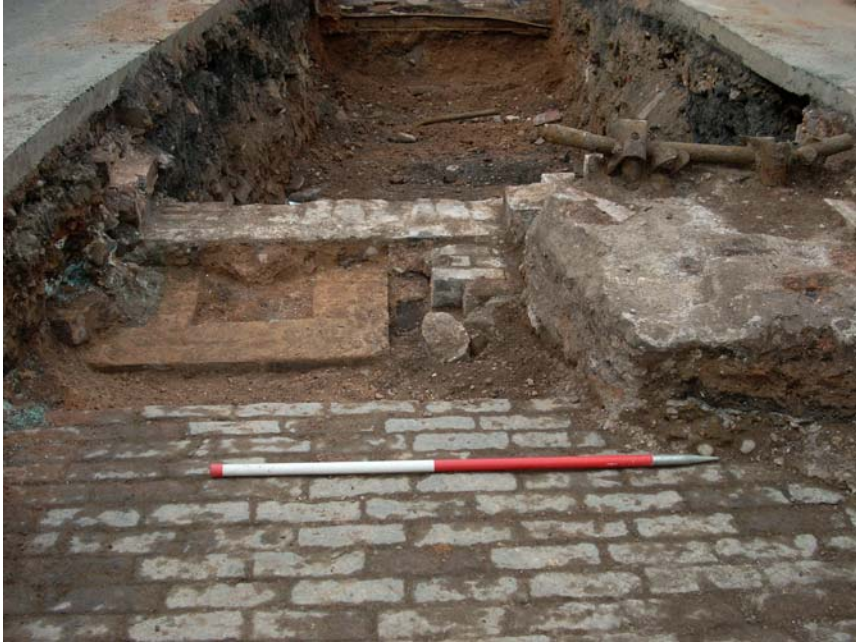
Plate 8

- 5.6.1 Later structures identified within Trench 1 comprised a series of walls and surfaces constructed from yellow firebricks, located between the chimney and the canal (**1006**, **1007**, **1008** and **1018**, Plate 7). Some were stamped 'Stourbridge' and incorporated into these were two yellow bullnose brick piles, which may have formed part of a door way or roof support.
- 5.6.2 A later drain or sump constructed from blue bricks and concrete was located at the northern end of Trench 1 (**1014**).
- 5.6.3 At the southern end of Trench 1, a square concrete base with the remains of scaffolding (**1025**) was identified adjacent to the canal, overlying brick surface **1024** (Plate 8). A

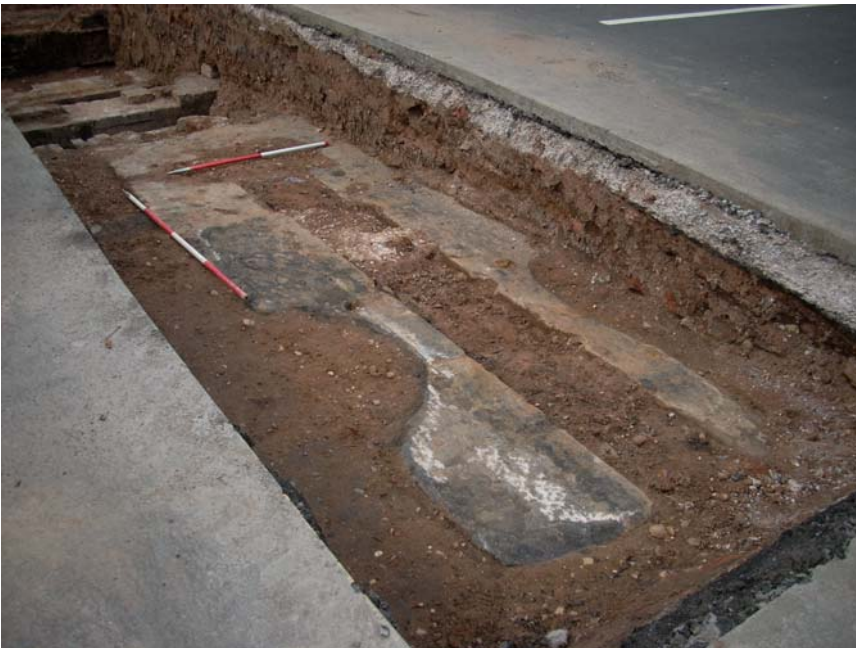
- 5.6.7 In Trench 4, later additions comprised two poured concrete machine bases, at either end of the trench (**4015** Plate 9 **4022** Plate 10). Machine base **4015** had the remains of iron fittings within it, and appeared to be very smooth poured concrete with few inclusions, probably moulded in shutters. Within this structure was a possible scoop feature (**4023**), filled with orange sand gravel and rubble (**4024**), similar to the overlying demolition deposits. At the base, however, was a deposit of wood and slate possibly suggesting this was a separate feature.

- 5.6.9 Overlying the structures at the eastern end of Trench 4 (machine base **4015**, surface **4017** and wall **4016**) were thin deposits of black silt, which are likely to represent *in-situ* trample from the industrial processes and use of the structures (**4004**, **4005** and **4006**).
