Shenstone Park Farm,
Staffordshire

An Archaeological
Watching Brief 2008

**Project No. 1798
June 2008**

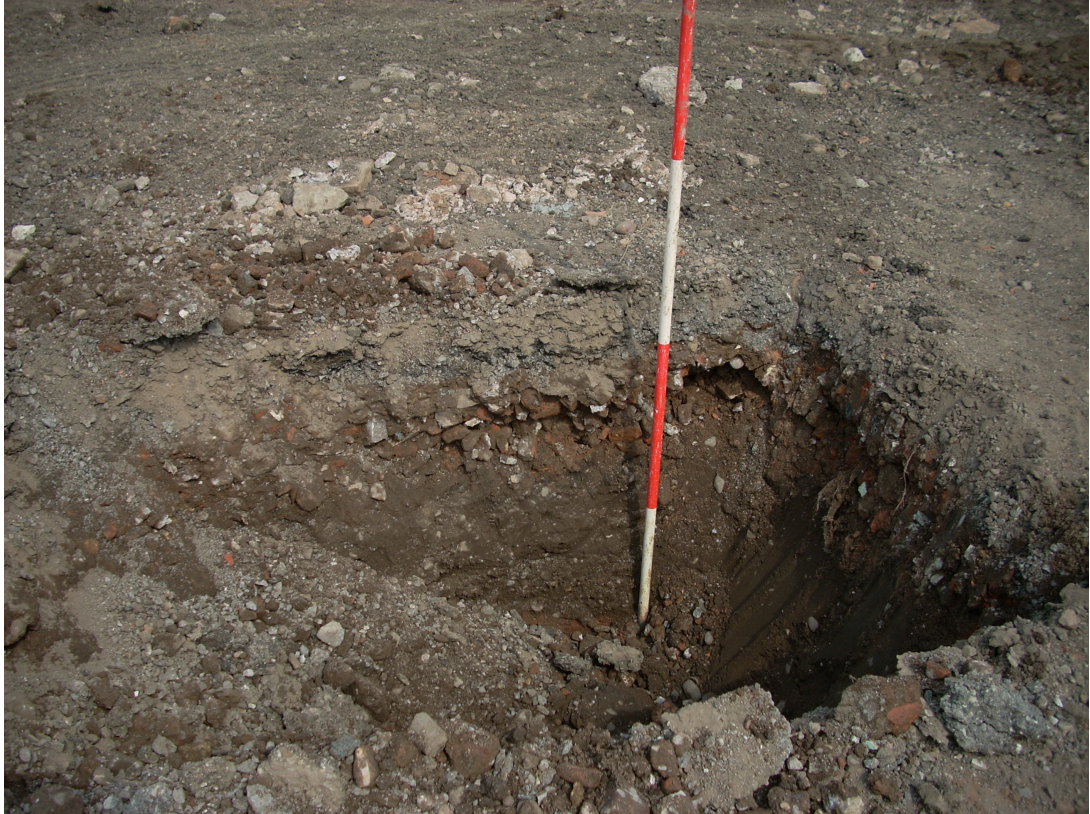
Plate 1 Trench 2 from the south

Dark brown clay sand 0.7m deep overlain by brick and tile rubble 0.15m deep sealed by dark grey hardcore material 0.1m deep. Total trench depth 0.95m.

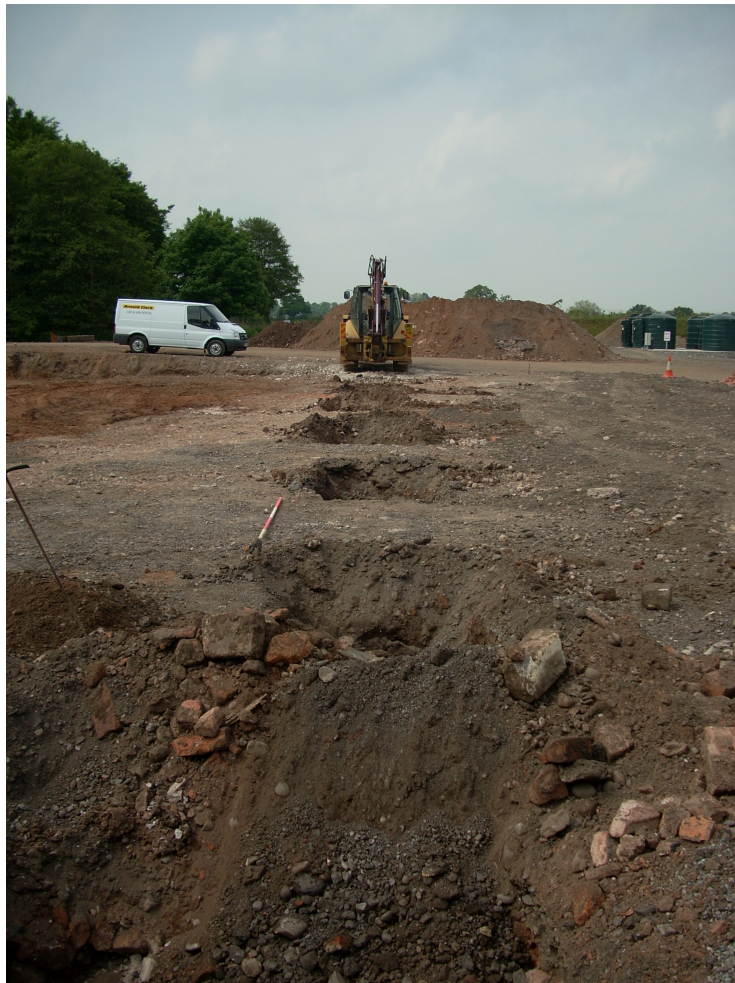
Plate 2 Trenches 1-5 from the northeast

No artefacts of medieval or post medieval date were identified in any of the trenches. Seven sherds of 19th/early 20th century pottery were recovered as unstratified surface finds near trenches 1-5.

Dark brown clay sand 0.75m deep overlain by brick rubble 0.15m deep and sealed by dark grey hardcore material 0.1m deep. Total trench depth 1.0m.

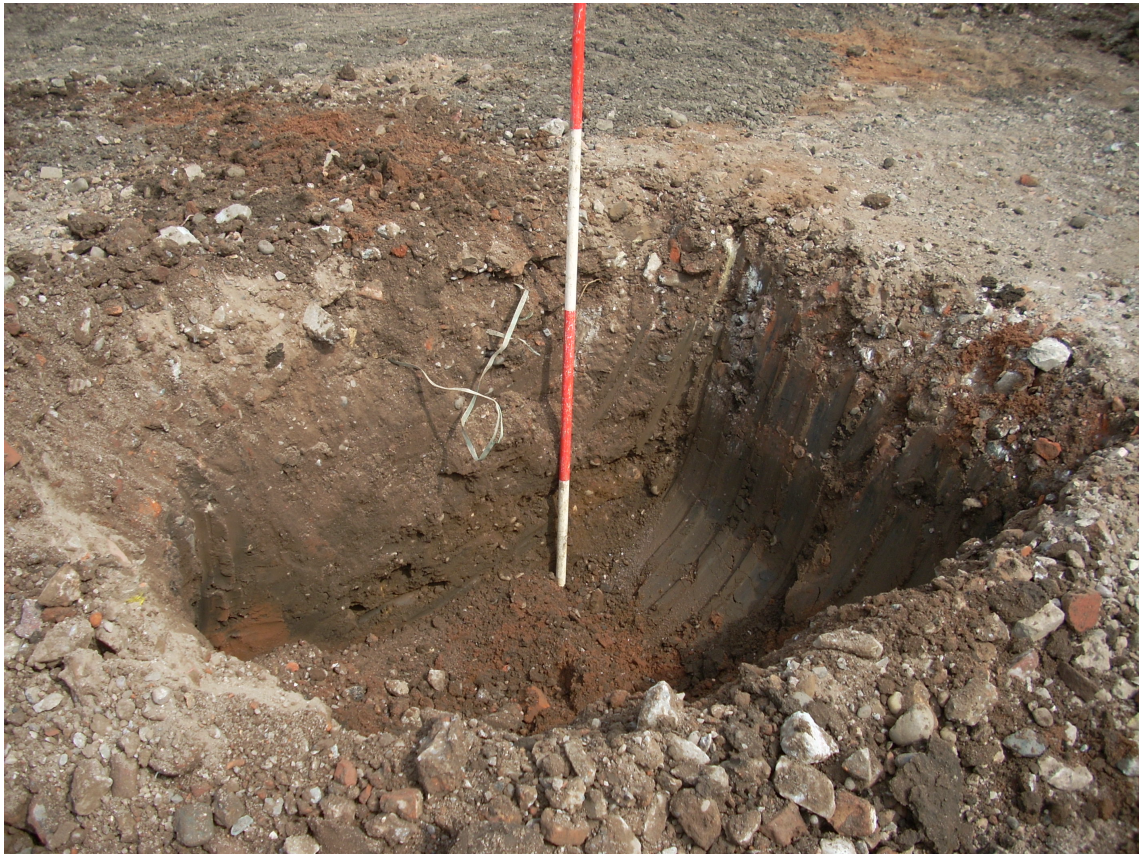
Plate 3 Trench 4 from the south

Dark brown clay sand 0.75m deep overlain by brick rubble 0.15m deep, sealed by dark grey hardcore material 0.1m deep. Total trench depth 1.0m.

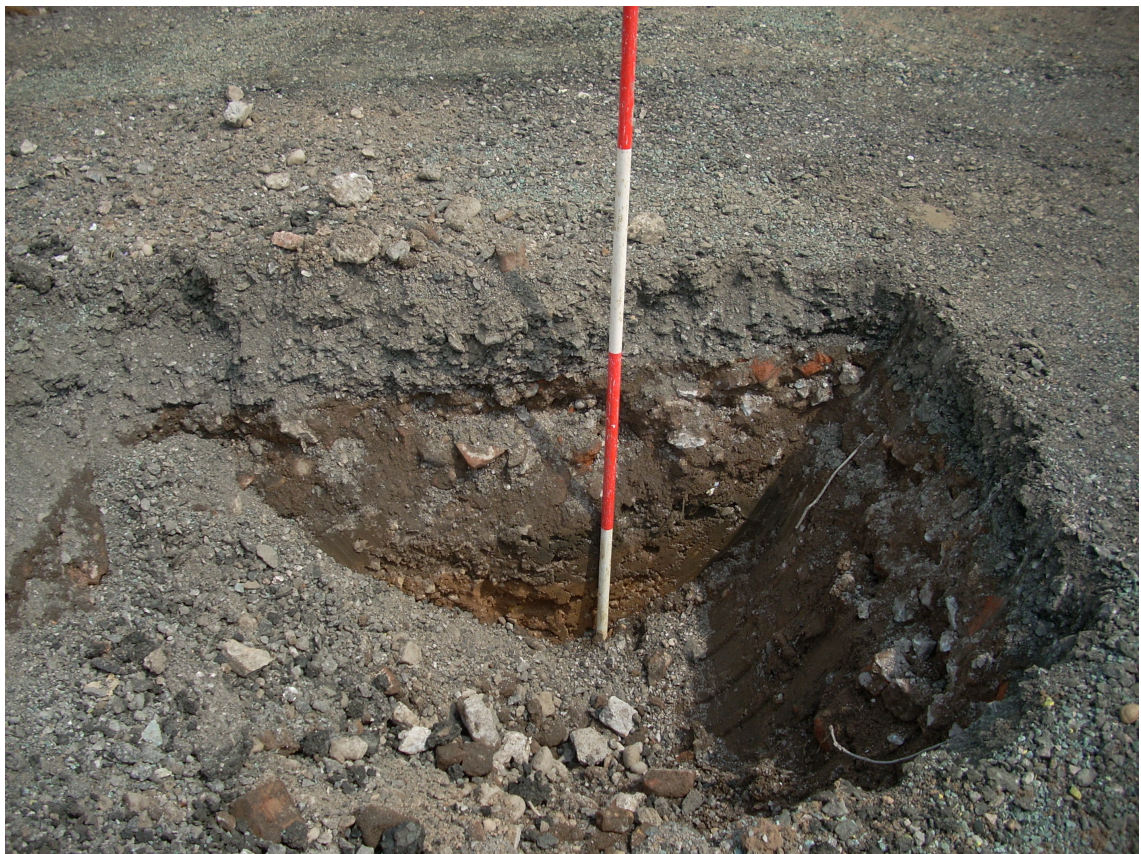
Plate 4 Trench 8 from the west

Orange clay sand 0.15m overlain by 0.5m of dark brown clay sand, sealed by 0.2m of brick rubble and 0.2m of grey hardcore material. Total depth 1.05m.

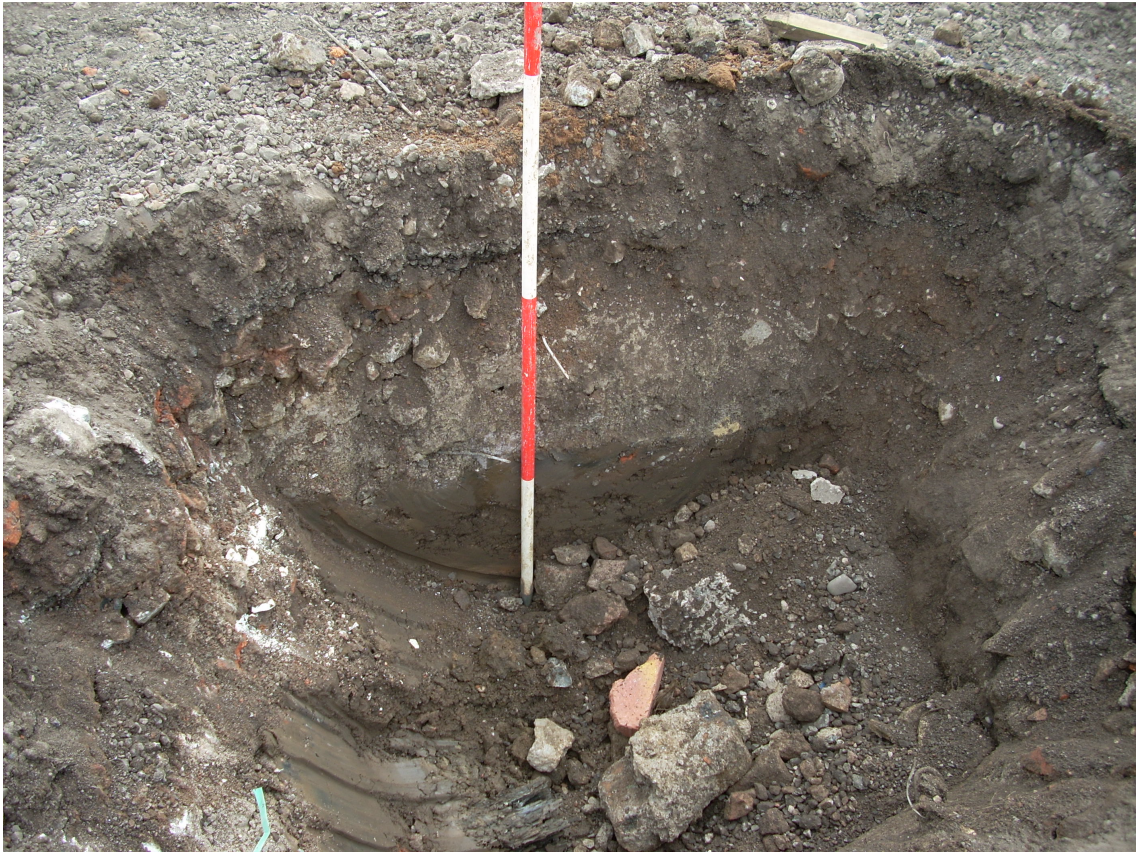
Plate 5 Trench 14 from the north

Dark brown clay sand 0.6m deep overlain by grey hardcore material 0.5m deep. Total depth 1.1m.

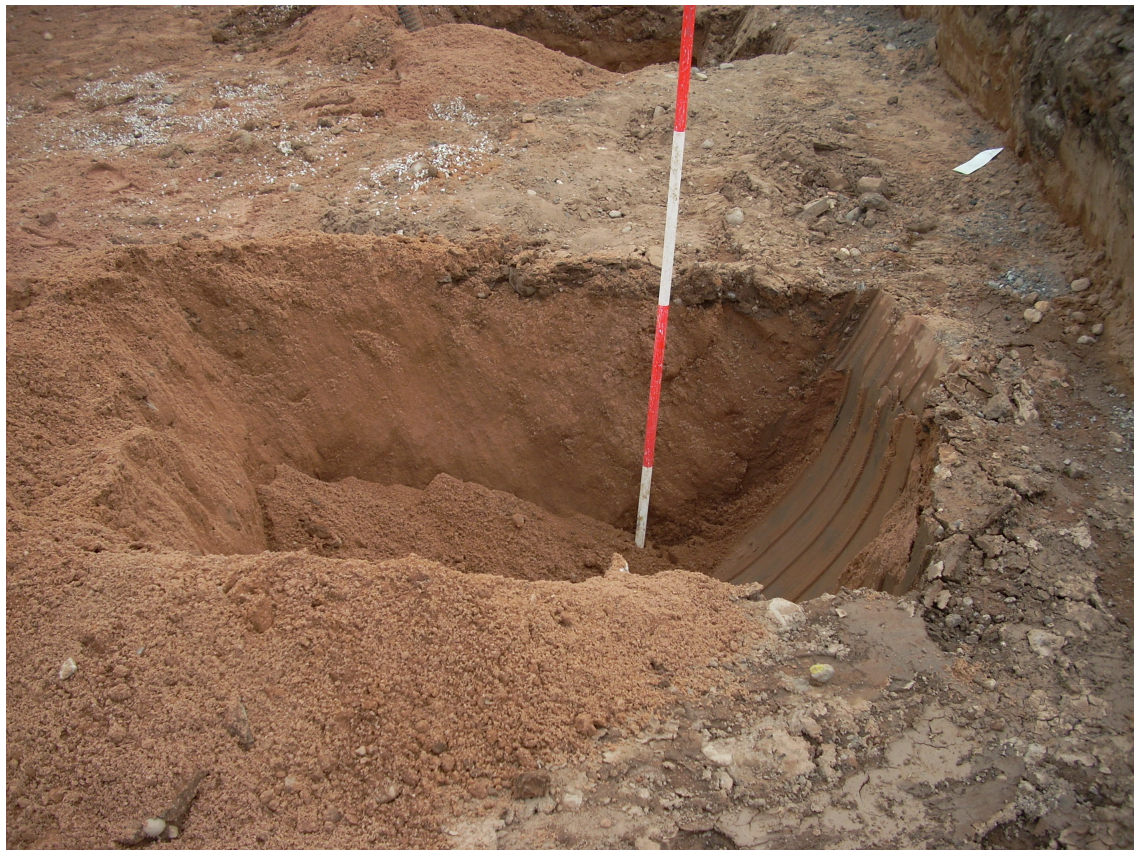
Plate 6 Trench 19 from the south

Soft orange clay sand 1.0m.

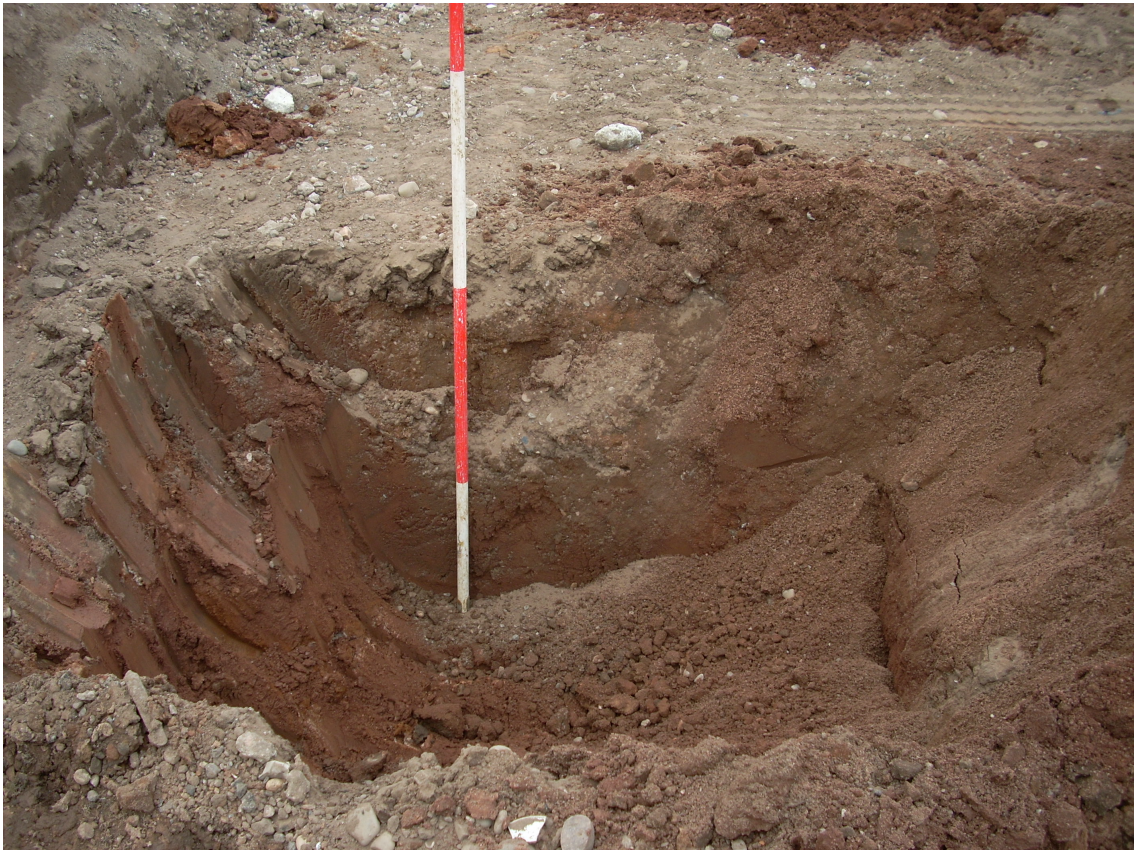
Plate 7 Trench 20 from the southeast

Red brown clay sand 1.0m.

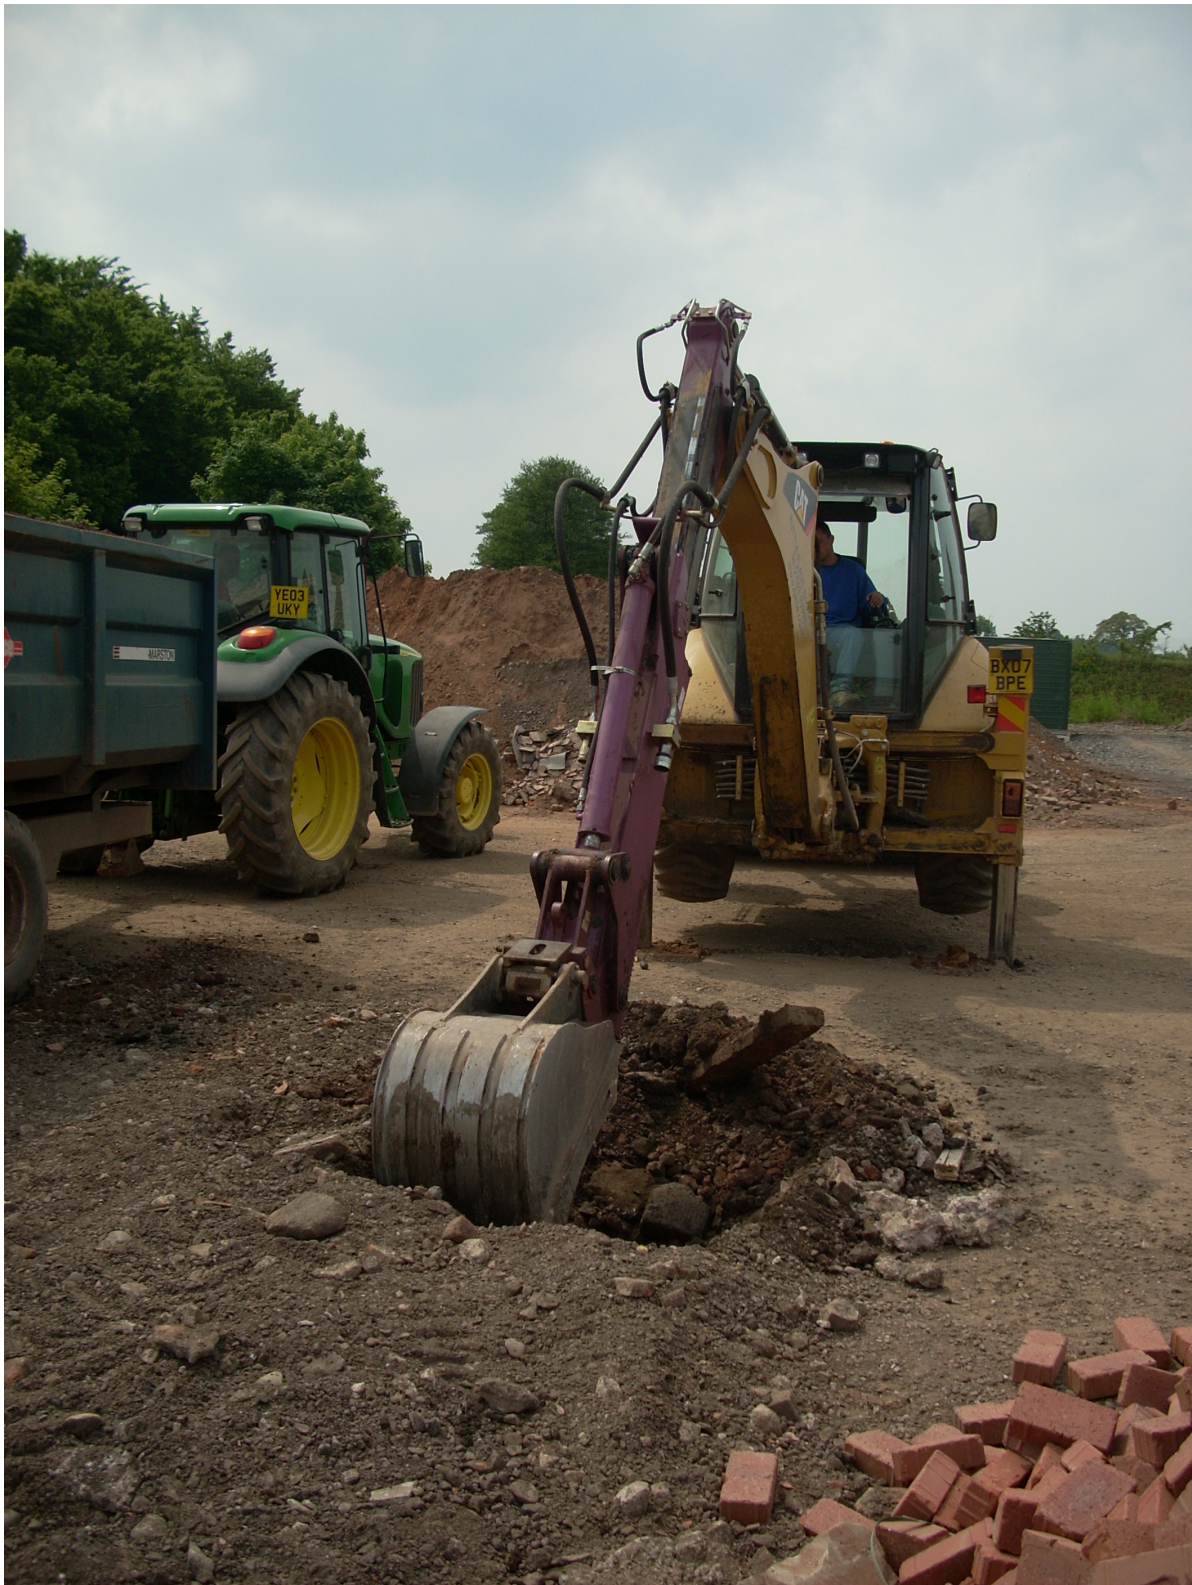
Plate 9 Trench 15 under excavation, from the north

Dark brown clay sand 0.6m deep overlain by hardcore material 0.5m deep. Total depth 1.1m.
