**Church of Saints
Nicholas and Peter,
Curdworth,
Warwickshire**

**An Archaeological
Watching Brief, 2008**

**Project No. 1854
September 2008**

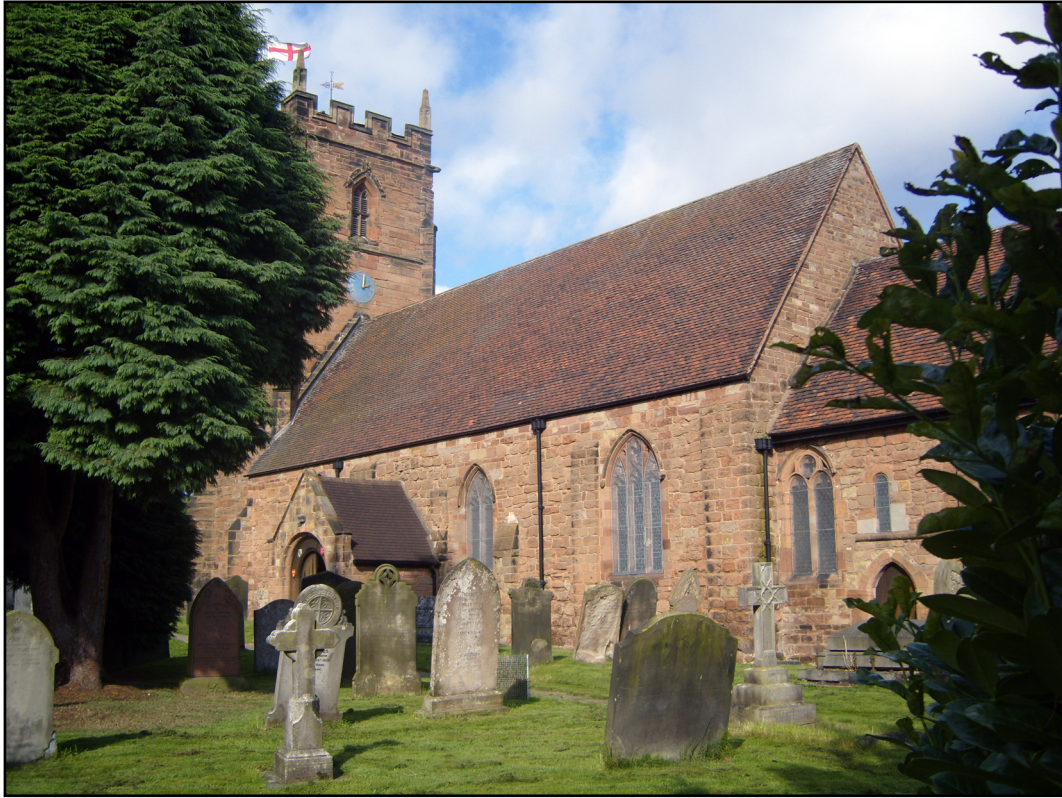
Plate 1: The church from the Southwest

The parish church of Saints Nicholas and Peter stands on a rise to the west of the main street of the village of Curdworth. The church consists of a west tower, an aisleless three-bay nave with south porch, and a two-bay chancel (plate 1). The chancel and two easternmost bays of the nave were built in the latter half of the 12th century; partial refenestration in the early 14th century was accompanied by the insertion of new pair of opposed nave doorways. A major construction phase was carried out in the 15th century comprising the extension of the nave by a further bay to the west, the construction of the tower, and the addition of the south porch. Restoration was carried out in 1800 when the south porch was rebuilt above the base, the 12th-century windows were blocked, and others deprived of their mullions and fitted with iron casements; low-pitched roofs covered with slates were substituted for the medieval roofs. In 1895 the church was again restored, the windows being renewed or opened out, and new, higher pitch roofs constructed.
