**HARVINGTON HALL,
WORCESTERSHIRE**

**ARCHAEOLOGICAL
WATCHING BRIEF
2008 -2009**

May 2009

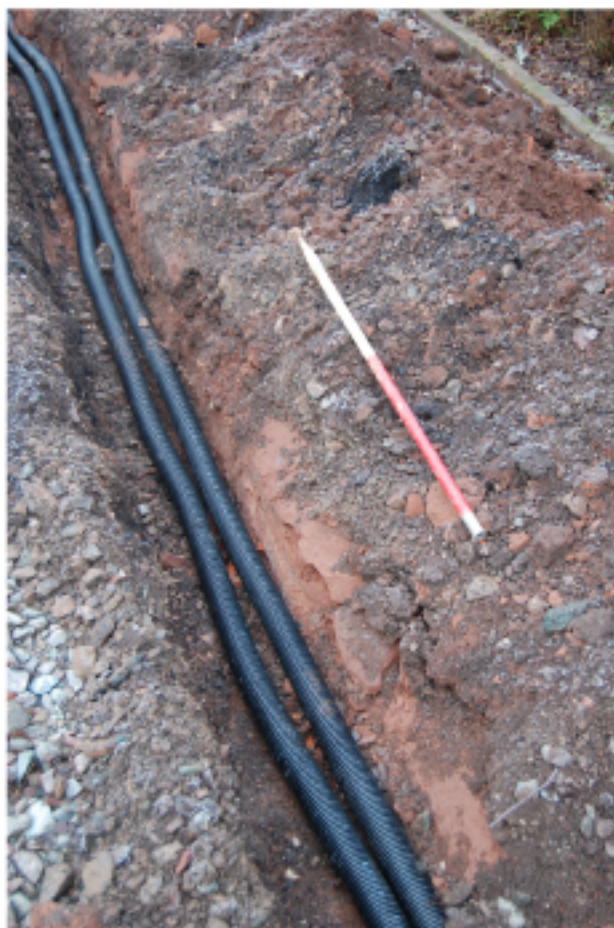
Rubble, sand, gravel and brick overburden, in differing concentrations, was encountered throughout the length of service trenches. However, set within the overburden, a linear course of unmortared worked sandstone blocks were exposed in section within a length of service trench that was aligned north-west to south-east between the chapel and the main hall (Plate 1). The course ran for 3.90m along the northern section of the trench, and was at a depth of 0.15m. The blocks were up to 0.20m in depth and up to 0.40m in length.

Service trench; course of sandstone blocks,
from the southeast

or remains within a context that pre-dated the later post-medieval period. The course of sandstone blocks that was observed during the excavation of the service trench, between the chapel and Hall, was clearly set within a later build up of overburden.

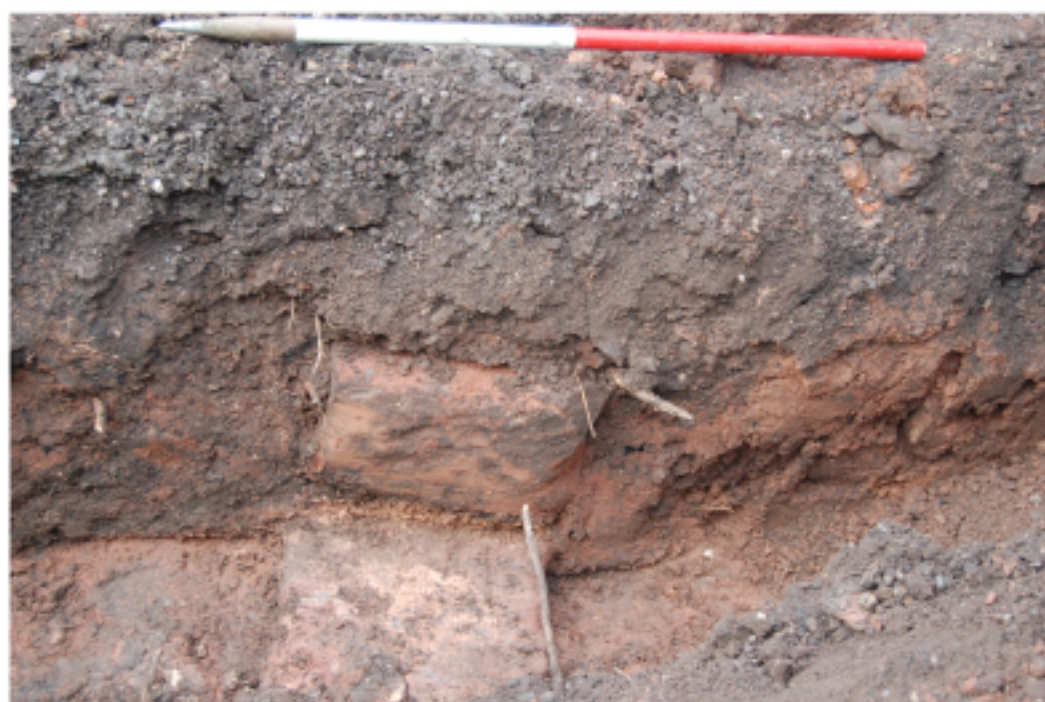
Another two, possibly associated, sandstone blocks were partially exposed, on a similar alignment, in a service trench outside the chapel (Plate 2). The blocks were 0.30m in width by 0.20m in depth.

Service trench; sandstone blocks outside the chapel from the east

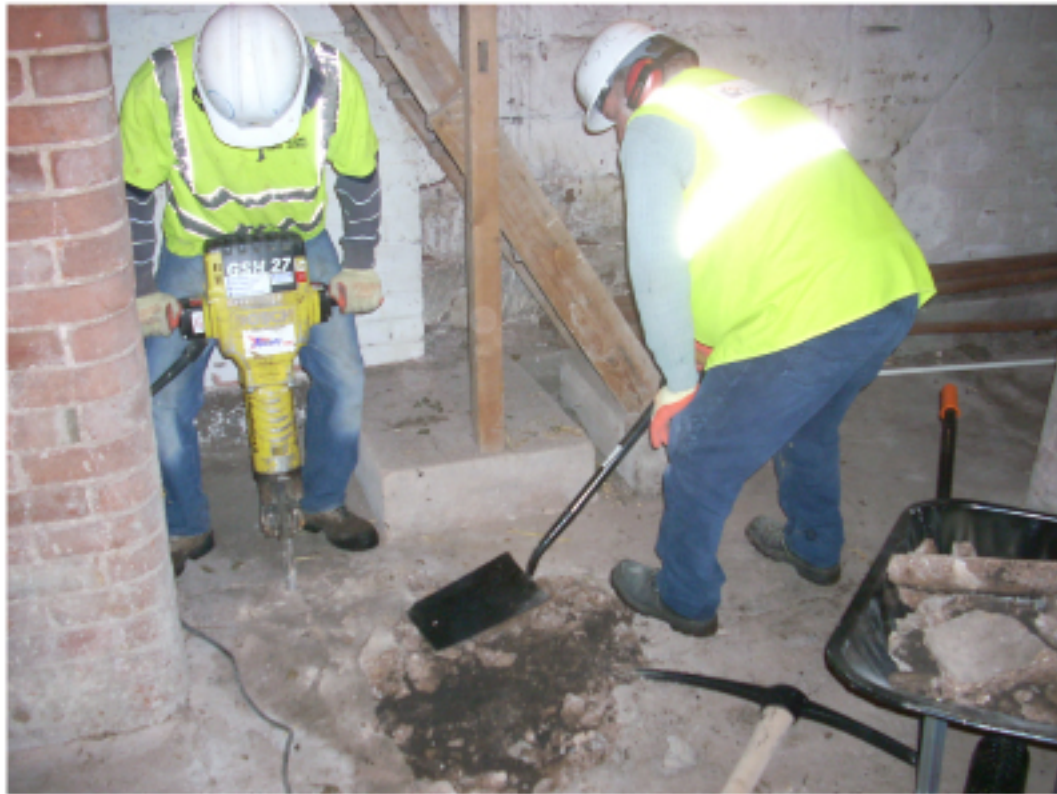
The groundworks took place within the raised ground floor of the southern end of the malthouse.

The depth required to complete groundworks, 0.30m, meant that any original or early archaeological features remained undisturbed.

Malthouse floor groundworks, from the east

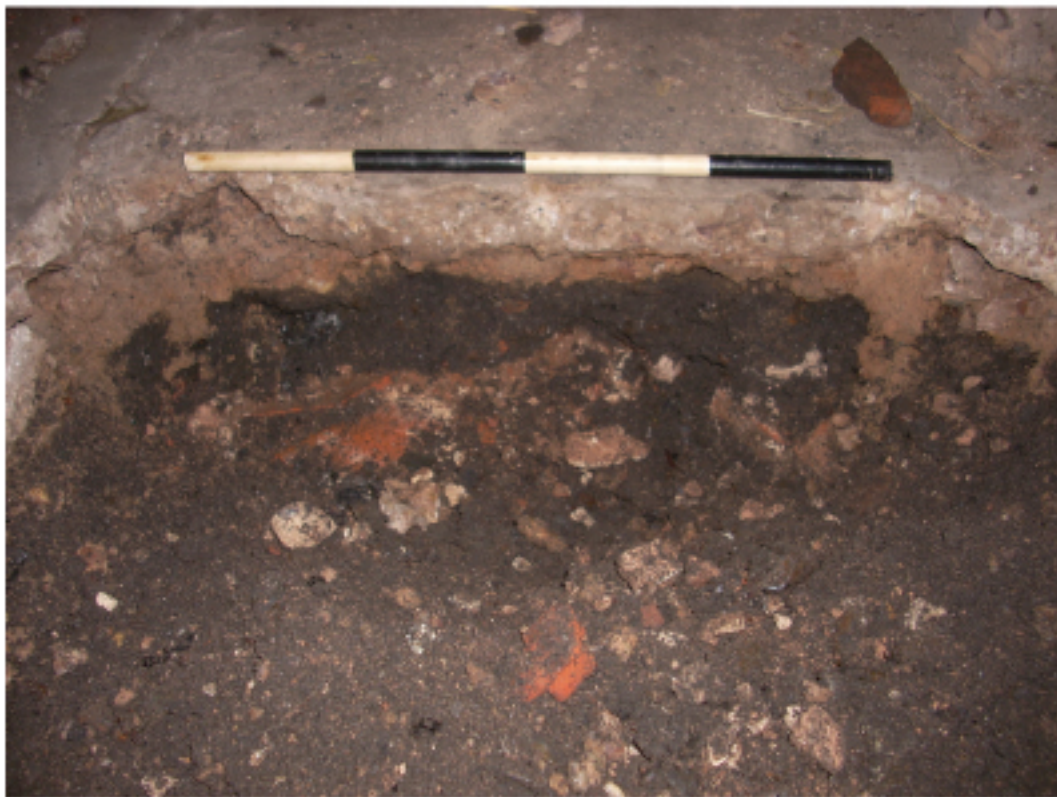
The deepest layer located was a rubble levelling layer of modern brick, tile and large stones excavated to a depth of 0.10m. Overlying this was another levelling layer comprised of coal dust and cinders that had a depth of between 0.05m and 0.09m. Sealing both layers was a concrete floor, measuring between 0.016m and 0.11m deep.

Malthouse floor stratigraphy, from the northwest

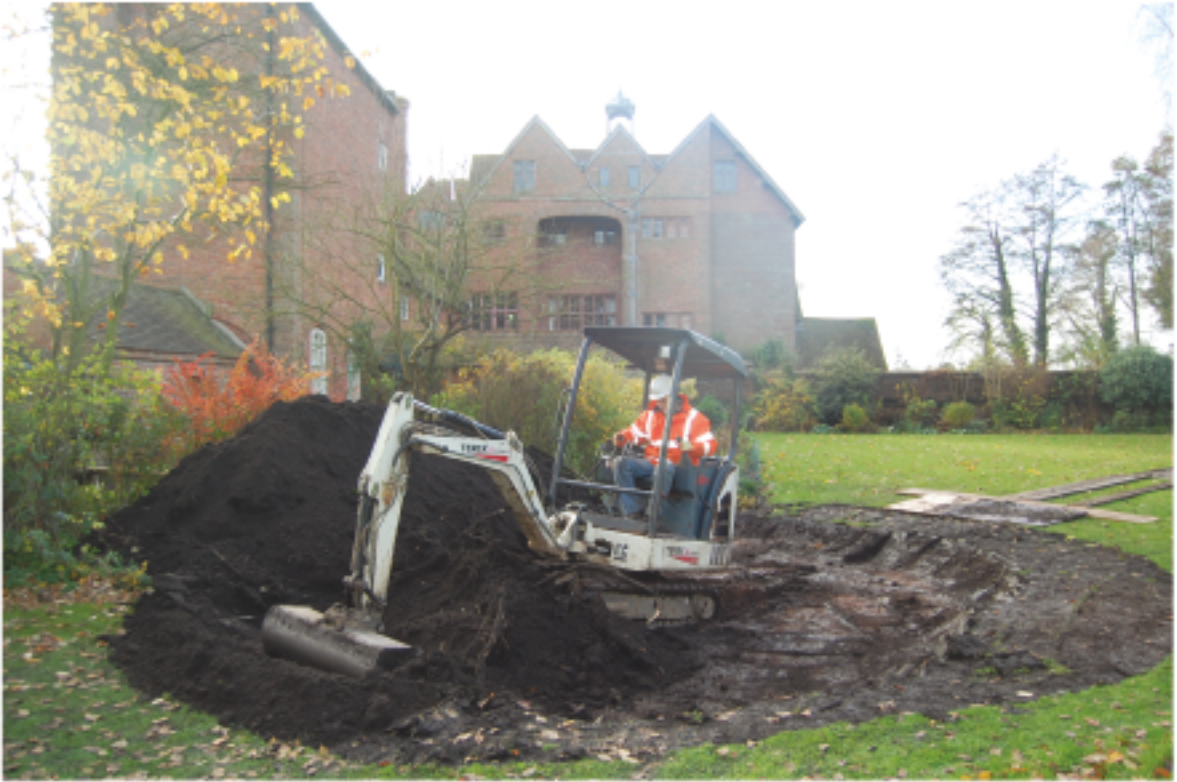
The deepest context reached during groundworks was a layer of pinkish clay-rich silt subsoil that remained unexcavated. The subsoil was overlain by a 0.35m deep dark brown organic topsoil that, in turn, was sealed by a 0.05m deep turf layer.

Mound construction groundworks, from the north

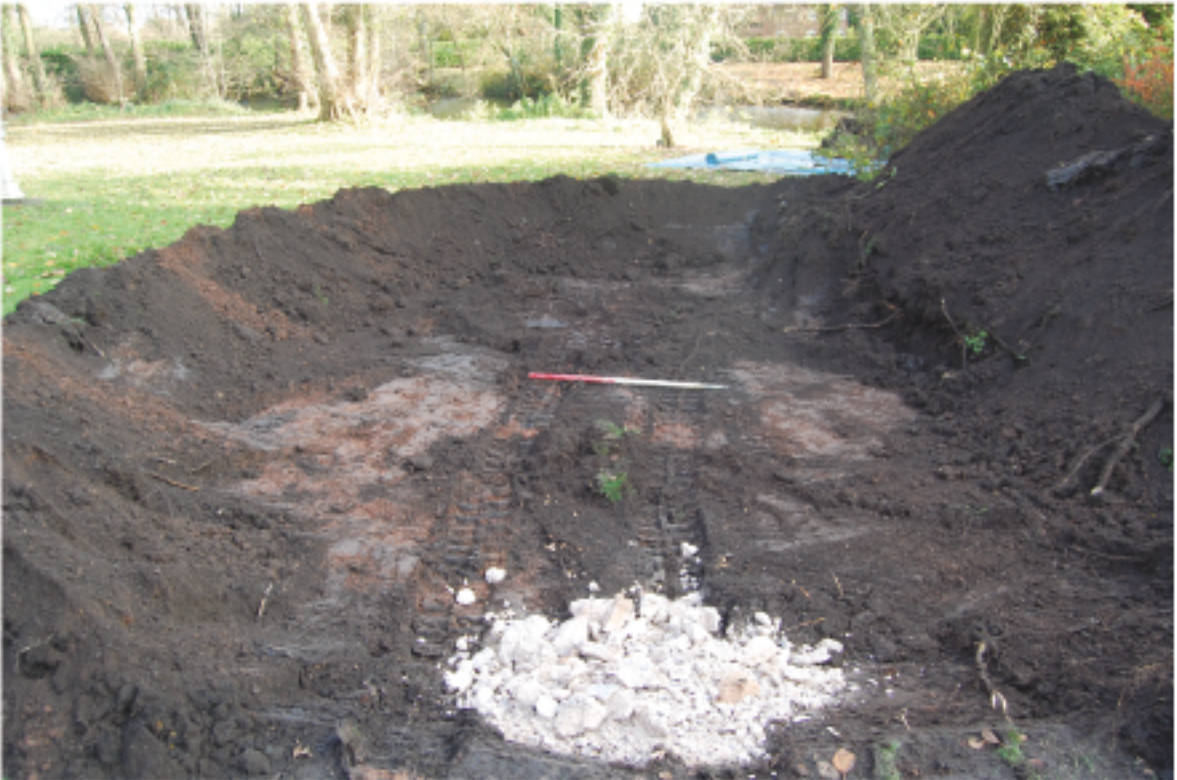
No archaeological features or remains were observed during groundworks.

Mound construction after excavation, from the south
