ST MATTHEWS CHURCH,
MORLEY, DERBYSHIRE

**ARCHAEOLOGICAL
WATCHING BRIEF**

Project No. 1968

12/2009

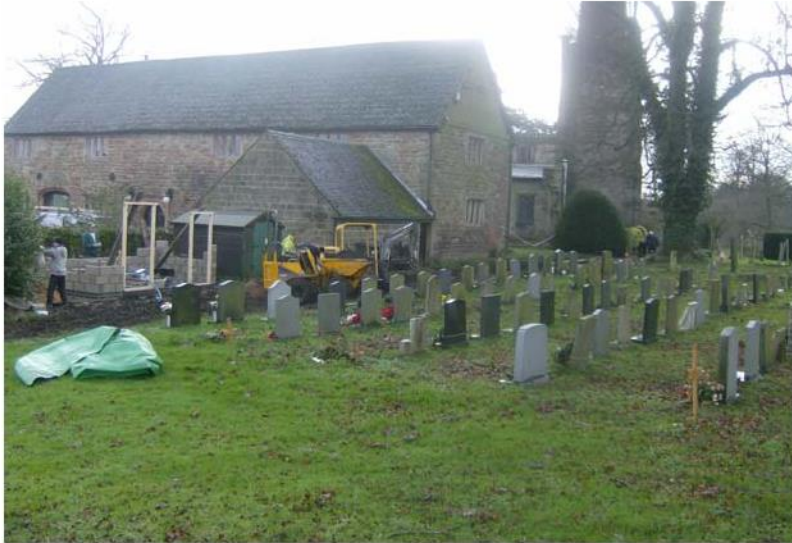
North end of site looking towards the southwest

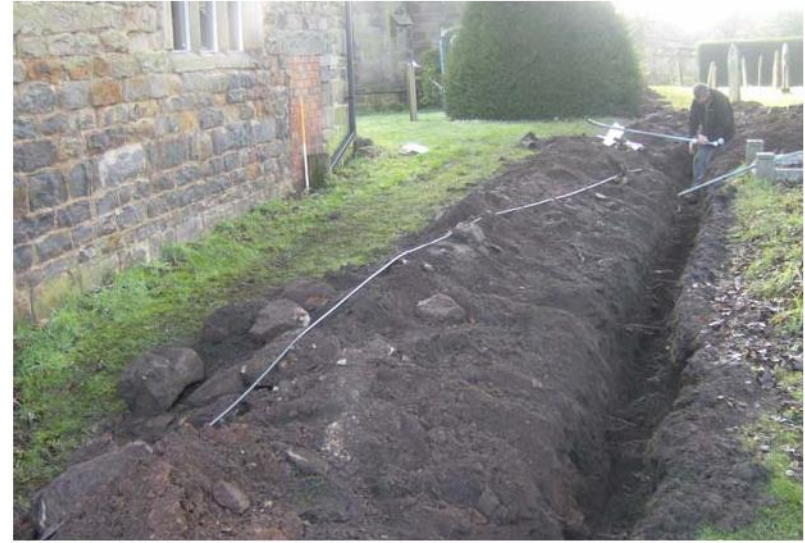
Sandstone block demolition rubble to the north of 1026

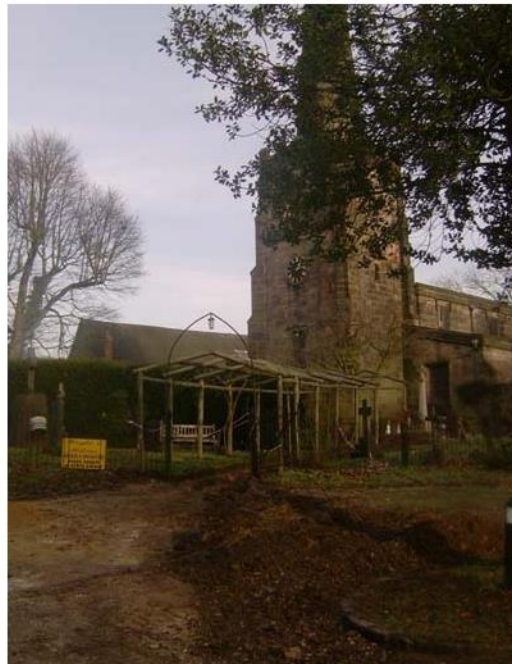
- 6.1.10. Sealing these layers on varying parts of the site were obviously modern deposits (not illustrated), although no artefacts were recovered from these. Plate 3 shows the modern car park and path surface on the southern side of the church. These deposits included, **1018**, a well constructed modern access road, excavated to a depth of 0.6m, **1019** chipped stone car park surface, 0.2m deep, **1015** the gravel foot path surface through the graveyard 0.1m deep. A turf and topsoil (**1007**, 0.2m deep) was located at the southern extent of the site and a turf and clay rich topsoil was located within the graveyard (**1017**), while the turf and topsoil at the very northern extent of the site (**1000**, 0.1m deep), sealed a layer of sandy sub-soil (**1001**).

Excavation for the footpath to the south of the church

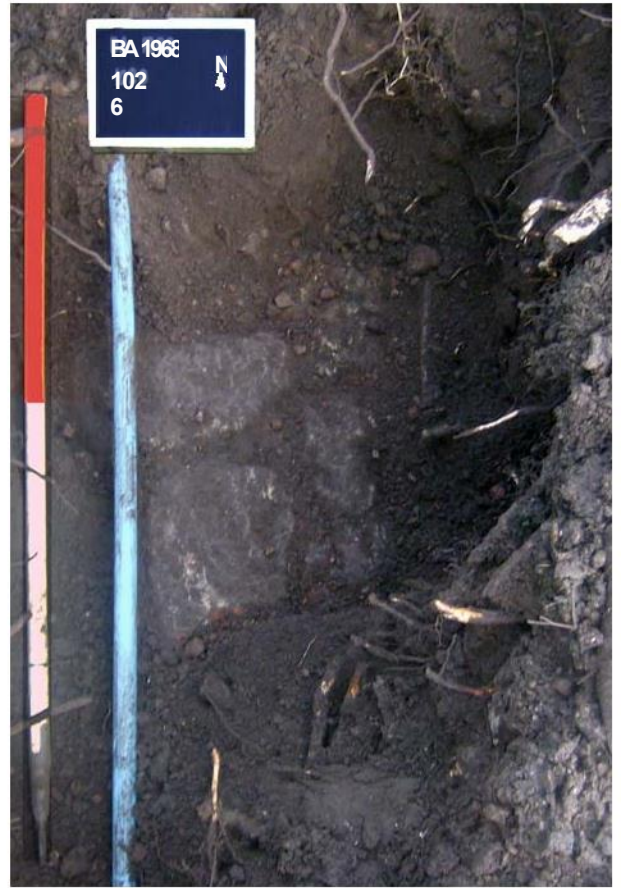
- 6.1.7. A further 5.5m to the north of surface **1020** was sandstone structure **1026** (plate 5). Structure **1026** was located 3.3m to the west of the southwest corner of the tithe barn where the service trench was widened to connect to a stop-cock on the existing water main. **1026** was constructed of rough-cut pink sandstone blocks and was revealed for an area 0.7m² and a height of 0.05m.

Feature 1026 looking north

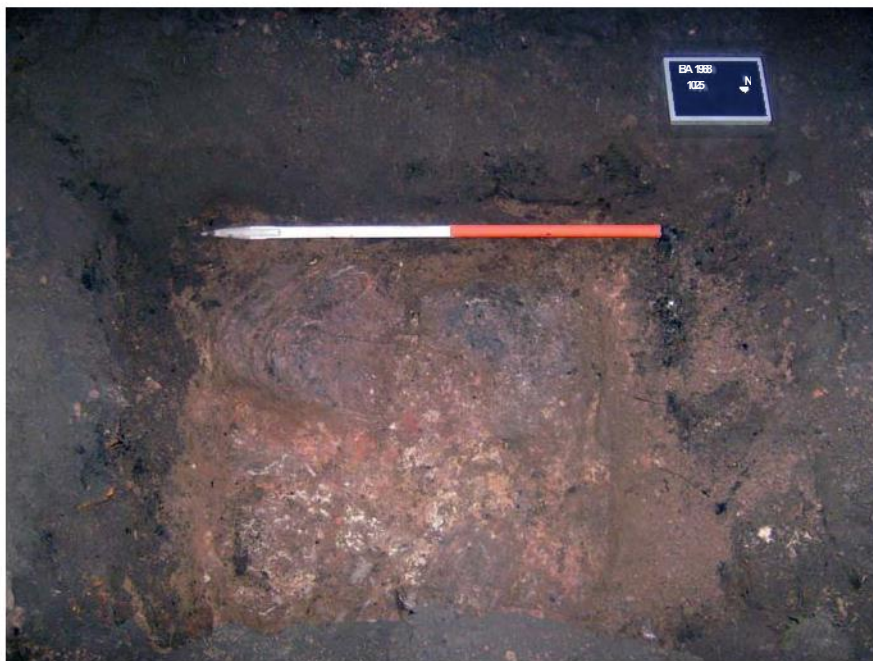
- 6.1.8. Towards the northern extent of site, within the excavation of a manhole, was located sandstone structure **1025** (plate 6). This was exposed in an area 1m², at a depth of 0.8m below the current ground surface. The structure was probably the remains of a wall aligned north to south and comprised of rough-cut sandstone blocks on the eastern side with a rubble core to the west. The full extent of this structure (width, length or height) was not revealed within the course of the excavation.

Surface of 1025 looking south
