ST MARY AND ST  
MARGARET'S CHURCH,  
CASTLE BROMWICH

ARCHAEOLOGICAL  
EVALUATION,  
2009

Project No. 1973

### ARCHAEOLOGICAL EVALUATION

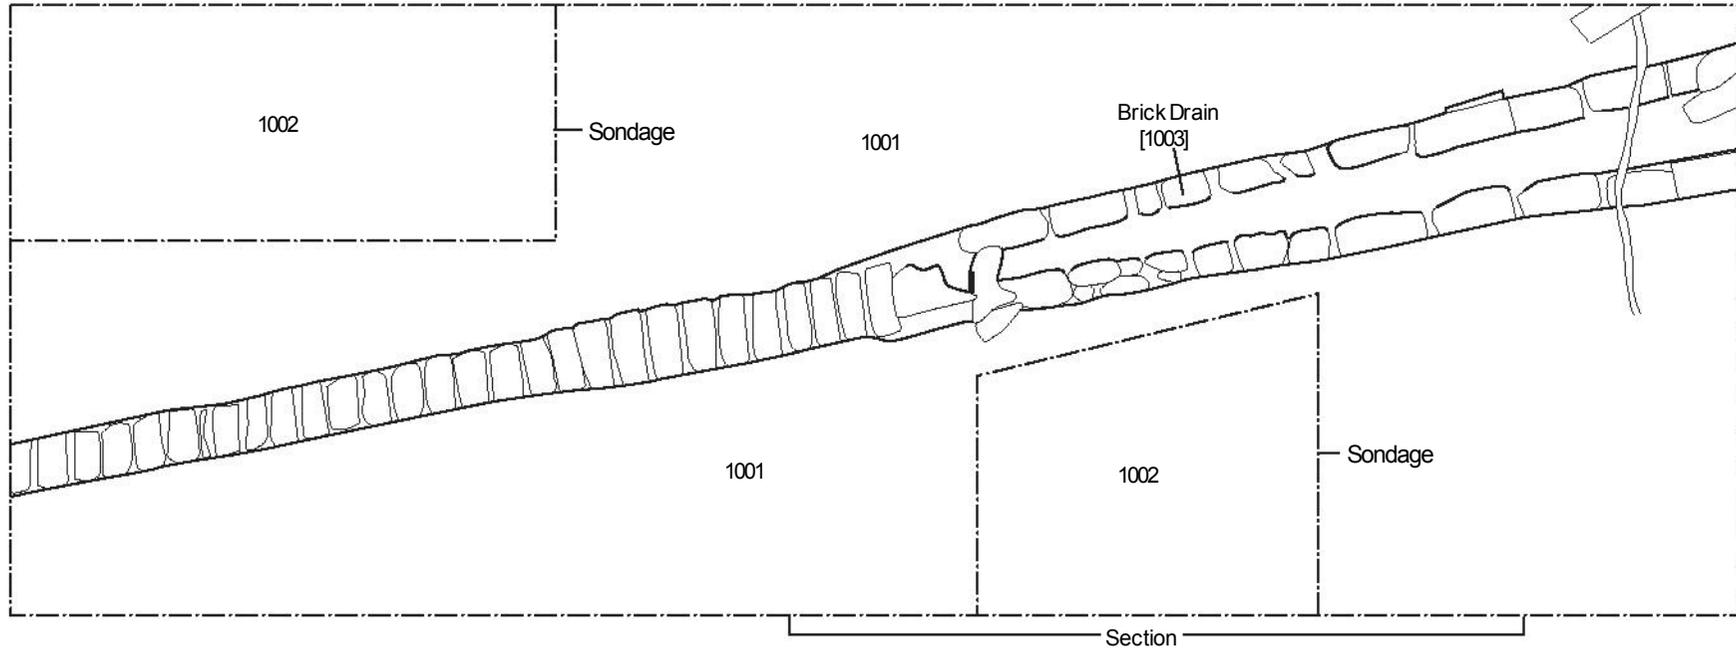
- 6.1.1. Trench 1 (Fig. 2, Plate 1) measured 6m in length by 2m in width and was broadly aligned east-west.
- 6.1.2. Orange-red sandy gravel natural subsoil (1002), was encountered at a depth of 0.50m and was overlain by light yellow-brown silty sandy gravel subsoil (1001) 0.32m deep. The subsoil was cut by a northeast-southwest aligned linear brick-lined drain, up to 0.40m wide (1003), which ran the length of the excavated trench. This feature was sealed by mid-brown sandy silt topsoil (1000).
- 6.1.3. Given the size and typology of the bricks found lining the drain the origins of this feature most probably dates to the 17<sup>th</sup> century (Chris Hewitson, Birmingham Archaeology, pers. comm.).
