**BARTON ROPEWALK
BARTON-UPON-
HUMBER**

ARCHAEOLOGICAL DESK-
BASED and HISTORIC
BUILDINGS
ASSESSMENT 2009

BARTON ROPEWALK,

**ARCHAEOLOGICAL DESK-BASED and HISTORIC
BUILDINGS ASSESSMENT**

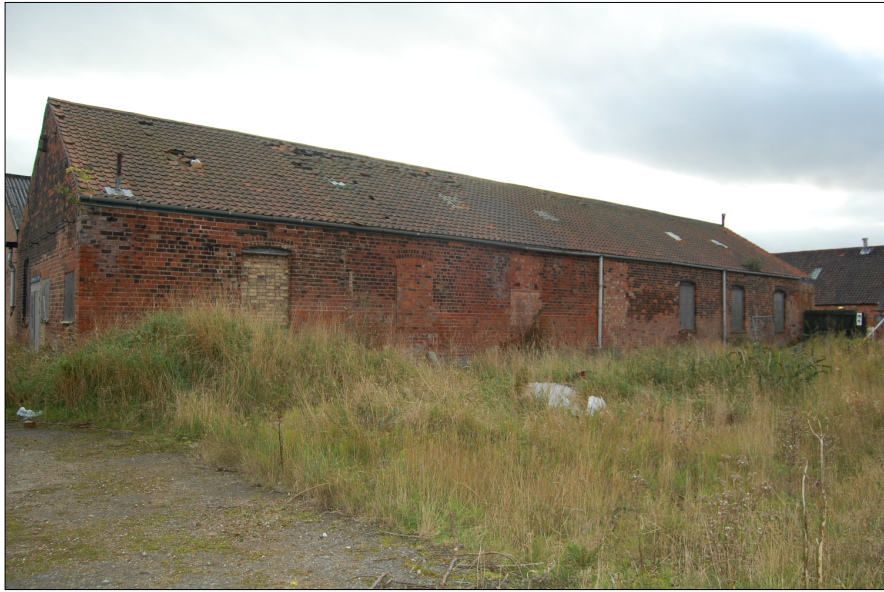
- 9.2.4. The original phase of **Section C** (Plates 9 to 11) was constructed in a reddish orange brick measuring 9 1/8 ins x 3 ins x 4 1/2 ins, and is laid in English garden wall bond. The north elevation has seven bays of segmental arch windows (now blocked) with brick sills. The east elevation also contains one of these original windows in addition to two inserted windows and a doorway. The west elevation has undergone a lot of repair and has an inserted machine door with steel lintel. The pitched gabled roof is covered in clay Roman tiles, which do not appear to be an original feature. Scarring and staining on the east wall suggests a previously adjacent building running towards the historic ropewalk building.

- 10.4.2. With regard to the ropeworks building at the north end of the site, it is recommended that historic building recording be carried out prior to demolition or wholesale alteration of the structures. An appropriate response in these particular circumstances would be a record equivalent to a Level 2 survey as defined by English Heritage (2006) which would require written descriptions, plans, and a photographic record to be carried out. It is also
