**NEWMAN BROTHERS  
COFFIN FURNITURE WORKS,  
13-15 FLEET STREET,  
BIRMINGHAM**

**ARCHAEOLOGICAL  
WATCHING BRIEF 2009**

**Project No. 1998**

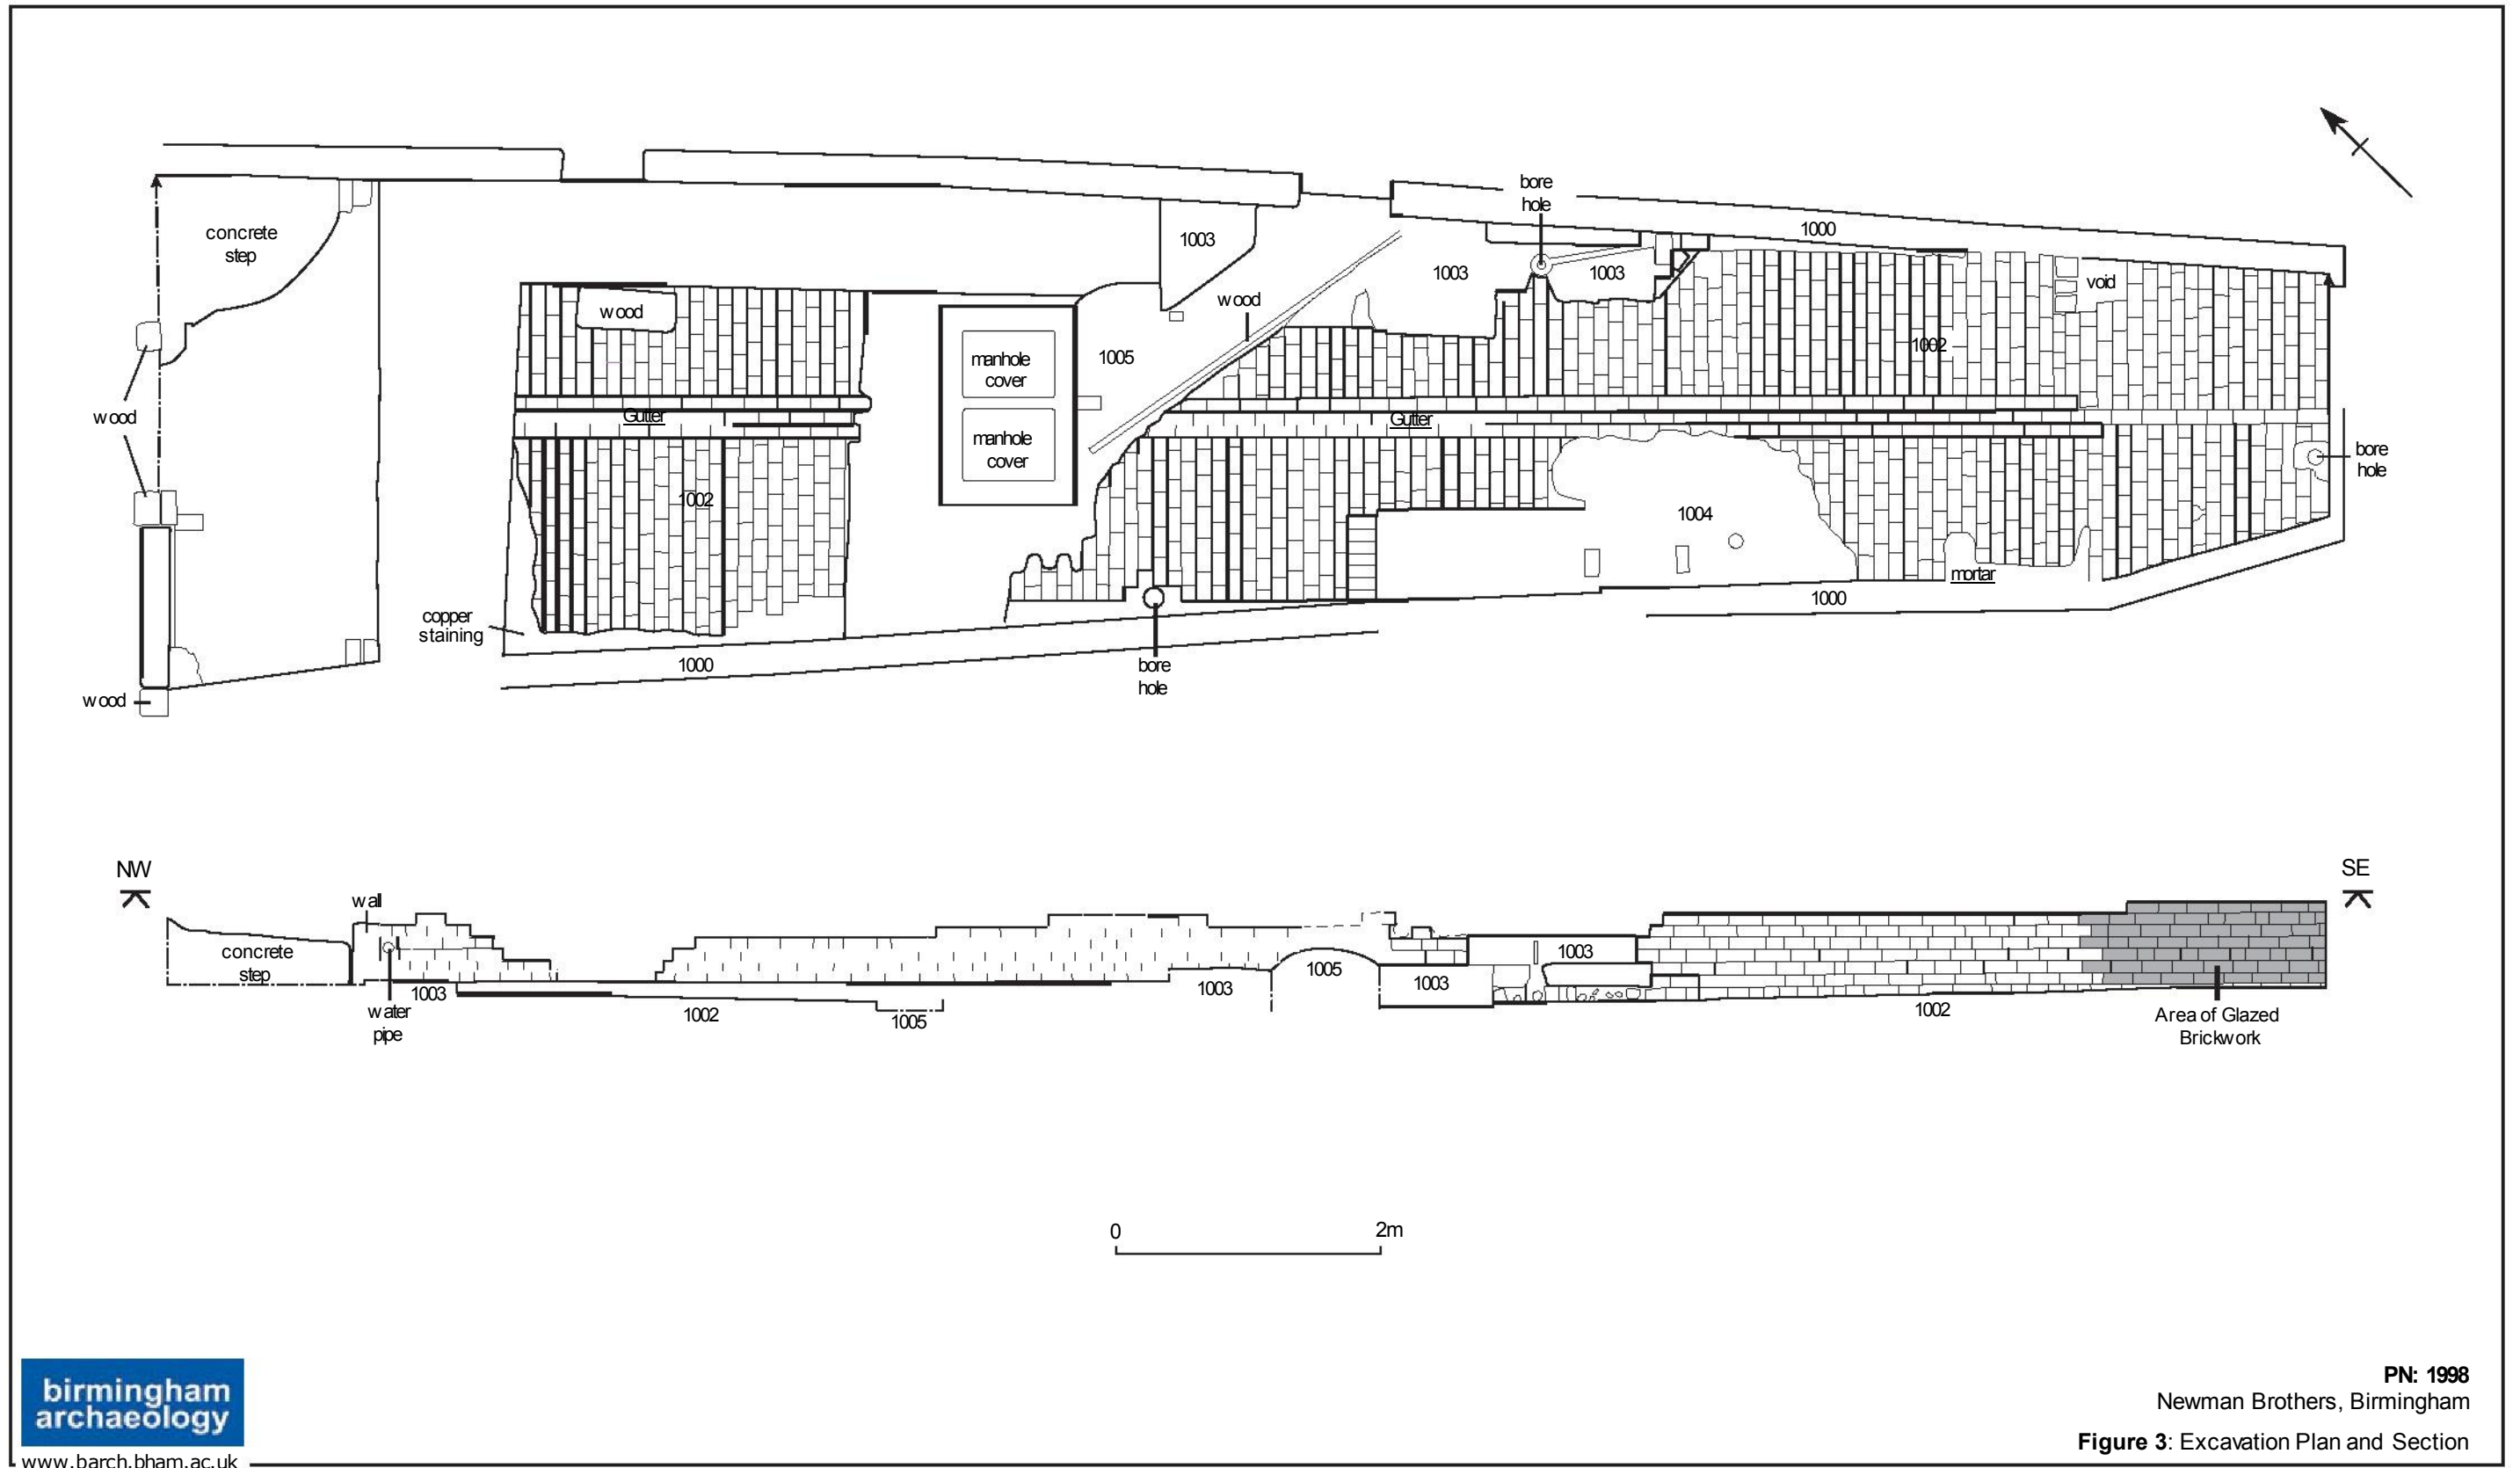
- 5.1.1. The results of the watching brief are illustrated in Figure 3 and Plate 1, while references to the surrounding buildings of the works are illustrated by Figure 2.

- 5.1.2. In the central part of the courtyard was a large sunken brick structure; this had been visible in plan, prior to the commencement of work and excavation revealed this to be up to 0.75m deep. The brick floor and wall of the structure were left *in situ*.

- 5.1.3. The structure was 16.4m long 3.85m wide and trapezoidal in plan orientated along the long axis of the central courtyard. The external wall (1000) was constructed in English bond of hand-made brick (9" x 4¼" x 3") worn in places with copper staining, and had been patched with later brick-work on the southwest side. At the southeast end of the structure the internal three sides of wall 1000 were faced with white-glazed bricks for a length of 1.85m corresponding with a narrowing of the southern corner of the structure. The glazed bricks were bonded with the remainder of the build of the structure.

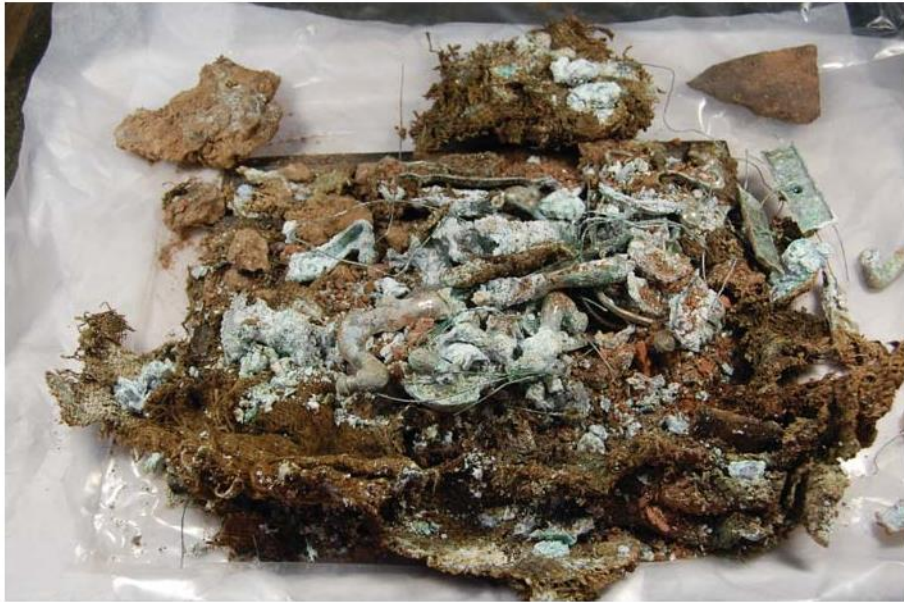
- 5.1.11. The northwest part of the structure was backfilled with loose brick rubble (1001), this was contaminated, so was not investigated in detail. Rubble backfill 1001 contained the remains of a hessian sack which contained silver plated coffin furniture and other items (Plates 2-4). This suggested the structure had been backfilled in the mid to late 20<sup>th</sup> century.

Within rubble backfill 1001 were the remains of a hessian sack which contained 1773g of silver plated coffin furniture, some strung together with copper wire and other unidentifiable corroded items. These finds are depicted in an undated loose leaf Newman Brothers catalogue. As the catalogue includes coffin accessories that were not made at Newman Brothers it may be quite late, perhaps dating to the 1960s or later (pers com Elizabeth Perkins).
