Police OCU, Oak Road,
West Bromwich, Sandwell

**ARCHAEOLOGICAL
WATCHING BRIEF 2010**

Project No. 2085

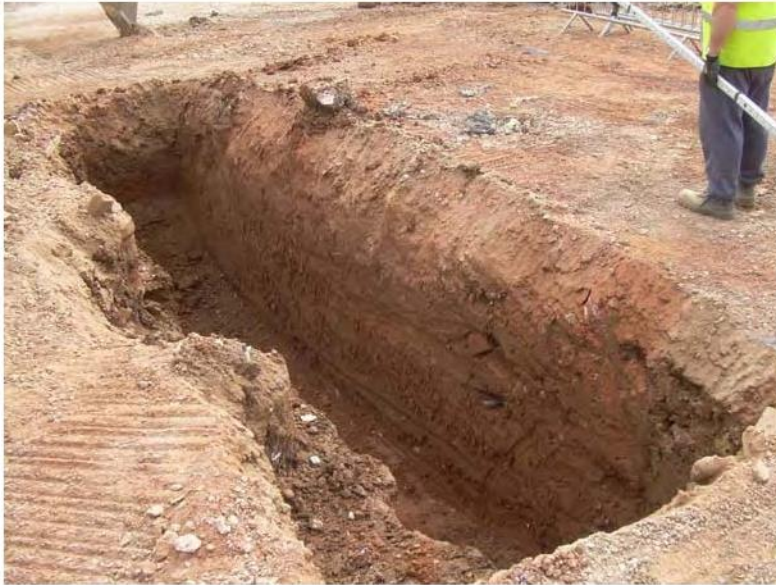
Plate 1

6.1.2.3 The northern end of the building foundations were dug to a depth of around 1.2m below the existing ground surface (Plate 1). The natural subsoil was not reached at this depth, with the earliest layer being a black silty clay that contained large amounts of brick rubble throughout. Overlying this layer was a 0.3m thick layer of pink/red sand. Sealing the red/pink sand was a layer of modern crushed stone, 0.3m in thickness, which was overlain by a layer of tarmac, 0.1m in thickness.

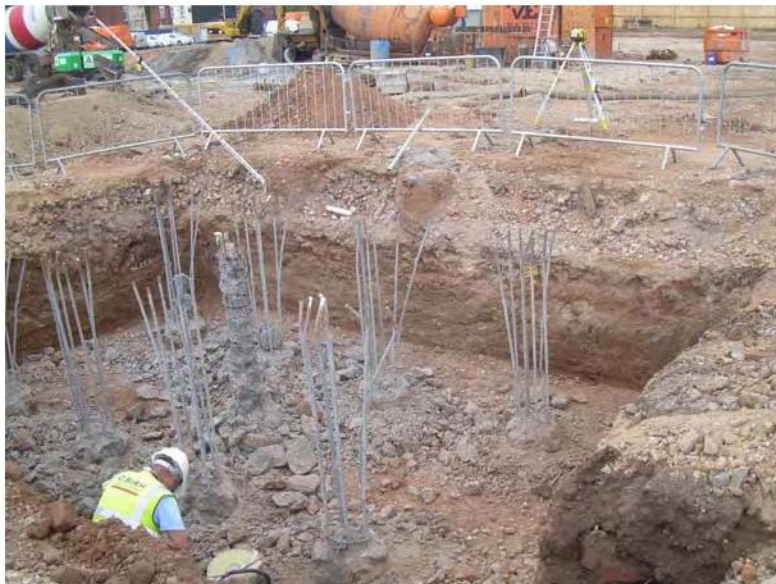
Plate 2

6.1.2.4 Two lift shafts were also excavated in the area of the building foundations, and these were dug to a depth of 1.95m below the existing ground surface (Plate 2). The natural subsoil here was located at a depth of c.1.45m below the existing ground surface and consisted of orange-red gravel. No significant archaeological deposits were visible.

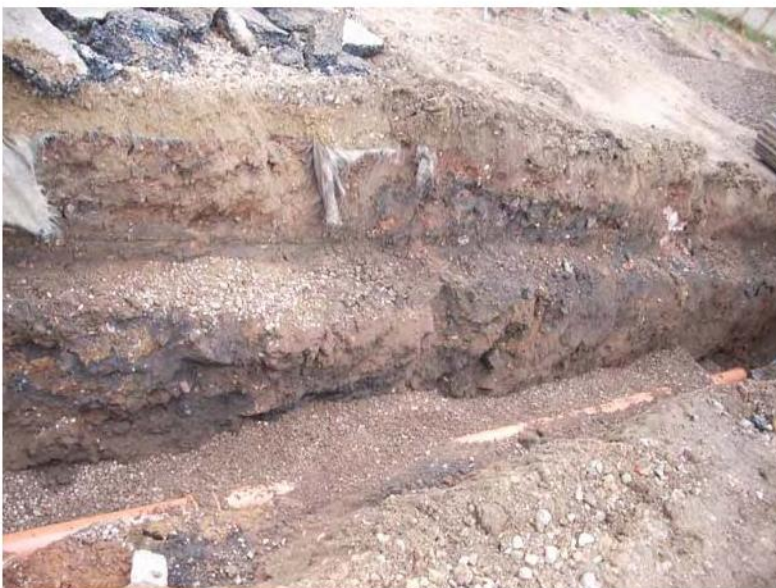
Plate 3

6.1.3.1 In this area, at the northern end of the site and to the west of the main building footprint, two pipe trenches and related manhole pits were dug (Plate 3).

6.1.3.2 These two pipe trenches, one east-west aligned, and one north-south aligned, were dug to a depth of c.2m below the existing ground surface. The natural subsoil was not located at this depth, with the earliest layer encountered being a black silty clay that contained fragments of 19th-century pottery and other 19th-century material. Sealing this was an orange silty clay, which was overlain by a brown silty gravel. Overlying the gravel was a tarmac surface. No significant archaeological deposits were noted in this area.

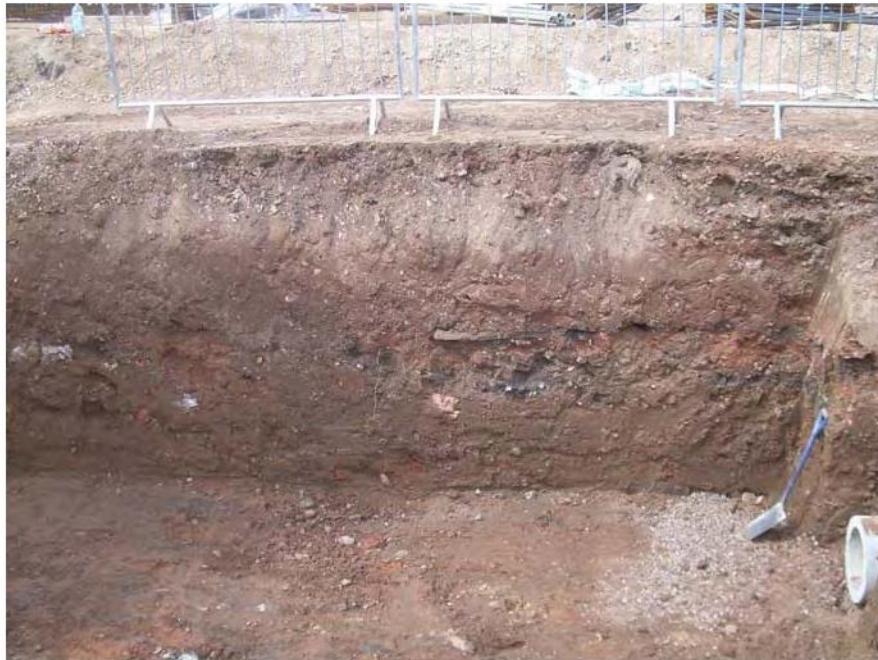
Plate 4

6.1.4.1 This area encompasses the groundworks relating to the excavation of storage tanks and pipe trenches for new services. A large trench was excavated to provide access for the ground works, with this being dug to a level of around 2m below the existing ground surface (Plate 4).

6.1.4.2 The earliest layer encountered was a mid brown silty clay that contained brick rubble fragments throughout. This was overlain by a layer of pink silty sand, which was overlain by a layer of dark brown silty clay. Sealing this layer was a mixed brick

rubble/stone demolition layer. No significant archaeological deposits were recorded in this area.

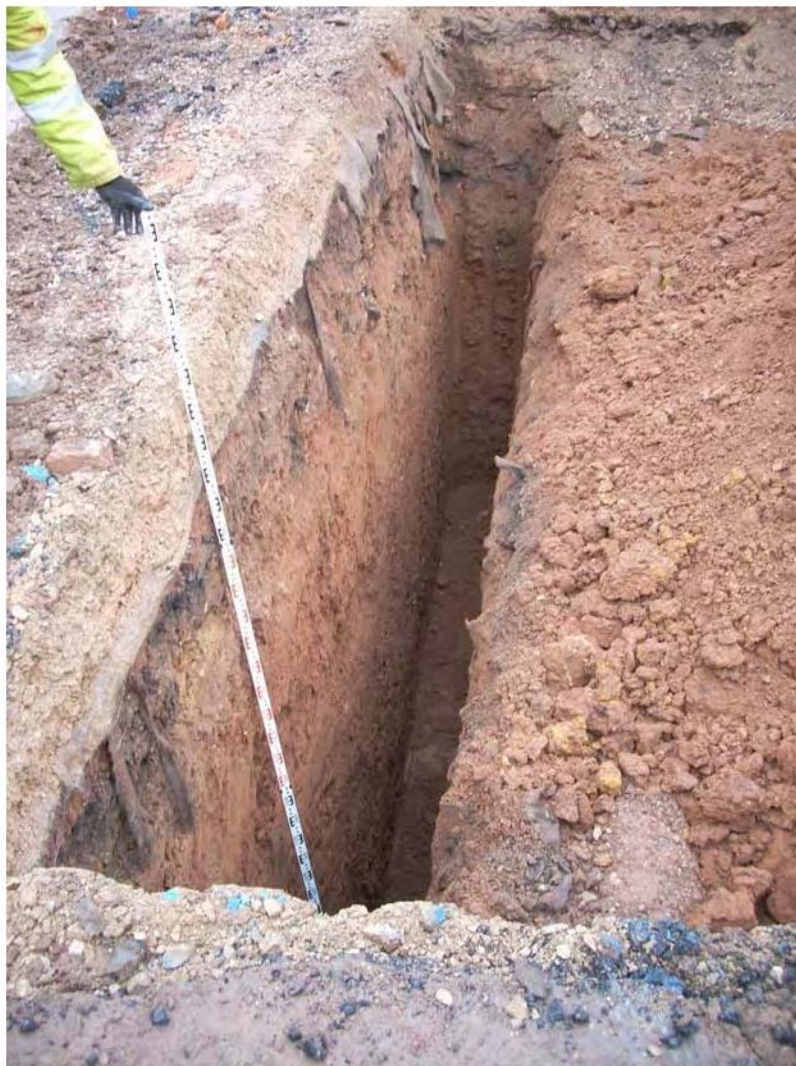
Plate 5

6.1.5.1 In this area, at the western part of the site, a trench was excavated for a fuel tank (Plate 5).

6.1.5.2 The tank was excavated to a depth of 4.5m below the existing ground surface (Fig. 3). The natural subsoil not located and the earliest layer encountered was a red-grey silty clay with stones throughout [403]. This was sealed by a layer of red-pink sand [402], which was overlain by a grey-black silty clay [401] that contained brick rubble throughout. Overlying this was a modern yellow crushed stone layer [400]. No significant archaeological deposits were identified in this area.
