Hilderstone Hall
Staffordshire

**Archaeological
Desk-Based
Assessment**

October 2010

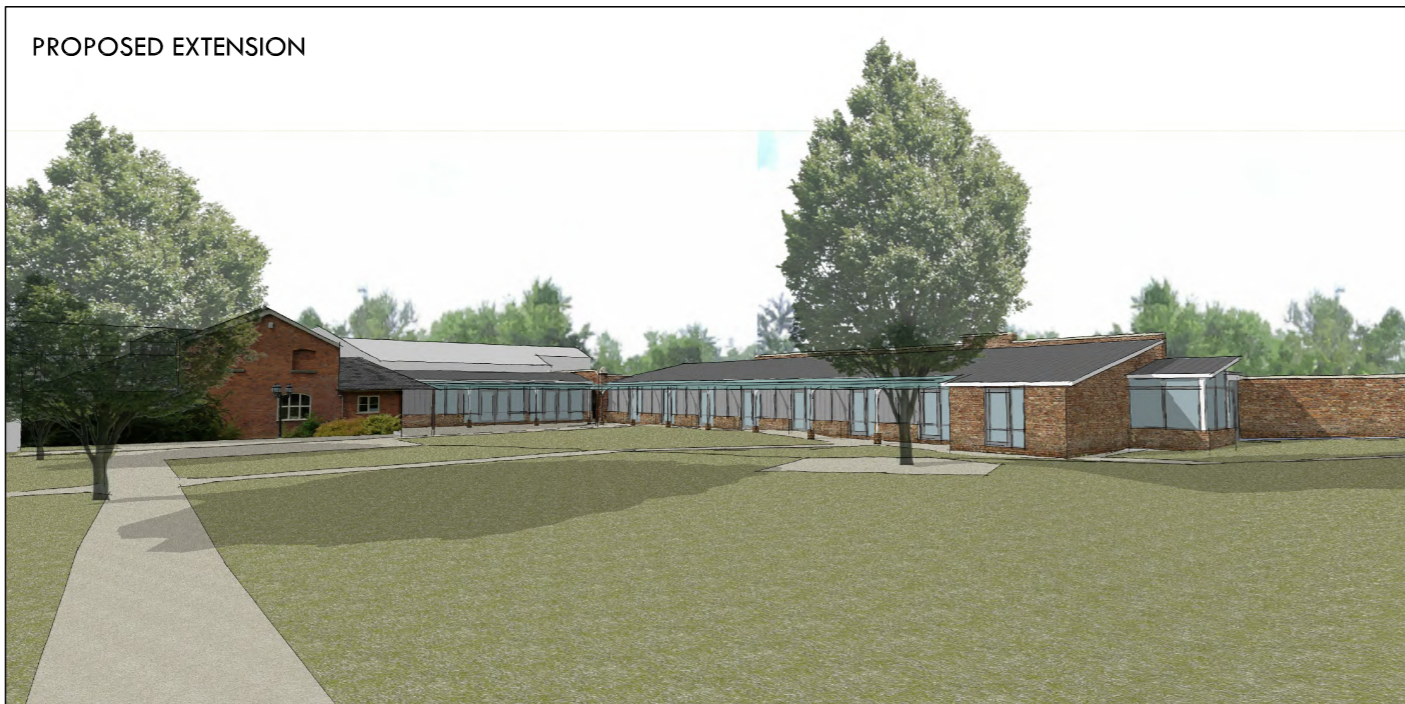
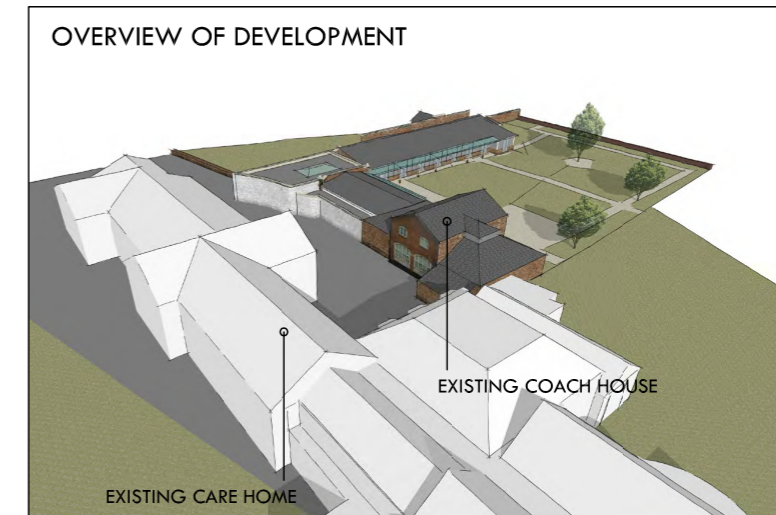
JOB REF: 10/137
 PROPOSED ALTERATIONS
 Hilderstone Hall, Stone
dwg. (D)003
 Indicative 3D Views
 Scale :NTS @ A3

PROPOSED EXTENSION

- 1.2.1 Barchester Healthcare is developing proposals to extend their current care-home premises by means of a single storey bedroom block to the rear and a conservatory/dayroom extension to one of the returns. The proposed new bedroom block is to be located in the walled garden to the rear of Hilderstone Hall and will consist of a link block between the existing 'Coach House' building and an existing garage, which will be converted for use as a kitchen and dayspace respectively. The new bedrooms will be located in a lean-to block running from the 'garage' and will make use of the current garden wall as its rear elevation. The dayroom extension/conservatory is to be added to the return of a late 20th century extension to the historic Hilderstone Hall, and its unintrusive nature means that it is unlikely to affect any underground archaeology and as such will not be assessed in detail here.

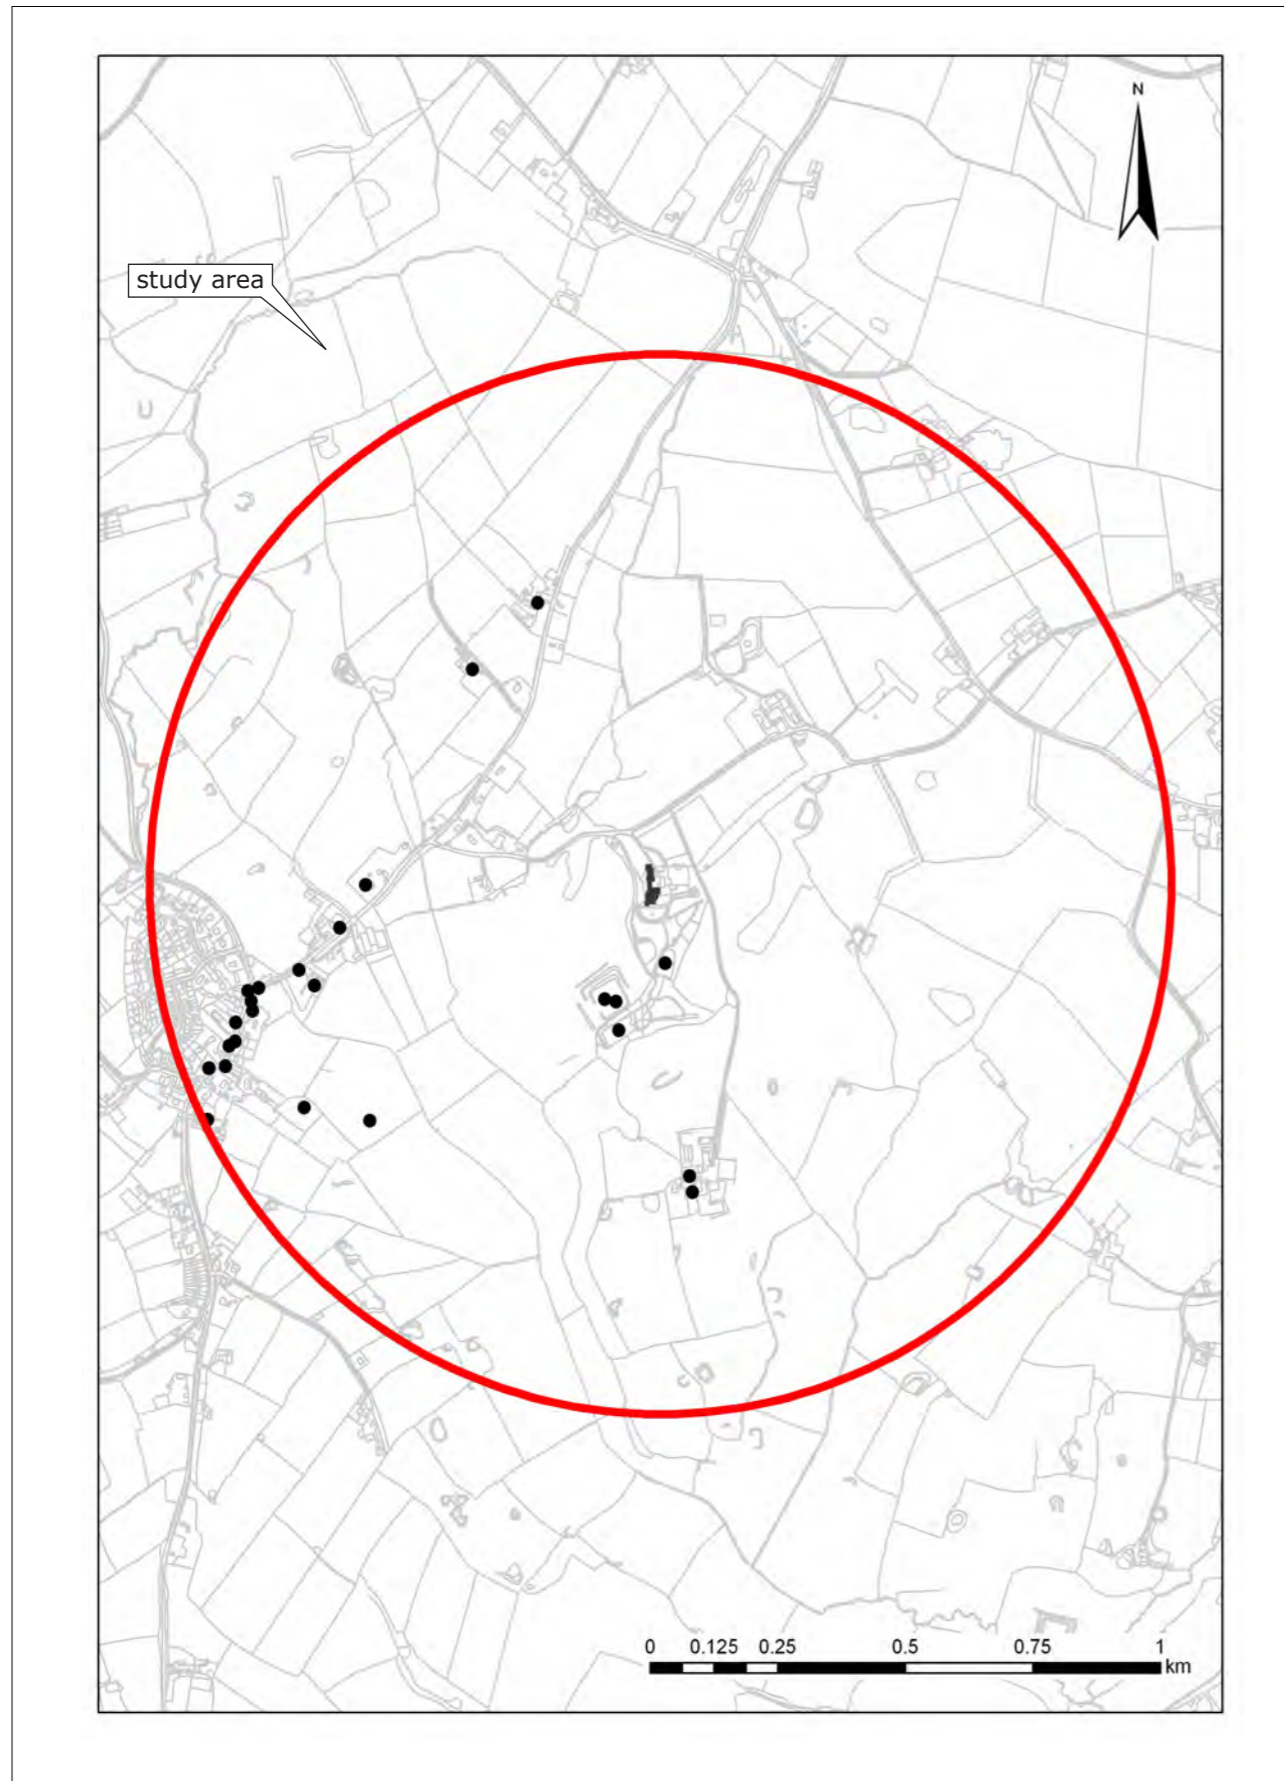
(a) SCC HER entries within Study Area

the Staffordshire HER within the wider study area; the sites are summarised in tabulated form below and locations are illustrated in Figure 5.

HER Ref.	Type*	Site name/description	NGR	Period/Date
02480	DE	Hilderstone/Helduluestone settlement	SJ 949 347	Anglo Saxon
00679	SAM	Hilderstone Moated Site	SJ 9558 3471	Medieval
00680	AS	Fishpond south of Hilderstone Moat	SJ 9560 3464	Medieval/Post Medieval
54120	AS	Fishpond northeast of Hilderstone Moat	SJ 9570 3477	Medieval/Post Medieval
02661	AS	Field system, south-east of Christ Church	SJ 9523 3425	Medieval
60658	FS	Token Findspots, Hilderstone	SJ 95 34	Medieval/Post Medieval
40088	HPG	Hilderstone Hall Park	SJ 9570 3470	Post Medieval
51326	HB	Milepost, Hilderstone	SJ 948 346	Post Medieval
54123	HB/DE	Bank Top Farm/ Home Farm, Creswell Road, Hilderstone	SJ 9533 3532	Post Medieval
54124	HB/DE	High Elms, Creswell Road, Hilderstone	SJ 9546 3544	Post Medieval
07684	LB (II)	Barn, Hall Farmhouse, Hilderstone	SJ 9575 3434	17 th century
53195	HB/DE	Hall Farm, Hilderstone	SJ 9575 3434	17 th century
07690	LB (II)	Horseshoe Farmhouse and Cottages, Hilderstone	SJ 9484 3461	18 th and 19 th century

07688	LB (II)	The Shop and Copes Cottage, Hilderstone	SJ 9486 3466	18 th and early 19 th century
07683	LB (II)	Hilderstone Hall, Hilderstone	SJ 9568 3490	c.1810 or earlier
07681	LB (II)	Hilderstone House, Creswell Road, Hilderstone	SJ 9512 3492	Early 19 th century
07682	LB (II)	Church Farmhouse, Creswell Road, Hilderstone	SJ 9506 3484	Early 19 th century
07685	LB (II)	The Smithy and School House, Hilderstone Road	SJ 9488 3471	Early 19 th century
07687	LB (II)	Lower Farmhouse, Hilderstone Road	SJ 9489 3468	Early 19 th century
07698	LB (II)	The Stores, Hilderstone Road	SJ 9481 3457	Early 19 th and late 19 th century
07699	LB (II)	Yew Tree House, Hilderstone Road	SJ 9481 3447	Early 19 th century
07694	LB (II)	Hall Farm Cottages, Hilderstone Road	SJ 9484 3457	Early 19 th century
07679	LB (II)	Christ Church, Creswell Road, Hilderstone	SJ 9502 3473	1827-9
07680	LB (II)	Churchyard Wall, gate piers and gates	SJ 9498 3475	1829

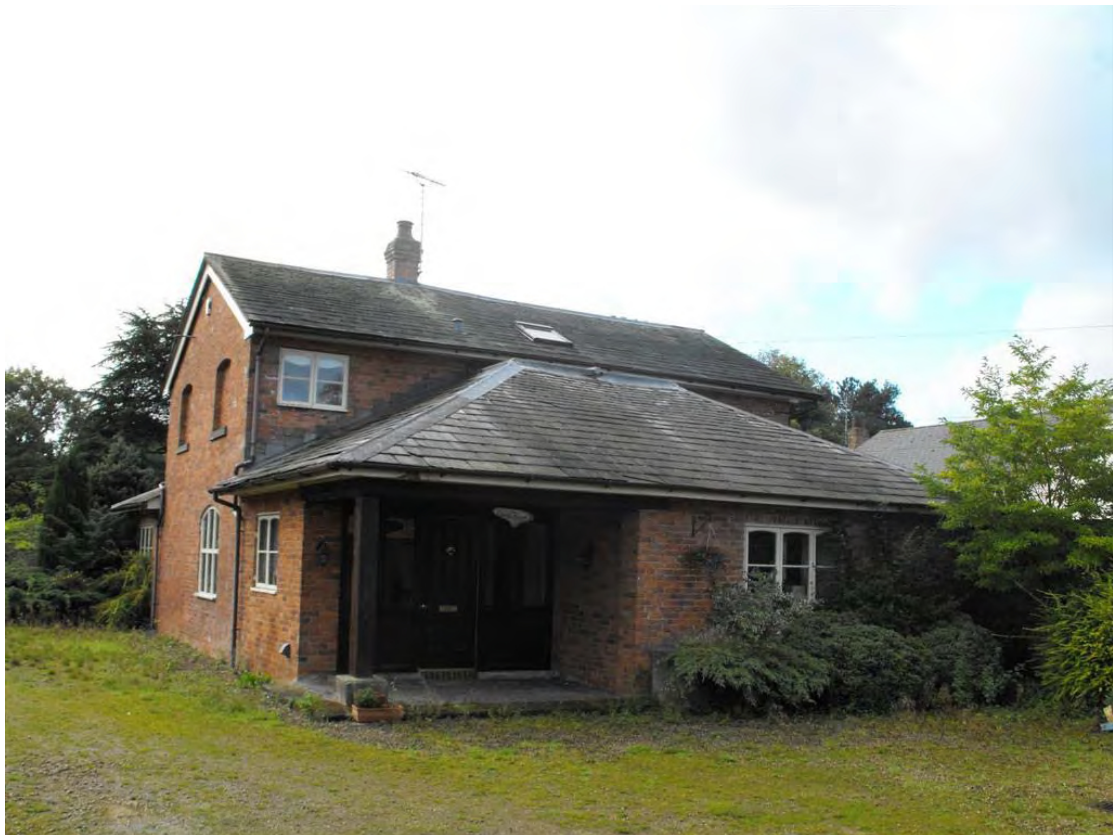
Plate 8: Coach House from north.

9.1.2 It is this internal wall elevation and the principal elevations of the 'Coach House' and garage that will be most effected by the proposed development. The 'Coach House' and the garage appear to be of a mid/late 19th century date from historic cartographic evidence and as such, particularly *in lieu* of the fact they form part of the curtilage of a listed structure should be treated as heritage assets as specified in HE6 of PPS5.

- A level 2 record⁴ of the affected elevations of the 'Coach House' and the garage should be carried out prior to any works that would serve to obscure them; this would entail a photographic, drawn, and analytical record.
- A level 2 record should also be made of the internal elevation of north wall attempt to identify and record any original fabric prior to any works that would obscure it.

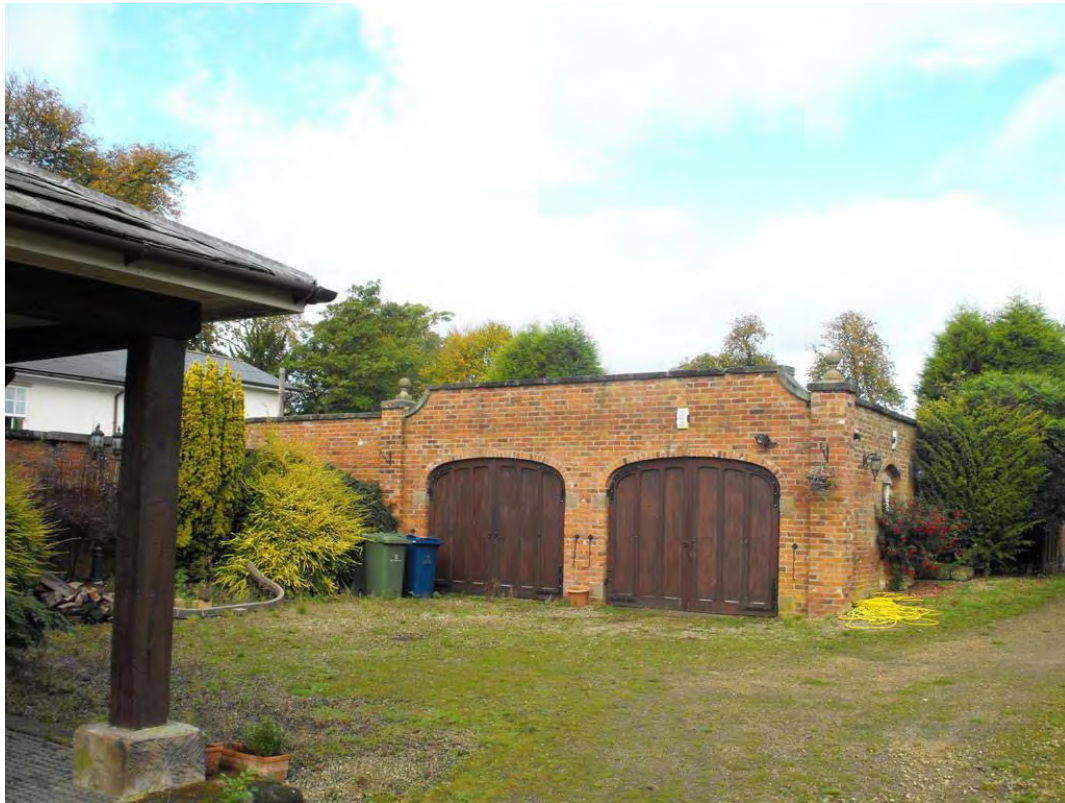
Plate 9: Garage from south.

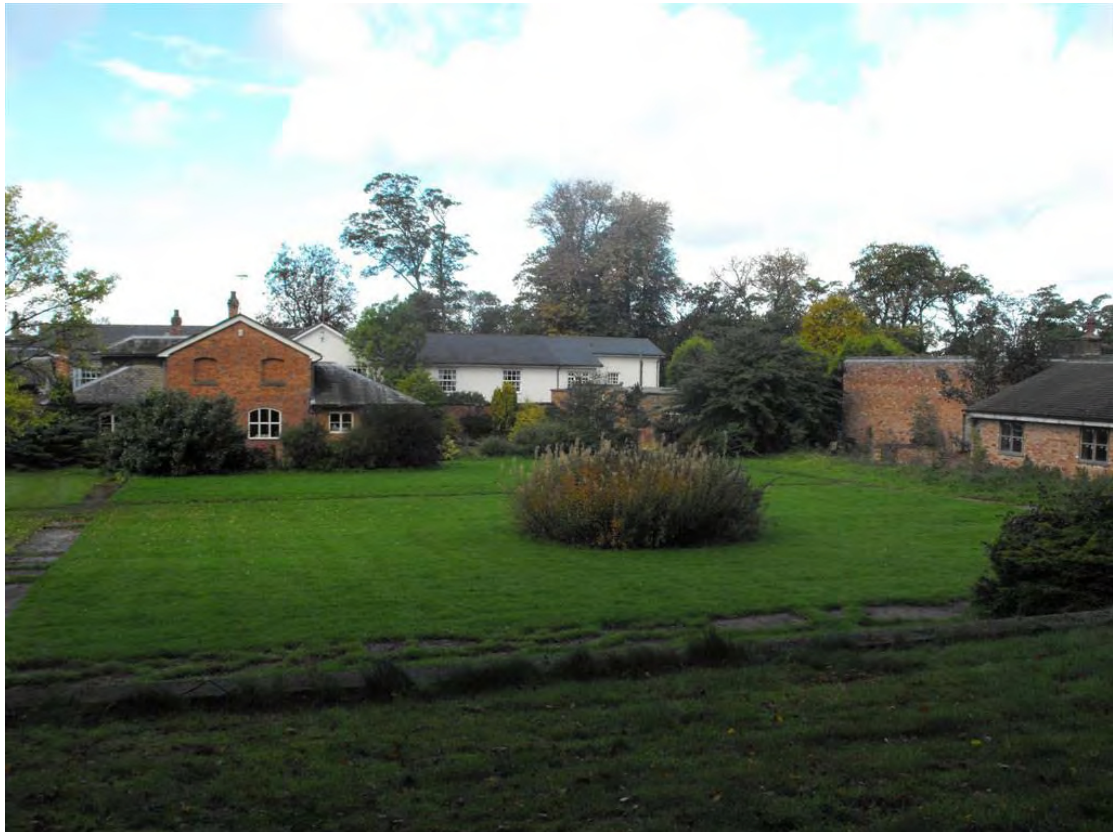
Plate 11: Walled garden (interior) from east.

9.1.1 The assessment has established that the proposed development site lies in an area that was within the vicinity of a known Anglo Saxon settlement and formed part of an intensively managed medieval landscape which was administrated from the predecessor of Hilderstone Hall on a nearby moated site from at least the 13th century. It would seem that current Hilderstone Hall appears to date from the mid-18th century and that it is likely that it was constructed on a virgin site relatively adjacent to the earlier manor house which occupied the moated site. It is unclear as to when the walled garden that will be affected by the proposed development was laid out, however it appears on the 1844 tithe map along with some of its associated structures, whilst it is also apparent that the internal elevation of the north wall, which will be obscured by the proposed development, was lined with greenhouses from at least the 1870s. It is also certain that the very little fabric remains of the original walls of the walled garden; the south and west walls have been completely removed, the east wall has been severely truncated, and the internal face of the north wall has been altered, punctuated and considerably refaced in new brickwork in recent times.

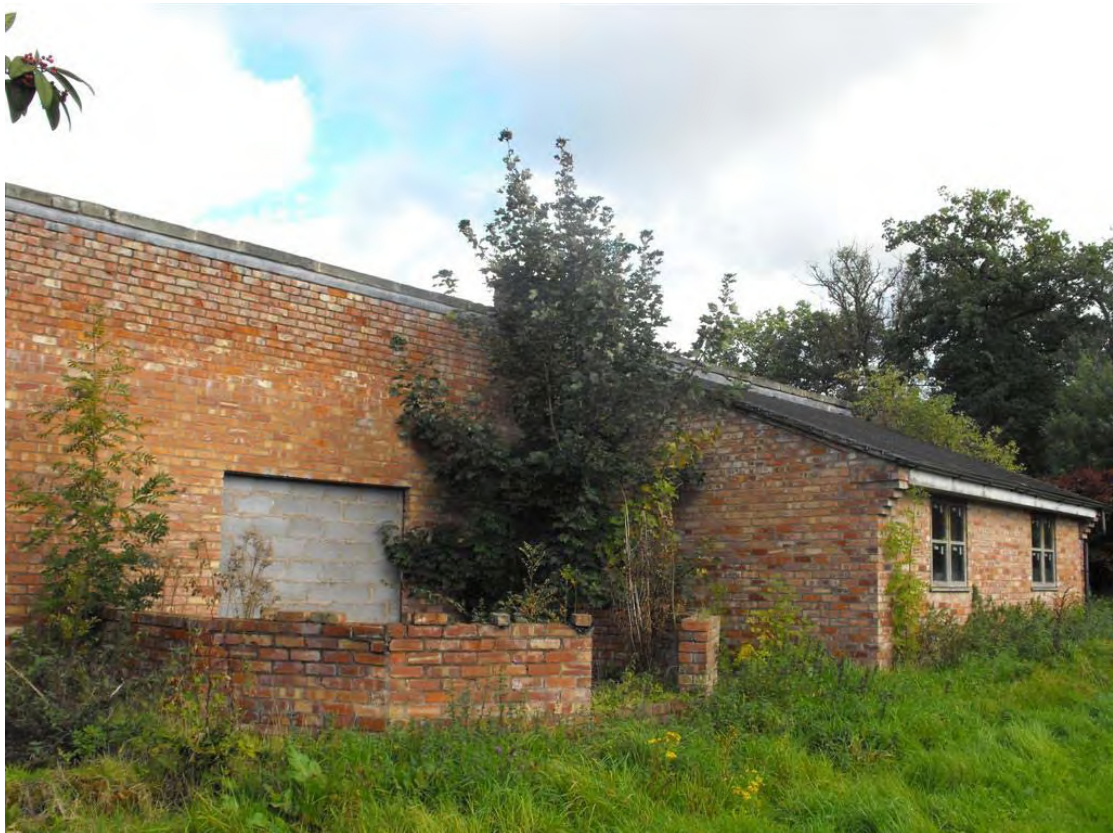
Plate 12: Section of wall and lean-to from southwest.

- 8.3.4 The walled garden is present on this map; it would seem that this has a wall on each of its sides, with a structure along the external side of the north wall and another structure in a similar position to the current 'Coach House'.
- 8.3.5 An 1870 estate plan of Hilderstone Hall (Not illustrated in this report due to copyright restrictions) shows that the much larger south wing of the hall had been constructed, whilst it appears that greenhouses had been constructed along the internal elevation of the north wall of the walled garden.
