KNOWLES MILL,
BEWDLEY

HISTORIC BUILDING
RECORDING AND
ARCHAEOLOGICAL
EVALUATION

Project No. 2129

November 2010

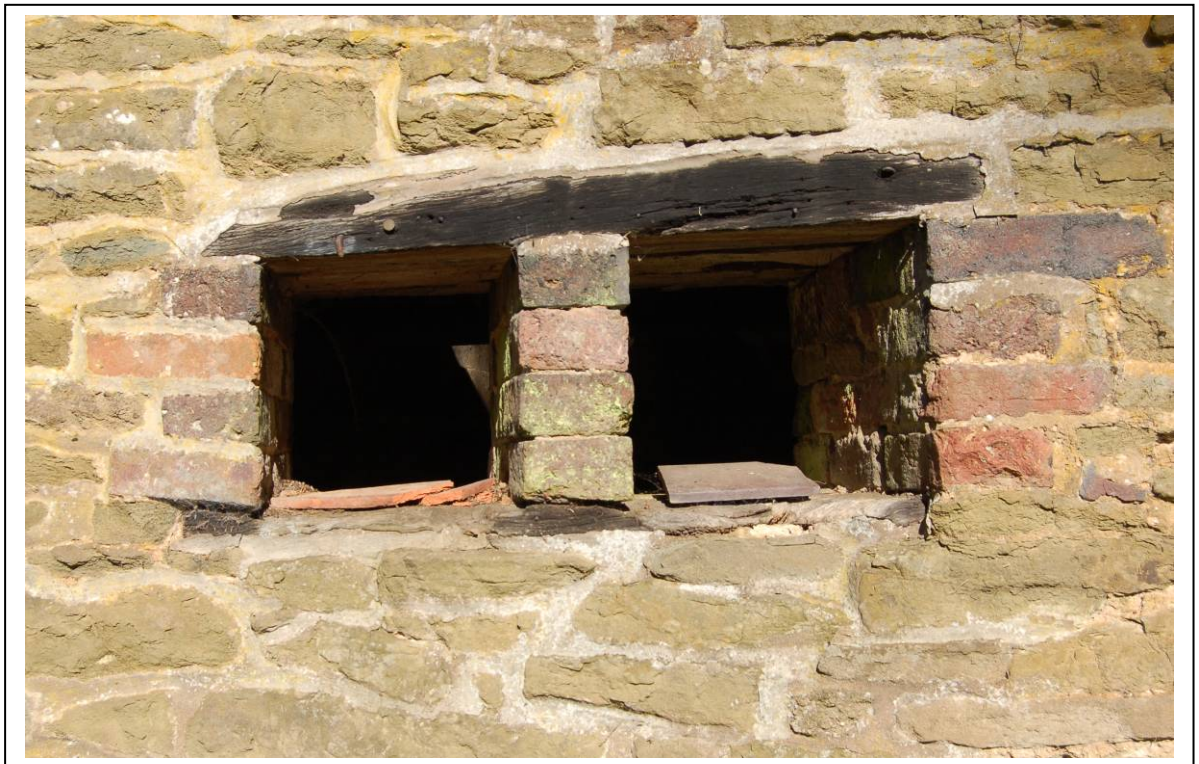
Plate 6: Detail of two holes to mill machinery, southern elevation

- 7.2.5. The southern elevation faces the small cartway between the mill and associated cottages. It is also constructed in roughly coursed sandstone. The ground floor has a window with wood lintel and wood casement frame that was inserted in the 20th century (Tim Booth pers. comm.). On the western side is a twin-opening that gives direct access to the mill mechanism (Plate 6). The brickwork surrounding the openings is in hand-made red brick as before but is possibly reused and the holes may have been inserted any time between the 18th and 20th centuries. There is evidence of belt wear on the side of the holes. The holes may relate to possible machinery that was attached to the main mill mechanism but this cannot be proved conclusively.

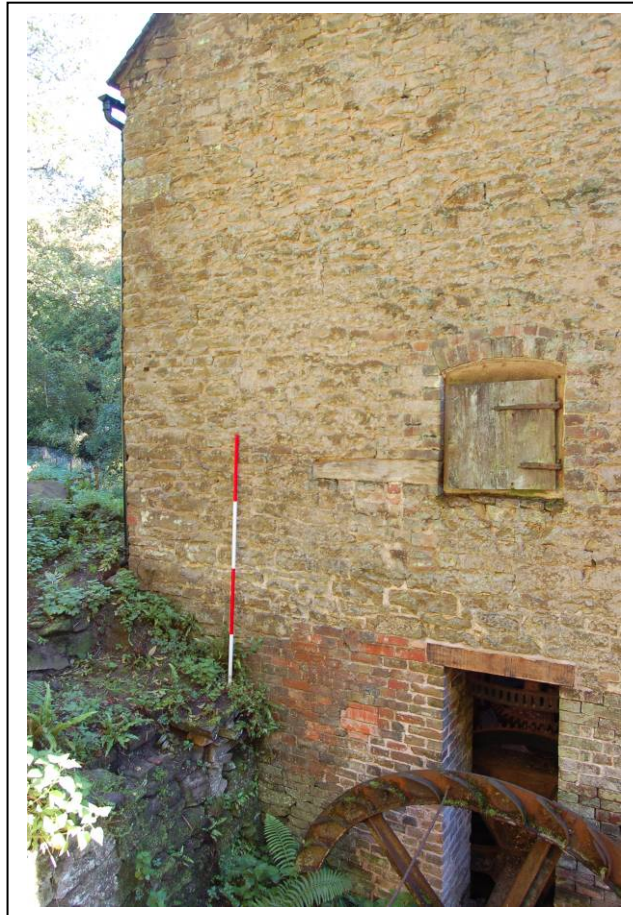
Plate 9: West elevation including wheel pit

- 7.2.12. The wall (western elevation) was almost entirely rebuilt to accommodate the current mill wheel with a replacement lintel above. A single blocked pudlock is visible in the wall at the correct level to have accommodated the pen trough. A blocked hole with wooden lintel is located adjacent to the opening above. This appears to have accommodated the axle for the ratchet system that lifted the penstock. The axle and gear system is still located inside the mill (SF 2129-9).

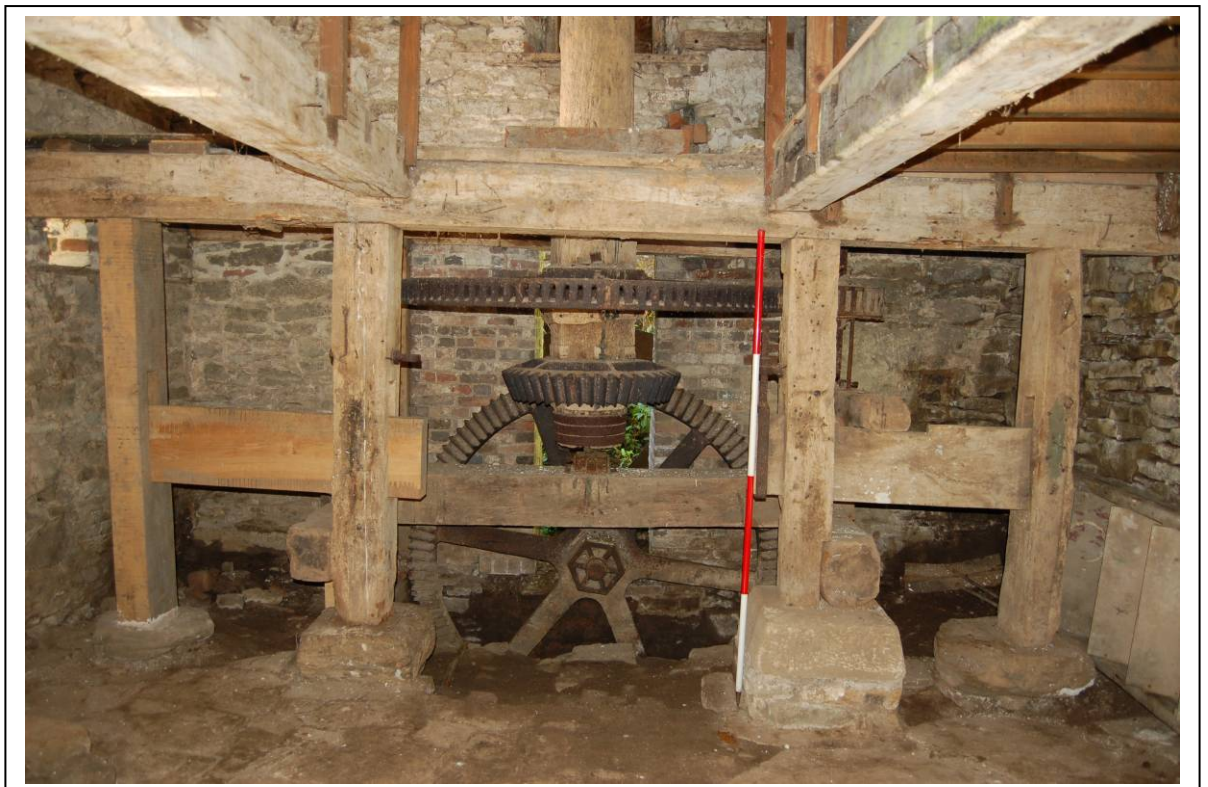
Plate 12: Mill machinery, ground floor, west facing

- 7.3.4. The mill machinery is supported on the hurst (timber framework) in the western side of the room (described below with mill machinery; Plate 12). The fabric of the hurst was replaced in 2010. This includes the replacement of the southern stud replacement of stone work and the realignment of the pit wheel.

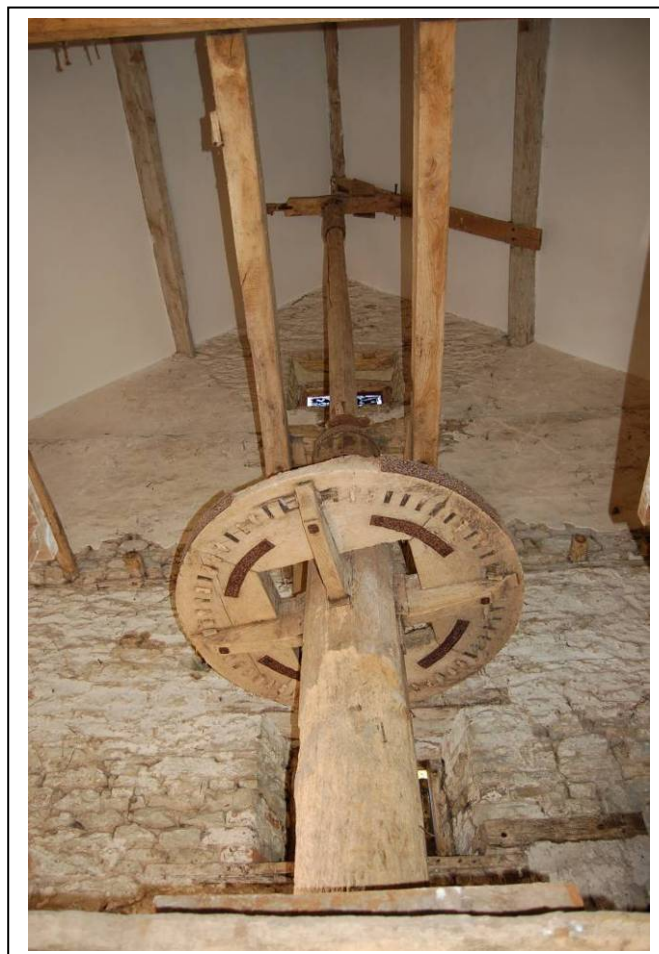
Plate 25: Crown wheel, main axle and sack hoist mechanism

- 7.4.6. The timber upright shaft (7) is undoubtedly the shaft used from earlier milling machinery and the same date as the crown wheel with compass arm fixing (Plate 25). If the iron great spur wheel were removed there would probably be found mortices where a wheel with compass arms was originally fitted. The vertical shaft shows signs of decay but is not serious enough to require replacement.

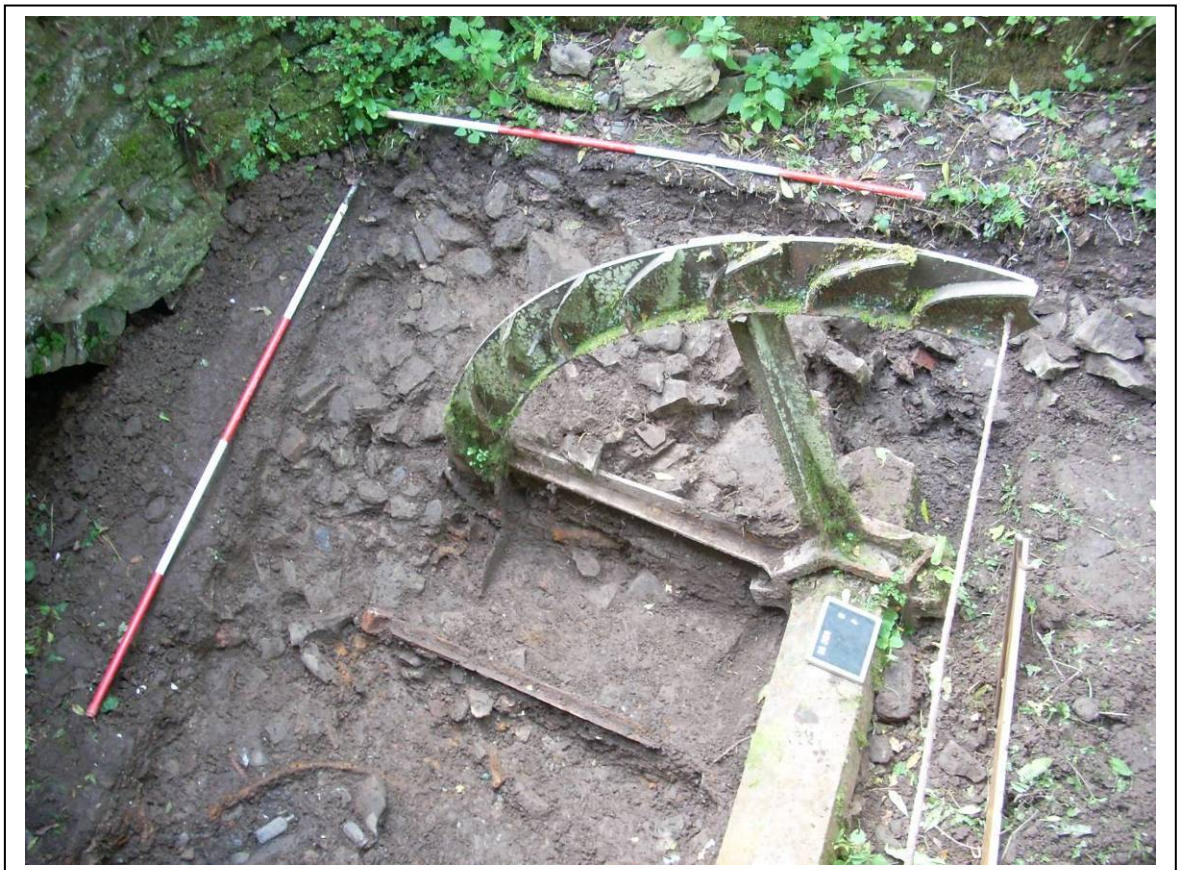
Plate 26: Trench 1, excavation of wheel pit, west facing

11.2.7. Excavation within the wheel pit revealed the lower portion of the iron wheel at its junction with the existing water table. Remains of a corroded wheel bucket were present at this level. To the west of the wheel a brick platform was partially revealed, onto which the wheel previously rested, although any bearing or supporting mechanism for the wheel was no longer present (Plate 28). The wheel had 30 buckets and calculations by Rod Sproat have been used to calculate the wheel rotation at optimum operation to be about $\frac{1}{4}$ of a revolution every second (see Appendix 6).
