Historic Building Record:
The Bothy
Heckfield Place
Heckfield, Hampshire
(NGR SU 731 612)

Planning Application 11/01757/FUL

Souterrain Project: SOU10/13-144

An 'as found' record was made of the historic building known as 'The Bothy' at Heckfield Place, Hampshire, prior to development and conversion works.

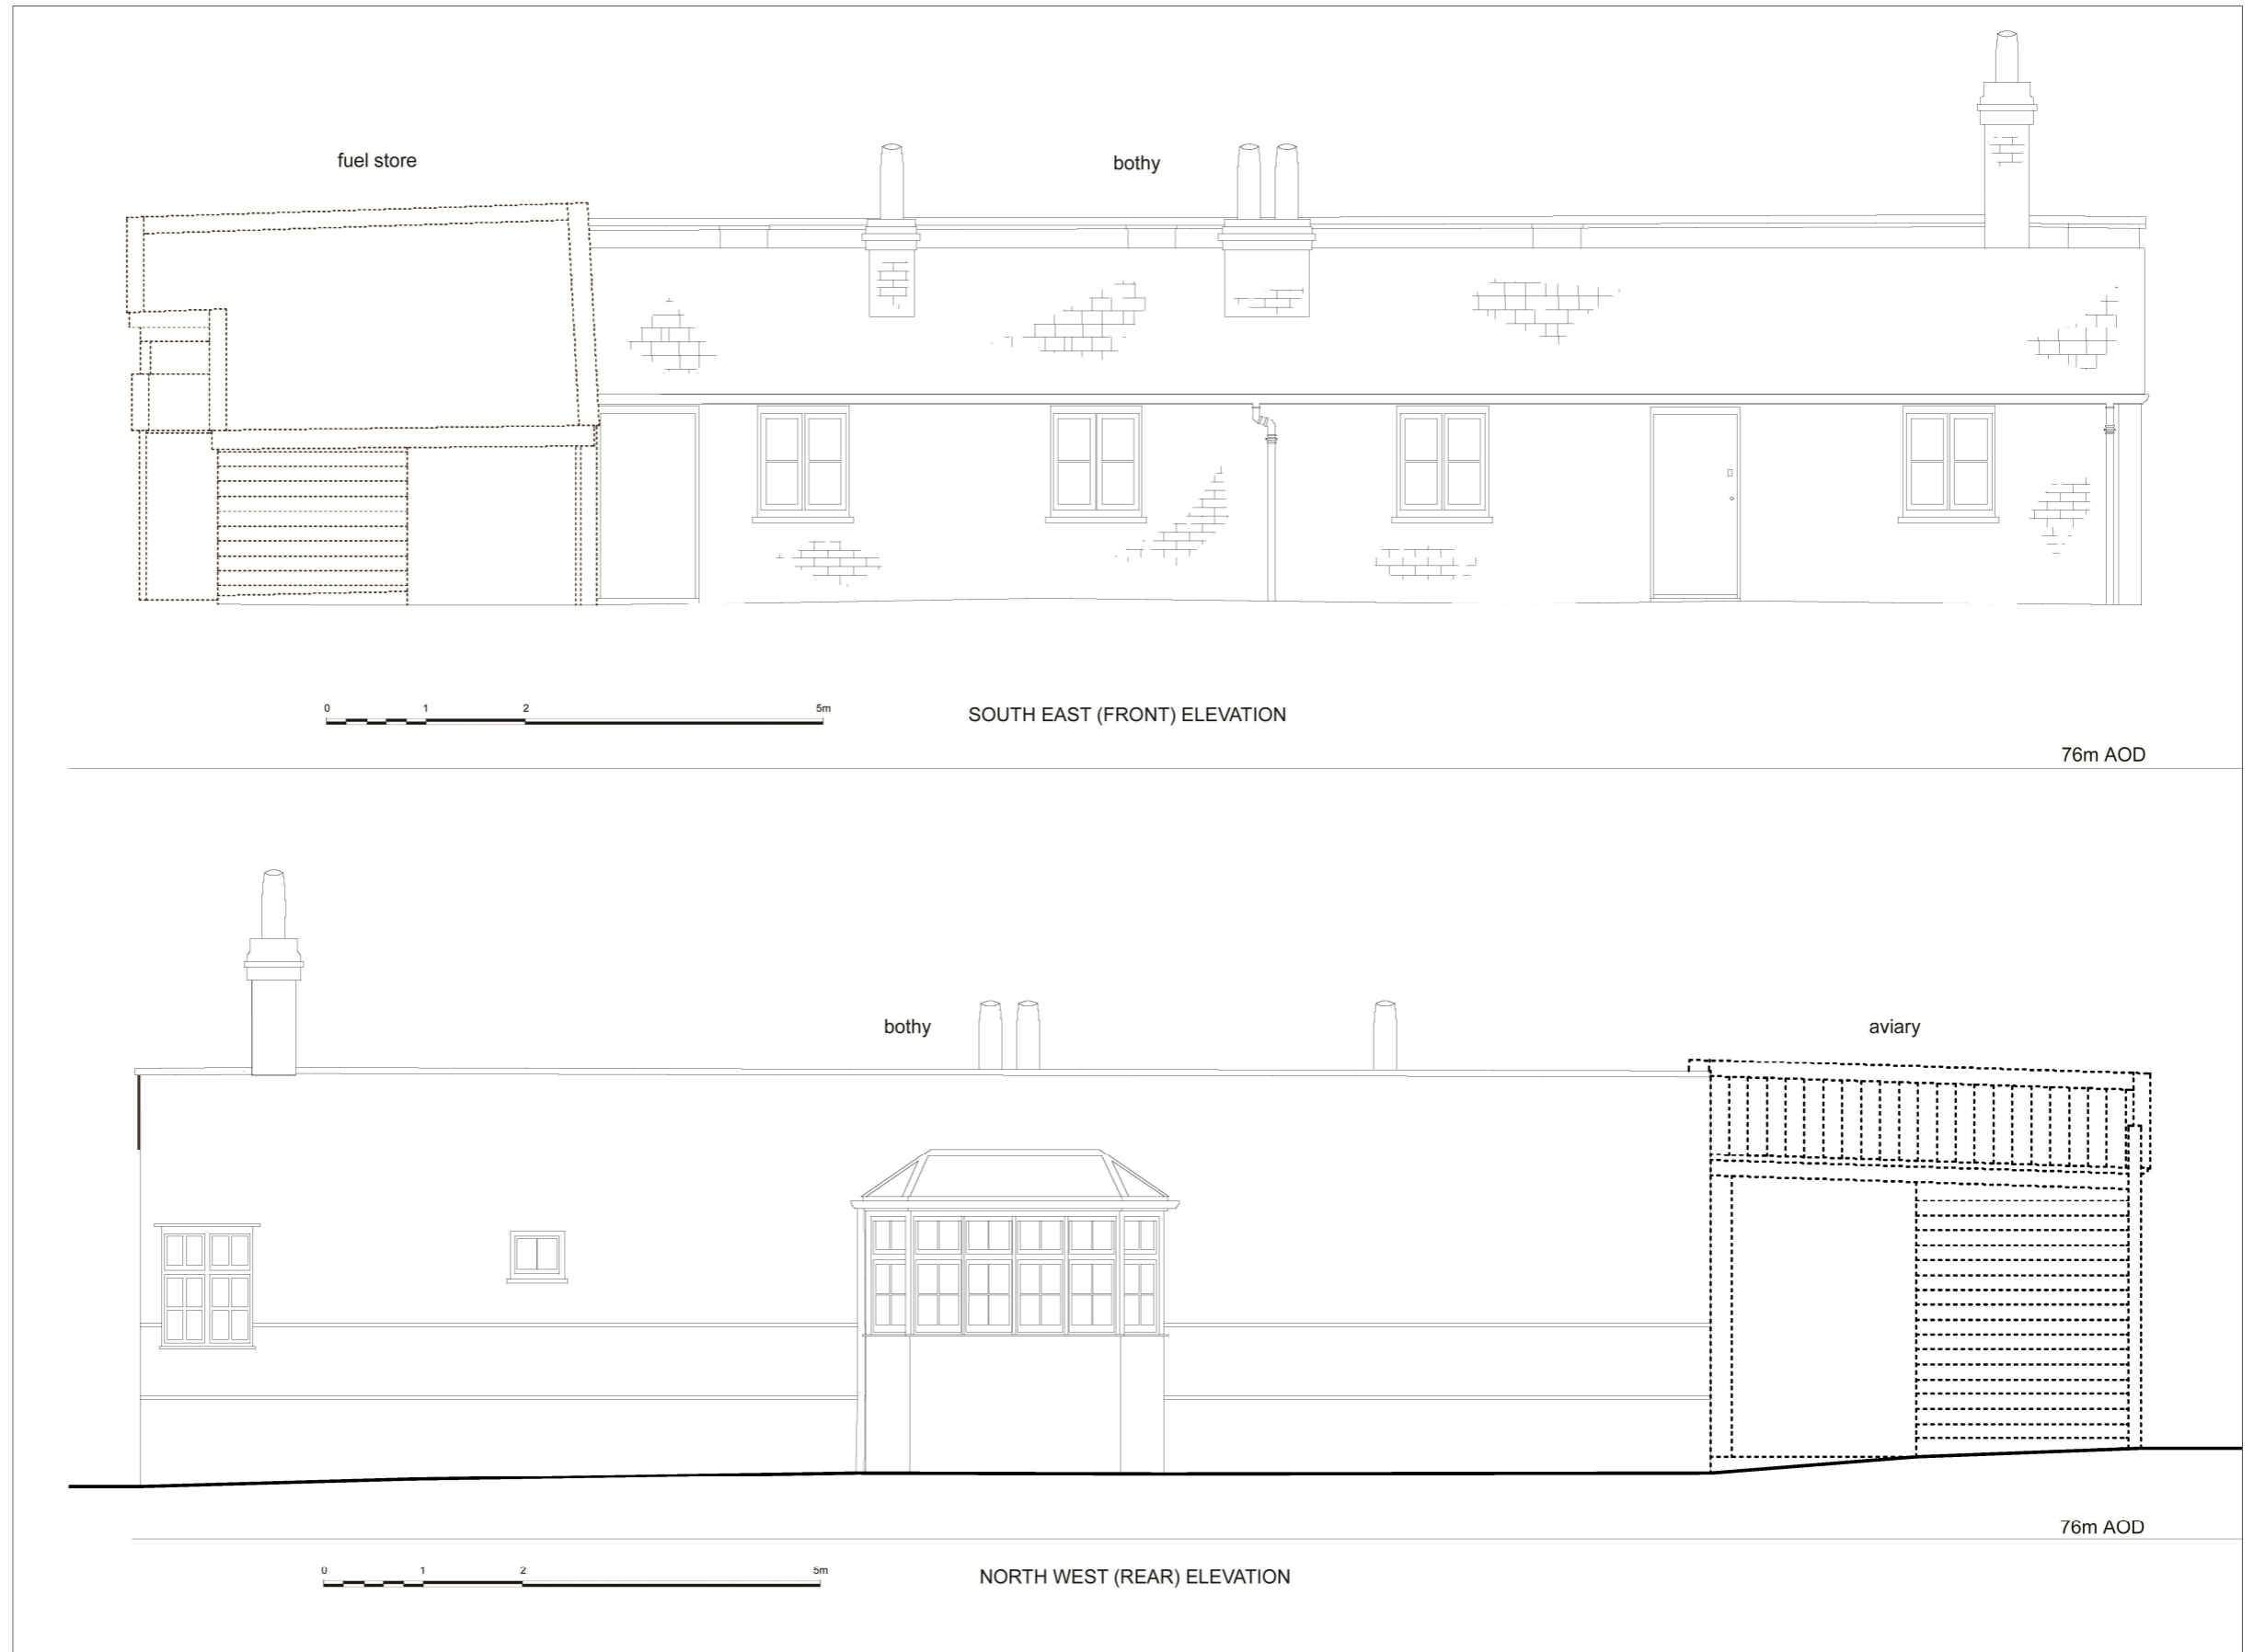
Figure 7.
The Bothy:
exterior elevations

- 6.2 The building is rectangular and single storey with a mono pitched roof (**1 to 5**). The rear exterior and end exterior walls are rendered. The front wall is whitewashed. The roof is slated. There are two centrally positioned chimneys, and a third in the south east corner, its flue integrated into the rear wall. The front wall has four, single-mullioned four-paned casement windows and two entrances (Figs. 3 and 5). Attached to the northeast end of the building there was a fuel store (Figs. 7 and 12; **31-34**) and an aviary (Figs. 7 and 12; **7-8**).
- 6.3 There is evidence of two distinct phases of construction throughout the building (Fig.14). These are referred to as Phases 1 and 2 in the following description.

- 6.10 An aviary was attached the exterior of the northeast end wall of the Bothy (Figs. 7 and 12). It is first recorded on the Ordnance Survey map of 1871 (Fig.5) and probably dated to the Victorian period. It comprised a wooden structure with a latticed facade facing southeast (**8**). It was latterly used for storing logs for fuel. Extremely dilapidated, the structure collapsed in 2013. To the rear of the aviary, also attached to the end wall of the Bothy, was a lean-to log store (Figs 7 and 12; **7, 32-34**).

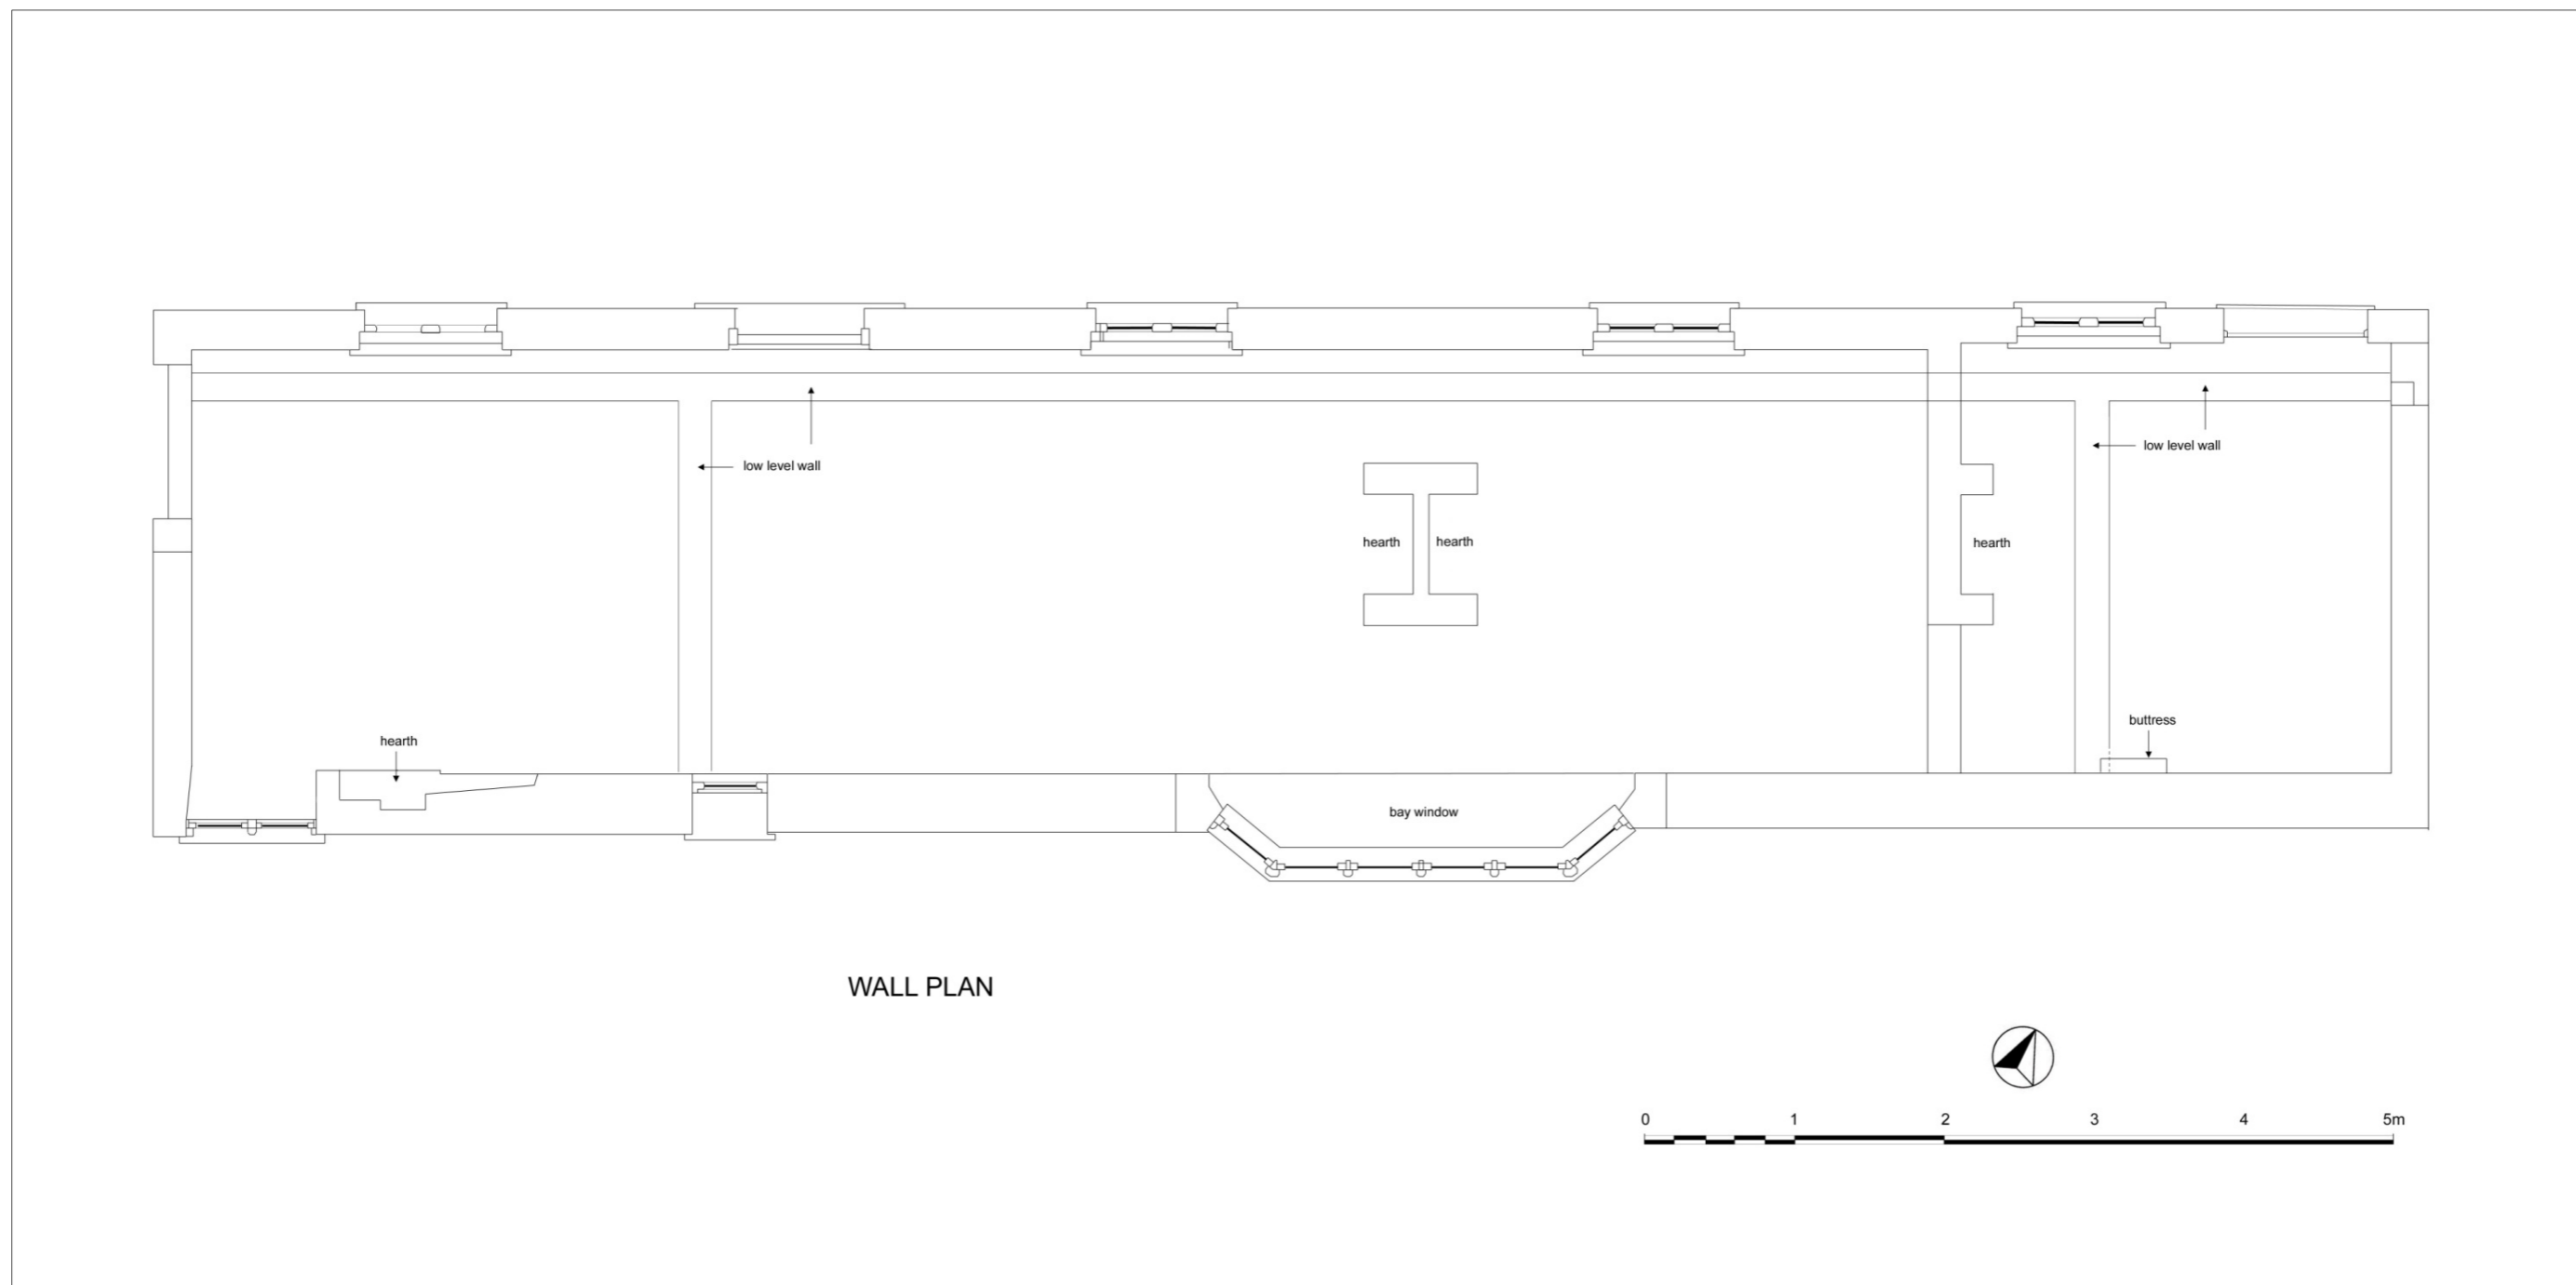
Figure 8. Wall plan showing position of low level wall. (based on survey drawing by Tait Architects, excluding low level wall)

- 6.5 The internal space (Fig.8) was divided into two rooms: a main room, 11.8m by 3m (**11**), and a small square room to the north east, 3 m by 3m. The main room could be entered from either a door in the front wall or another in the southwest wall (Figs.7 to 9, 11; **1, 2, 13, 29**). The northeast room was accessible only from the front of the building (Figs. 7 to 9; **2, 22**). The dividing wall (**20**) has an integrated fireplace on its northeast side (**21**). This dividing wall was seen to abut, and therefore post-date, the rear wall (Figs. 8 and 14; **20**). The three centrally-placed fireplaces (Fig.8; **1 to 3, 11, 19, 21**) belong to Phase 2.

- 6.8 In the small room at the northeast end of the building there was a low wall (Figs.8-11, 134; **24, 25, 31**). This low wall belonged to an earlier structure (i.e. Phase 1) which adjoined the rear wall (Fig.14). In Phase 2, the low wall was concealed beneath the suspended wooden floor. The wall was removed in 2013. The archaeologist was informed of a low wall (now removed) that had run the length of the building in the main room, below the former floor level. Subsequent investigation along short lengths of the floor through the modern back-fill deposit proved the remains of the truncated wall, which was built directly upon the geological stratum (**27, 28**). There was, however, no means of determining the date of the structure, or its subsequent incorporation into the Phase 2 structure. Two unstratified pottery sherds (18th / 19th century and 19th century) were recovered from the modern backfill deposit. Remains of the low wall could also be seen incorporated into the end wall of the Phase 2 structure (Figs.10, 11 and 13; **29**).

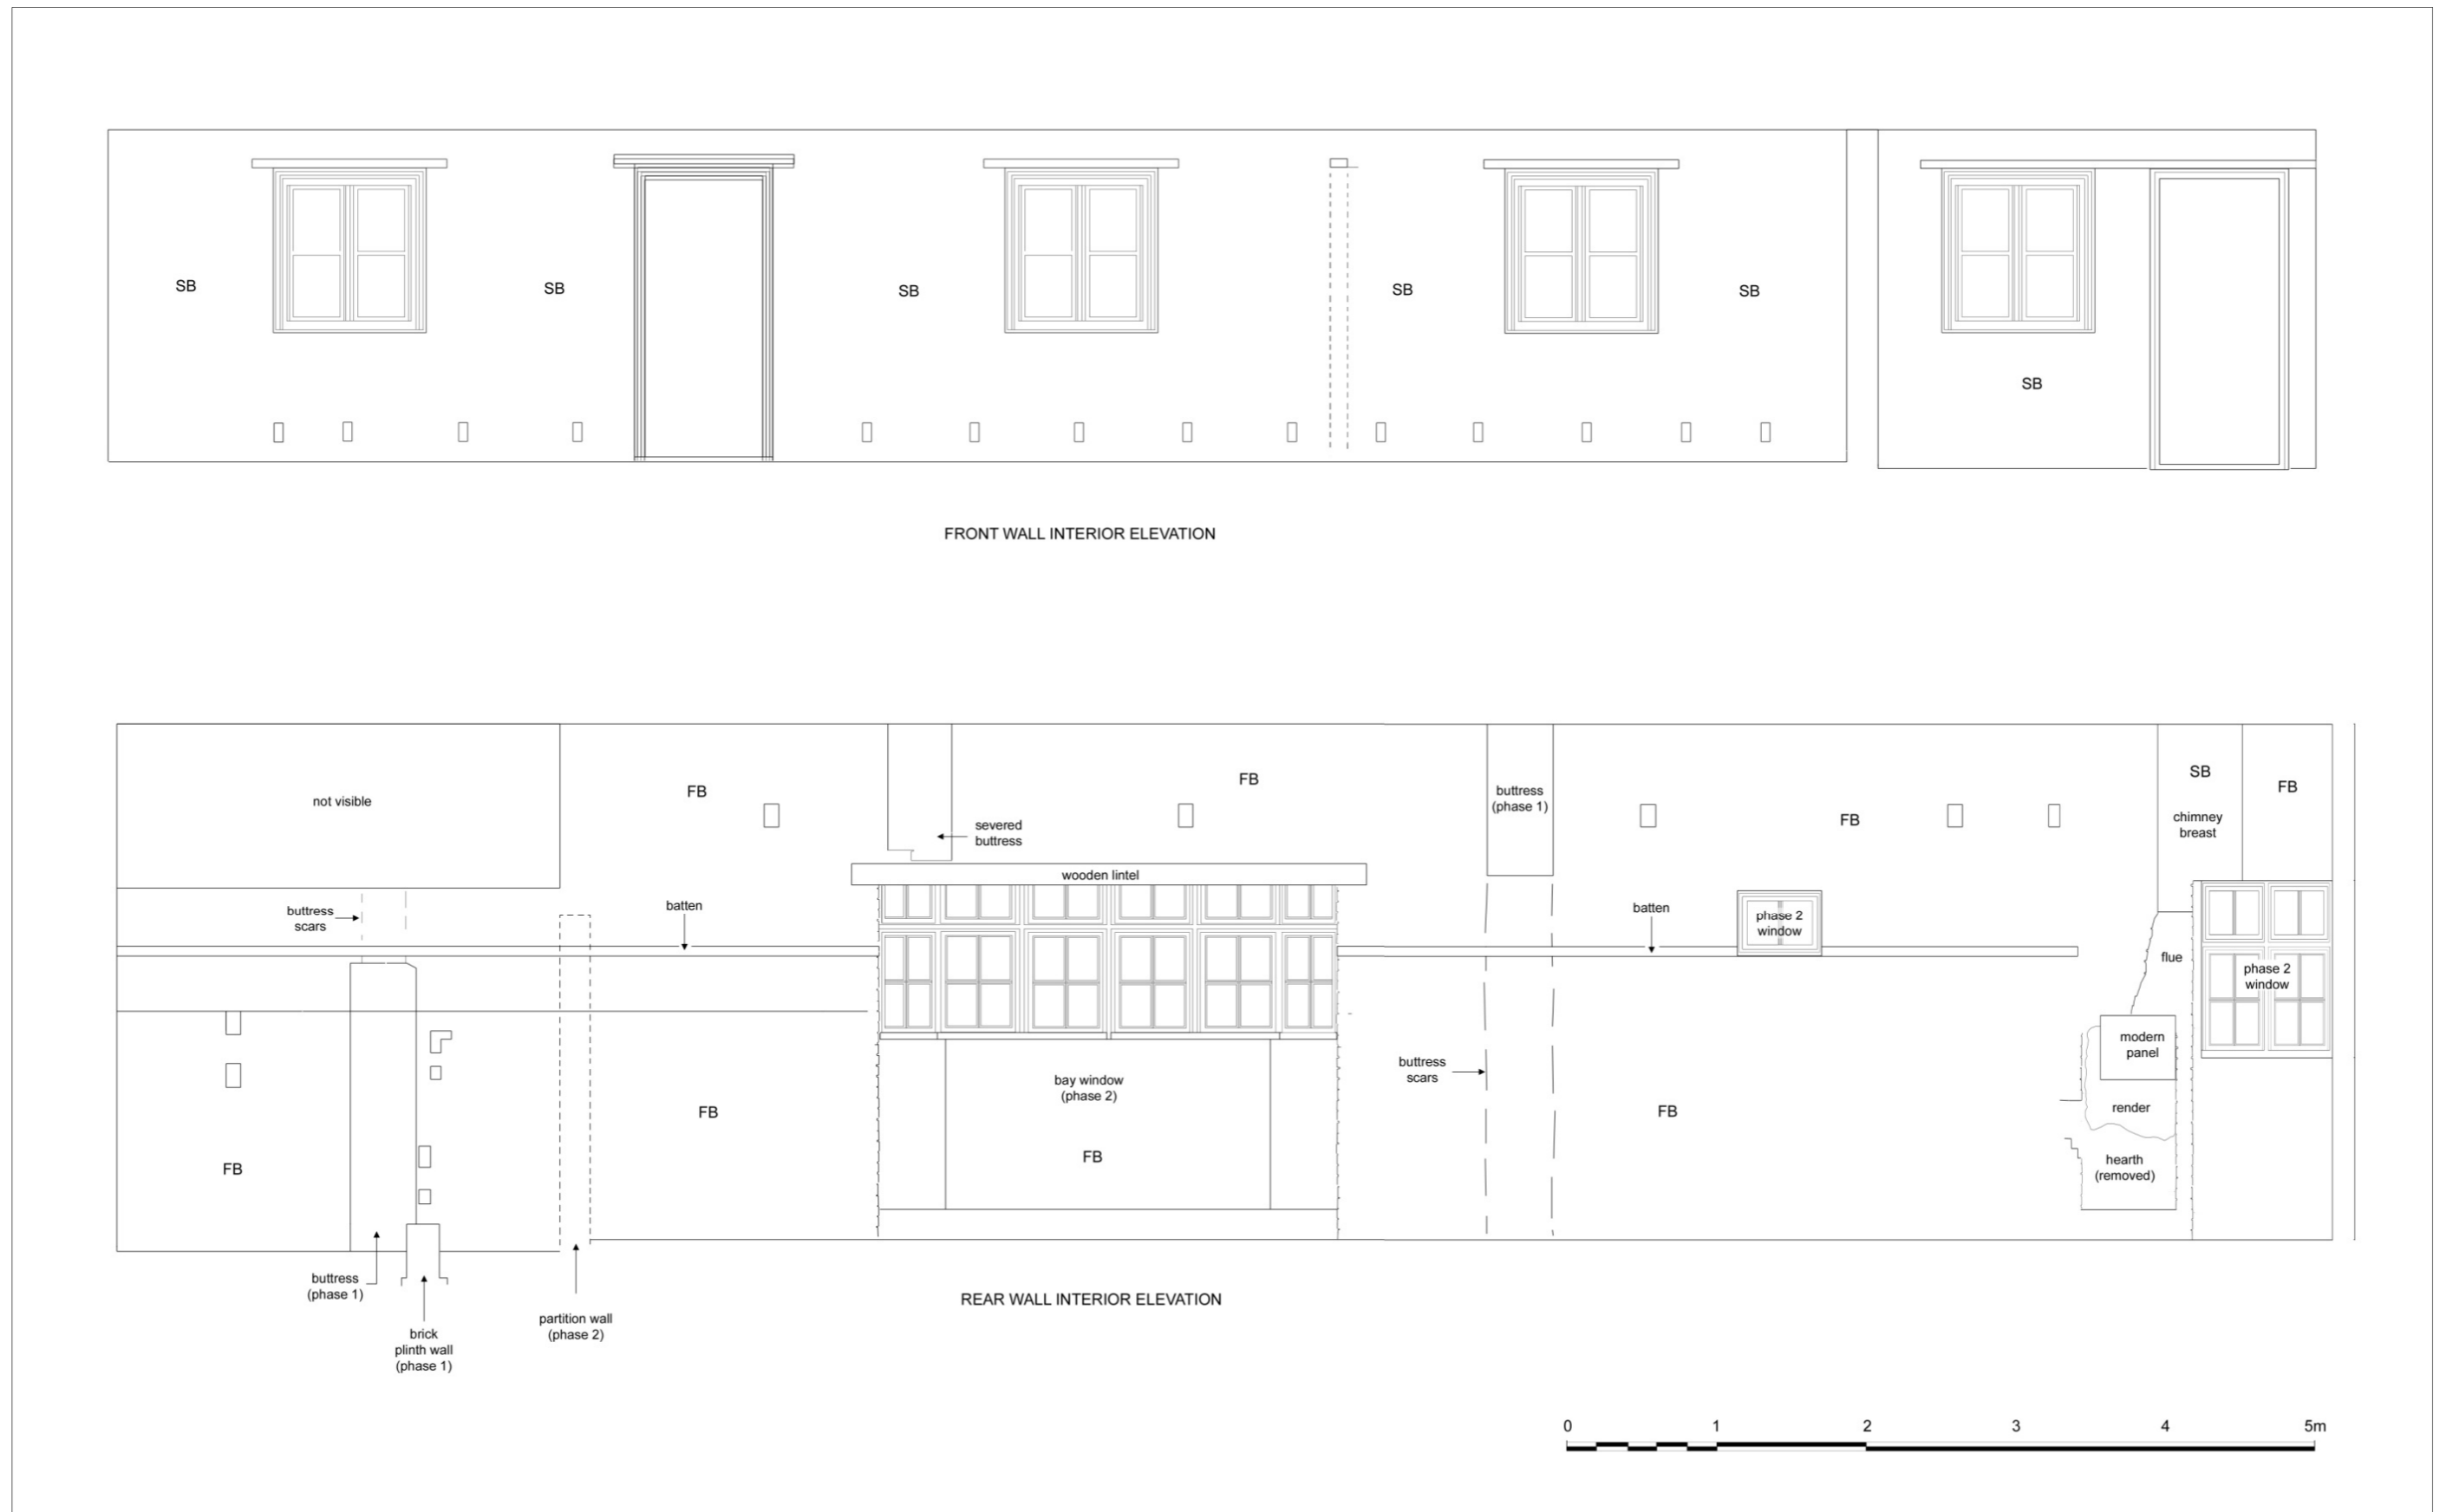
Figure 9. The bothy: interior elevations (after base survey drawing by Tait Architects)

- 6.6 The internal walls had been stripped of render and whitewash, exposing the brickwork. Notably, the rear wall is similar in appearance to the walls which surround the Walled Garden, less than 20m to the southwest. The brickwork is Flemish Bond with well-finished pointing and there are remains of buttresses set apart at fairly regular intervals (Fig.5; **15 to 18**). The wall is stepped, 1.5m above existing floor make-up level (Figs. 9, 10 and 13), and there is a horizontal wooden batten at 2m (Fig.9; **16 -18, 20**). A bay window has been inserted in the centre of the rear wall

(Figs. 7-9, 10; **5-6, 12, 16**). This alteration involved interruption of the batten and the removal of a buttress, leaving only the upper portion of the latter *in situ* above the window (Fig. 9; **17**). Below the window, the brickwork of the bay is also Flemish bond. Previously hidden by render, the pointing work of this part of the wall is markedly poorer than the original wall on either side of the bay. This may suggest that the exterior was the only face intended to be seen (not rendered as it is today); the choice of the brickwork bond maintaining the wall's external appearance.

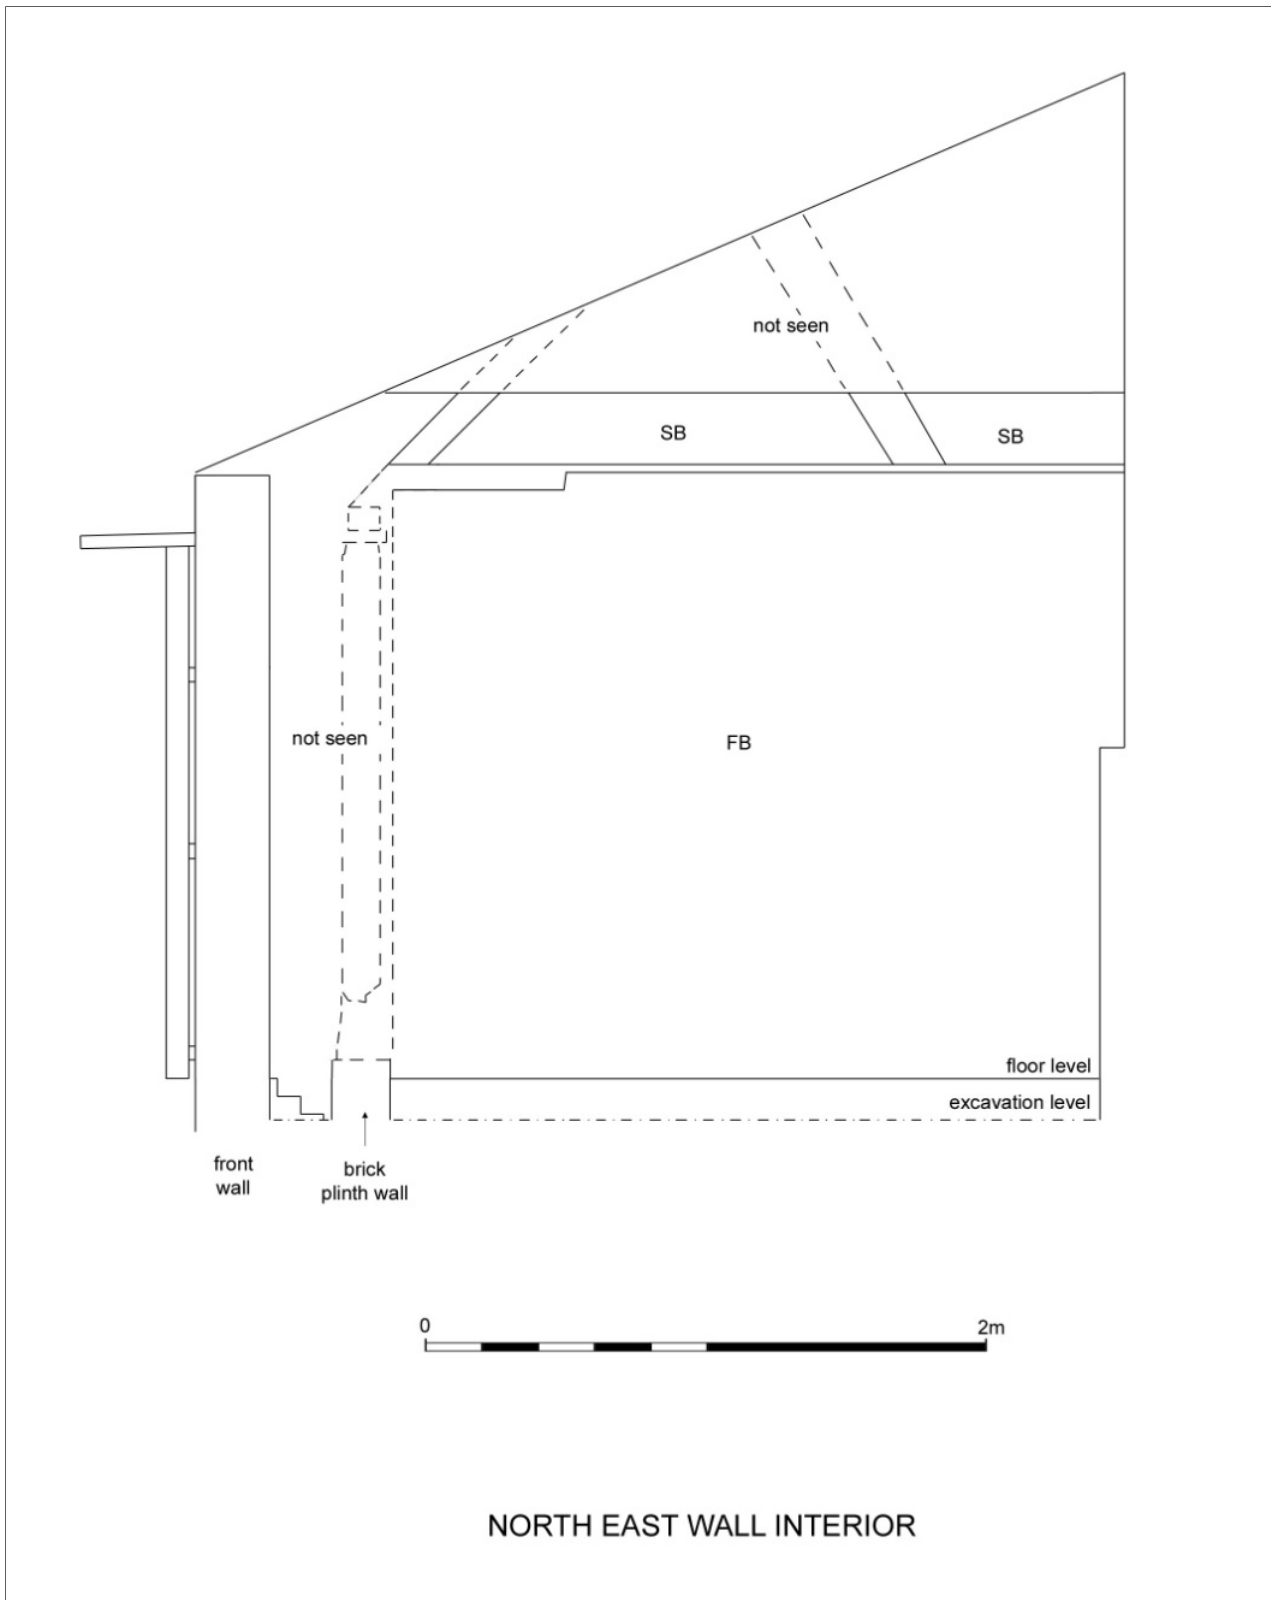
Figure 10. The bothy: interior elevation. North east wall
(survey drawing by Souterrain Archaeological Services Ltd)

- 6.9 At the time of the 2011 visit, the upper parts of the rear and end walls were concealed. The removal of ceiling joists in 2013 enabled closer examination of the upper rear and southwest walls (**30**). The roof frame timbers in south west end wall mirror those at the northeast end (c.f. Figs. 10, 11 and 13), all of which belong to the Phase 1 building. In the south west wall the timbers have been severed to allow the insertion of a doorway Fig.10; **13**). The end elevations show evidence the building having been extended to the north west (Figs. 10, 11 and 13; also see **3, 4, 32**). Curiously the angle of the roof timbers seem to suggest that the Phase 1 structure had a mansard pitched roof.

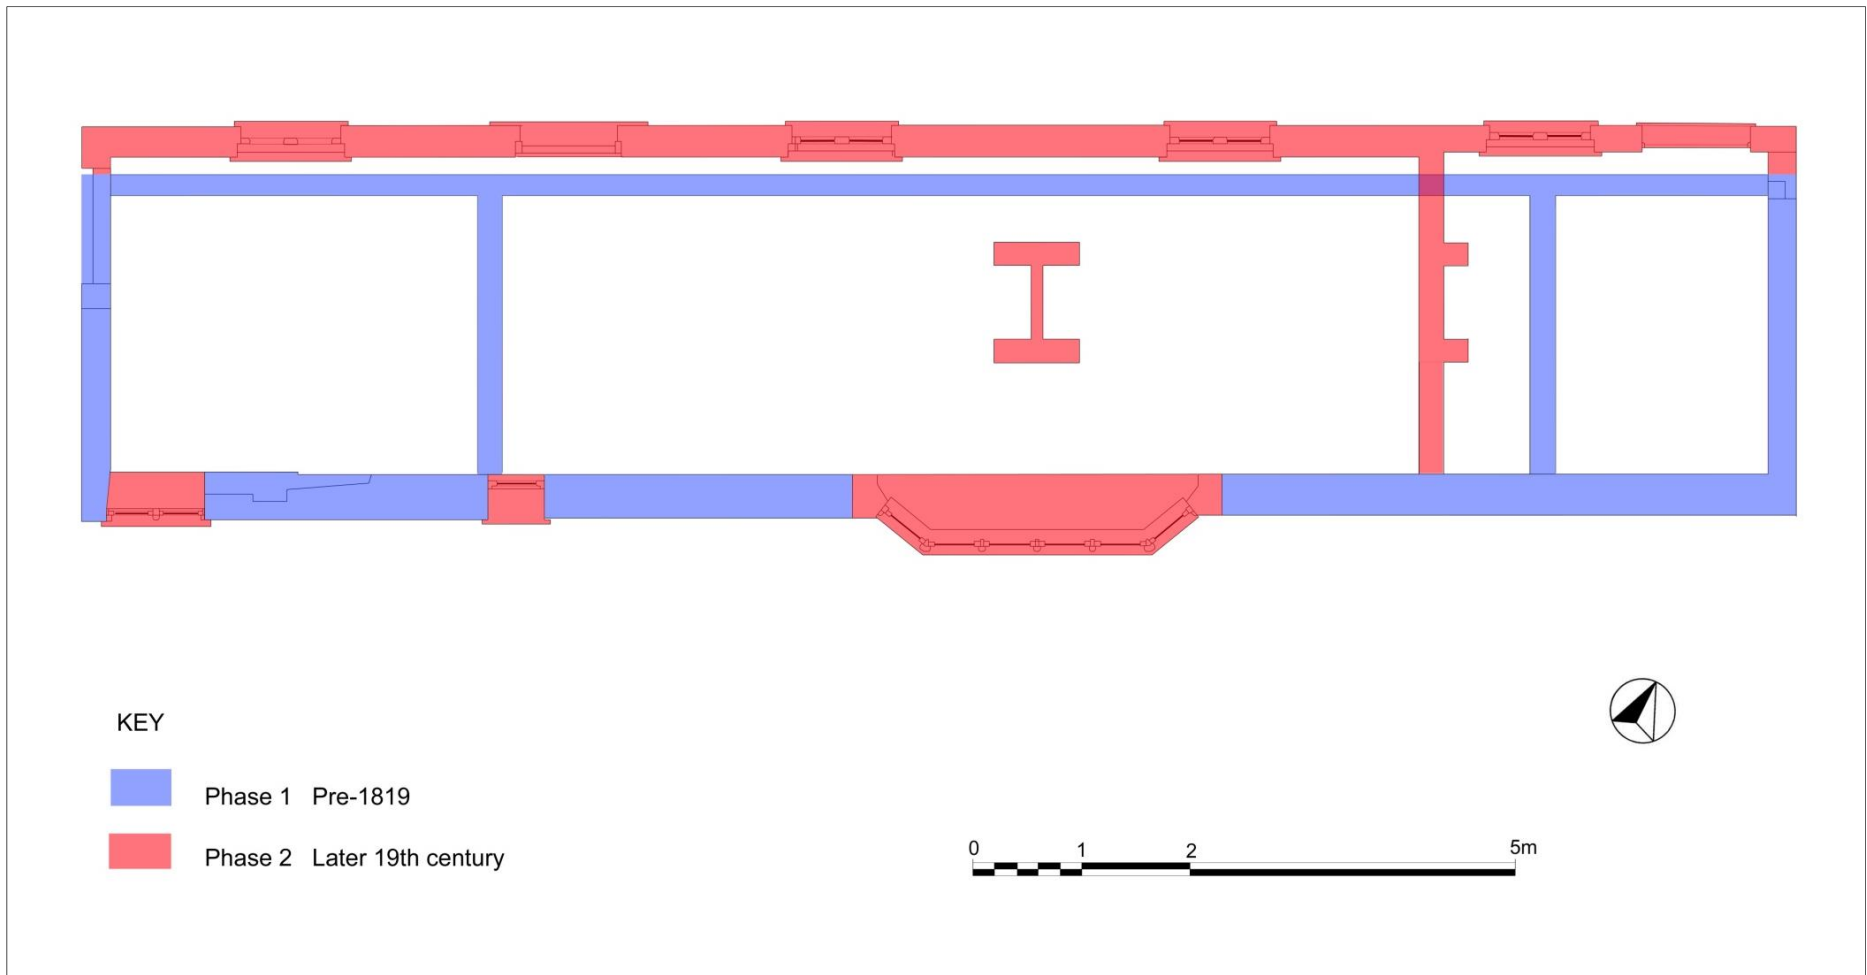
Figure 14. Phase plan (composite based on surveys by Tait Architects and Souterrain Archaeological Services Ltd)

- 6.12 Figure 14 shows the probable wall layout of the original structure (in light red). The structure was attached to the northwest side of the rear wall, the latter which was built in-keeping with the style of the walled garden. It probably consisted largely of a timber framework supported by a low pedestal, or plinth, wall. The roof of the structure was either mono-pitched or more likely, mansard. The structure was fairly narrow (c.2.25m). Whether it was an earlier form of the gardens' bothy is open to question. It may have been a veranda-like, recreational part of the garden (notably, the building overlooks one of the former lakes to the northwest), or something

more functional, such as a potting shed or green house. The map evidence shows that a structure was present in 1819. In consideration of the similarity of the rear wall with that of the walled garden, it is likely that the Phase 1 structure is the building depicted on the map.

- 6.13 The building was widened (Fig.14: blue). It was a functional building, possibly with overnight living quarters for the gardeners. The floor of the new building was suspended concealing the low walls of the former structure and the new front wall was insulated by a cavity wall. Three hearths and chimneys, all centrally placed, were added. A bay window was added inserted to the rear wall and the southwest wall was breached for a doorway. The finish of the brickwork finish at the front of the building was not a consideration as it was whitewashed.

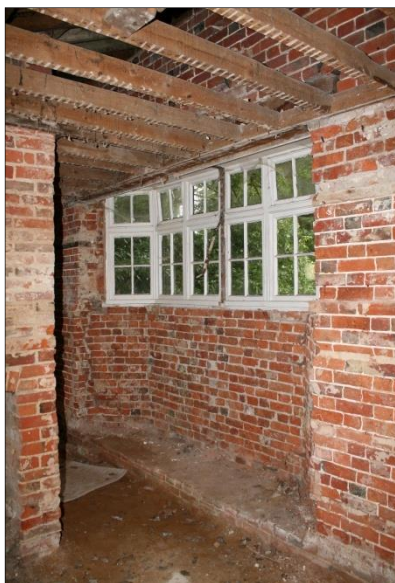
11

- 6.4 At the time of the first site visit in 2011, the suspended wooden floor had already been removed (**11**). Sawn wooden joists at regular intervals indicate a suspended board floor throughout the building. The extant floor surface comprised recent finely-compacted crushed and powdered rubble and concrete.

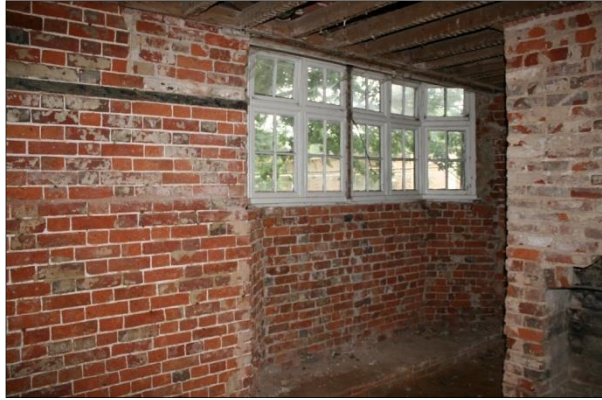
14	S	The Bothy. Main room. Hearth in rear wall.	08/07/2011
15	SE	The Bothy. Main room. Rear wall	08/07/2011
16	SW	The Bothy. Main room. Rear wall, bay window	08/07/2011
17	SE	The Bothy. Main room. Rear wall. Remnant of buttress above bay window	04/11/2013
18	SE	The Bothy. Main room. Rear wall.	08/07/2011
19	SW	The Bothy. Main room. Central fireplace	08/07/2011
20	NE	The Bothy. Main room Dividing wall.	04/11/2013
21	SW	The Bothy. Northeast room. Fireplace	04/11/2013
22	W	The Bothy. Northeast room. Front wall	04/11/2013
23	E	The Bothy. Northeast room. End wall (NE)	04/11/2013
24	NE	The Bothy. Northeast room. Remains of low-level wall	08/07/2011
25	SE	The Bothy. Northeast room. Remains of low-level wall	08/07/2011
26	NE	The Bothy. Main room. Front wall. Internal wall (cavity wall) partly removed)	08/07/2011
27	SW	The Bothy. Main room. Truncated remains of low level wall	08/07/2011
28	NE	The Bothy. Main room. Truncated remains of low level wall	08/07/2011

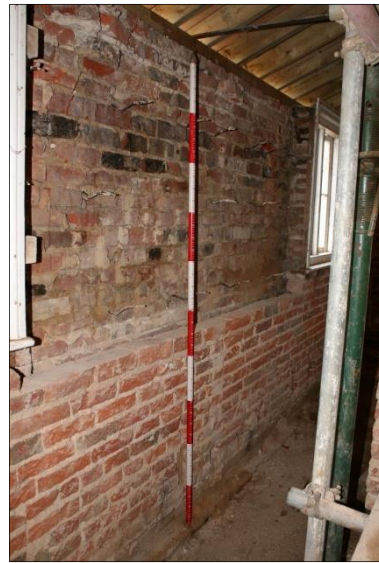
26

- 6.7 In contrast with the rear wall, the brickwork of the front wall consist of two walls each built in stretcher bond, separated by a cavity which is supported by iron ties (**26**). The mortar pointing is notably less-well executed than that of the rear wall.

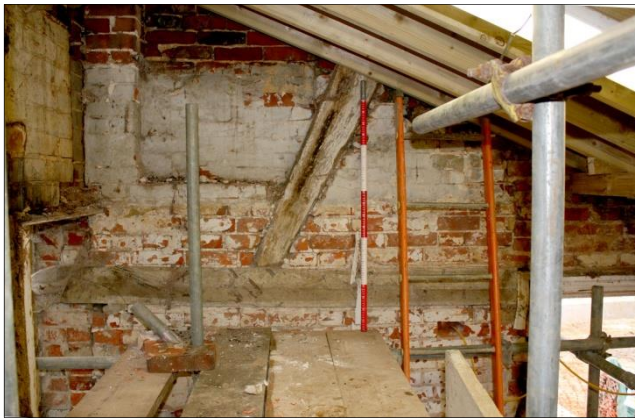
29	NE	The Bothy. Main room. End wall (SW), exterior. Low level wall integrated in later wall below doorway	08/07/2011
30	SW	The Bothy. Main room. End wall (SW), interior. Phase 1 wall and roof frame.	08/07/2011
31	S	The Bothy. Northeast room. Rear wall. Remains of buttress and low level wall.	04/11/2013
32	SE	The Bothy. End wall viewed(SW) from inside the fuel store	04/11/2013
33	S	Rear wall of the fuel store, interior	04/11/2013
34	NE	End wall (NE) of the fuel store, interior	04/11/2013
