**Historic Building Record:
Pipers Cottage
Pipers Hill, Great Gaddesden
Hemel Hempstead, HP1 3BY**

Souterrain Project SOU14-331

On the 14th February 2014, an 'as found' record was made of Pipers Cottage in Great Gaddesden, Hertfordshire, prior to its restoration and redevelopment.

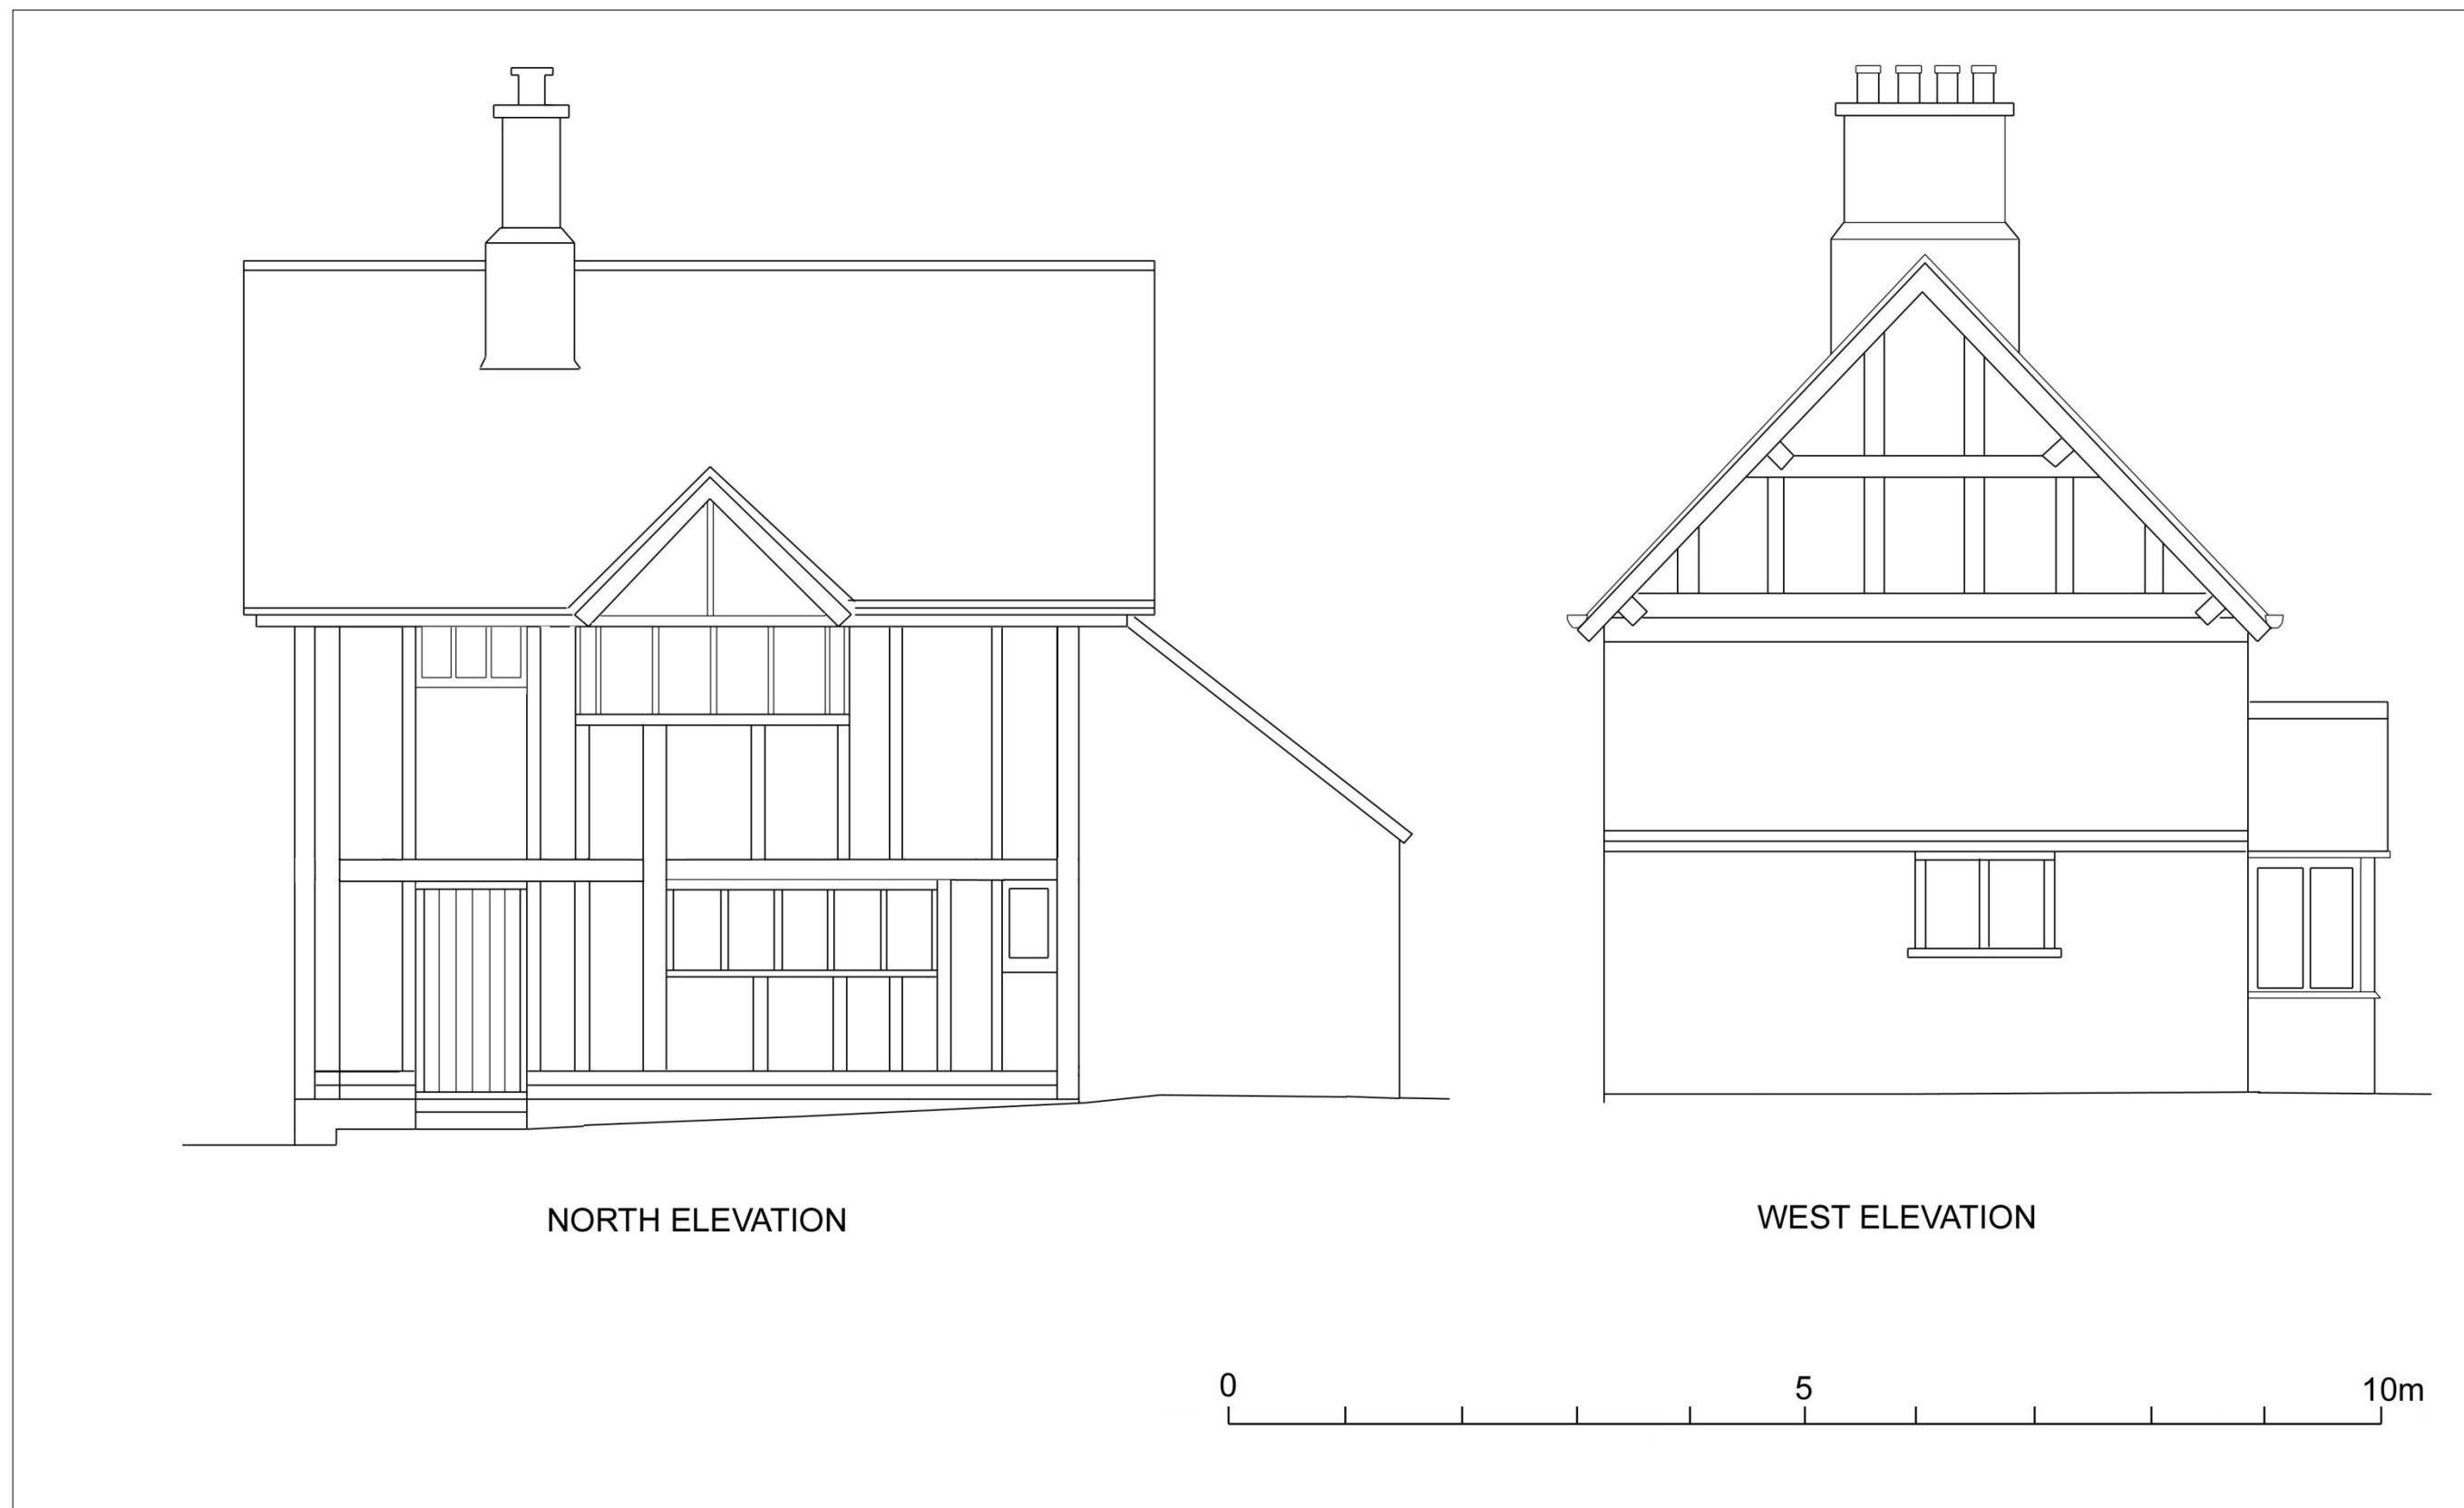
Figure 6. Pipers Cottage, north (front) elevation and west elevation

- 5.2 The exterior of the building (Figs. 6 and 7; **1 - 4, 5**) is as described in the listing text (*ante* 4.2).

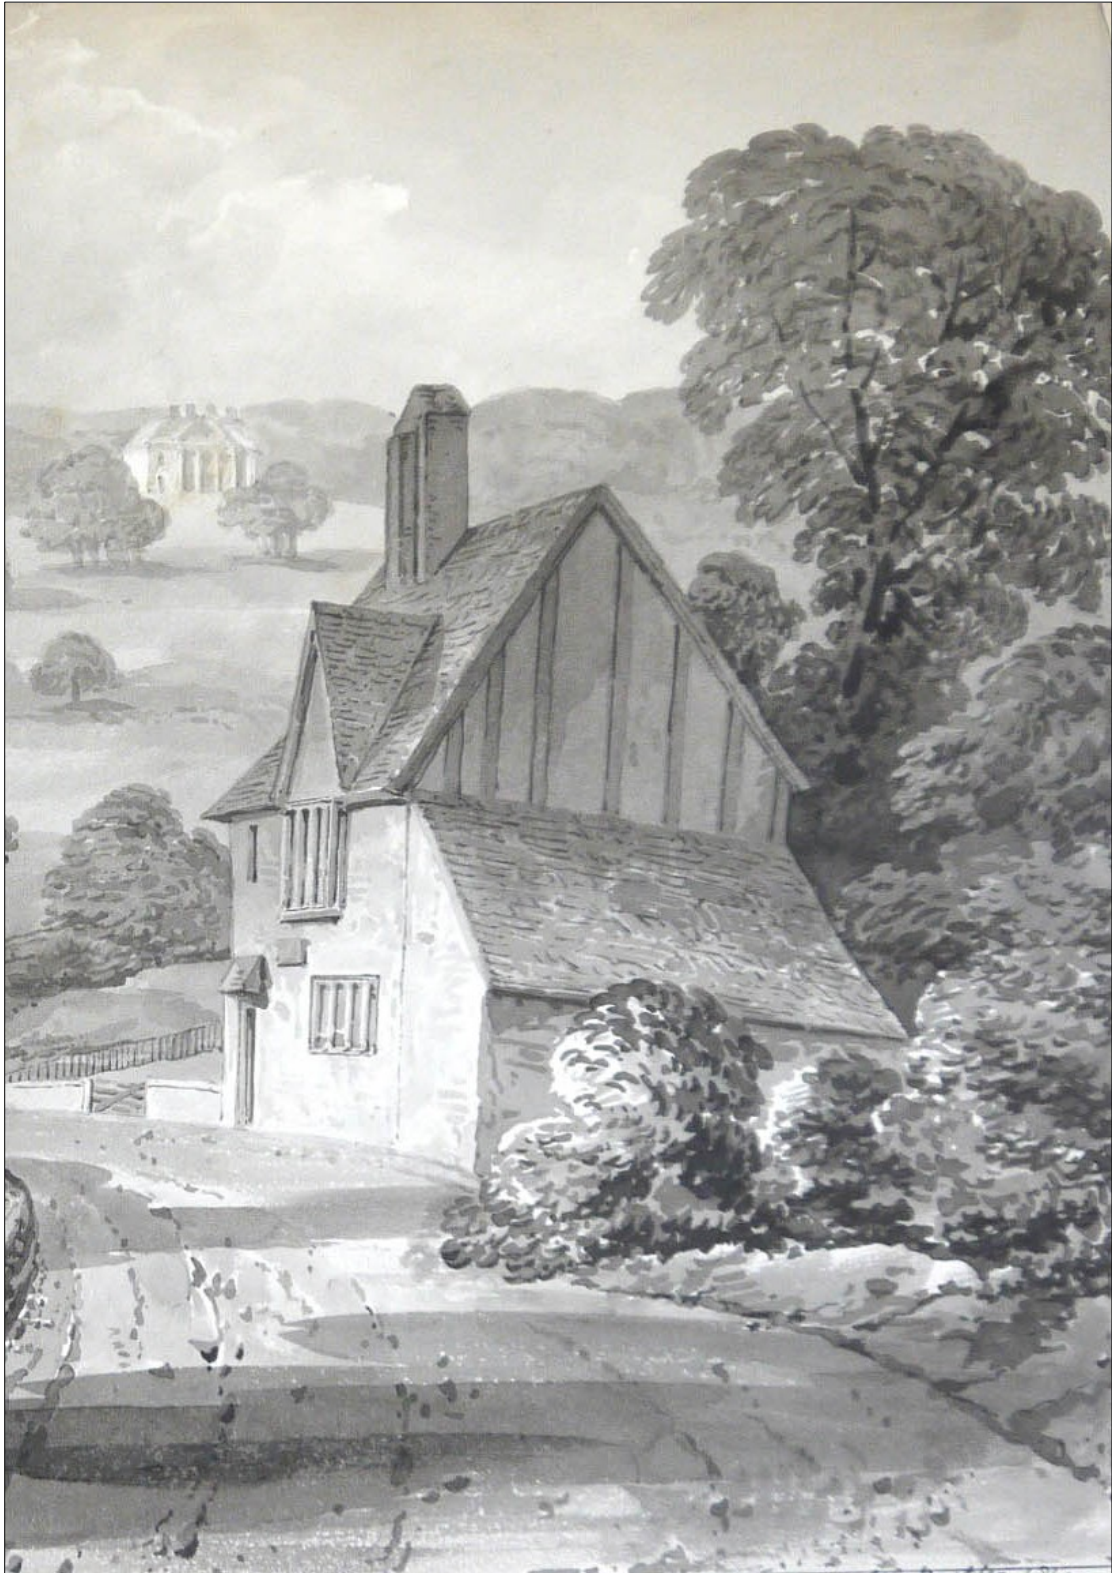
Figure 13. Extract from 'View in Great Gaddesden, Hertfordshire' by J.C Buckler, 1840.
Courtesy of Hertfordshire Archives and Local Studies

- 4.8 In 1840 the cottage was illustrated by J.C. Buckler in a general view of the village facing south west¹³ (Fig.13). The general appearance of the building is as it is today. The chimney is noticeably on the front side of the roof only. The timber frame is extant only on the west wall, although this may be simply 'artistic licence'.

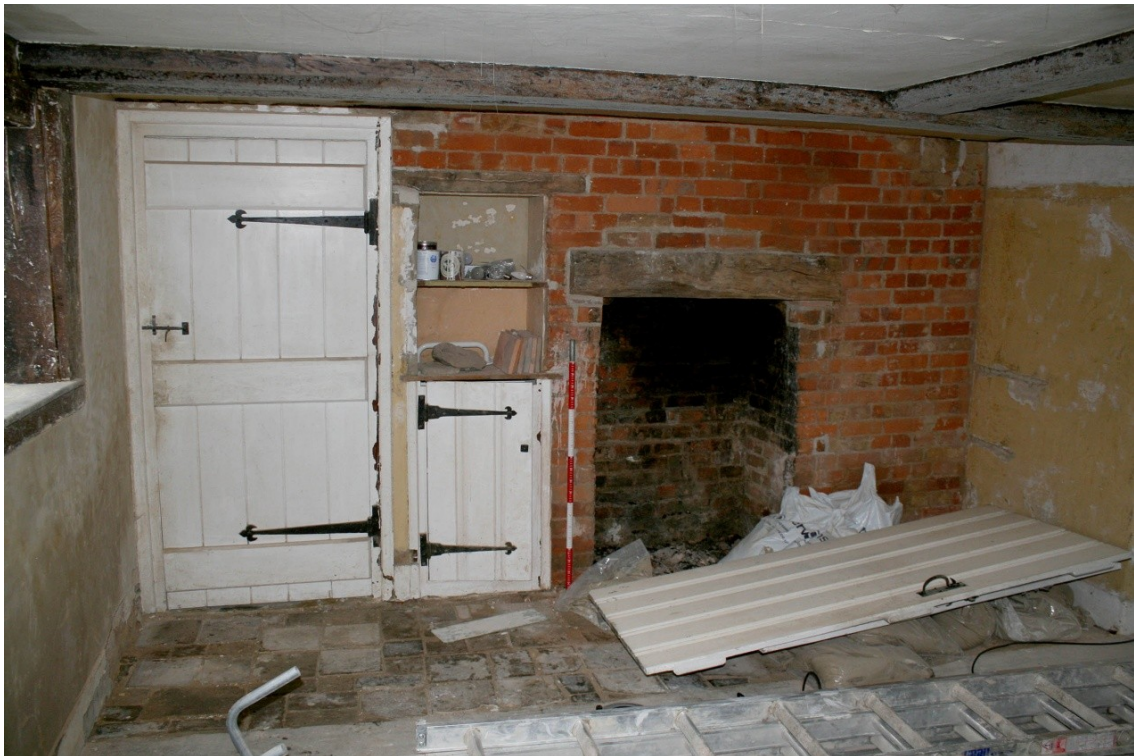
A brick-built chimney with recessed hearth dominates the east side of the room (8, 8). To the north of the hearth, a second recess has been built into the chimney breast; last used as a cupboard, this may have been a fuel (i.e. wood) store. The brick chimney is likely to be 19th century.

| PHOTOGRAPHIC INDEX | | | |
|---|---|---|--|
| 8 | IMG_6963 | SE | Ground floor. Living room. Chimney |

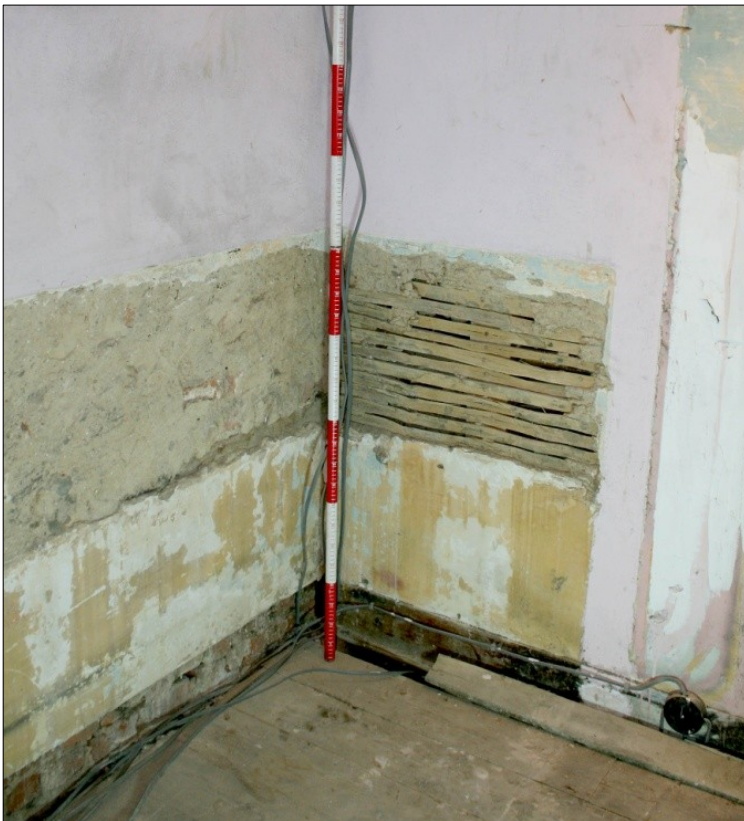
- 5.7 This level is comprised of a front and a rear bedroom and a bathroom; the latter located in the northeast corner (Fig.9). The floor is boarded throughout. The rooms are divided by plaster and lathe partition walls (e.g.22). The bedrooms were each heated by a small hearth set in the main chimney stack (Fig.9; 16, 26-27). The grates (19th century) are still present. The timber frame of the building is extant on north and west walls (14-17, 21). The underside of the wall plate above the oriel window has a series of circular stave holes and rectangular stud mortices (15, 18). It does not appear to be the former location of a window. There is no shutter groove or other indications of an opening for a window. A single cross-beam is visible in both the front and back bedroom (16, 19 and 25). This positioned at an angle of 87 degrees to the building's longitudinal axis. The cross-beam is in effect the tie beam of a roof truss. Its underside has a series of circular stave holes and rectangular mortices (20) indicating that it was previously in-filled with wattle and daub. Noticeably, this beam (i.e. truss) is offset c.0.45m east of the cross-beam which is visible on the ground floor (*ante*. 5.4). In the northeast corner of the bathroom the wall plate is secured to the corner post of the building by an iron tie (23).

| PHOTOGRAPHIC INDEX | | | |
|---|---|---|--|
| 22 | IMG_7045 | SSE | First floor. Bathroom. Plaster and lathe partition wall |

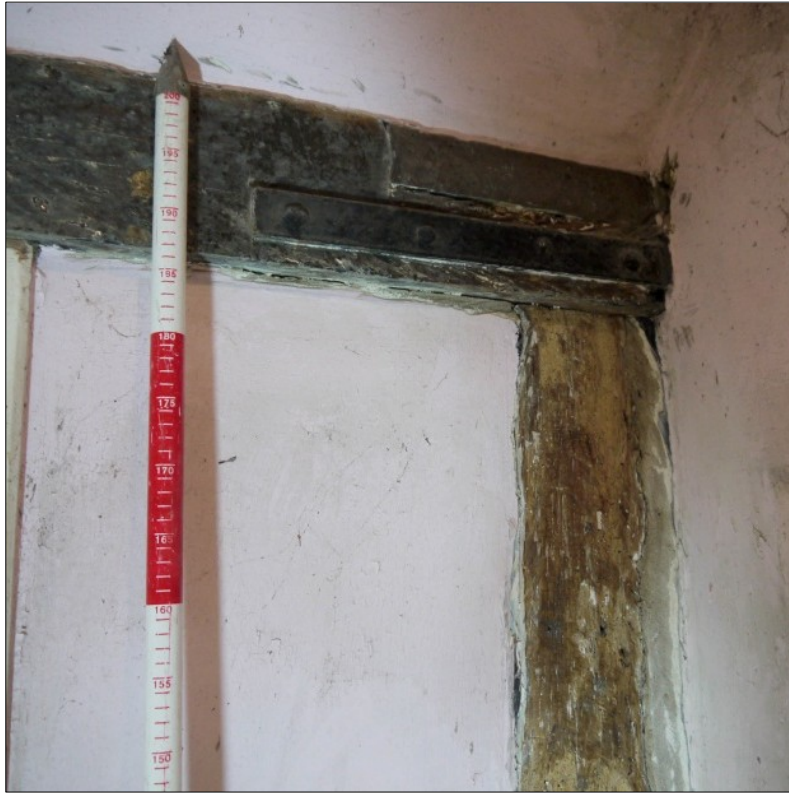
| PHOTOGRAPHIC INDEX | | | |
|---|---|---|--|
| 23 | P1030362 | NE | First floor. Bathroom. Wall-plate/ corner post junction with iron brace |

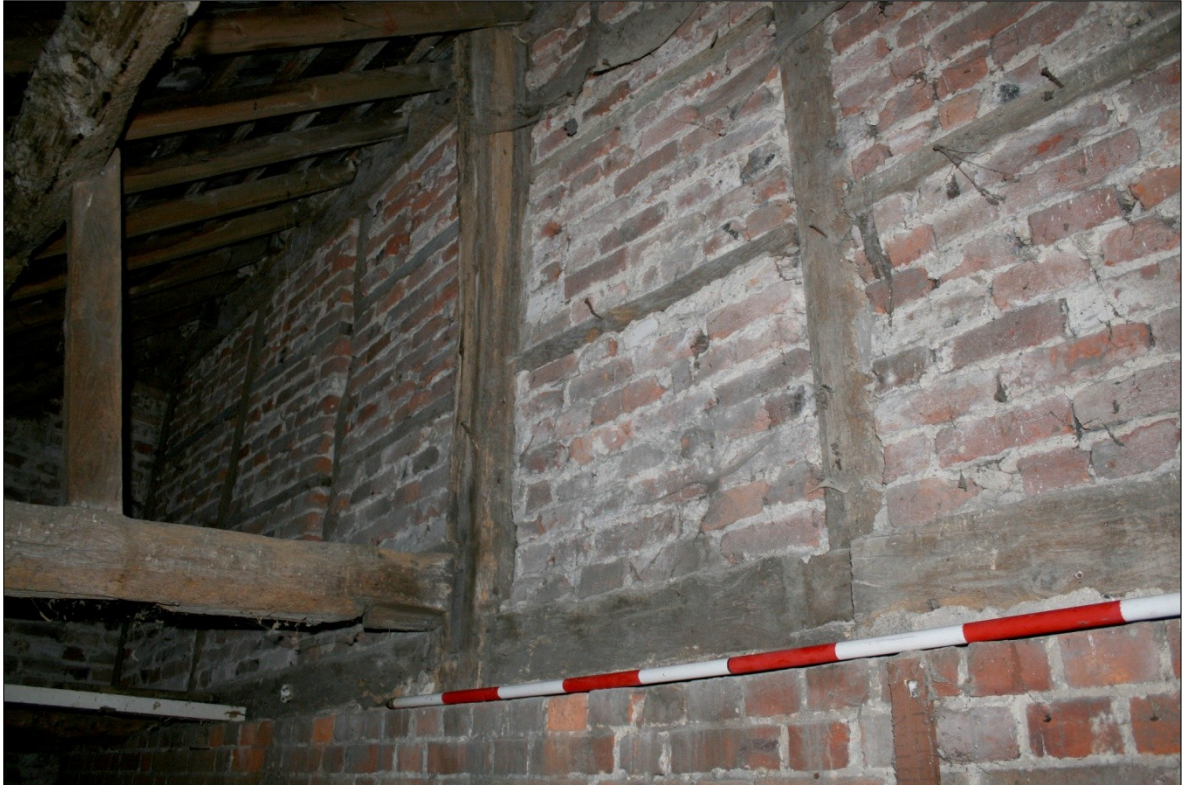
- 5.6 The ground plan of the lean-to annexe/store is rhomboidal (Fig.8; 29). The roof frame is constructed of re-used timber. The timber frame of the west wall of the dwelling house is extant (30-31).

| PHOTOGRAPHIC INDEX | | | |
|---|---|---|--|
| 30 | IMG_6988 | NE | Store. West wall of dwelling. |

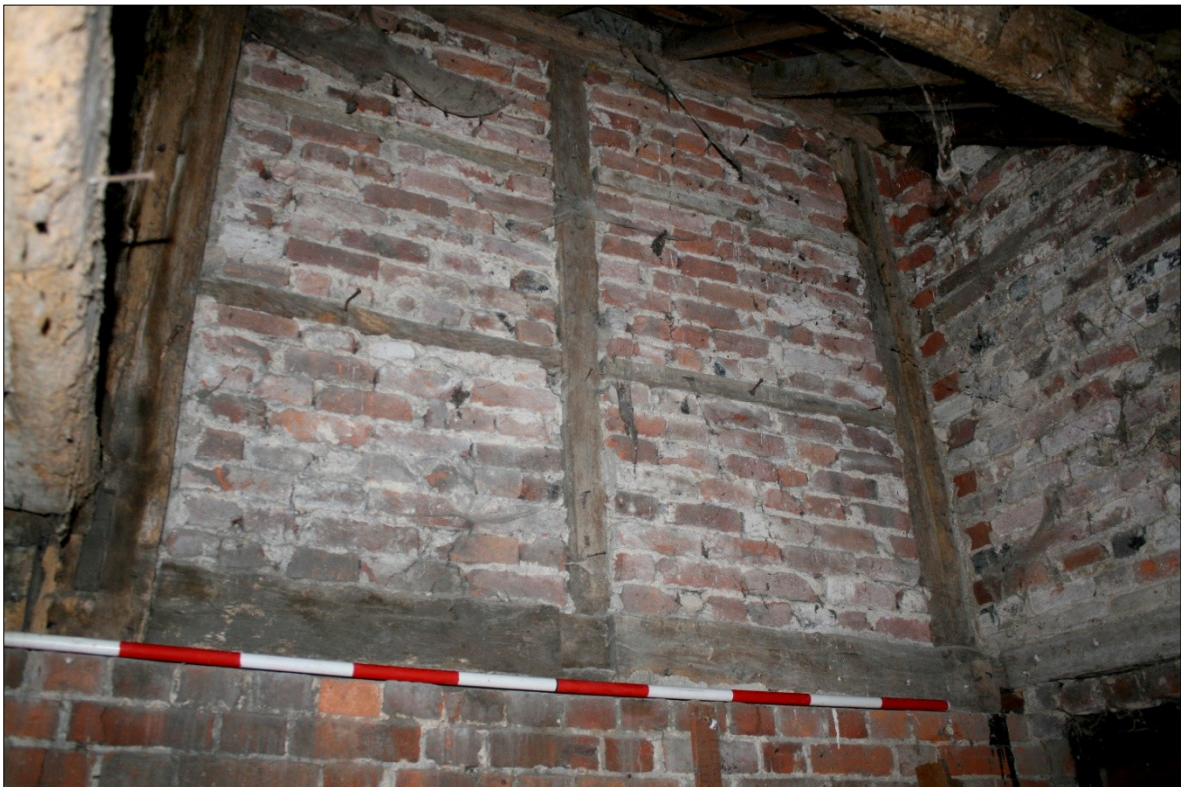
| PHOTOGRAPHIC INDEX | | | |
|---|---|---|--|
| 31 | IMG_6993 | SE | Store. West wall of dwelling. |

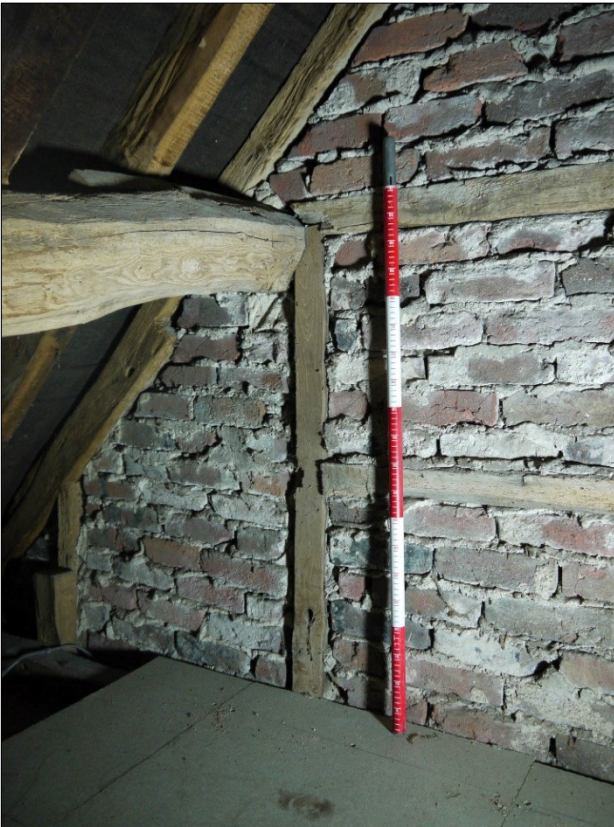
- 5.8 Only the roof space on the west side of the chimney was accessed. The roof space has been floored over in sheets of modern chipboard. The upper part of an axial floor beam runs from west wall to the chimney (Fig.11; 32, 39). The beam, presumably derived from another structure, has mortices, and possible crude stave grooves, along its length. The underside of the beam is not visible on the first floor. There is a single roof truss present (Fig.11; 32). This is situated immediately west of the chimney stack. It has clasped purlins carried by the collar, with two queen struts. The collar has stave grooves on its upper side (35-36) and stave holes on its underside (37), indicating that the frame was formerly in-filled with wattle and daub. Each of the purlins is joined at the point where it meets the truss (33-34). The tie beam is obscured by a modern chipboard floor which covers the entire roof space, which also conceals the joists, wall plates and all lower junctions of the roof frame. The lower part of the tie beam/truss is visible at first floor level (*ante*. 5.7). Carpenter's numerals on the principal rafter and purlin denote that this was the second truss, or second cross frame (38). The wall frame of the west wall is extant (40). The purlin on the south side rests upon the west wall (40, 41), whereas the purlin on the north side is supported by a prop (41, 42), although it is uncertain which structural member carries the prop.

| PHOTOGRAPHIC INDEX | | | |
|---|---|---|--|
| 41 | P1030349 | NW | Roof space. North purlin propped at west wall |

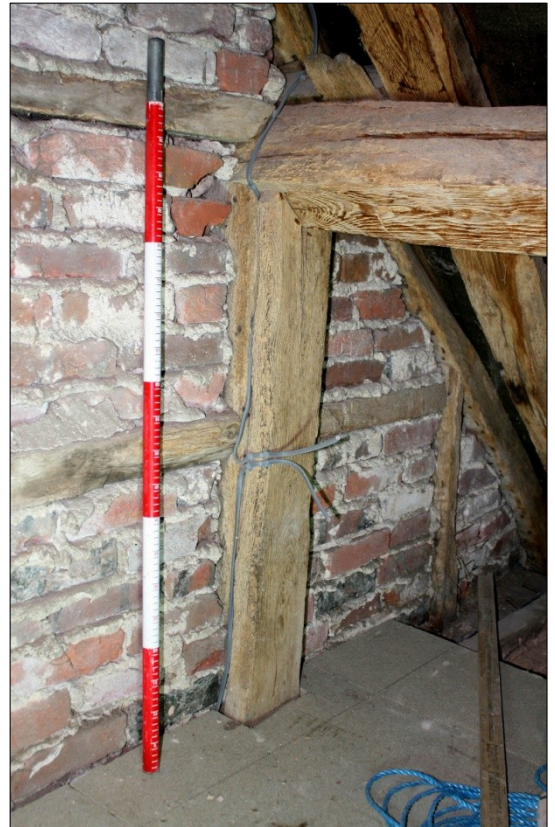
| PHOTOGRAPHIC INDEX | | | |
|---|---|---|--|
| 42 | IMG_7032 | NW | Roof space. South purlin carried by west wall |
