Archaeological Investigation at
Bradwell Village Pre-School
Memorial Hall
Vicarage Road, Bradwell
Milton Keynes MK13 9AG
(NGR 483181, 239557)

Planning Application Ref. 14/01247/FUL

Souterrain Project ID.SOU14-365

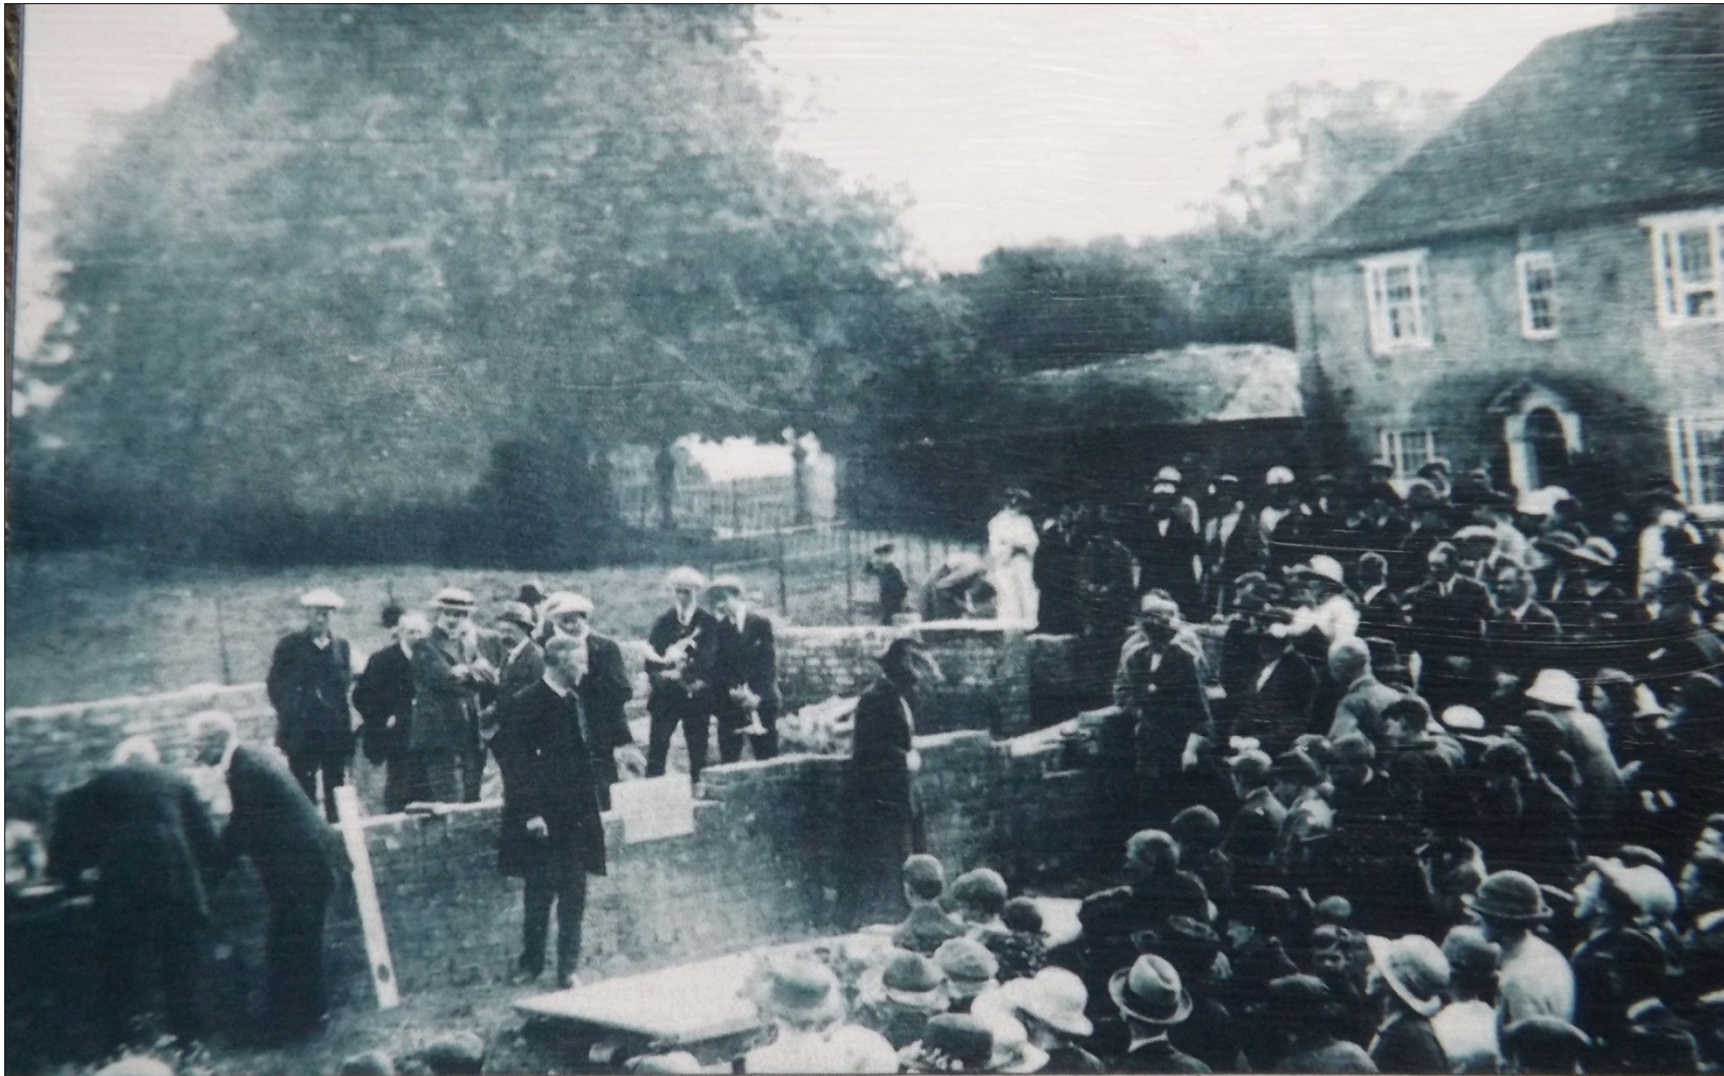
Figure 6. Laying the foundation stone of Bradwell Memorial Hall c. 1924. Facing south; the bailey earthwork is visible behind the building site. (photograph courtesy of the Bradwell Hall Memorial Hall Committee).

- 2.2 The Memorial Hall was built in the early 1920s in honour of those who served in the Great War. It is located on the north-western edge of a Norman motte and bailey earthwork, known locally as Bradwell Castle (Figs. 2 and 6). The earthwork is now a Scheduled Monument (No. 19002). The hall itself is believed to occupy part of the earthwork, and is thus included in the scheduled area. Scheduled Monument Consent was thus acquired from English Heritage by the planning applicant's agent before the development commenced². The site also lies within an archaeological notification area defining the medieval core of old Bradwell village.

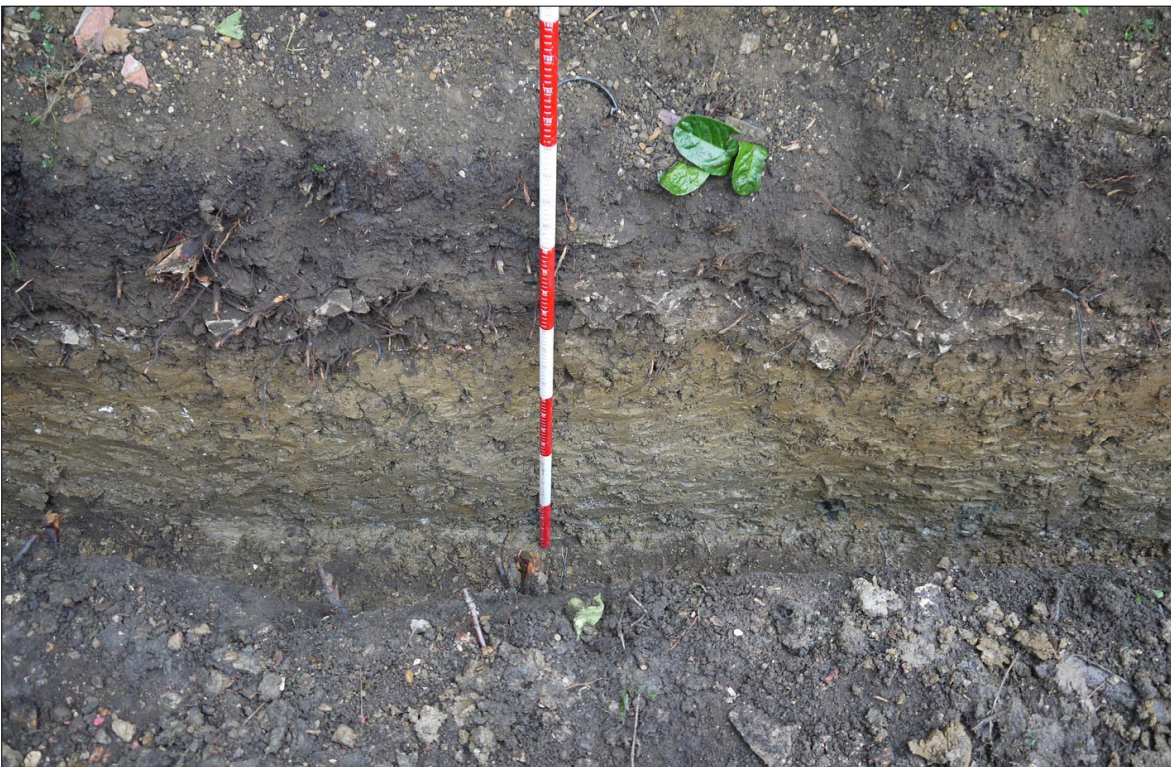
13.5. Section B. General stratigraphic sequence. Facing SE
