Archaeological Investigation
at Piper's Cottage
Piper's Hill
Great Gaddesden
Hemel Hempstead, HP1 3BY

**Archaeological Investigation at
Piper's Cottage
Piper's Hill, Great Gaddesden
Hemel Hempstead, HP1 3BY**

Souterrain Project SOU14-331

September 2014

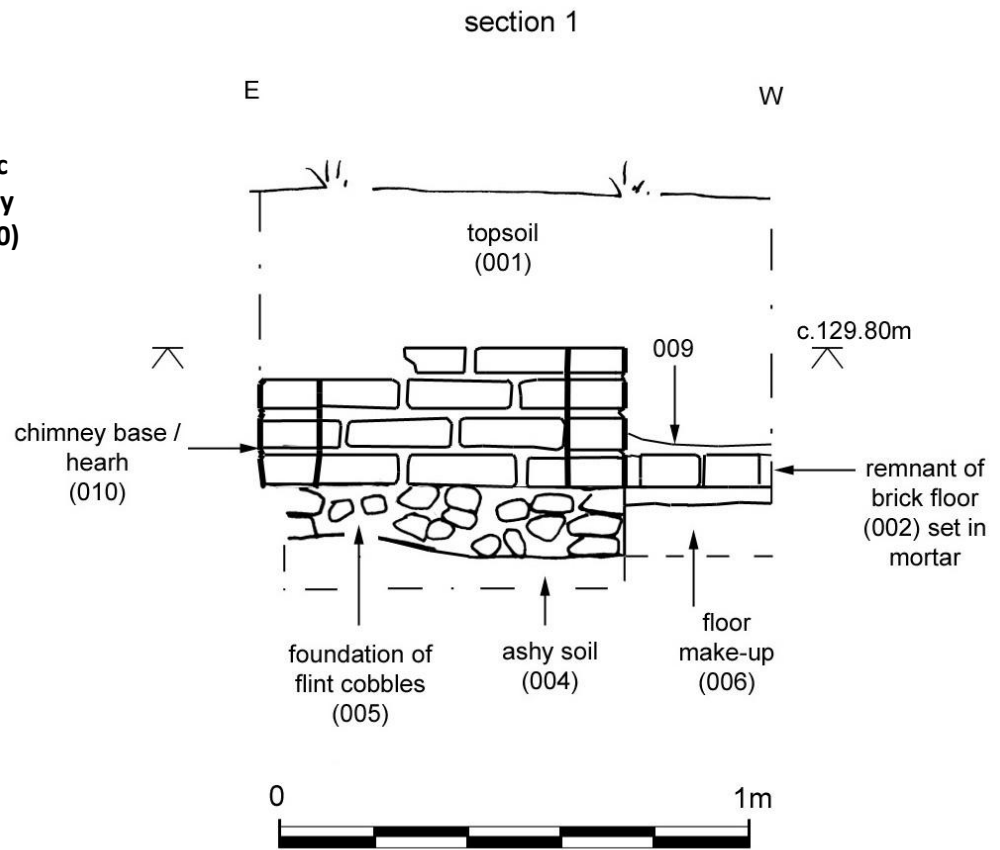
Figure 10. Post-medieval building foundations in NW drainage trench. Facing SE

- 8.7 In the southeast corner of the room there was a small rectangular brick structure (010) interpreted as the base of a chimney and a hearth (Fig. 6 and Figs. 9 to 12). The wall of the structure was the width of a single brick (c.0.11m) and survived up to four courses (0.33m). The bricks were of a post-medieval form, probably of 16th or 17th century date (*post.9.7*). The structure was evidently in-filled at the time of the building's demolition, containing a quantity of smashed red clay roof tiles, ashy soil and broken pottery, of late 18th century - early 19th century date (*post. 9.4-9.5, Table 3*). A few residual medieval sherds were also present (*post. 9.2, Table 1*).

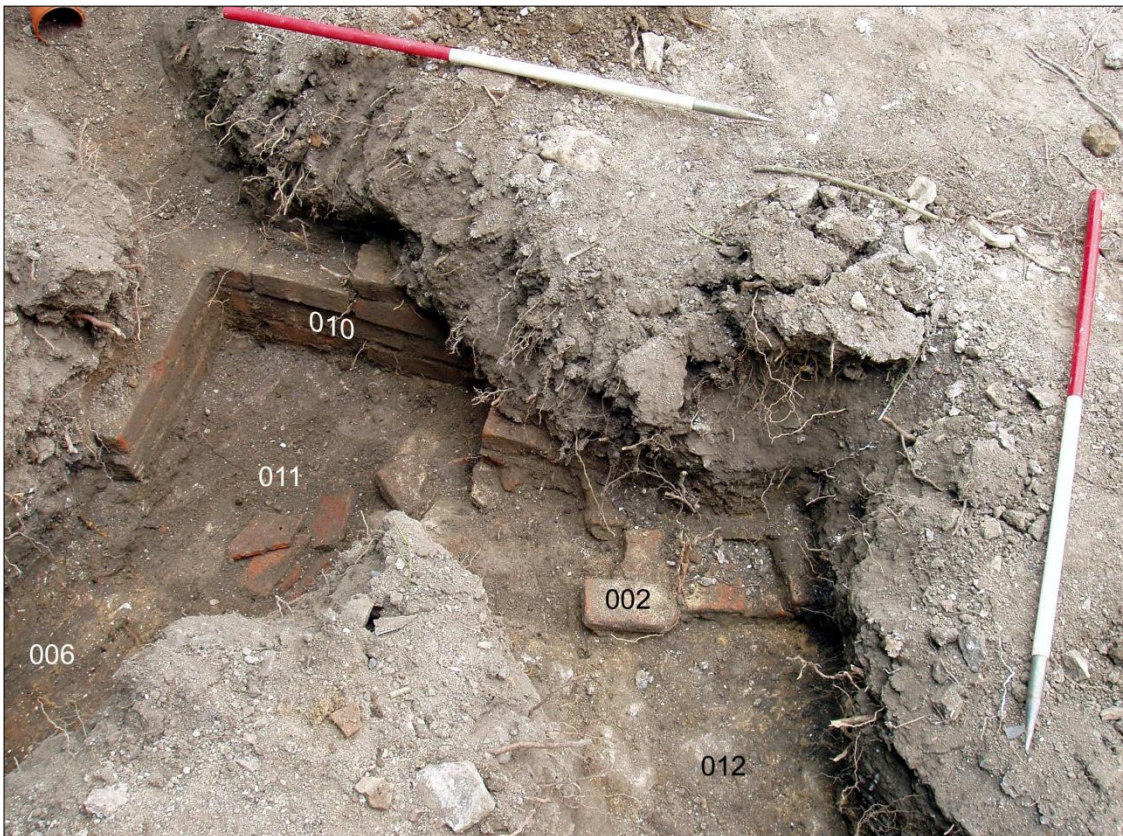
Figure 11.
Post-medieval
building
foundations in NE
drainage trench.
Facing N

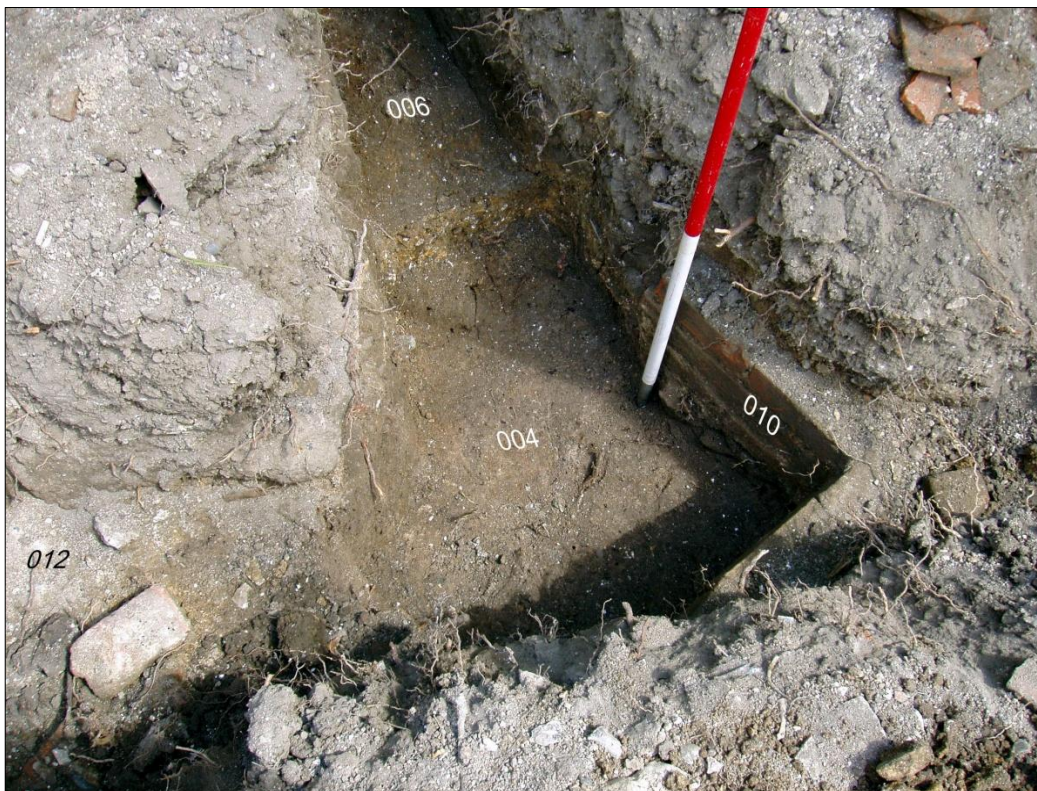
Figure 12. NE drainage trench, after removal of demolition deposit (011) and a portion of floor (006). Facing N

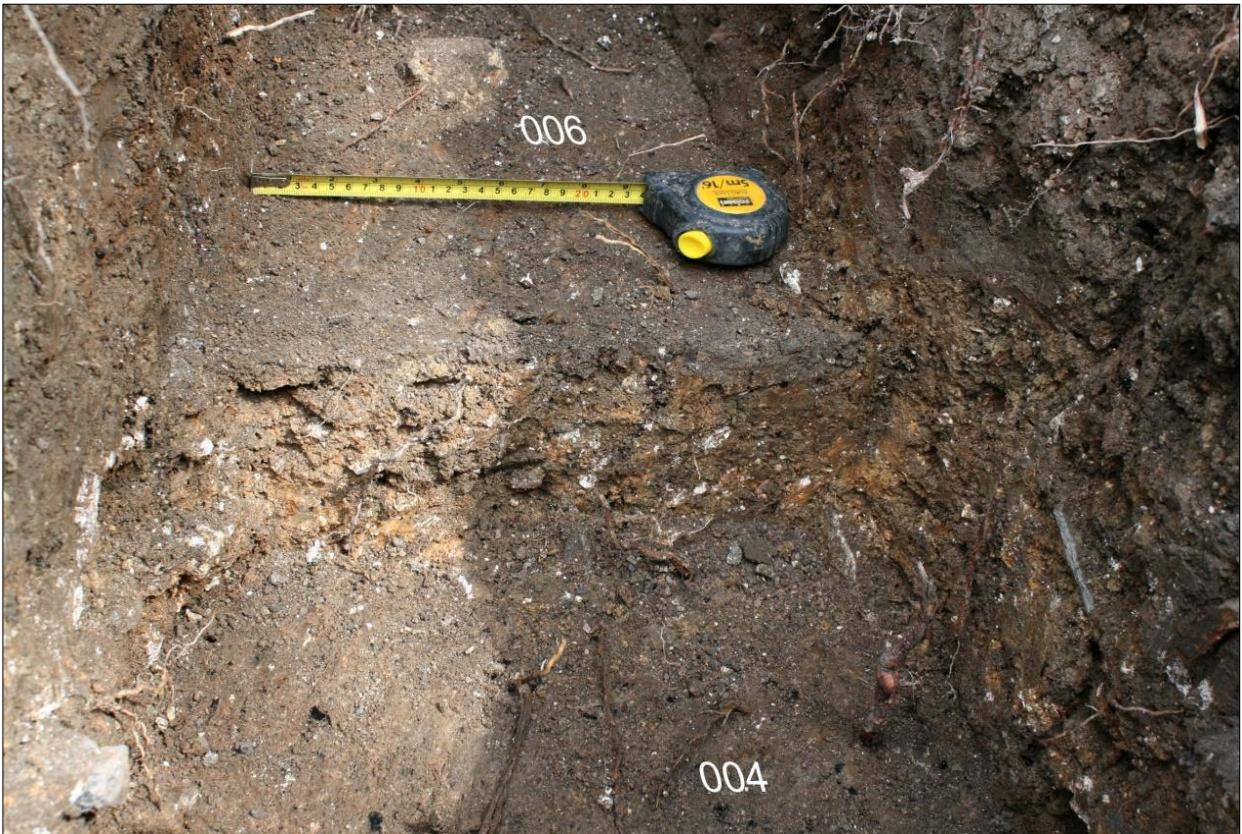
Figure 13. Detail of section through floor-make-up in NE drainage trench. Facing N

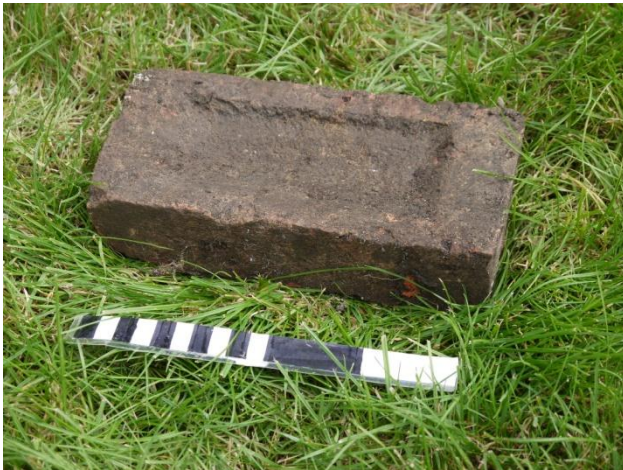
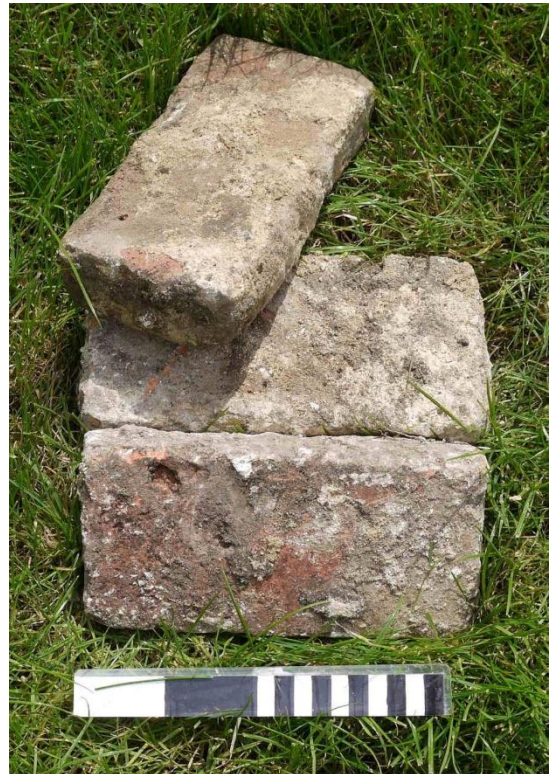
Figure 14. Brick types

Above: early 19th century form. Right: Post-medieval (c. C 16th / C 17th) form.

9.7 Two distinctive forms of hand-made brick were used in the construction of Piper's Cottage. These are shown at Figure 14. The earliest form is found in the in-fill of the north and west timber walls frames (the west wall is concealed by the lean-to). Bricks are shallow in gauge (height) and have

rounded arisses. Dimensions are variable, three main sizes being as follows: $7\frac{7}{8}$ " x $3\frac{3}{4}$ " x $1\frac{3}{4}$ " (200 x 95 x 44mm); $8\frac{5}{8}$ " x $4\frac{1}{8}$ " x $2\frac{1}{8}$ " (219 x 105 x 54mm) and $8\frac{3}{4}$ " x $4\frac{1}{8}$ " x $1\frac{3}{4}$ " (224 x 104 x 95mm). This type of brick was present in the excavation area in five contexts: chimney / hearth structure (010); floor remnant (002); wall structure (017), rubble in-fill of the cellar (033), and the rim structure of well [032]. In the latter structure, the presence of mortar showed that they were derived from the demolished house. It is therefore most probable that the material used for Piper's Cottage was also salvaged from the earlier building.

- 9.8 The second form of brick was used for the construction of the rear and east walls of Piper's Cottage and the lean-to. It was also used for a back yard at the rear of the lean to and was found within the make-up of the living room floor of the existing house. Its dimensions are generally uniform: $8\frac{3}{4}$ " (220mm) x $4\frac{1}{4}$ " (110mm) x $2\frac{1}{2}$ " (65mm) and it has a characteristic rectangular 'frog' on its underside. It is presumed to date from the early 19th century.

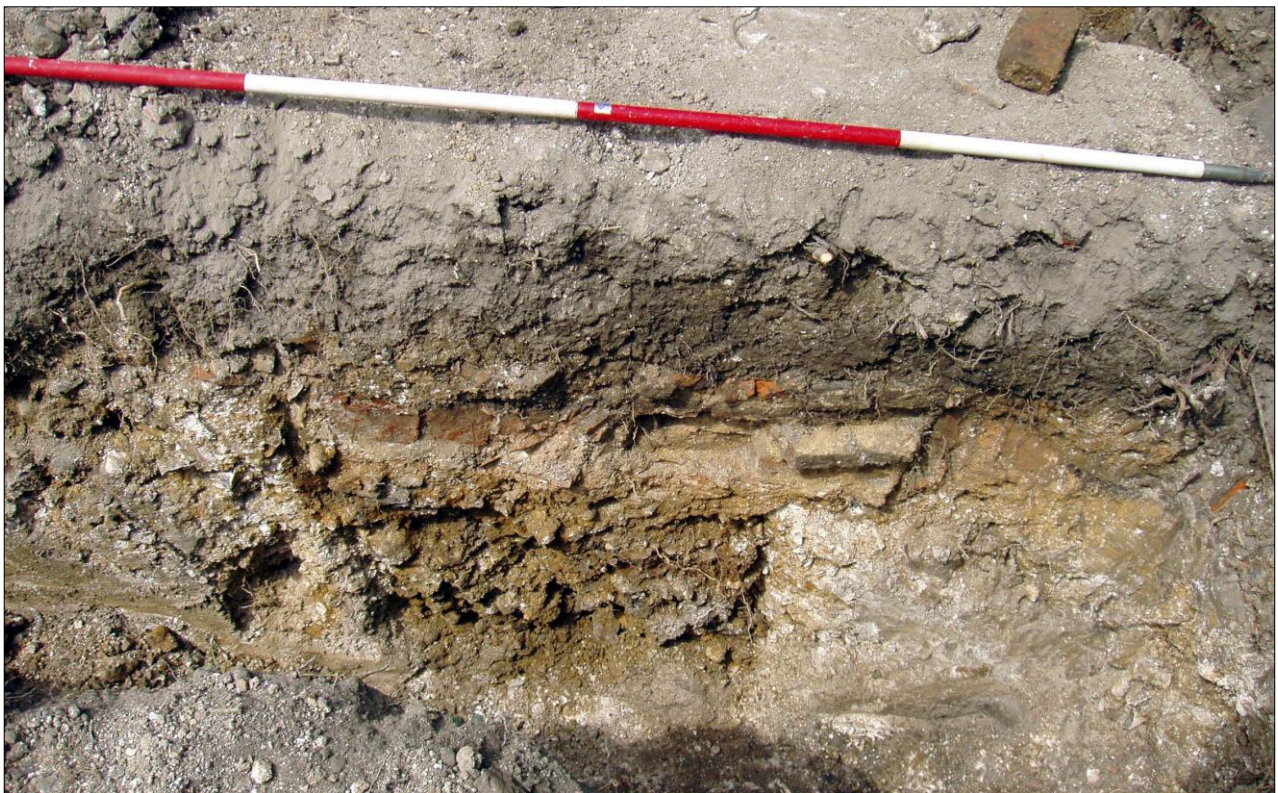
Figure 16.
Post-medieval cellar
exposed in foundation
trench on the east side
of Piper's Cottage.
Facing NW

- 8.10 To the northwest of the room, a cellar (030) / (031) was partly exposed during the excavation of a foundation trench for the new building (Figs 6 and 16). The cellar was cut into the chalk to a depth of at least 2m, though was un-bottomed. Only its southeast side of the cellar was revealed; about 5 sq.m. The eastern extent of the cellar was partly defined in the north-western drainage trench. The side of cellar had been cut into differential geological deposits (chalk and calcareous clay) and had been retained by a wall composed of irregular pieces of limestone bonded with mortar (031). The fill of cellar (033) consisted of dark brown soil and fragments of post-medieval bricks (*post.9.7*). Pottery indicated that the cellar was back-filled in the early 19th century (*post. 9.4-9.5*, Table 3).

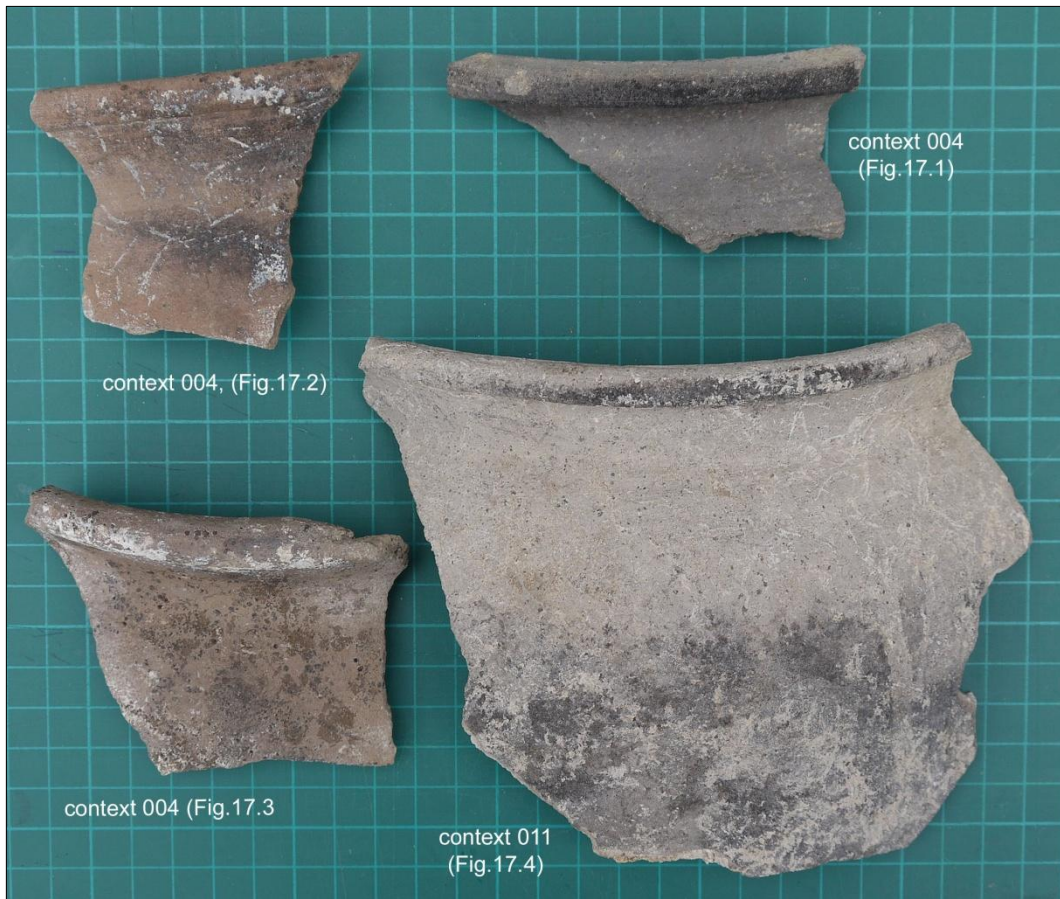
Figure 18. 12th/ 13th century pottery: Hertfordshire Type Grey Ware

9.1 A total of 31 sherds (1037 grams) were recovered during the investigations from stratified contexts. These are arranged by order of context in the catalogue (Table 1). The assemblage dates broadly to the 12th / 13th century. All sherds are variants of Hertfordshire Type Grey Ware, a coarse sandy ware, notably of a type found at Chalgrave in Bedfordshire³². The diagnostic forms are cooking pots, many of which are sooted. There is an overall minimum vessel count (MNV) of 21 (Table 2). The fabric comparison was done by Jackie Wells.

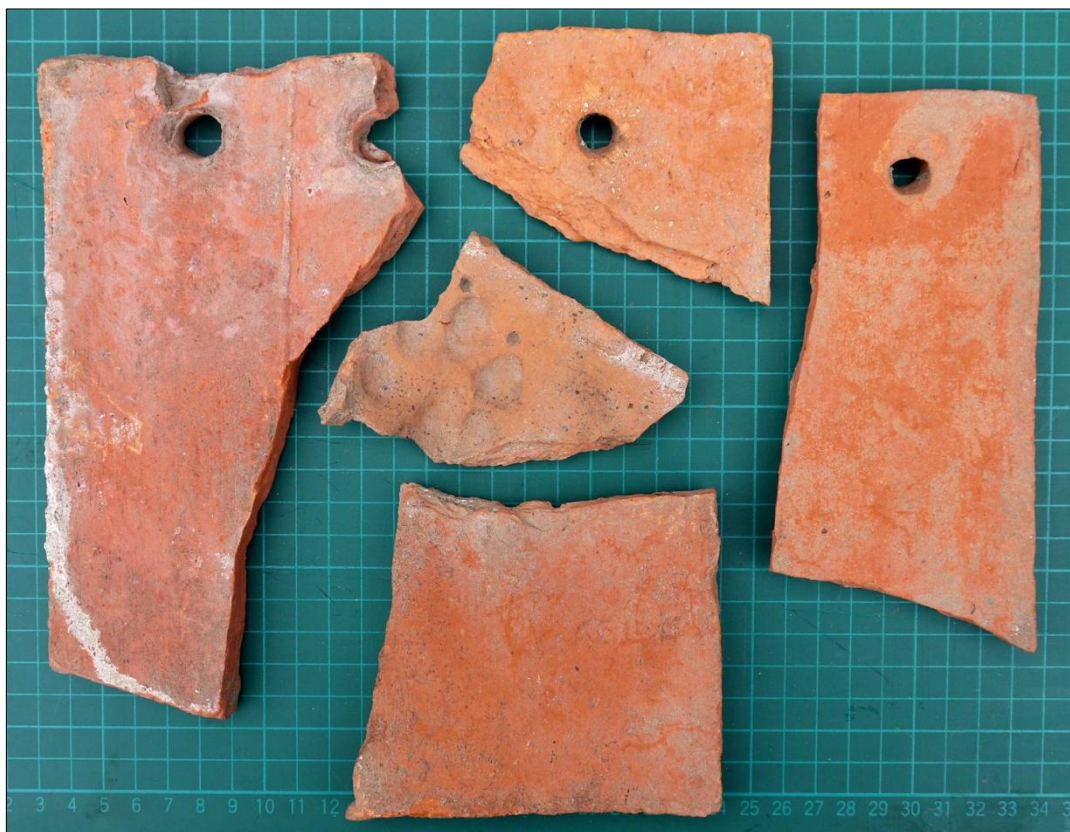
Figure 19 . Post-medieval roof tiles from context (011)

9.6 Fragments of red fired clay roof tiles were present in fill (011) of the chimney/ hearth structure (010) and possible pathway features (021) and (022). The tiles are understood to have been derived from the post-medieval building which was demolished on the site in the early 19th century. The approximate dimensions of each tile are 6" (150mm) wide x 10" long (254mm) x c. ½" (13mm) thick. Each tile has two round peg holes ½" (12.5mm) diameter set apart 1½"(38mm). A single fragment of orange-red fired clay tile (probably roof tile) was found in pit [025]. This was 5/8" (16mm) in thickness. Its date is uncertain though possibly either medieval or post-medieval.
