Archaeological Investigation:  
Church Walk House,  
No. 2 Church Walk,  
Newton Bromswold,  
Northamptonshire, NN10 0SS  
(NGR SP997657)

Planning App. Ref. 17/00853/FUL  
HER Event No. ENN108839

Project: SOU17-556

January 2018

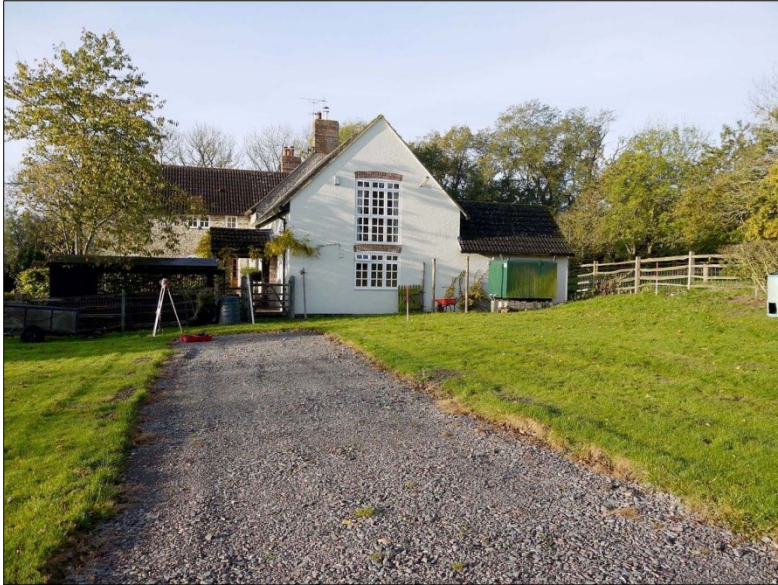
**Figure 3.**  
Pre-excitation overview of the site showing aspect of postulated earthwork along the northwest boundary. Facing southwest

- 6.2 In view of the presumed historic origin of a linear earthwork on the north-western boundary of the property (*ante. 4.4*; Fig. 2) a detailed topographical survey was undertaken of the immediate locality of Church Walk (c. 30 x 30 m) prior to ground reduction (Fig. 6). This would enable not only illustrate the aspect and disposition of the earthwork, but enable a better understanding of the context of any associated archaeological features found during ground work. The south-eastern side of this earthwork prior to ground work is shown on Figure 3. The contours on Figure 6 are at intervals of 10 cm.

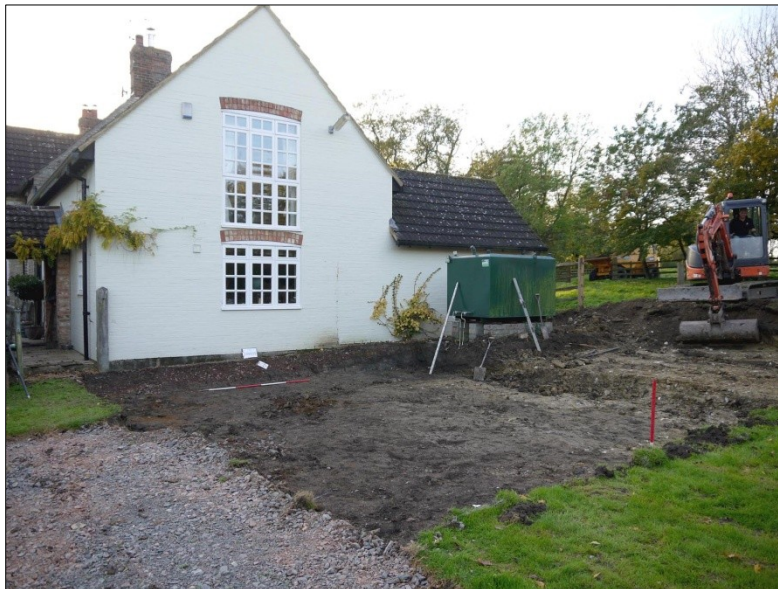
**Figure 4.**  
Area of ground reduction. Facing southwest

- 6.3 Ground reduction was carried out by a mechanical excavator fitted with a wide grading bucket, under the direction of the archaeologist. The area of ground reduction and ground deposits (Figs. 4 to 10) were surveyed to Ordnance Survey National Grid co-ordinates and height datum using RTK differential GPS. A digital photographic record was made and written descriptions were made of ground deposits using a context recording system (Appendix 1).

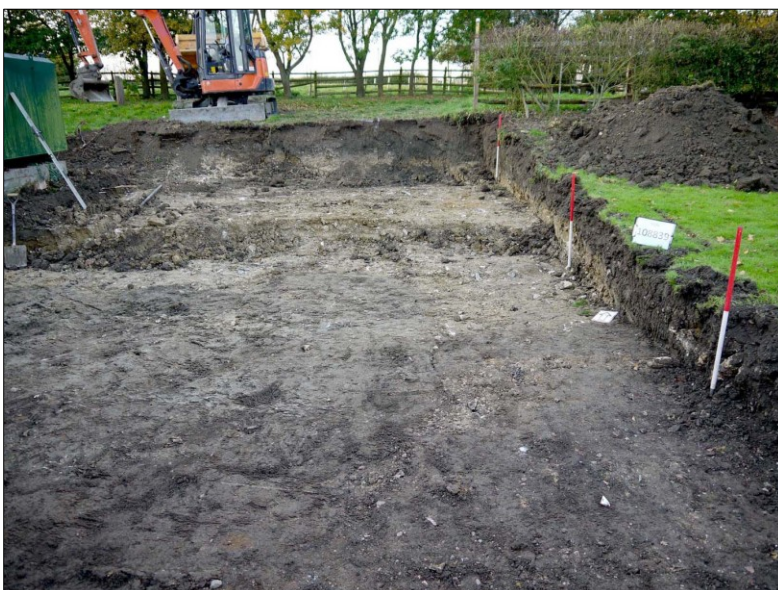
**Figure 5.**  
Area of ground reduction. Facing northwest

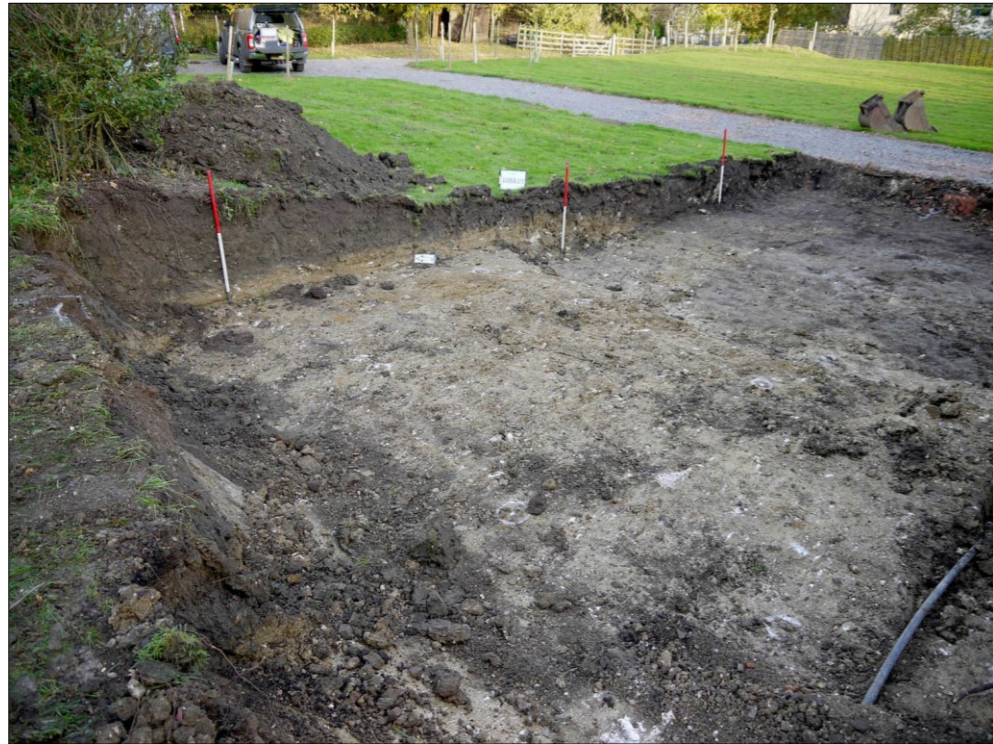
Figure 8. Overview of Section 1. Looking southeast from Church Walk

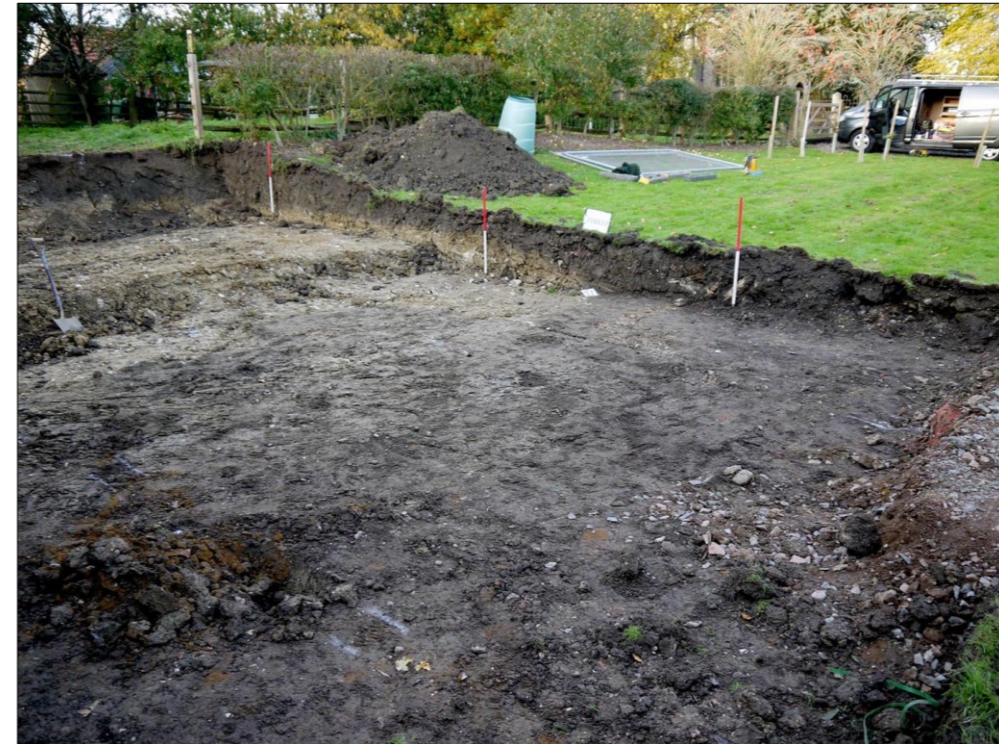
Figure 9. Overview of Section 1. Looking north towards Church Walk
