Historic Agricultural Buildings
at Mercer's Farm,
9 High Street, Earls Barton,
Northamptonshire

Historic Building Record

Historic Environment Record Event No. 109717
Planning Refs. WP/16/00675/FUL & WP/18/00319/FUL

March 2020

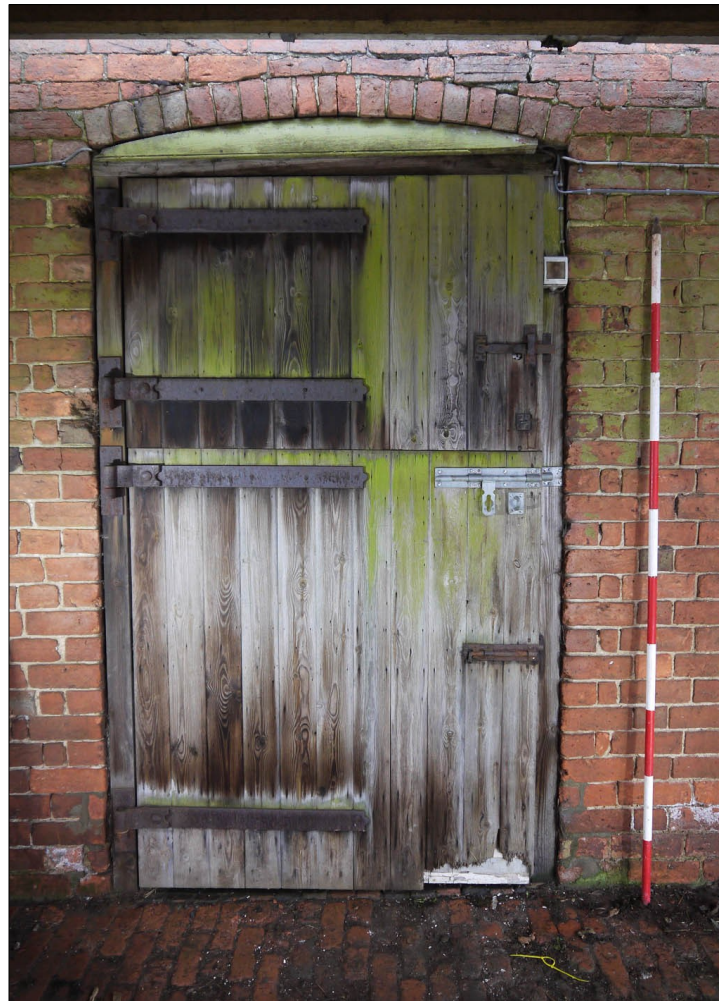
23. Building 2 (cow house/milking parlour), entrance with stable-type door. Facing NW

- 4.9 The end cell is a loosebox with the capacity for two beasts. It is accessed from the farmyard via a split stable-type door [21, 23], which was typically wide for a cow or a bull. The floor is brick and the walls and low ceiling are lime-washed [39]. A brick-built manger spans the width of the cell along the northern wall. The manger has a timber rail a wrought-iron tethering ring towards either end. The manger trough is cement-formed. Above the western half of the manger, there is a timber-framed feeding rack fixed to the wall. The cell was lit, by a half-shuttered/ half-slatted window in the east (gable end) wall, with additional ventilation via two small cast-iron air-bricks, one at the front, the other in the gable end (Fig. 12, elevation 2; Fig. 13, Elevation 3). There were no indications of trapdoors in the ceiling, for dropping hay from a first-floor loft.

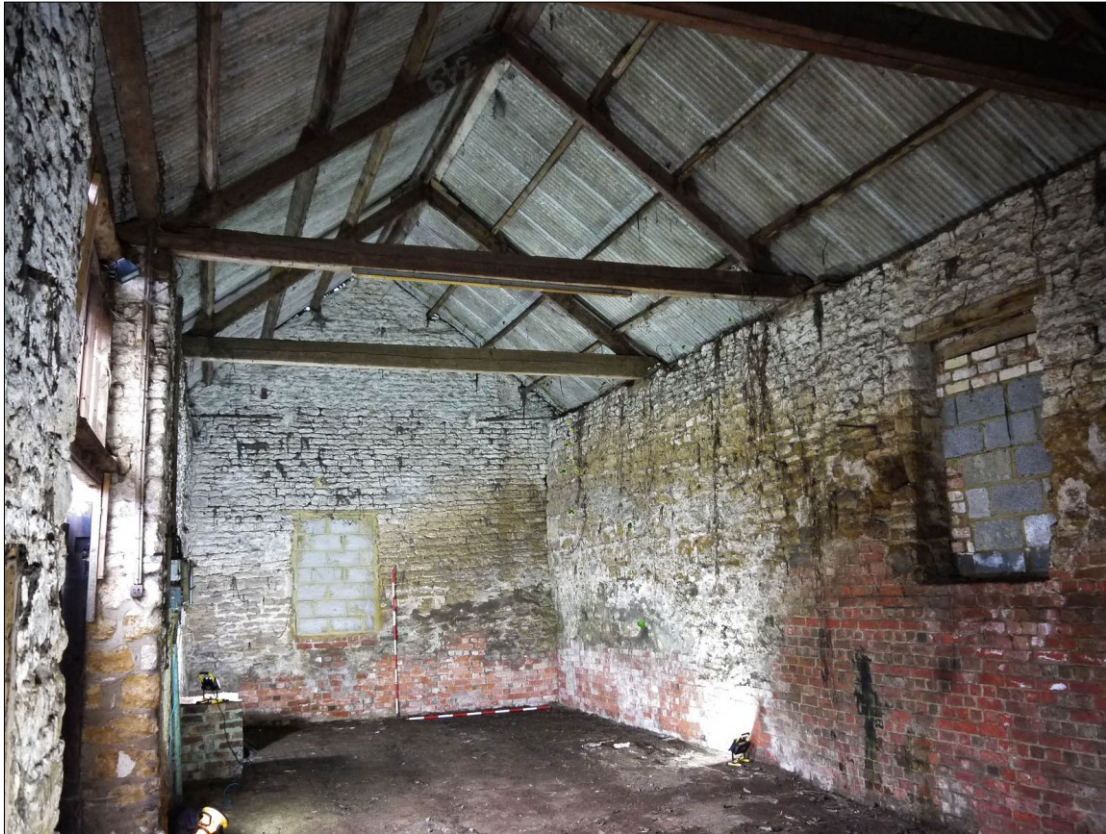
33. Interior of the Building 1, the stone barn. Facing NNW

- 4.5 Inside the barn the areas of wall that are below ground level have been extensively re-built in brick [33, 37, 38], undoubtedly to control damp and decay. The bricks are a type commonly manufactured in the late 19th and early 20th century. The floor of the barn was covered in laid brick, of the same type used in the wall repairs. Partial removal of the brick floor in December 2019 revealed it had been laid above a thin layer of sand-mortar blinding above the geological stratum. A series of sectional clay land drains had been laid in the geological stratum. The drainage pipes were an extruded type with flat base, commonly manufactured in the late 19th and early 20th century⁸. The roof is held by three machine-sawn, 'A'-frame trusses of a 20th century type (Fig. 14, [32-36]), which are probably constructed from imported pine. There are no discernible fittings inside the building.

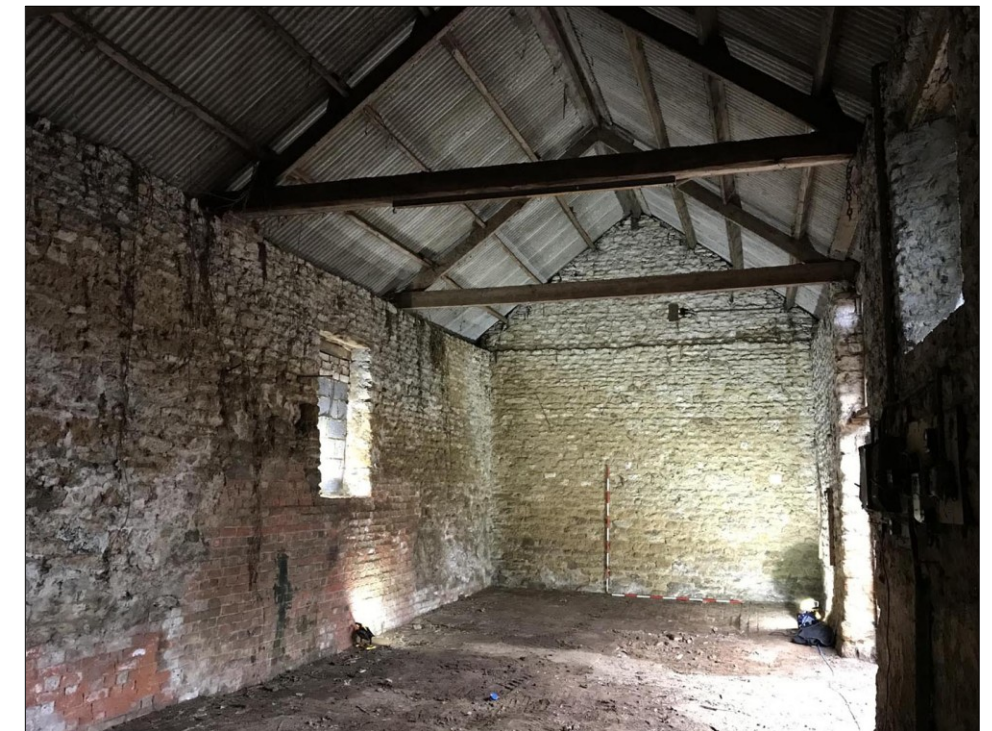
37. Interior of the Building 1, the stone barn. Facing SE

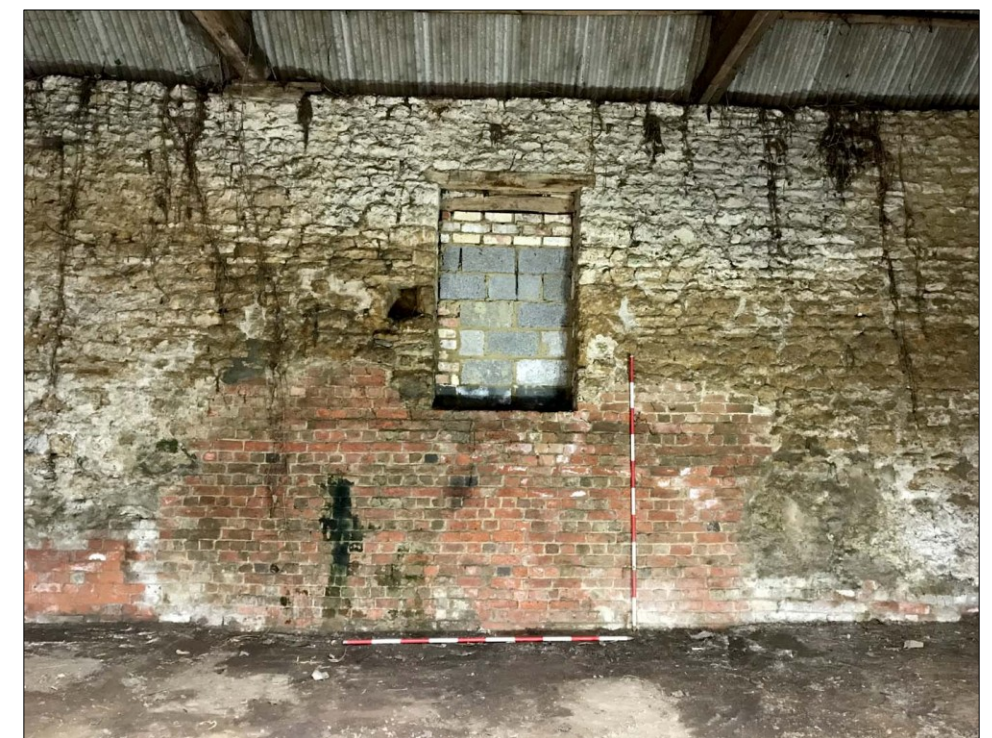
38. Interior of the Building 1, the stone barn. Facing NE

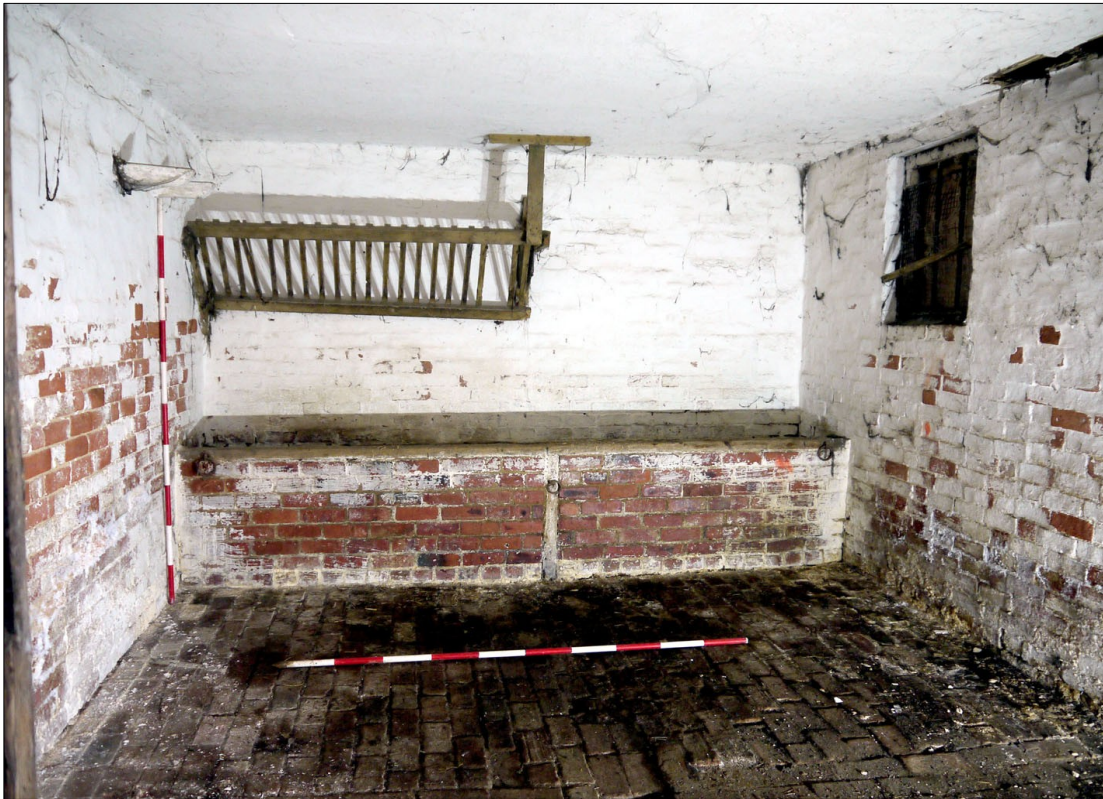
39. Interior of the loosebox, NE end of Building 2. Manger. Facing NW

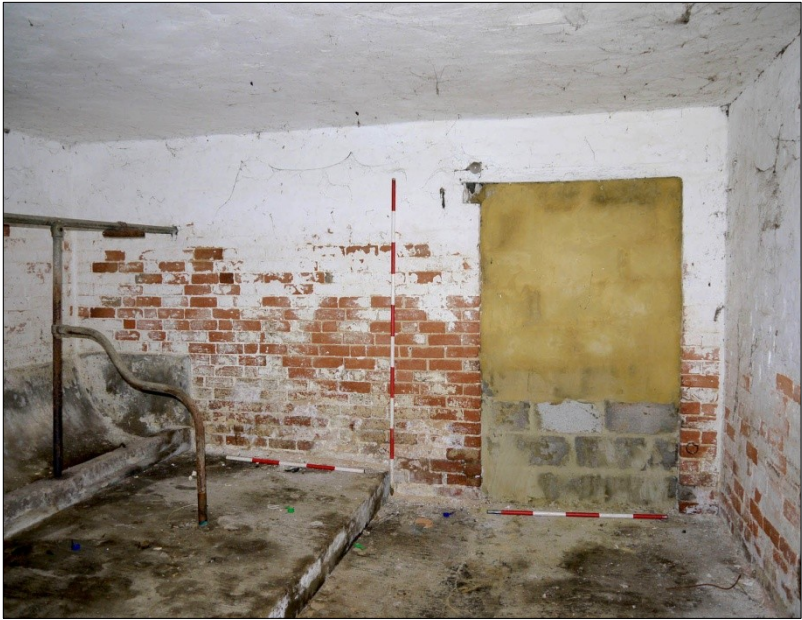
41 Interior of the SW box (milking parlour) of Building 2. Manger (L) and blocked doorway (R) to the the NE box. Facing NE

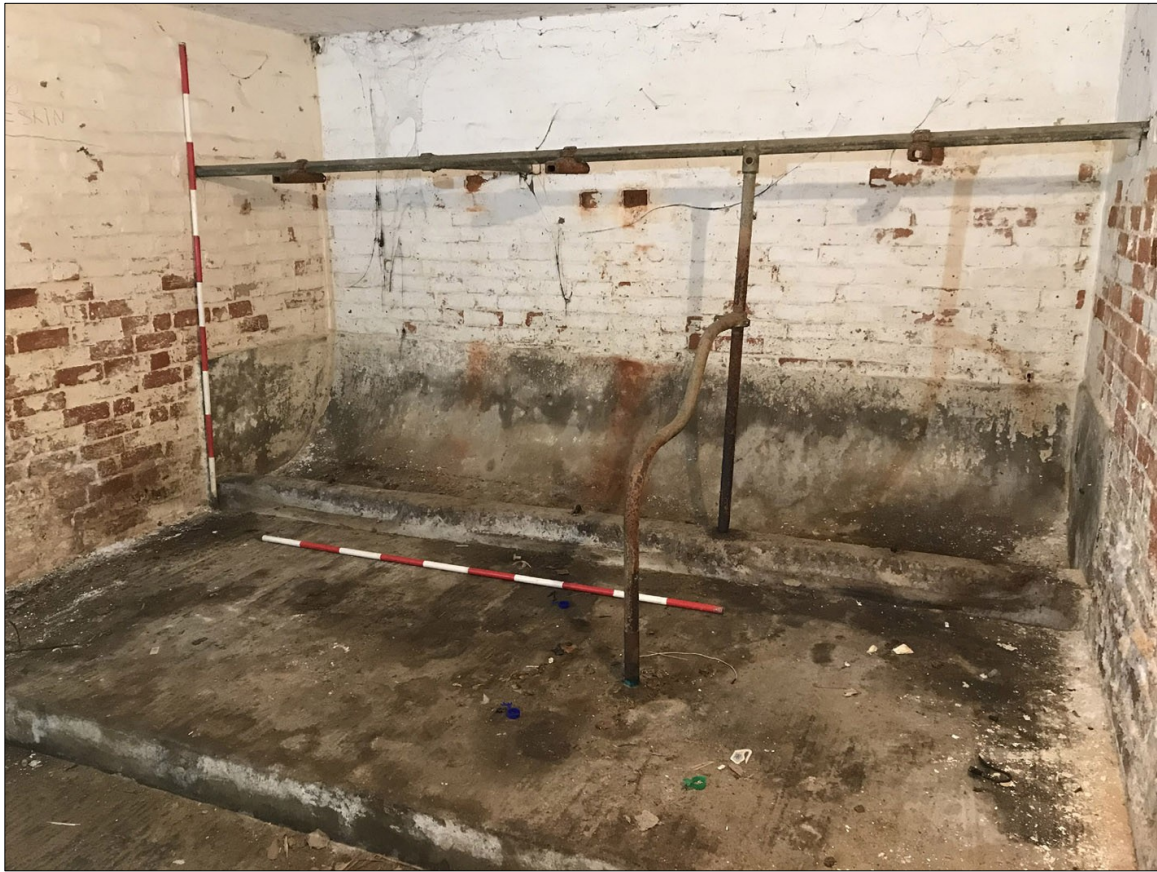
44. Building 2, SW box (milking parlour), cow stalls and trough manger. Facing NW

- 4.11 The west cell was a milking parlour with two stalls. Unlike the loosebox, the floor is built of concrete. This has a step (c. 17.5 cm) up to the stalls which are located in the northern half of the building, where a feed trough of formed concrete spans the rear wall [41, 44]. The floor of the stalls area is very slightly sloped away downwards to the lower level (the cleansing passage) allowing separation and drainage of effluence. The stall divider is made of galvanised tubular steel set into the concrete floor and secured by a horizontal brace fitted to the side walls above the head-height of cows. Although tube galvanising appeared in England as early as 1876⁹, its general use as stall dividers in milking parlours is thought to have been prompted by government legislation in 1959¹⁰. Access to this milking parlour was via a doorway from Building 3 (Fig. 12, Elevation 2) [42]. Initially lit solely by a half-shuttered/ half-slatted window in the front elevation [43], a single electric light bulb was fitted to the east wall.

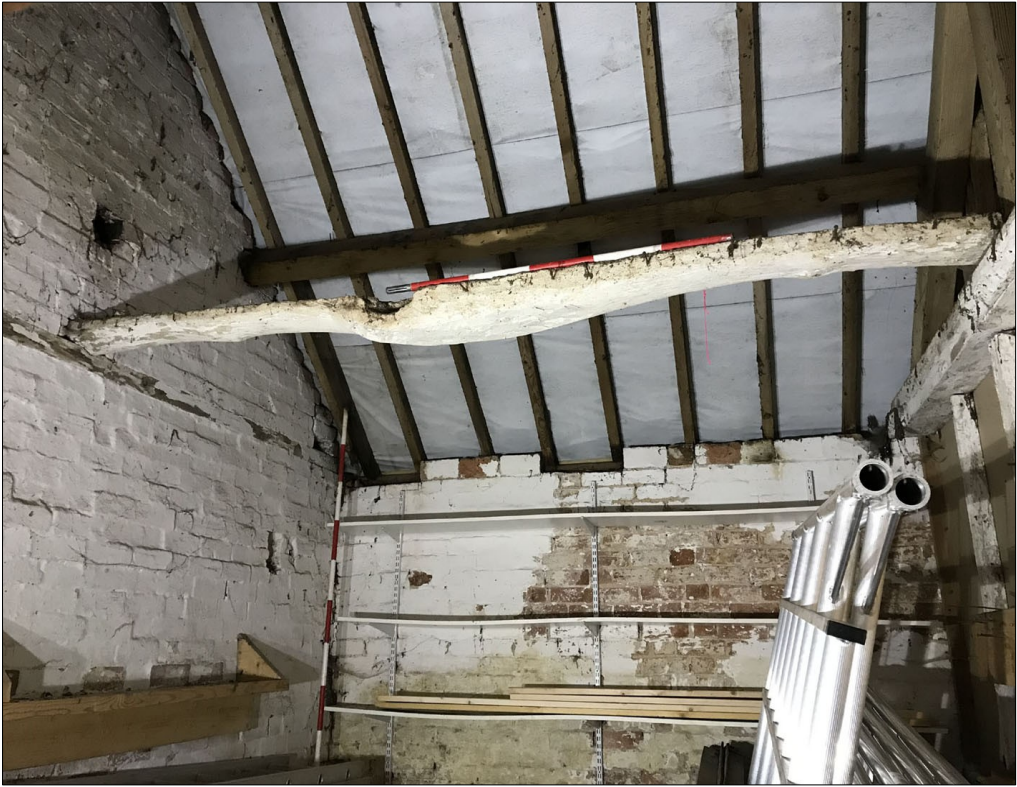
59. Loosebox at the SE end of Building 5, showing a re-claimed cambered oak tie beam used as a longitudinal /spine beam. Facing SW

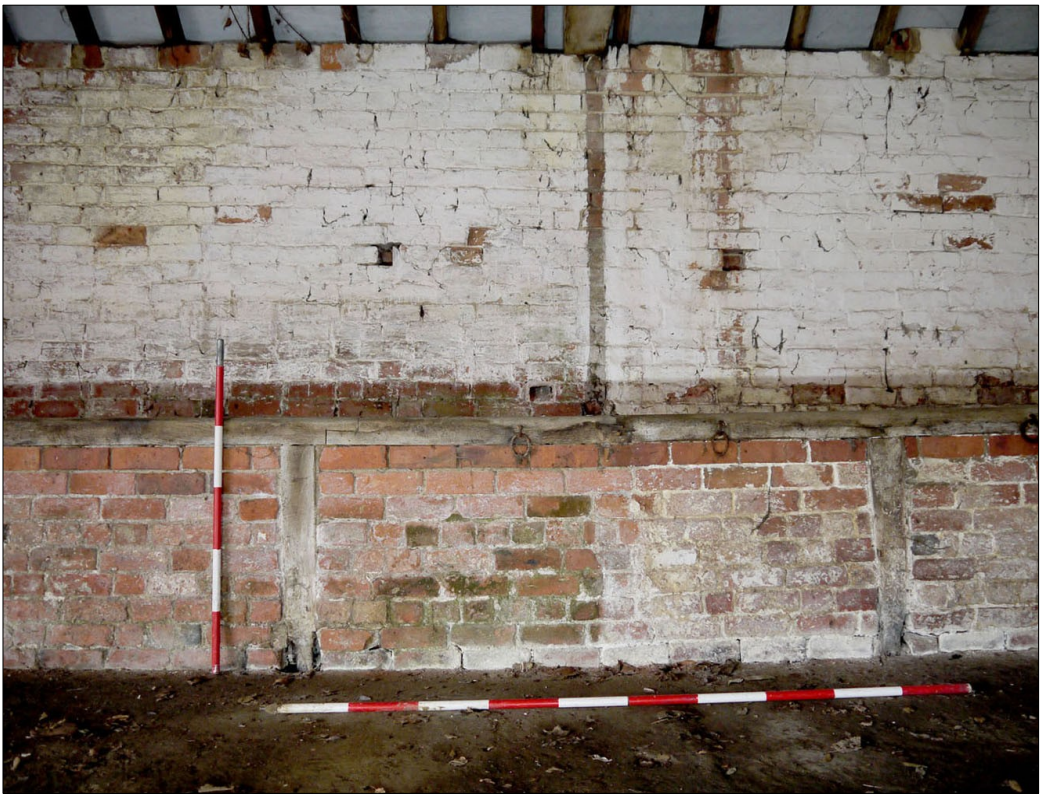
58. Brick-built manger in Building 5 (open-fronted cow shelter), facing SW

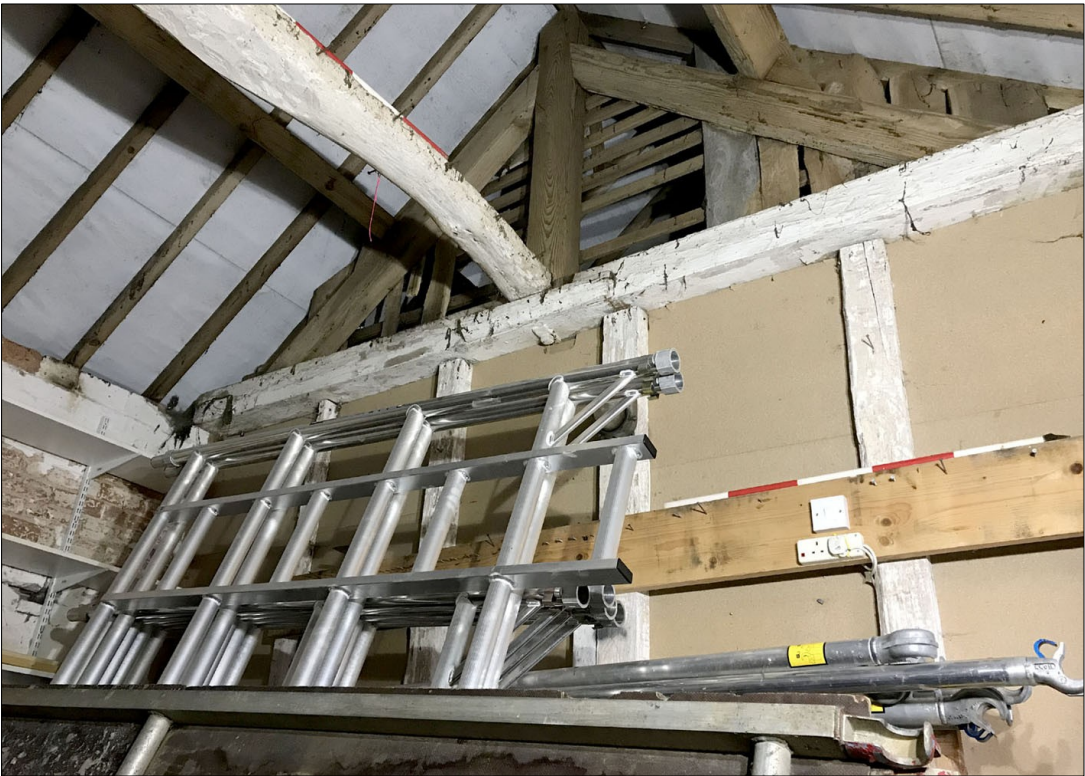
60. Loosebox at the SE end of Building 5, showing the partition wall constructed of re-claimed oak timbers. Facing NW

- 4.21 Visibility inside the loosebox was restricted due to present use as an equipment store. Significantly, however, the partition separating the loosebox from the open shelter is a stud wall built of re-claimed hand-sawn timbers (presumably oak) (Fig. 15, Section 5; [59]), while a salvaged cambered oak tie beam is in use as a longitudinal /spine beam [60]. The timbers were presumably reclaimed from a pre-Victorian farm building.
