Former Site of Japonica Cottage,
76 High Street, Gretton,
Northamptonshire, NN17 3DF
(NGR 489943, 294150)

Archaeological Investigation

Northants HER Event No ENN109595
Planning App. Ref. 17/00566/DPA
Souterrain Project SOU19-661

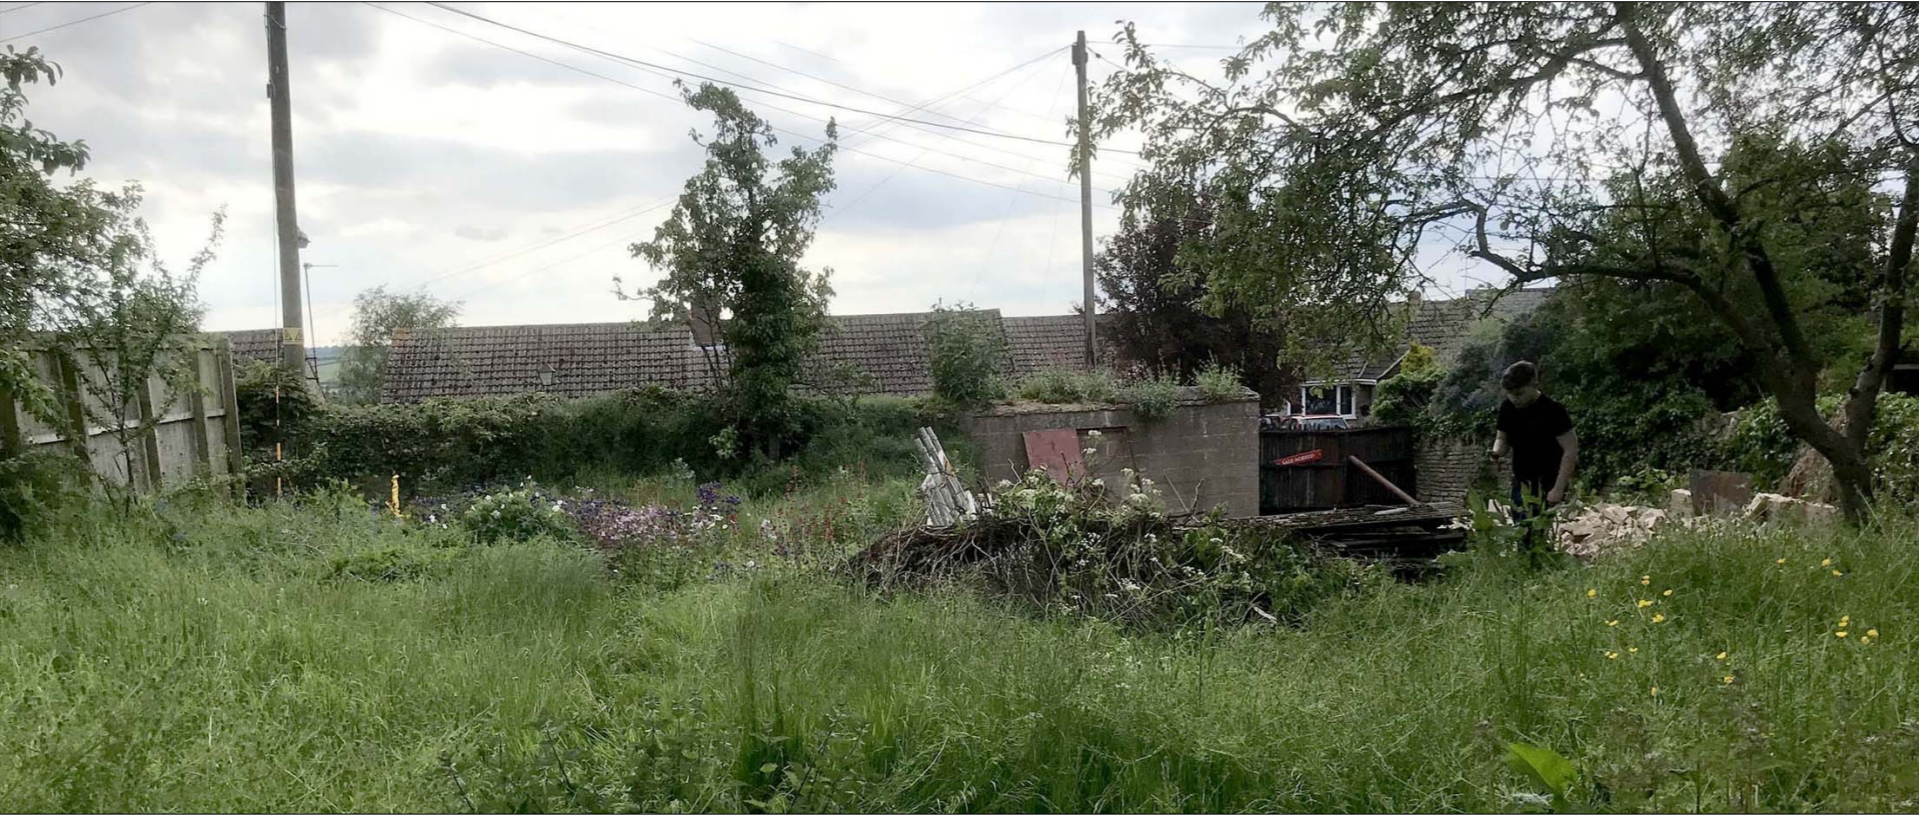
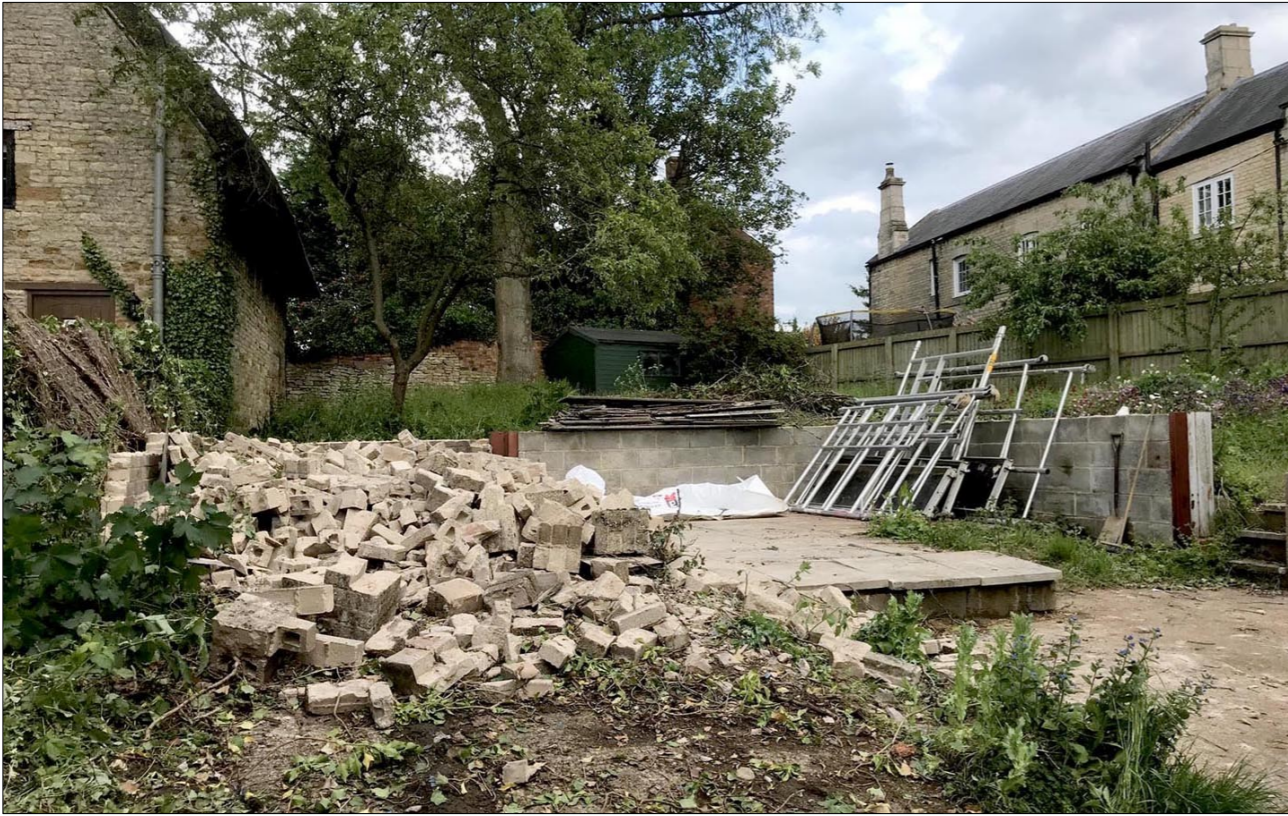
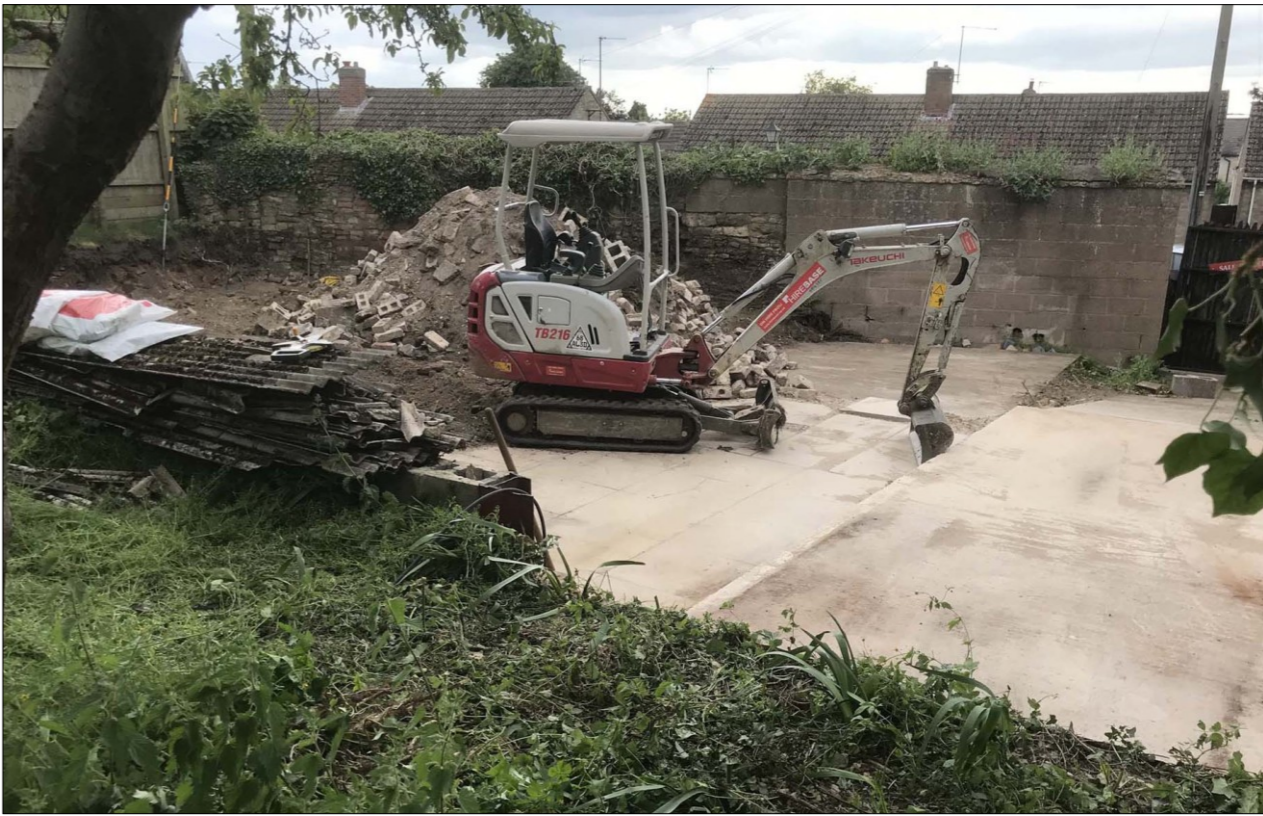
Figure 8. Pre-commencement views of the site, 28.05 2020

- 6.3 A certain amount of ground modification and excavation, largely associated with demolition work, had taken place prior to the archaeological recording in March. Figure 8 shows three post-demolition, pre-commencement photographs of the site taken by the Developer in May 2019. Figure 9 shows general views of the site take by the archaeologist on arrival at the site on the 4th March 2020. Groundwork had comprised the removal of existing retaining walls and building foundations; excavation/reduction of ground on the east side of the existing retaining wall; excavation of an L-shaped foundation trench for a new retaining wall; and excavation of a soak-away with associated drainage trench. Unfortunately, none of the above was overseen by the archaeologist.

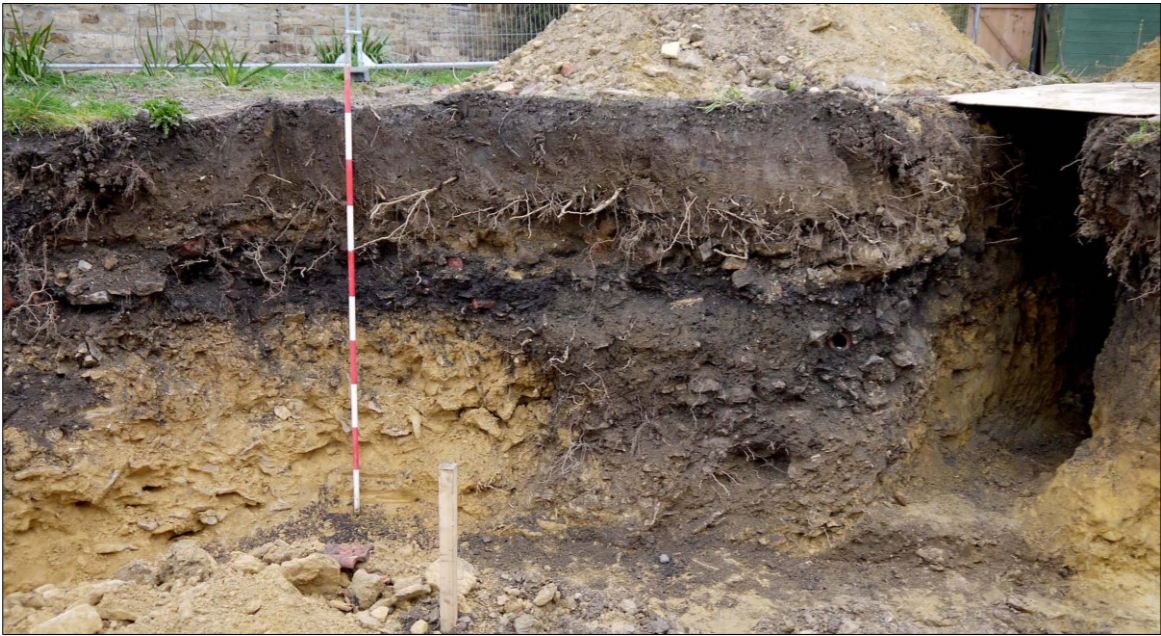
Above: 04.03.2020. Upper part of cellar revealed in Section 1. New soak-away trench to right

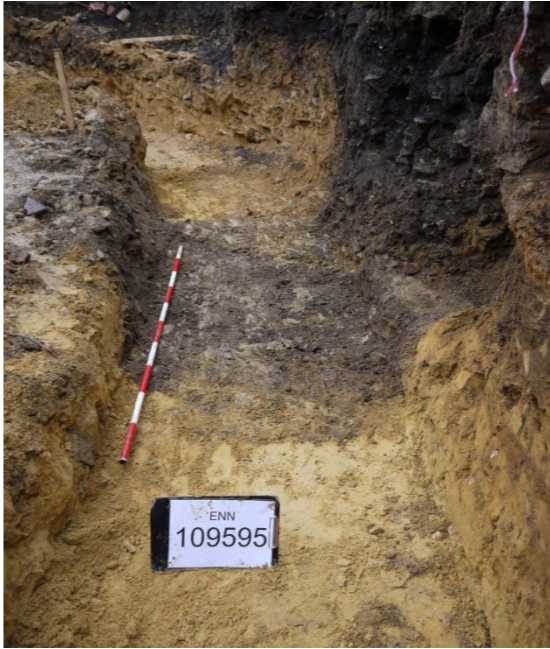
Above: 04.03.2020. In-filled cellar revealed in new retaining wall trench

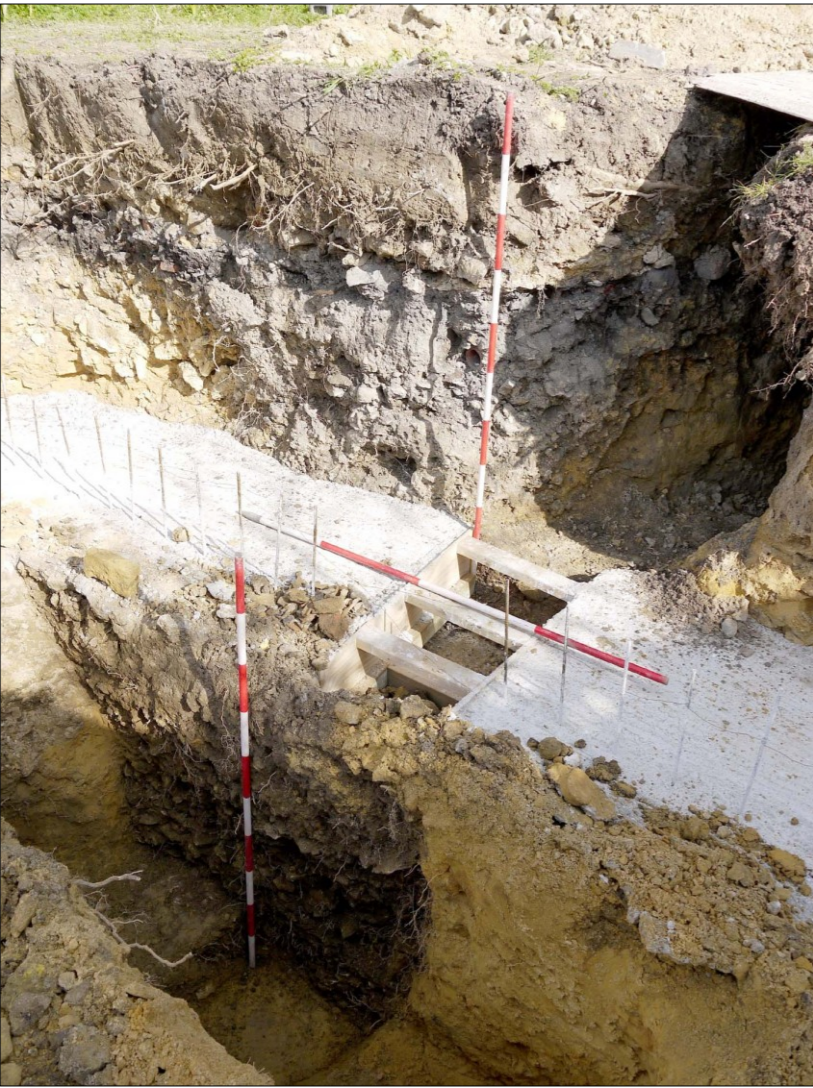
Left:
23.03.2020.
View to NE after completion of retaining wall foundations. Section 1 in the background, Section 3 in foreground

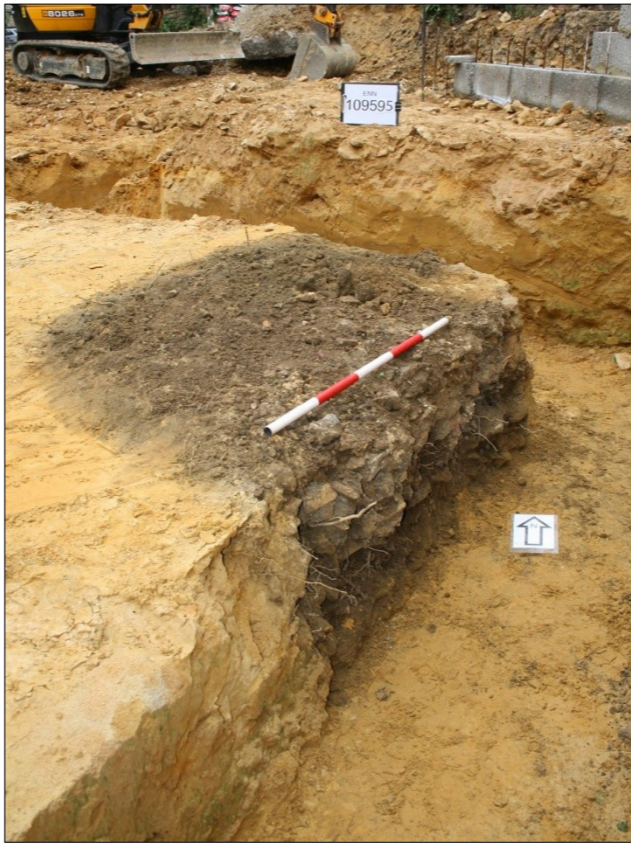
Right.
12.06. 2020.
Western end of the cellar, exposed after ground preparation showing location of Section 4). Note. The lower part of the cellar is no longer visible

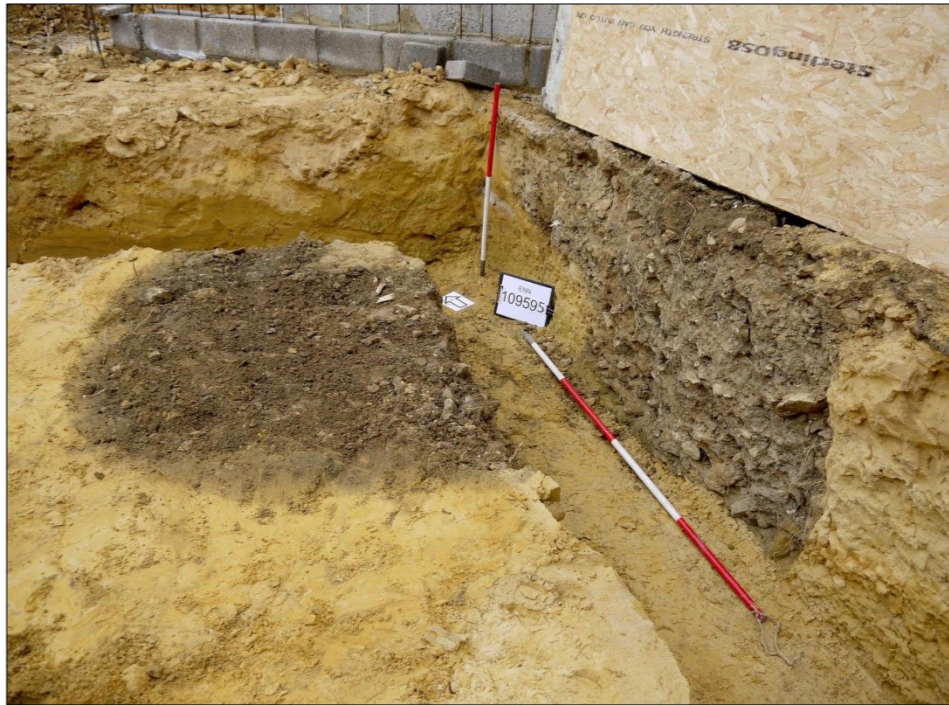
- 8.7 The cellar appears to have been timber-lined. It was deep (2.26 m), long (4.1 m), though fairly narrow once the timber lining was in place (c. 1.32 - 1.4 m). Unfortunately, relative dating of cottage foundation and cellar could not be achieved via stratigraphic analysis, owing to modern disturbance. Nevertheless, the planimetric relationship of the cottage and cellar (reconstructed by combining the Ordnance Survey 25" scale outline of the property with the 2020 GPS site survey), strongly suggests that the two features respected one another, from which it may be inferred that they were once in contemporary usage. If this was the case, the cellar was probably covered by an above-ground structure of some kind, attached to the smaller of the two dwellings.

Above. 12.06. 2020. Western end of the cellar. The upper part of Section 3 to right

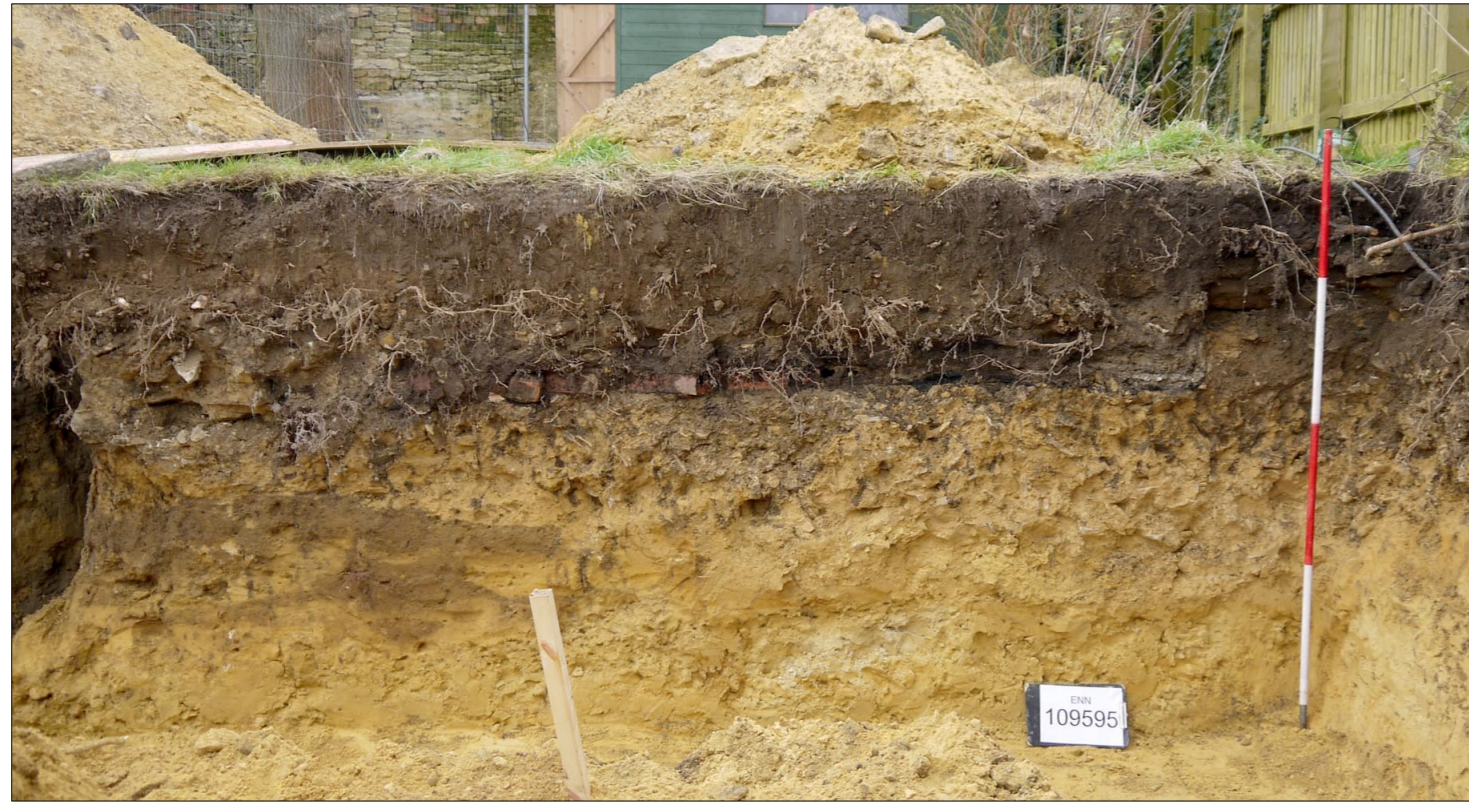
- 6.4 Historical research in the course of the present archaeological Investigation has revealed that the L-shaped building consisted of two adjoining cottages, both known as Japonica Cottage (*post*, 7). The cottage flanking the street frontage is understood to have been of greater size. Foundations of the smaller dwelling were exposed in the south-eastern section cut back for the new retaining wall. (Figs. 10-12, Section 1). They comprised remnant lower courses of the

Above: 05.03.2020. Southern half of Section 1. Post-medieval building foundations and floor. Facing SE

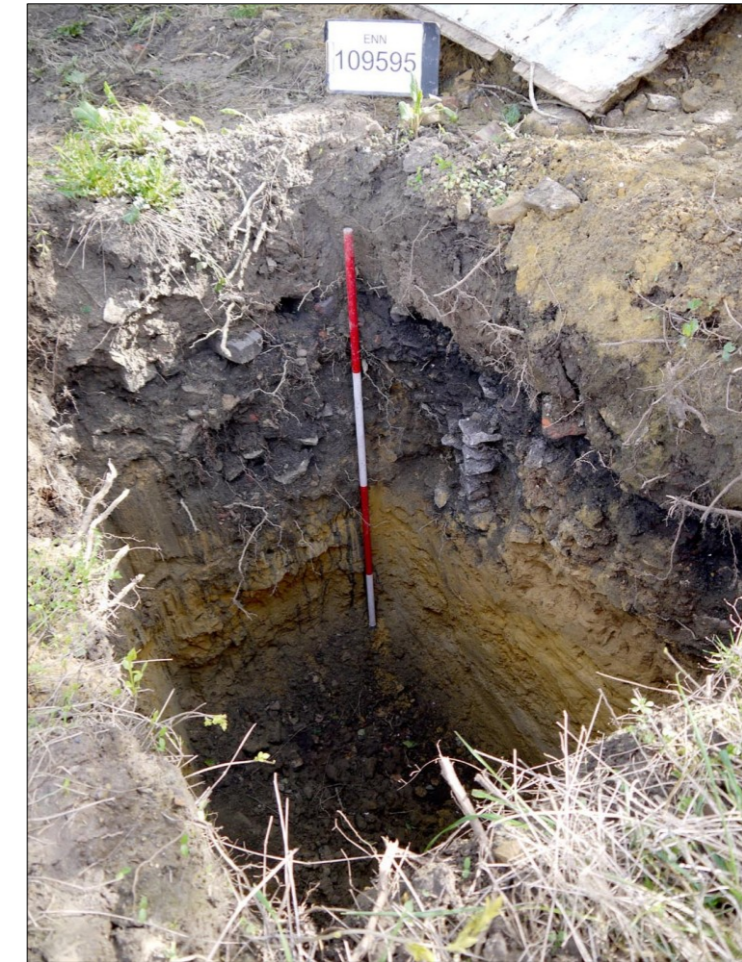
Right: 23.03.2020. Cottage walls exposed in new soak-away pit. Facing SW

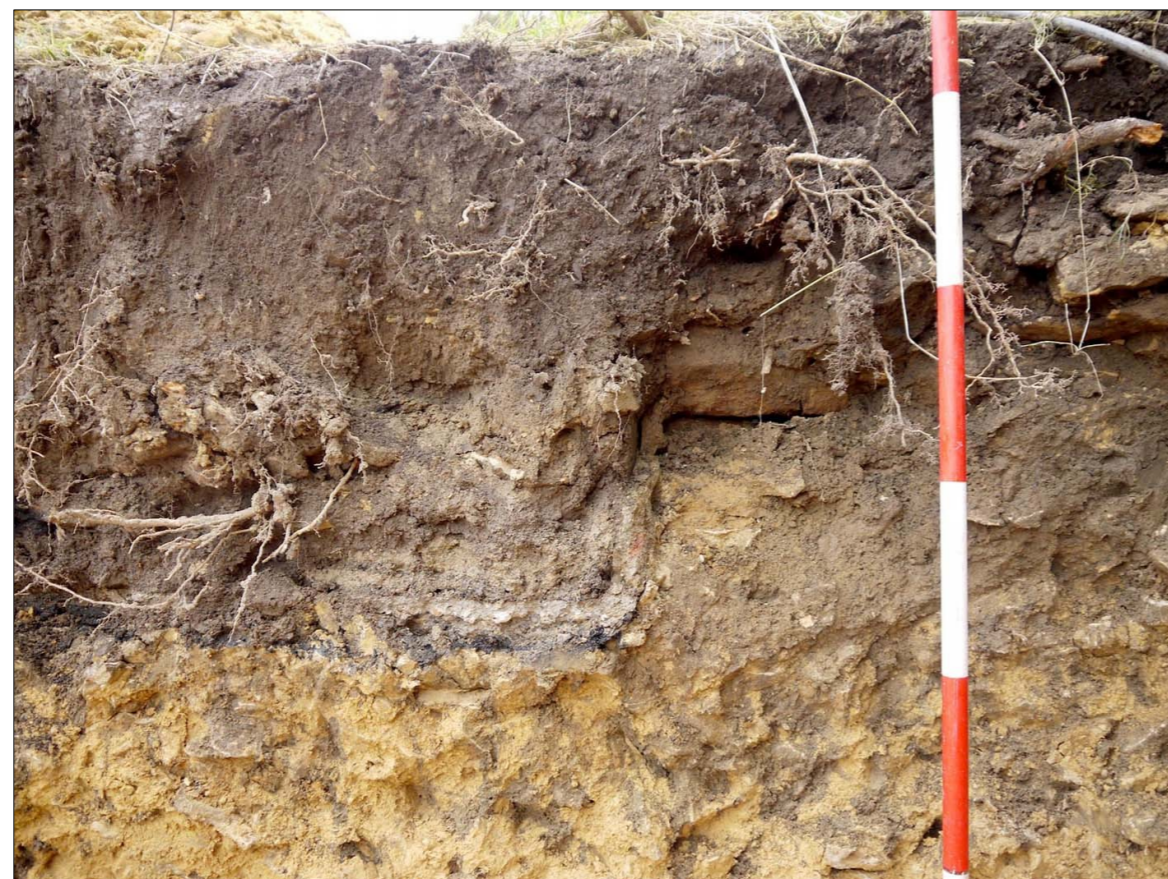
- 8.5 The archaeological evidence revealed that the cottages were constructed on terraced areas cut into the rising ground to the east. These areas were prepared with a foundation layer of fragmented sandstone. The only floor layers that survive belong to the smaller cottage, the floor of which was stepped up into the slope. An *in situ* fragment of a pozzalanic floor (composed of lime-ash composition with crushed pieces of fired clay) still exists beneath the south-eastern baulk of the site, which is quite possibly a portion of the original cottage floor. Such floors have been exposed elsewhere in early post-medieval buildings (*ante*, 6.5). Over time, worn and damaged parts of the floor were patched with brick, which were set on a bedding layer of gritty silty clay. At the north-western end (i.e. front) of the smaller building the floor covering was replaced, at some juncture in the 19th or 20th century, by quarry floor tiles.

Right: 05.03.2020. Southern half of Section 1. Post-medieval pozzolanic floor. Facing SE

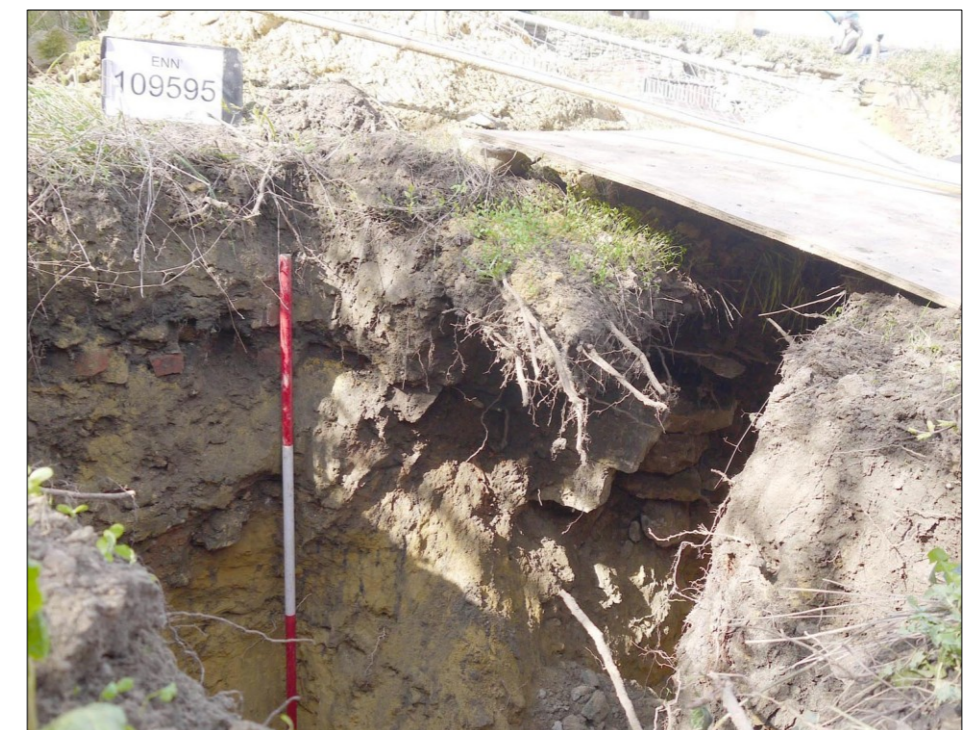
Above: 23.03.2020. Cottage walls exposed in trench for new soak-away. Facing W

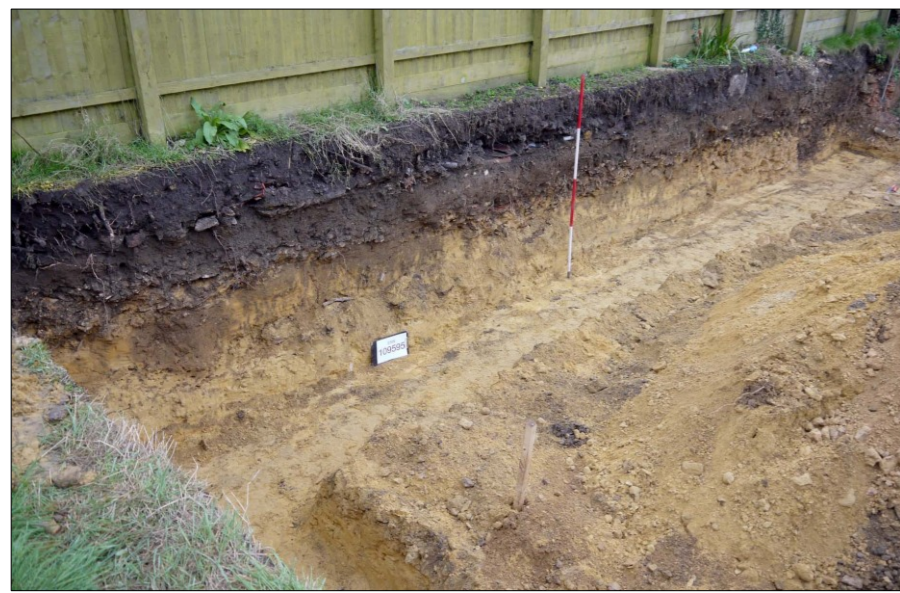
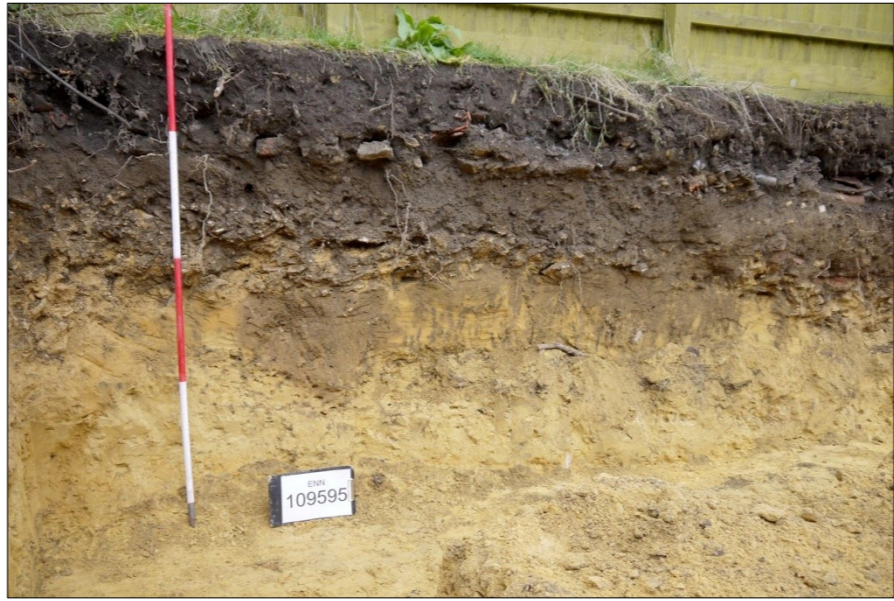
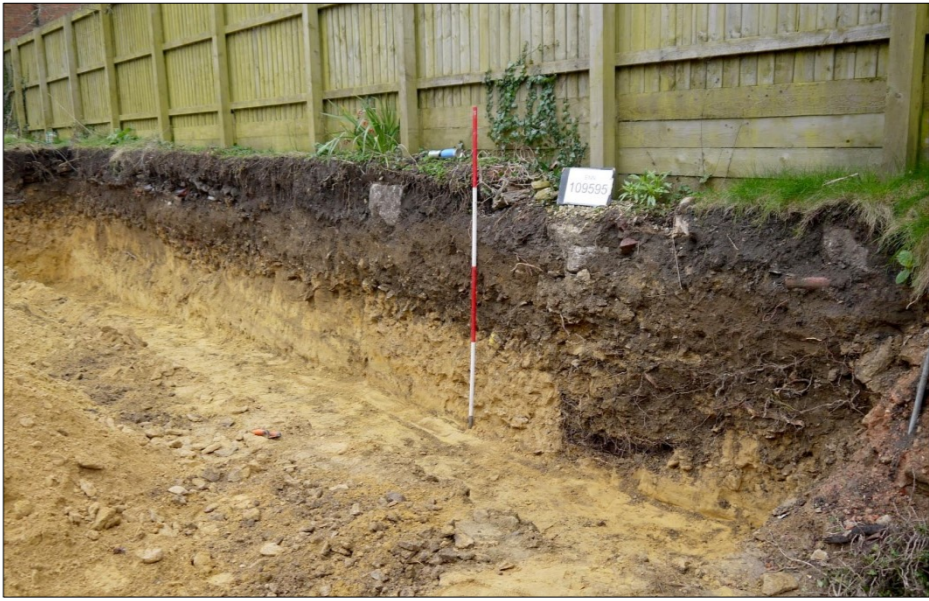
Figure 14. Section 2

- 6.17 There was little trace of the cottage in the south-western section (Figs. 10 & 14, Section 2). An extensive layer of fragmented limestone (036) was interpreted as a continuation of the ground preparation layer for the cottage observed in Section 1 (i.e. (019) / (008)). A change in level seemed to denote the point at which the floor of the cottage stepped down to the northwest, at which point there was a small fragment of tiled floor (050). The ground preparation layer lay directly above the geological stratum (023), sealing a number of undulations and earlier ground disturbances. Most of the latter ((40), (42) & (44)) were very irregular in a form and were either natural in origin (i.e. where trees or shrubs had once stood), or possibly the result of horticultural activities. They were filled with light brown sandy soil, and devoid of artefacts. Towards the southeast end of the section was a possible

Section 2 overview, facing SW

Stratigraphy above features [038], [040] & [042], facing SW

Section 2 overview, facing SE; feature [045] to right

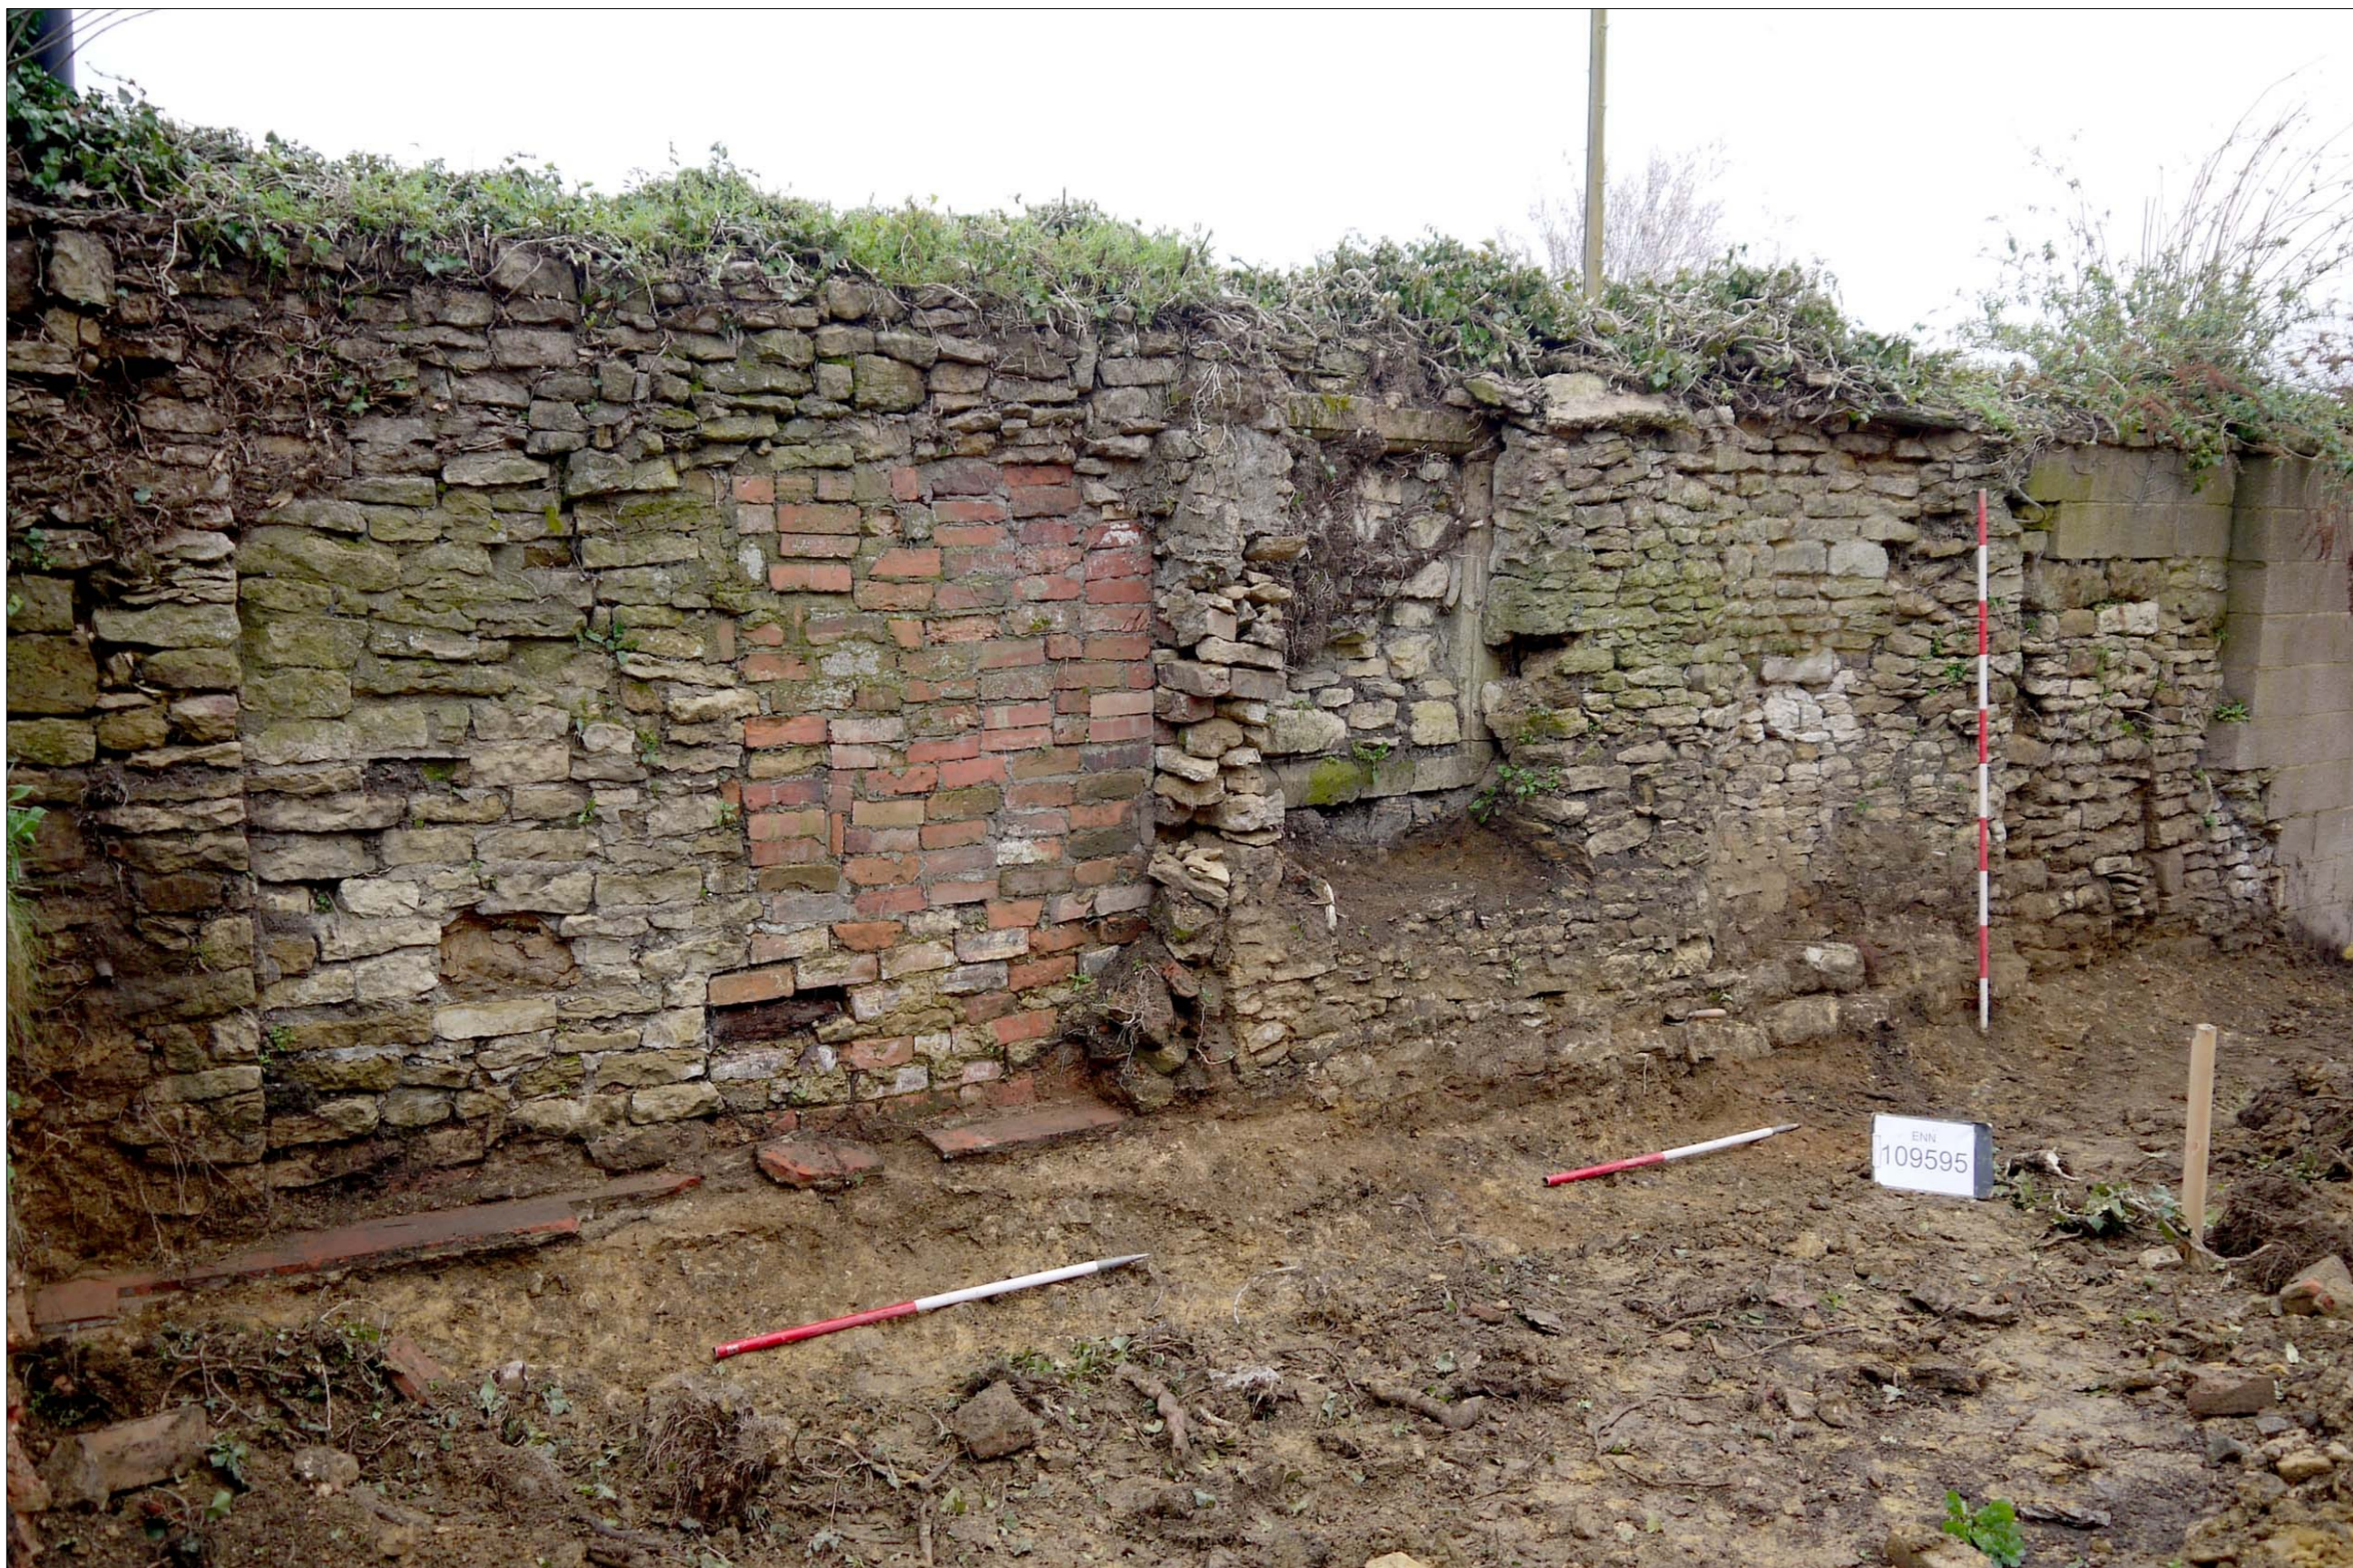
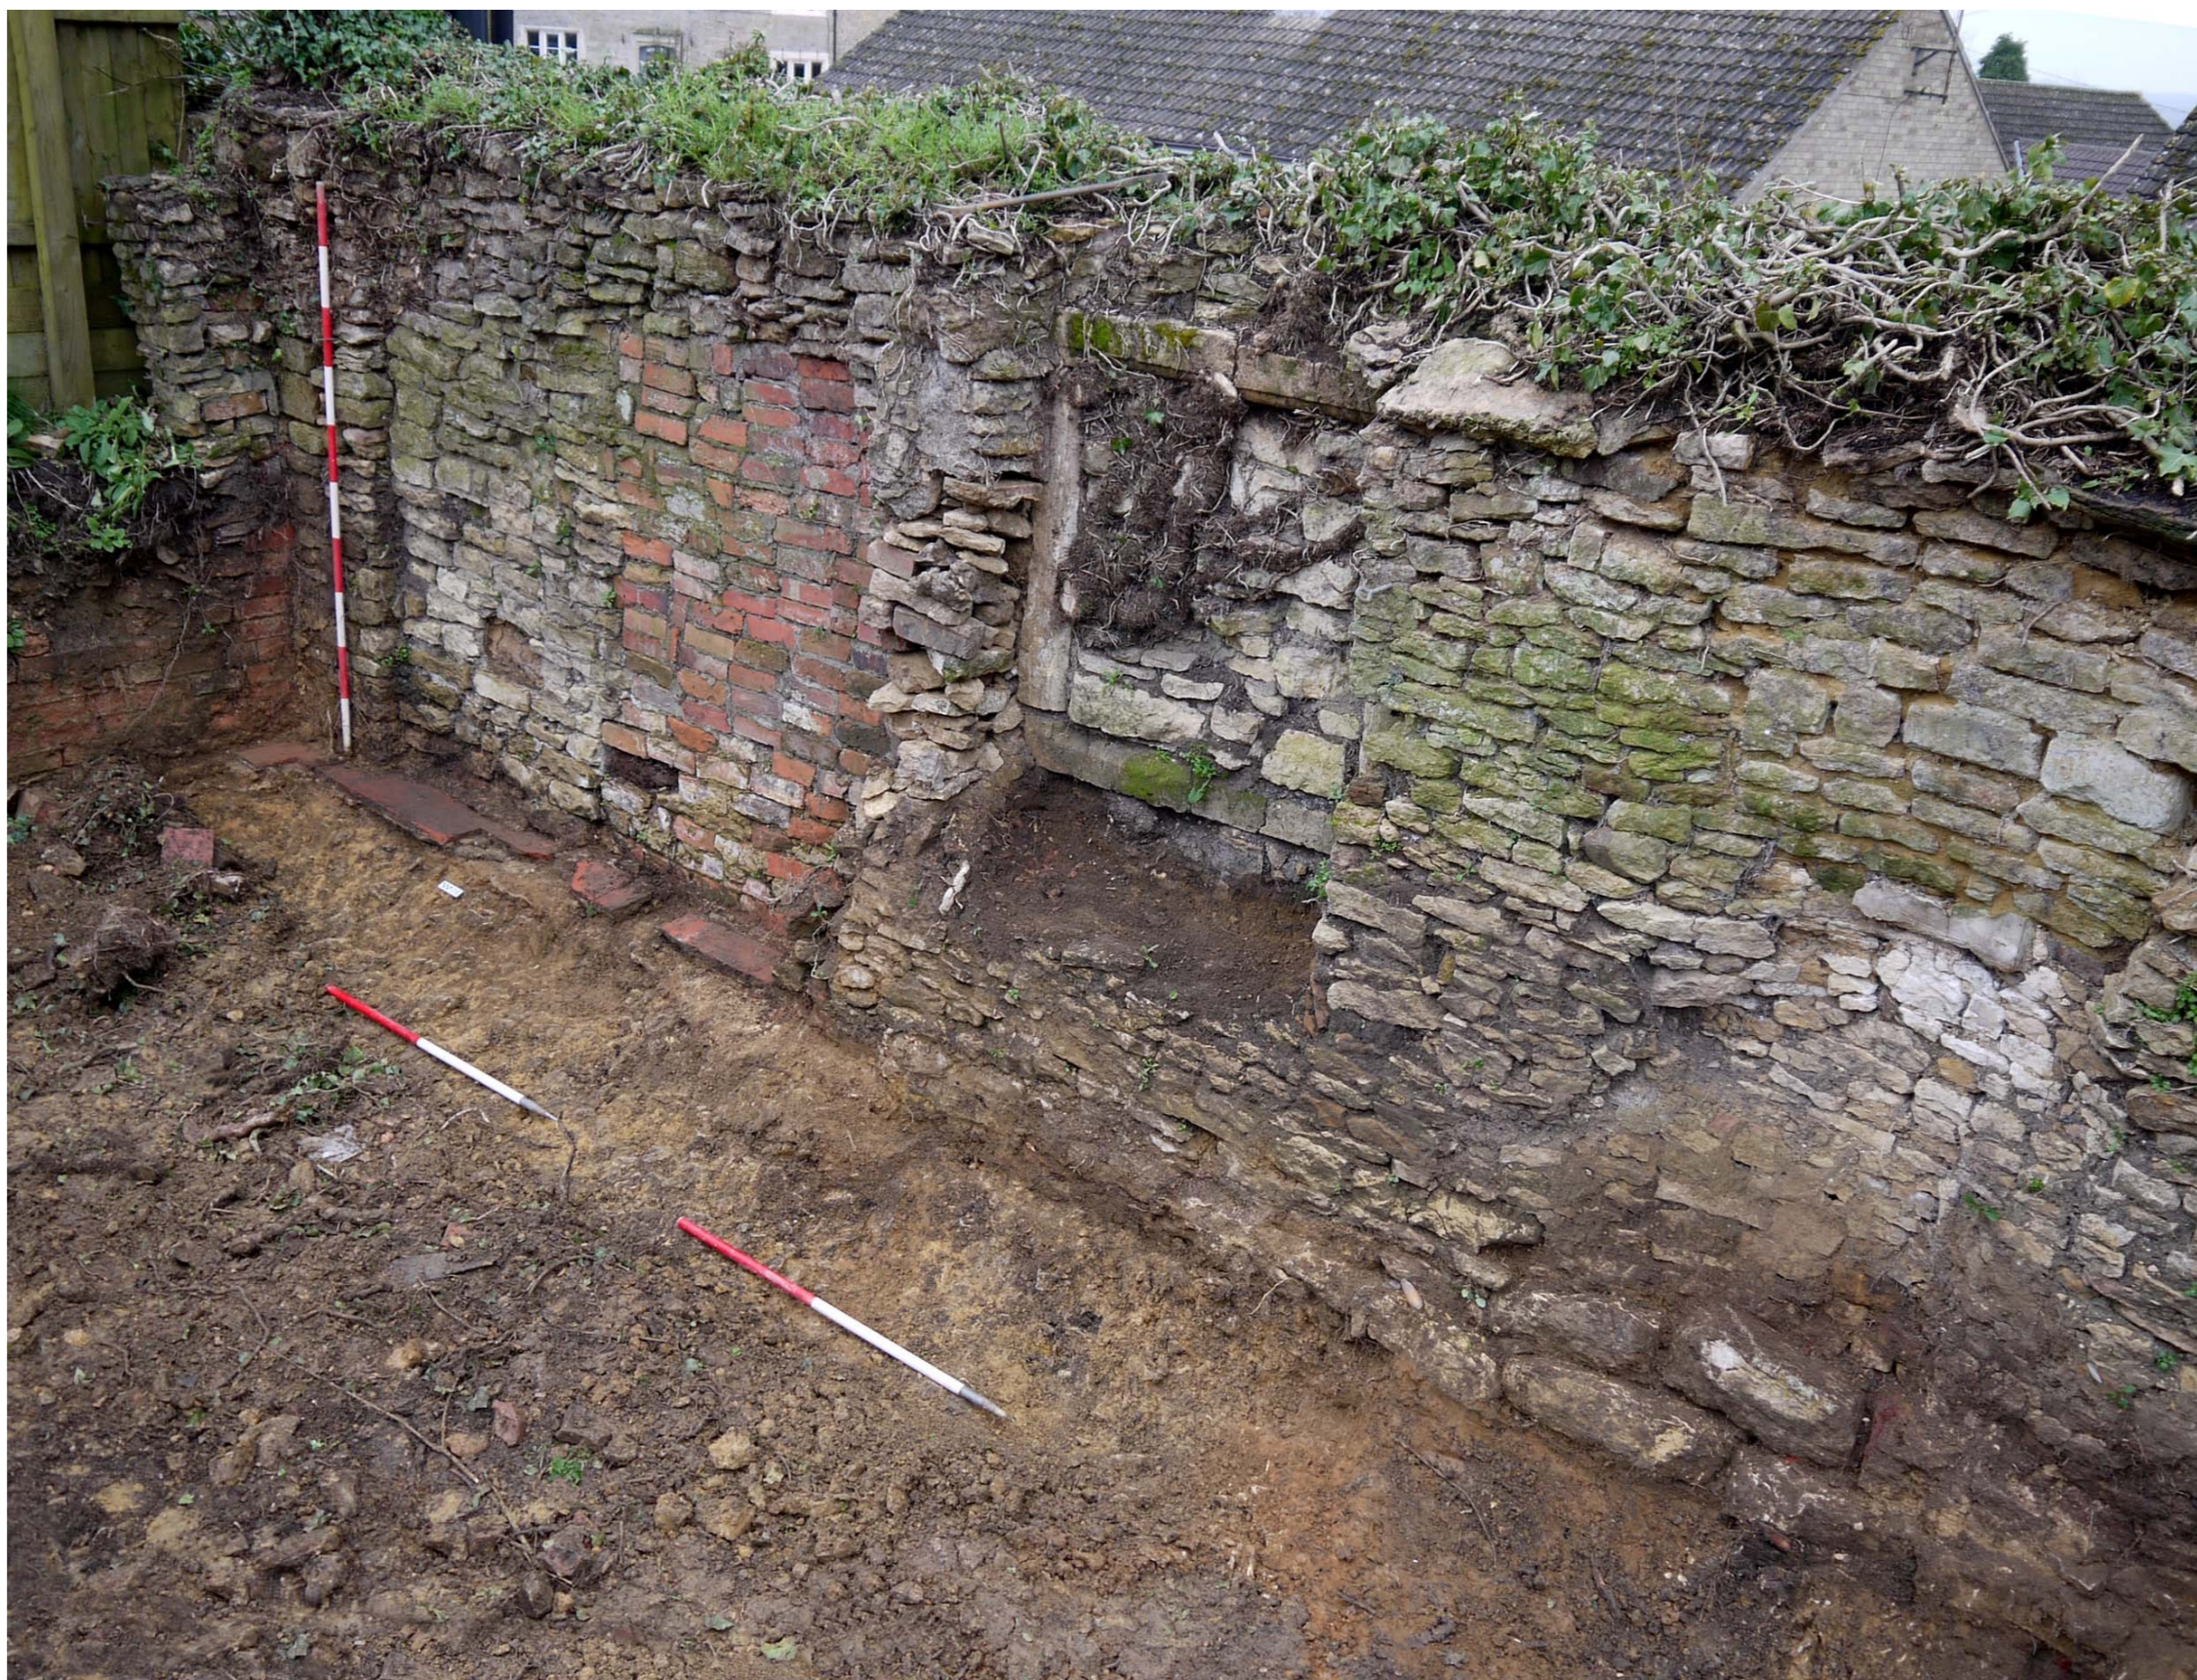
- 6.23 The investigation revealed a remnant of floor layers at the south-western end of the cottage (Figs. 15, 16 & 18). This comprised 19th / early 20th red quarry floor tiles laid on a bed of lime mortar, beneath which was a thin layer of greyish brown gritty clay, c. 0.03 m thick. These floor deposits were, in turn, laid upon a bed of light brown (?puddled) clay c. 0.03 m thick, overlaying a thick deposit (at least 0.2 m) of fragmented yellow limestone, akin to layer (036) in Section 2, which was, likewise interpreted as a prepared foundation layer for the cottage.

Figure 15. Former front interior wall of the cottages, facing NW (15.03.2020)

Figure 16.
Former front interior wall
of the cottages, facing SW
(15.03.2020)

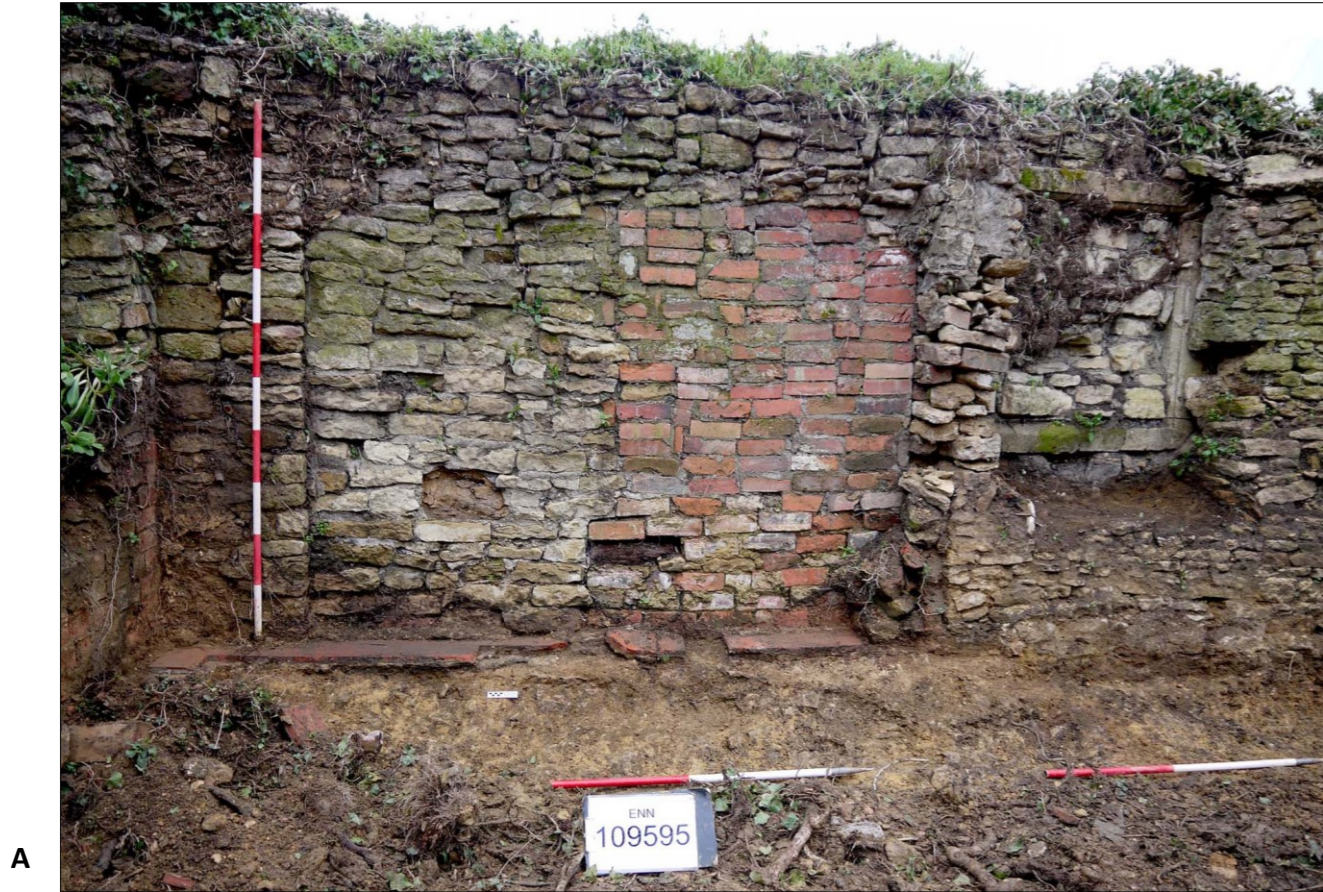
A

A: Block front door and window (brick) of the smaller cottage. Cottage dividing wall to right of brickwork.
