Former Site of Japonica Cottage,
76 High Street, Gretton,
Northamptonshire, NN17 3DF
(NGR 489943, 294150)

Archaeological Investigation

Northants HER Event No ENN109595
Planning App. Ref. 17/00566/DPA
Souterrain Project SOU19-661

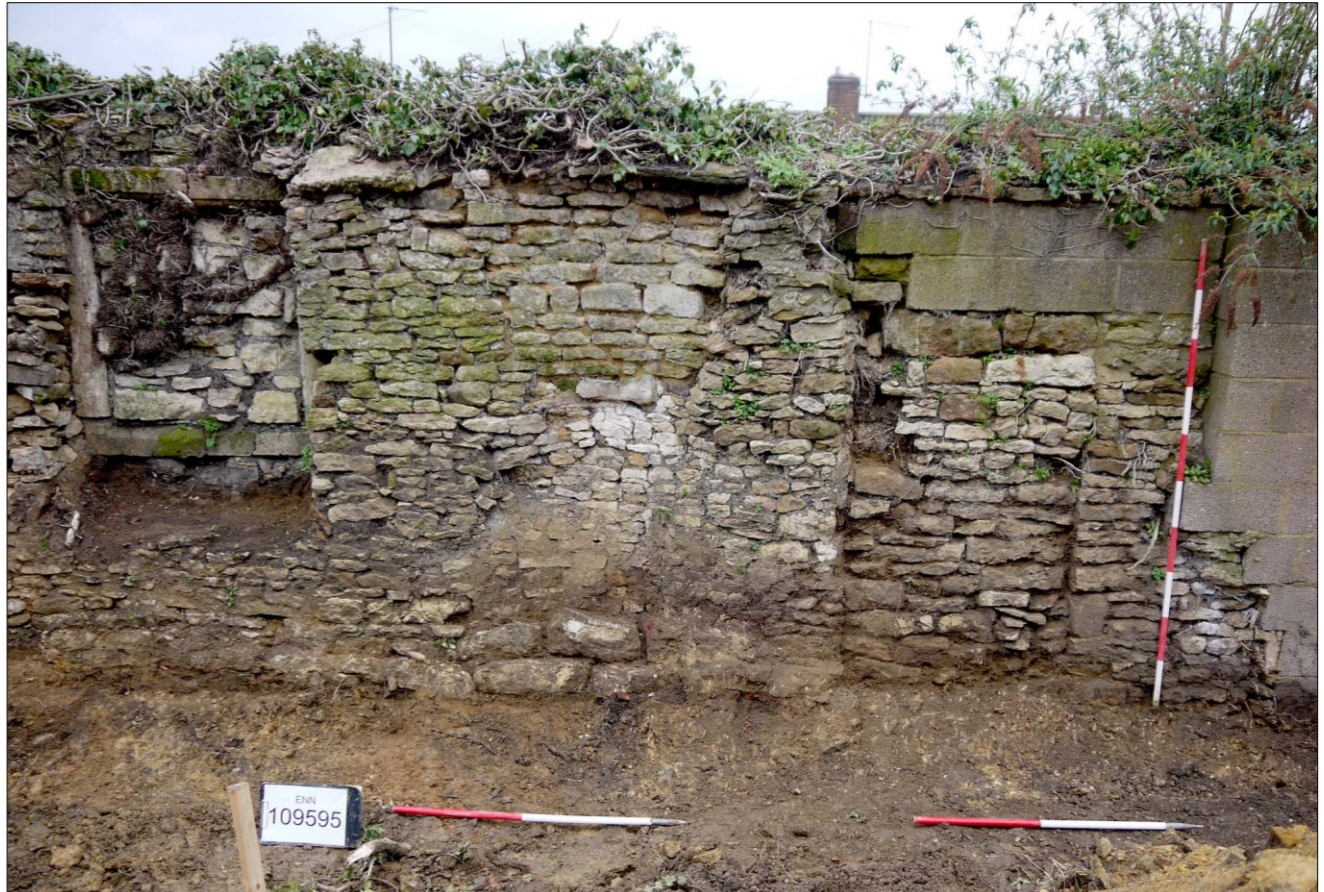
C

C: Blocked front doorway to the larger cottage. This entrance had been blocked prior to c. 1910 – see Figure 22

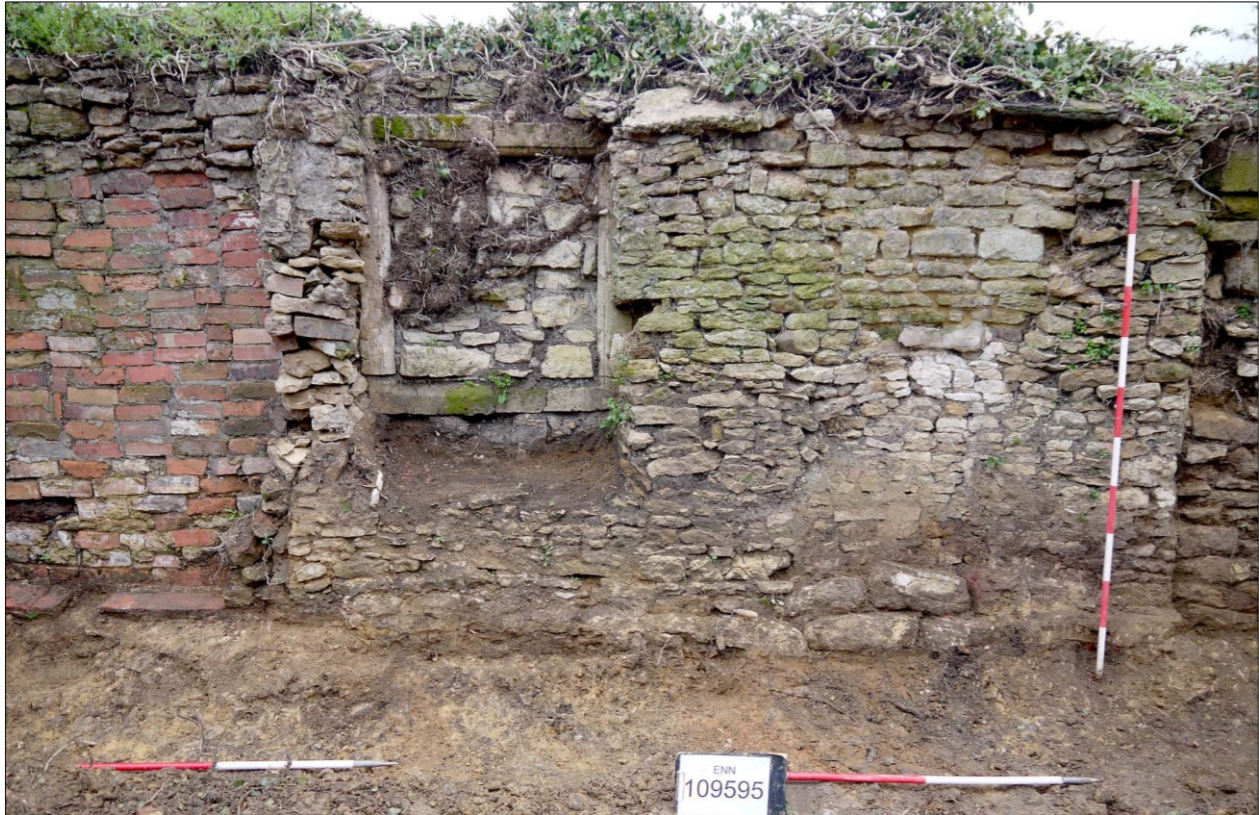
B

B: Blocked stone-framed front window of the larger cottage.

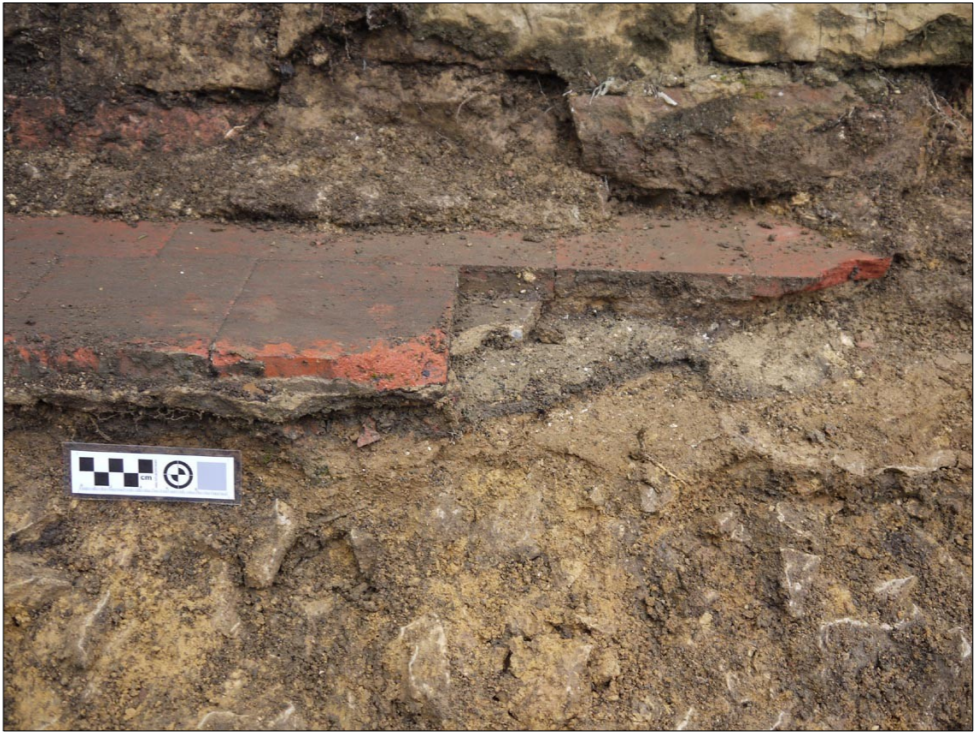
- 6.23 The investigation revealed a remnant of floor layers at the south-western end of the cottage (Figs. 15, 16 & 18). This comprised 19th / early 20th red quarry floor tiles laid on a bed of lime mortar, beneath which was a thin layer of greyish brown gritty clay, c. 0.03 m thick. These floor deposits were, in turn, laid upon a bed of light brown (?puddled) clay c. 0.03 m thick, overlaying a thick deposit (at least 0.2 m) of fragmented yellow limestone, akin to layer (036) in Section 2, which was, likewise interpreted as a prepared foundation layer for the cottage.

Figure 18. Remnant of floor layers in the smaller cottage (15.03.2020)

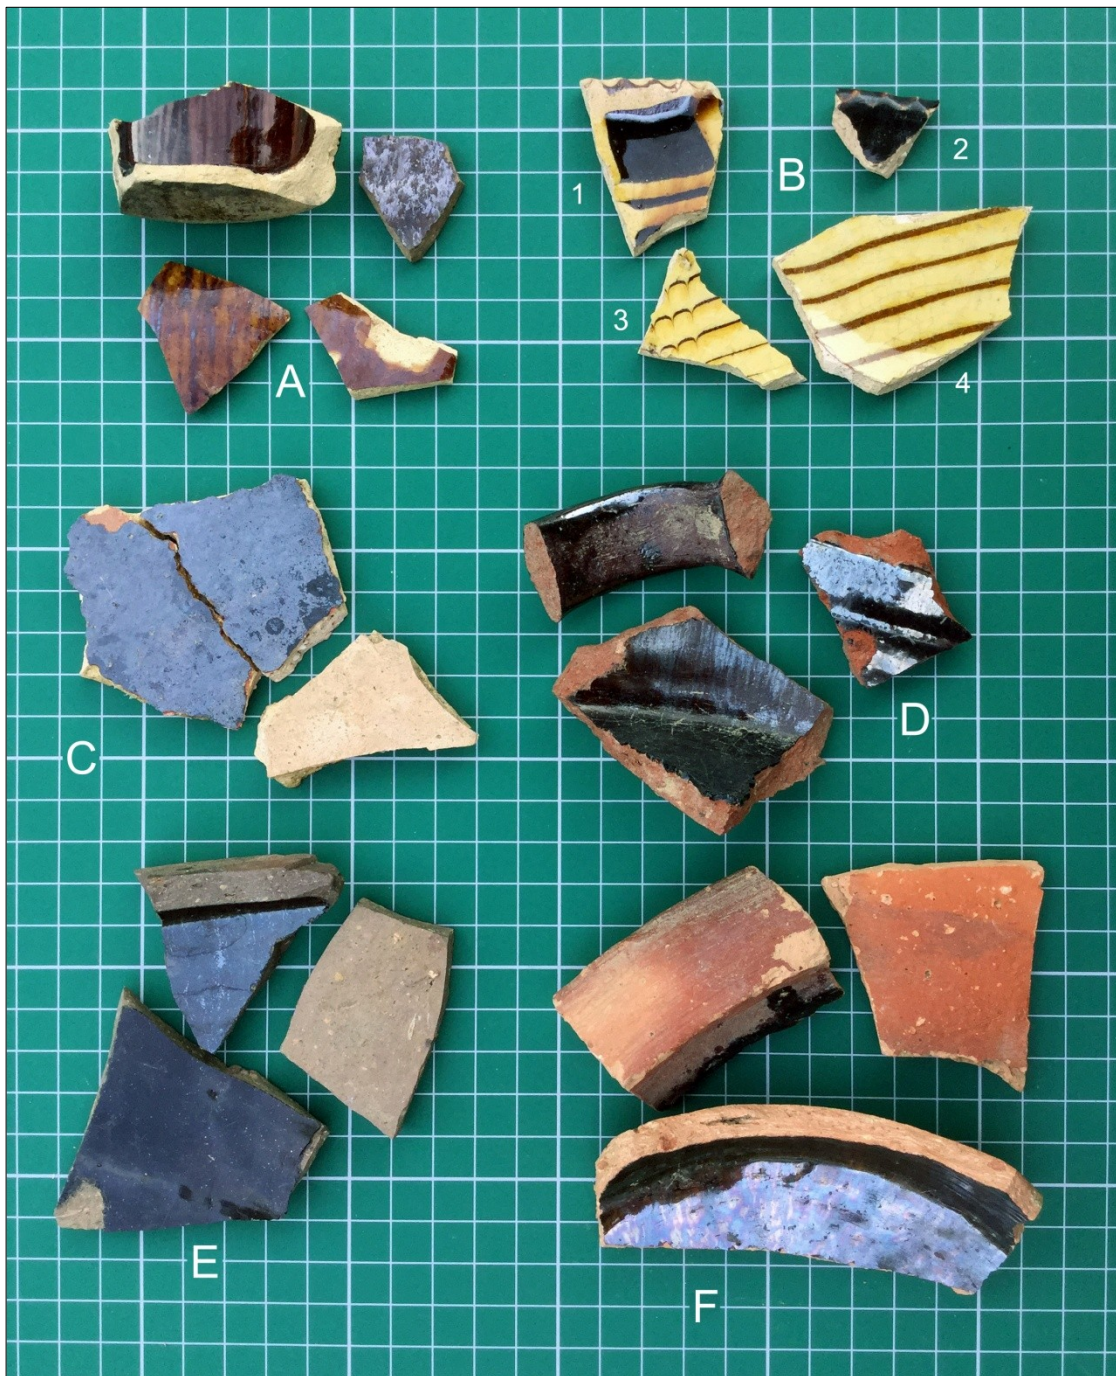
Figure 20. Types of Late 17th / Early 18th century pottery from the cellar in-fill (011)

- A. Manganese-glazed mottled ware
- B. Staffordshire-type, press-moulded slipware
- C to F. Black glazed earthenwares

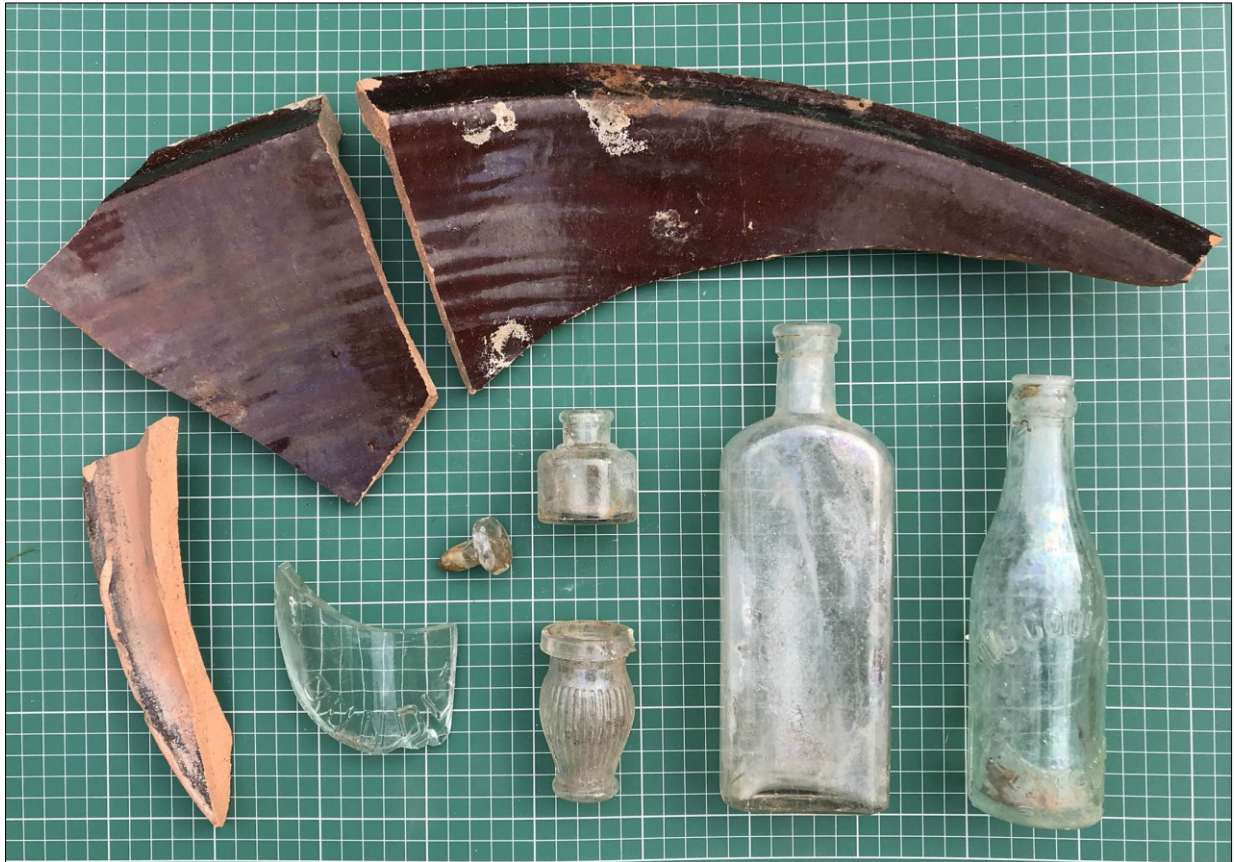
Figure 21. Sample of early 20th century artefacts from land drain (034)

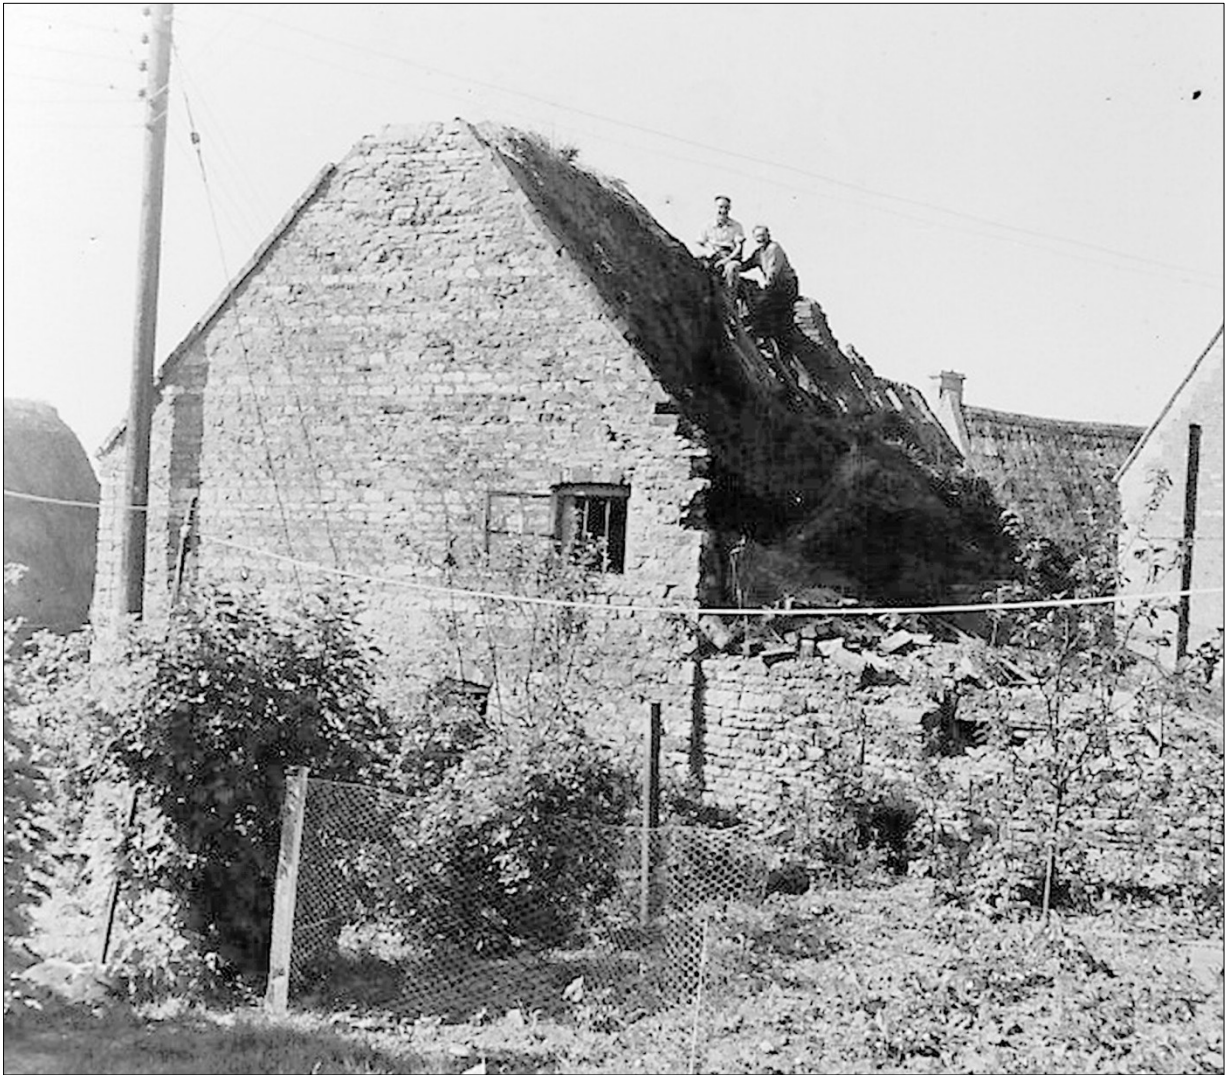
Figure 27. Demolition, 1959. Removing the thatched roof of the larger cottage (Coleman's cottage). Remains of the smaller cottager to right

- 6.20 In 1959 the cottages were demolished, or rather, dismantled by hand, as a series of record photographs show (Figs. 26 to 29). The lower half of the front wall of the larger cottage was evidently retained to serve as a property boundary wall, the doorway and windows blocked with stone and / or brick.

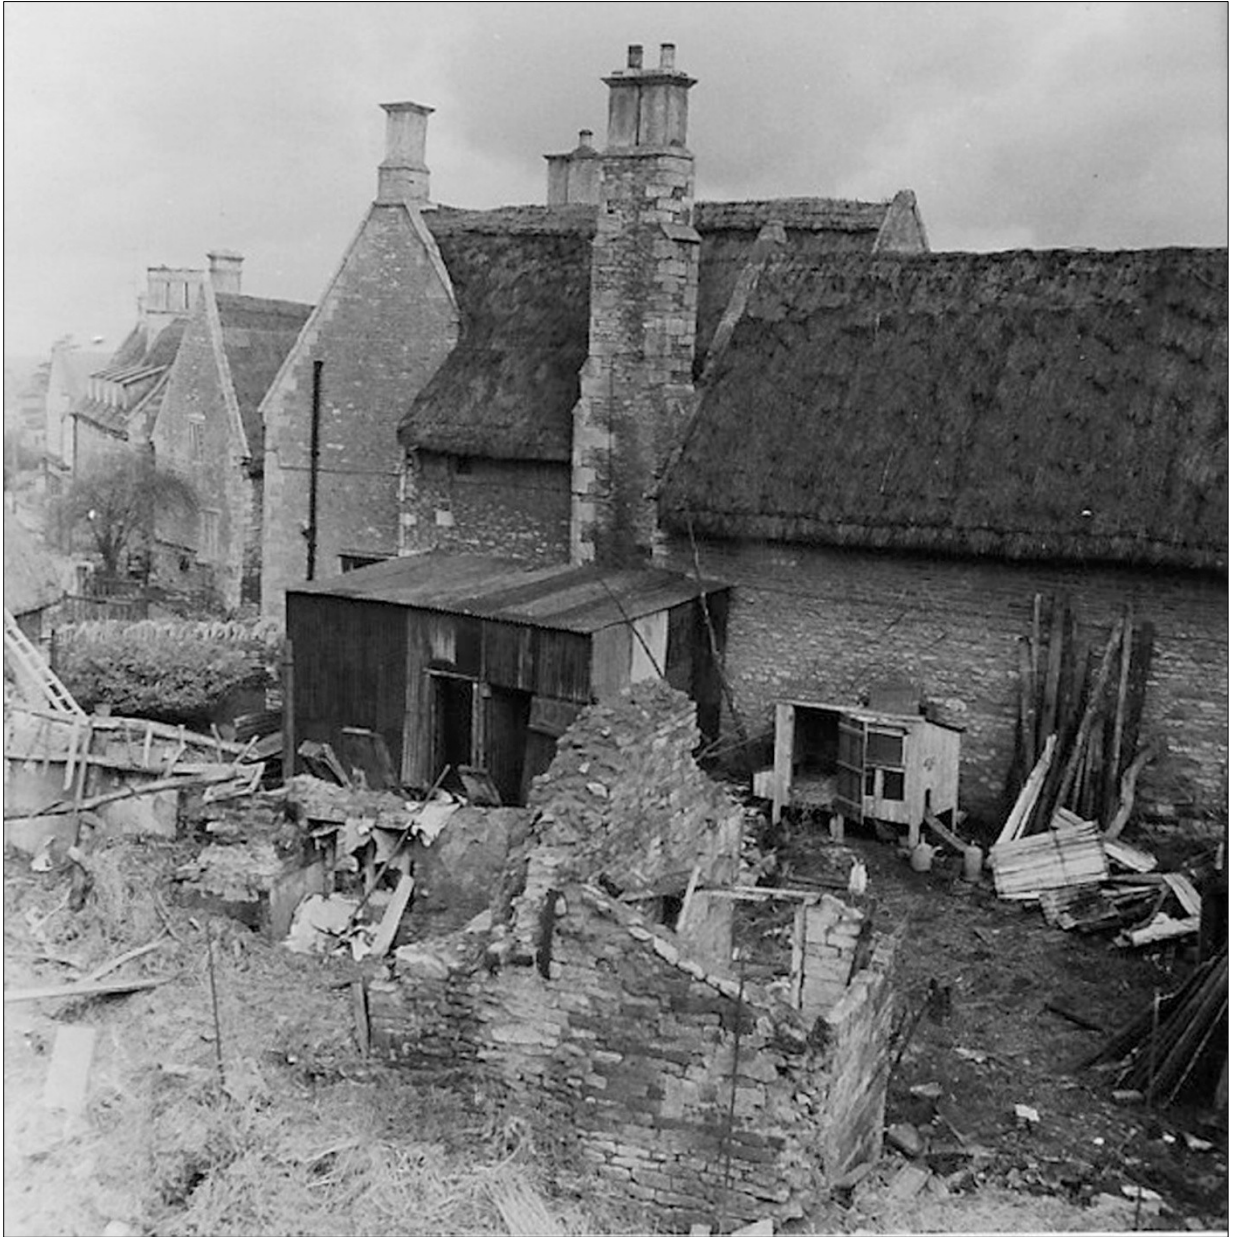
**Figure 28. Demolition, 1959. The smaller cottage (Spendlove's cottage).
The photograph shows the SE end of the building and attached outhouse with catslide roof**

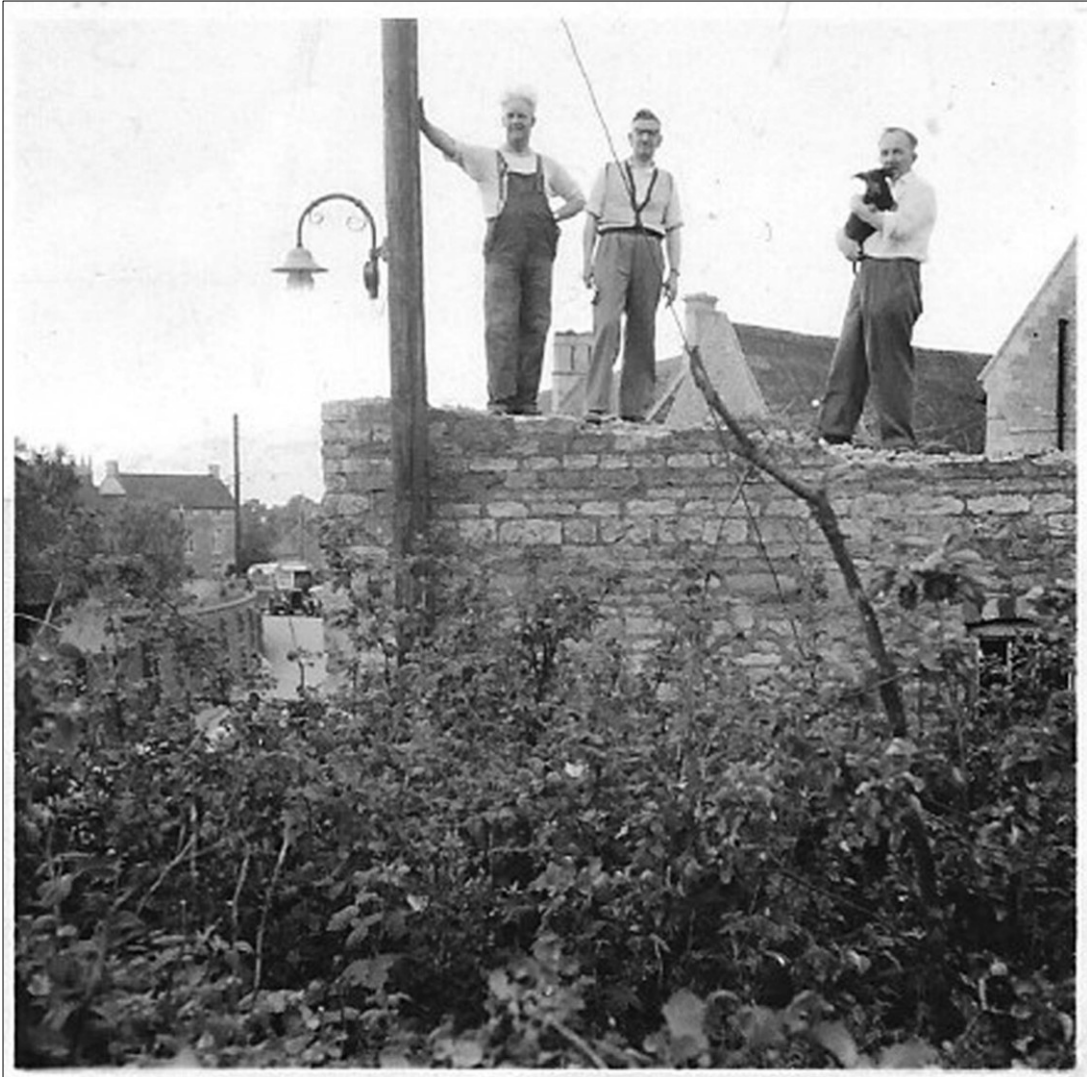
Figure 29. Demolition, 1959. The SW gable end of the larger cottage

The wall on the street frontage was retained at approximately this height
