8 ALSWITHA TERRACE  
KING ALFRED PLACE  
WINCHESTER  
HAMPSHIRE  
(NGR 448265, 130123)

ARCHAEOLOGICAL  
WATCHING BRIEF

Planning Application Reference No. 08/02143/FUL

Southern Project No. SOU09/140

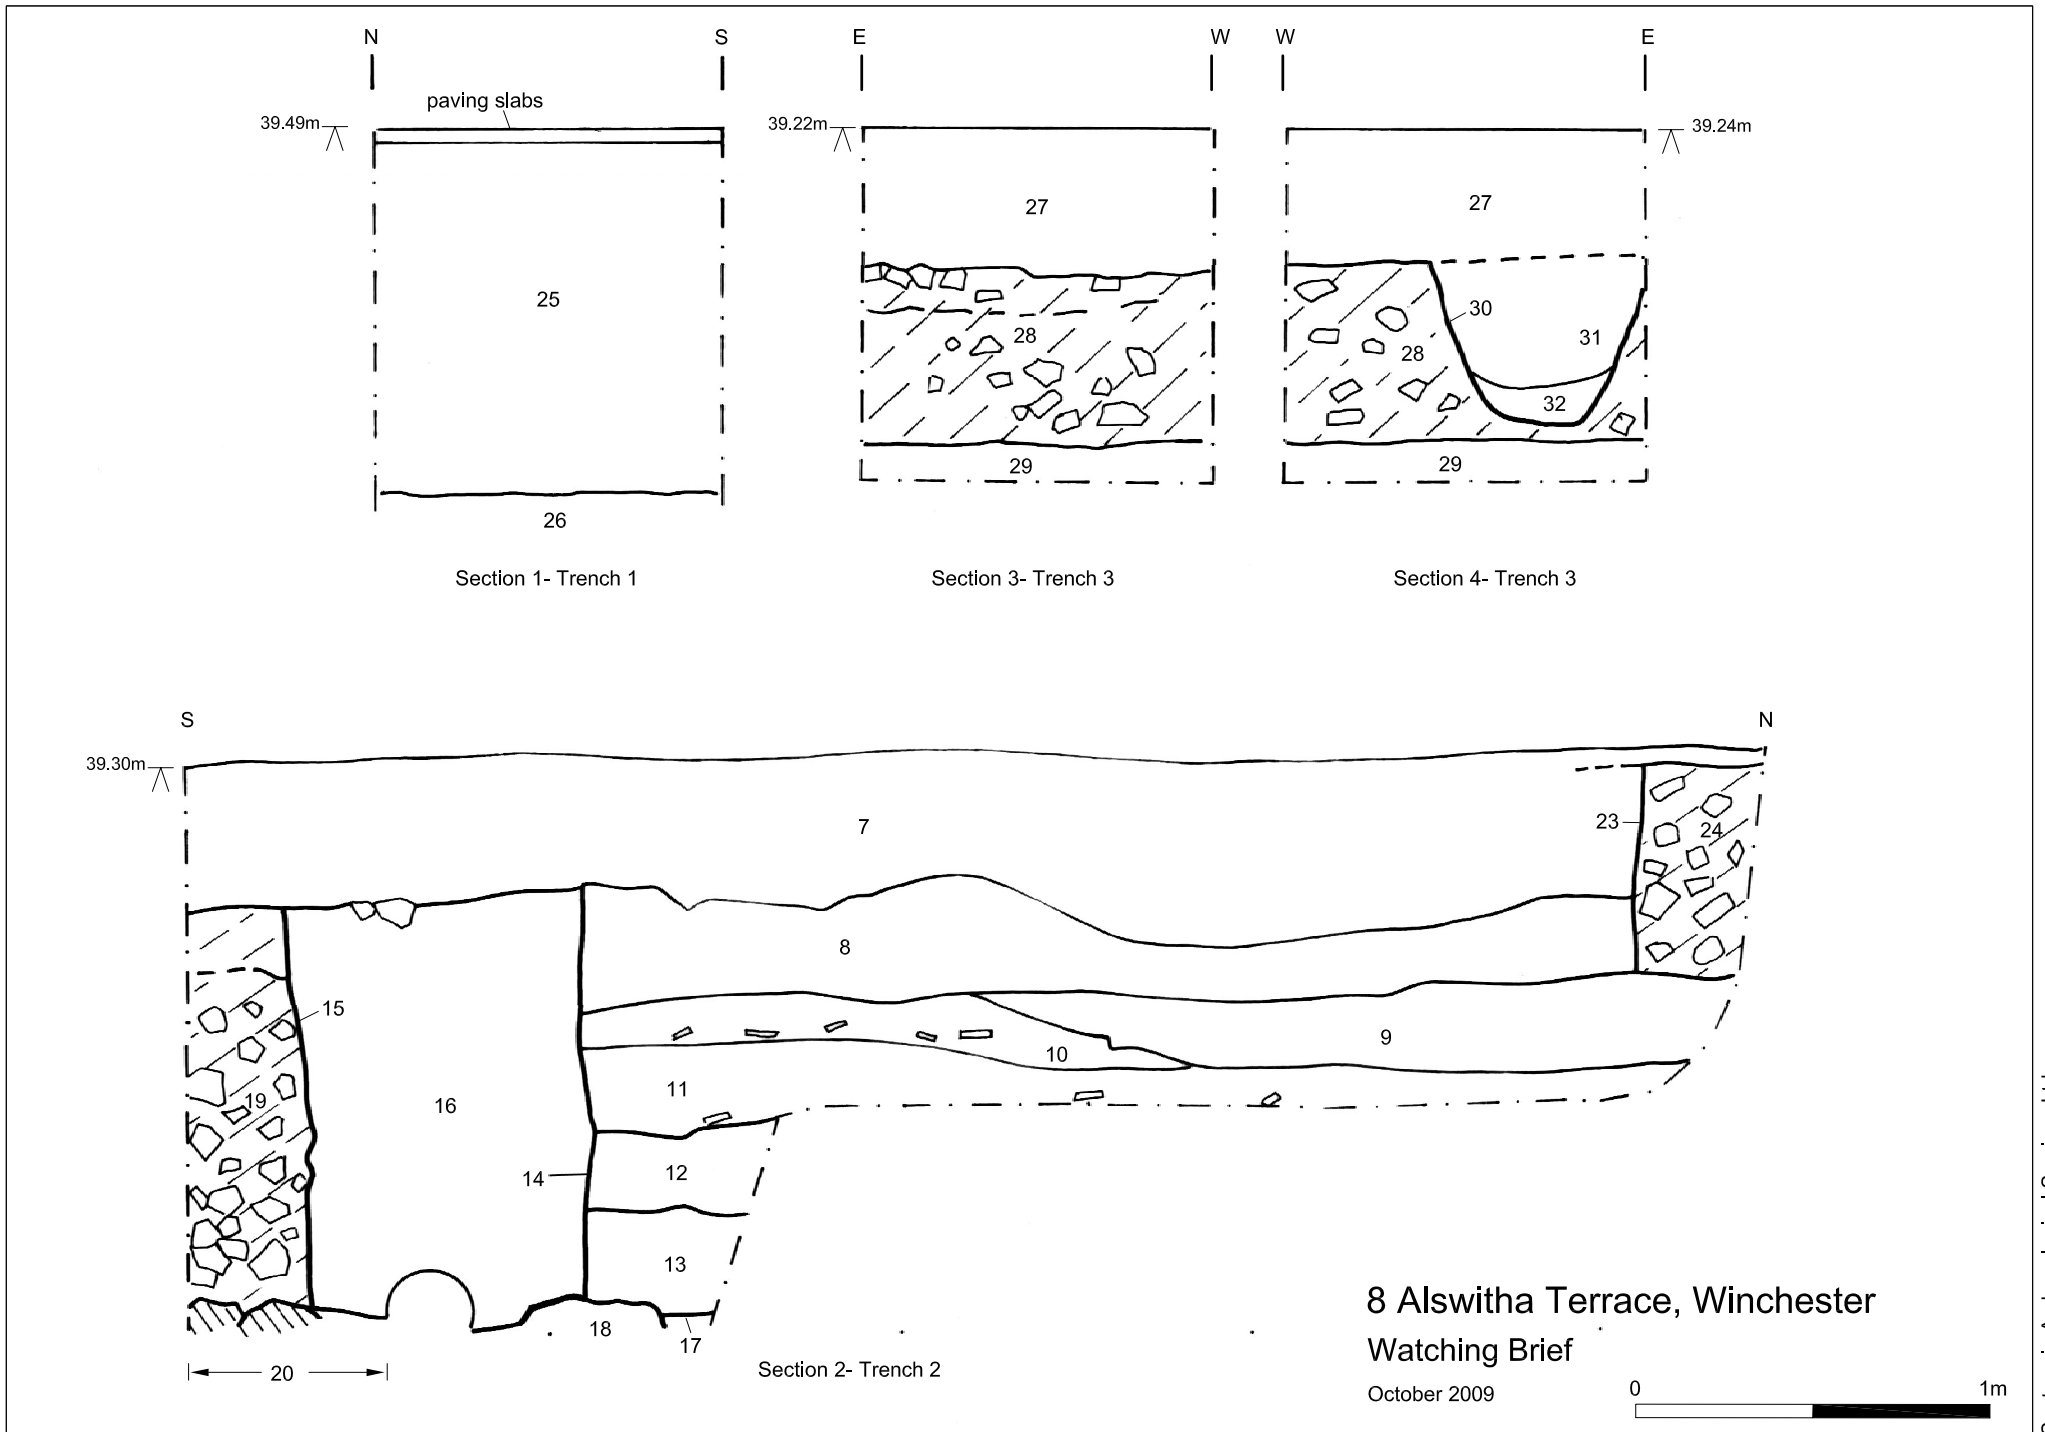
Figure 3: Sections 1 to 4

The earliest archaeological deposits and features (Figs. 2 and 3) were located in the south end of the trench where three distinct contexts were attested: the footings, or fill of a wall foundation trench (20); a foundation deposit of a floor or wall (18) and a fill, possibly that of a foundation trench (17).

There was a clearly defined succession of six, largely horizontally-bedded, layers above the chalk foundation (contexts (13), (12), (11), (10), (9) and (8).

Layer 13 comprised light brown, flinty rubble, c.0.24 – 0.28m thick, in which no finds were observed. Above it was a layer of soft dark reddish brown silty clay, with occasional charcoal flecks and small pieces of chalk (not dissimilar in the colour and texture of (17)); 0.18 - 0.24m thick. There were no artefacts visible. Above (12) was a layer of flinty rubble (11) with occasional tile fragments, which extended northwards to the end of the trench, where it probably continues beneath Alswitha Terrace. Directly above this was a deposit of dirty grey chalky soil (10) containing tile fragments and small pieces of roofing slate, which appeared to be a localised dump of rubbish. It was overlain by a layer of compacted flinty rubble (9) which extended north to the end of the trench (where it lay on top of layer 11) and presumably continued beneath Alswitha Terrace. Layer (8) comprised fine rubble (mortar, sand, pieces of chalk and flint and crushed pieces of brick and tile)

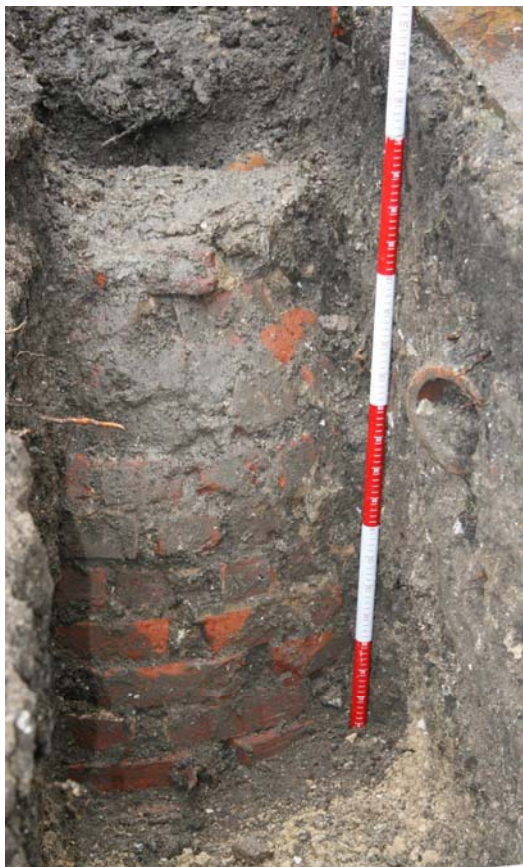
**Plate 2.** Trench 1: 19<sup>th</sup> century  
soak-away facing north

At the south end of the Trench 1 a large bee-hive shaped brick soak-away (2) was exposed, which is understood to have been contemporary with the 19<sup>th</sup> century terraced houses. The foundation trench ([1] and [3]) for this soak-away was cut into layer (6/25).

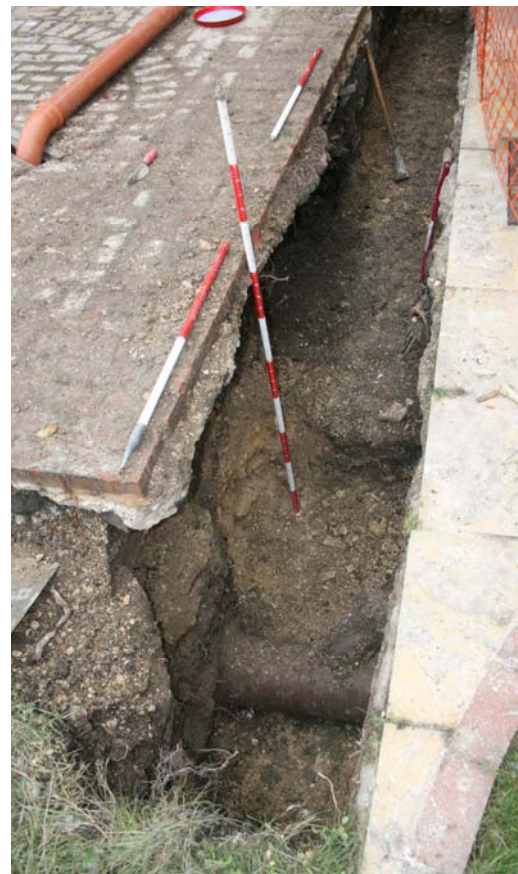
**Plate 3.** Trench 1: medieval wall  
foundation (north of pipe, after soak-  
away removal), facing north

On the south side of the soak-away the ground had suffered further disturbance in the 19<sup>th</sup> century from the insertion of the sewerage pipe. Notwithstanding this, the partial footings of a wall were encountered *in situ* during the present development, between the soak-away and pipe. Three *in situ* blocks of fine-grained faced ashlar (Plate 6) were exposed, but were unfortunately removed before the archaeologist could make adequate records. The blocks formed the north face of a wall, which appears to have been c.0.46m in width and aligned ENE-WSW. Due to the instability of the trench sides it was not possible to hand clean the section or examine the feature for subtle remains of stratigraphic relationships. Nevertheless, the approximate course of the wall could be plotted and appears to have been a continuation of footings exposed in Trench 2. The top of this feature was encountered at c.1.3m below ground level, and its base at c.1.5m.

It is believed that the wall (22) formed a part of Hyde Abbey, perhaps part of the cloister.

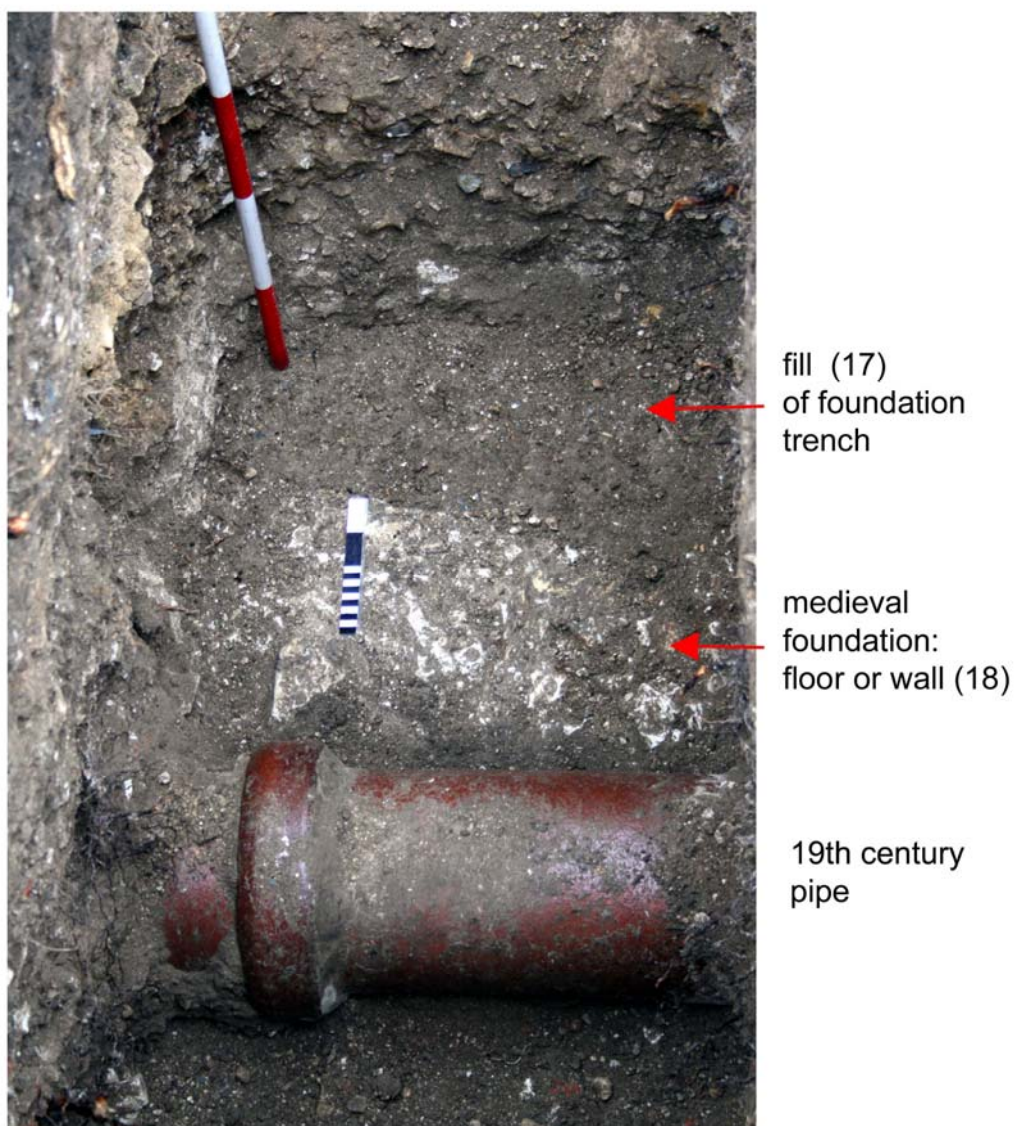
**Plate 4. Archaeological features in Trench 2, facing north**

The first impression upon excavation was that the compact pieces of chalk (18) represented a wall foundation (Figs, 2 and 3; Plate 4), and that the dark reddish brown silty clay (17) abutting it to the north could be the back-fill of a foundation trench, especially on account of flecks of charcoal and chalk mixed within the latter deposit. As it was not necessary to excavate the construction trench for the development any further to the north, the extent of the deposit remains unknown.

Upon hand excavation, the silty clay deposit had the 'feel' of a natural deposit, whilst cleaning of the interface between the two abutting deposits, showed the chalk to slope steeply (80°) downwards to the north, indicating that the silty clay deposit was stratigraphically, the later event of the two.

The true extent of the chalk foundation (18) to the south could not be ascertained; the 19<sup>th</sup> century pipe appeared to sit upon it. Due to a prolonged torrential down pour of rainfall and the use of a breaker on the site it was deemed no longer safe to further examine these deposits on the south side of the pipe. Whilst unambiguously, a foundation, it remains uncertain as to whether this was for a floor or a wall.

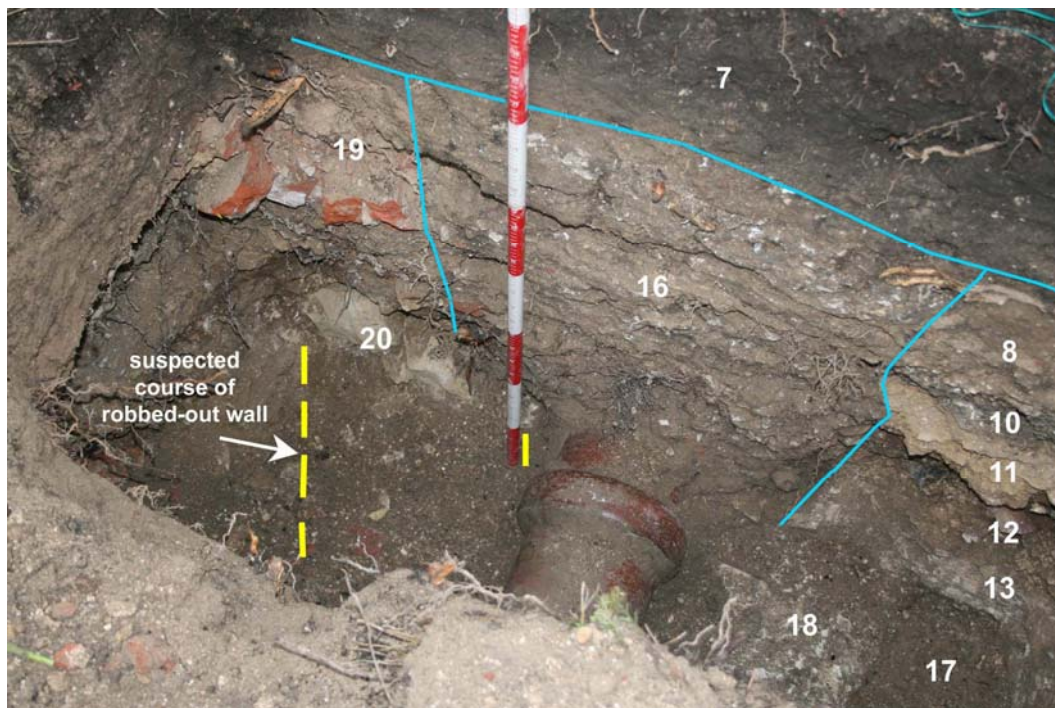
**Plate 5. Trench 2, south end, facing south-west**

Notably, in Trench 2, remnants of the lower course of a wall, or its foundations, were exposed and removed on the south side of the pipe during groundwork. The character and alignment of these remains were unfortunately reported to the archaeologist after the event, but sufficient shattered limestone masonry was still visible in section to ratify the account. These remains were more or less at the same level as the chalk foundation. The sections revealed no stratigraphic deposits above the limestone wall footing other than backfill (16 and 19) of 19<sup>th</sup> century trenches. The pipe was evidently laid within the foundations of the abbey, for geology was not exposed.

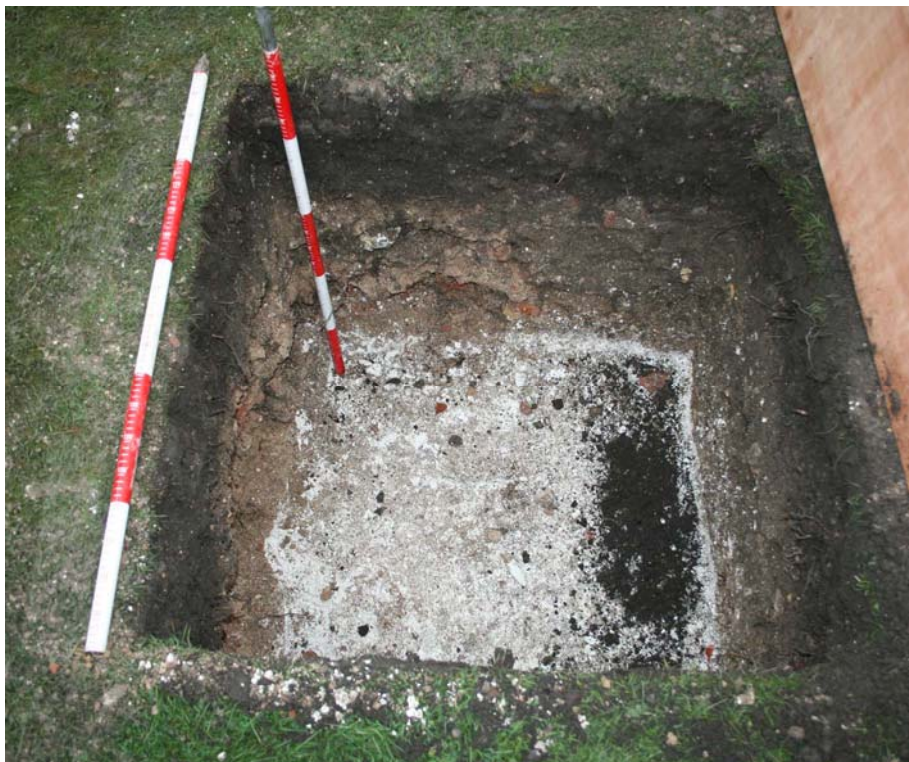
**Plate 7. Soak-away pit, facing north**

The trench measured 1m x 1m x 1m in depth. The lowermost deposit (29), a stiff compacted white chalk, interpreted as natural geology, was reached at c.0.9m and penetrated c.0.1m. The top of the deposit was fairly horizontal and dirty yellow in colour, denoting that it been a surface. Above this was a rubble deposit (28), c.0.5m in thickness, consisting of crushed and shattered red bricks and mortar. The bricks were hand-made. No artefacts other artefacts were present. The rubble was sealed by grey-black topsoil (34) c. 0.4m in thickness. In the south-facing section of the trench a negative feature [30] was present, possibly a small pit. This contained two distinctive fills of brown chalky earth (32 and 31), but was devoid of artefacts. It appeared to have been sealed by the topsoil.

The rubble was perhaps from the 17<sup>th</sup> century gaol which was demolished in the late 19<sup>th</sup> century.
