RIBBA HALL OUTBUILDING
BUILDING RECORDING REPORT
MONITORING OF

RIBBA HALL FARM,
BISHOPDALE, LEYBURN,
NORTH YORKSHIRE

NAA 18/87
October 2018

BUILDING RECORDING

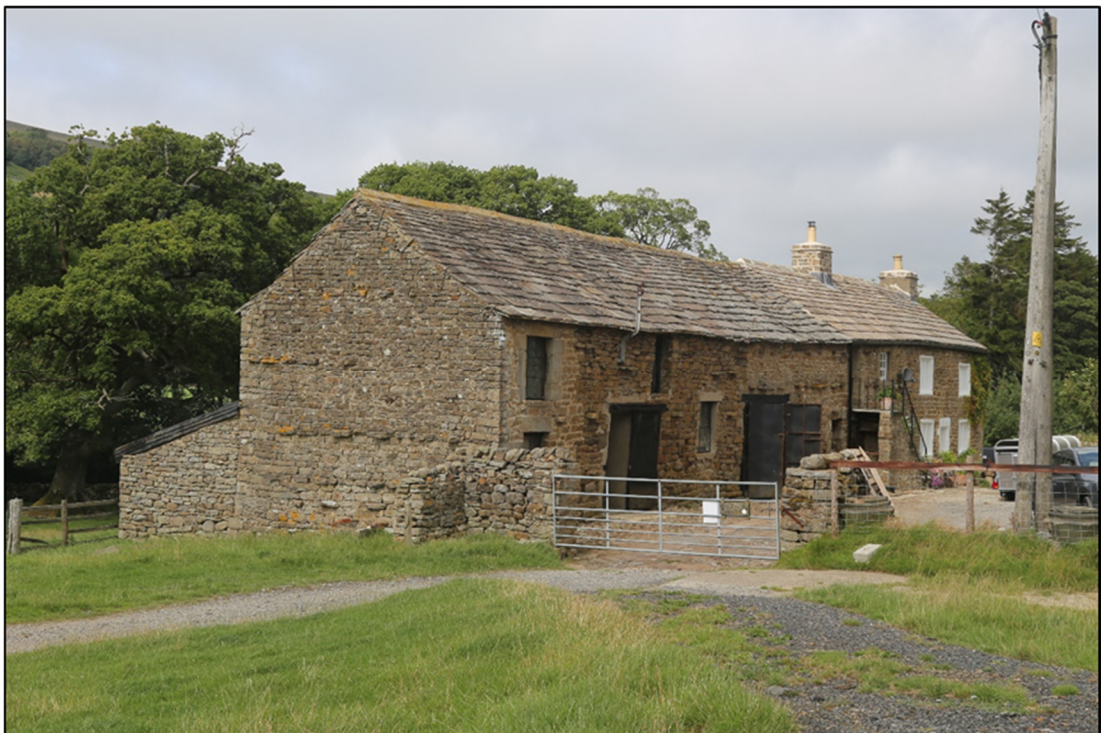
Plate 1: view of Ribba Hall Farm from the south.

1.2 Ribba Hall is a 17th-century yeoman farmhouse that is located on the south side of Bishopdale Lane (B6160). The farmhouse is located at the north end of the building, with an attached byre and barn range to the south.

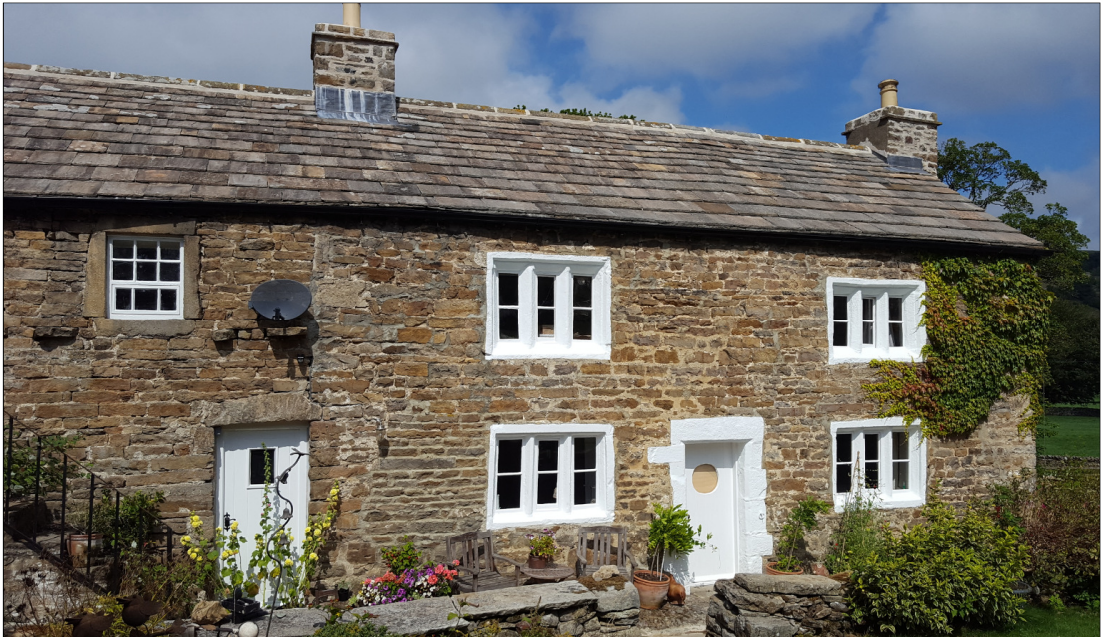
Plate 2: view of east facing (main) façade of farmhouse.

5.2 The farmhouse is the best-preserved of the elements and features four three-light mullioned windows on the east facing (main) façade and two end stacks (Plate 2). The south section is more utilitarian in design, with windows and doors of various sizes, some with rough stone surrounds and some without. At the north end of the building, a two-storey extension has been added on the west side, probably in the early 19th century (Fig. 2; Plate 3).

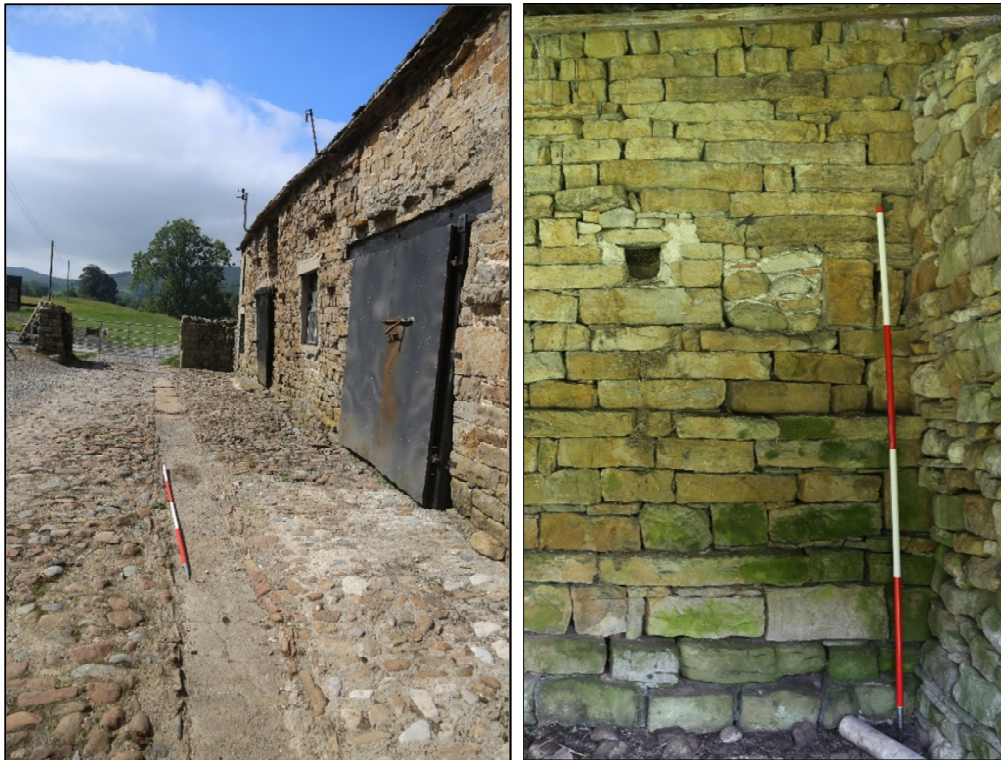
Plates 5 and 6: view of the drain in front of the east-elevation looking south-west and west facing elevation, blocked window (134) at south end with adjacent modern ventilation hole (132).

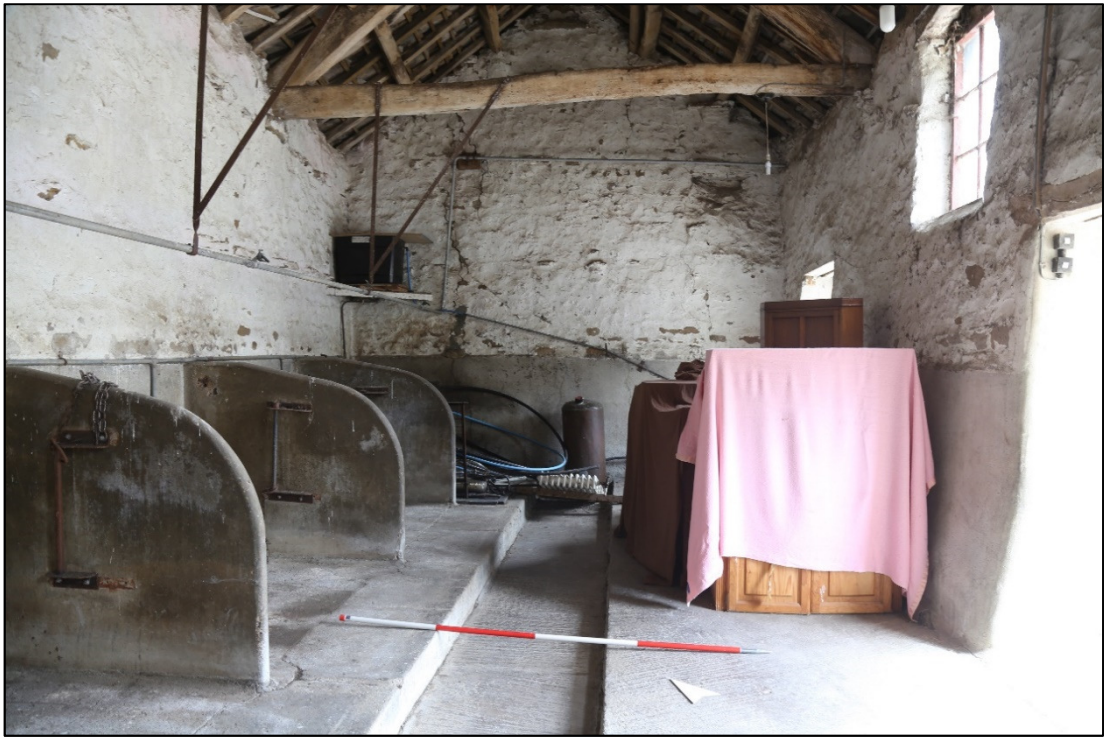
Plate 7: interior of the byre looking north-east.

- 5.18 The roof of the byre is held by three simple A-frame trusses (304). The height of the room, the ridge visible along both gable ends and the blocked doorway into the barn (400), would all indicate that the building originally featured an upper storey. However, there are no visible joist holes along the two long walls, although it should be noted that the surface of these are currently heavily rendered.

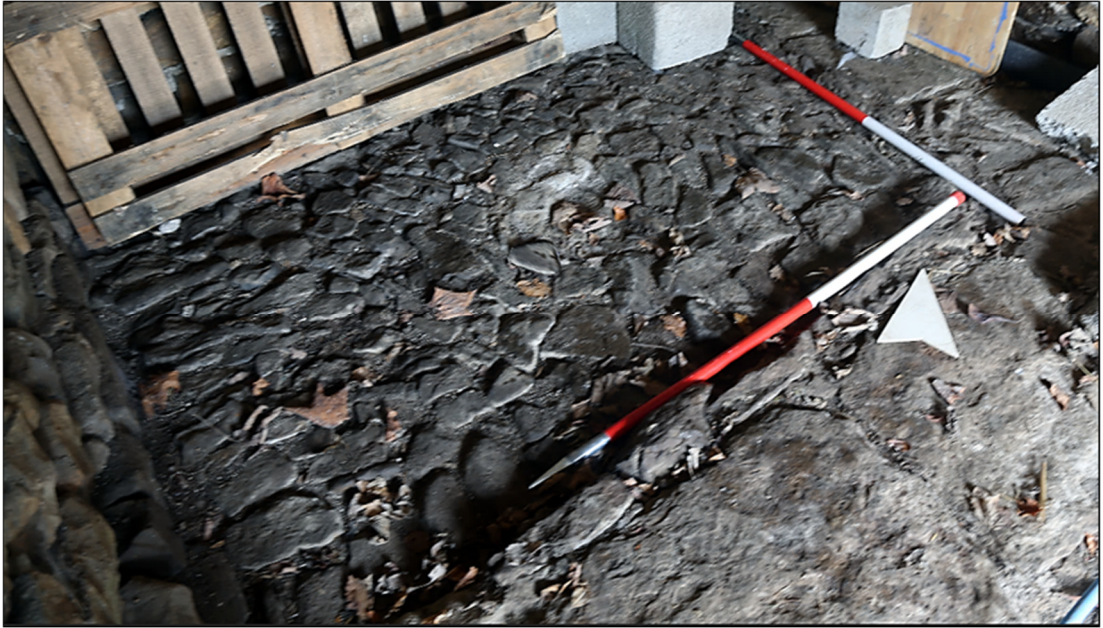
Plate 8: cobbled floor (412) probably associated with a calf pen in the north-west corner of area 410.

- 6.6 As discussed above, **410** would have initially served as a winnowing floor but was subsequently converted for use as a calf house; evidence of this is the cobbled floor (**412**). Cobbled surfaces such as this are usually found in areas frequently used by cattle or horses, as the stones provide additional traction for hooves.

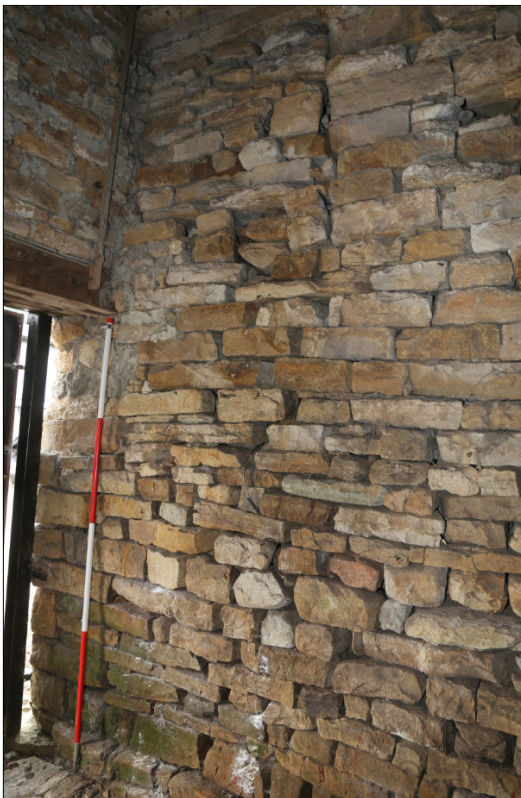
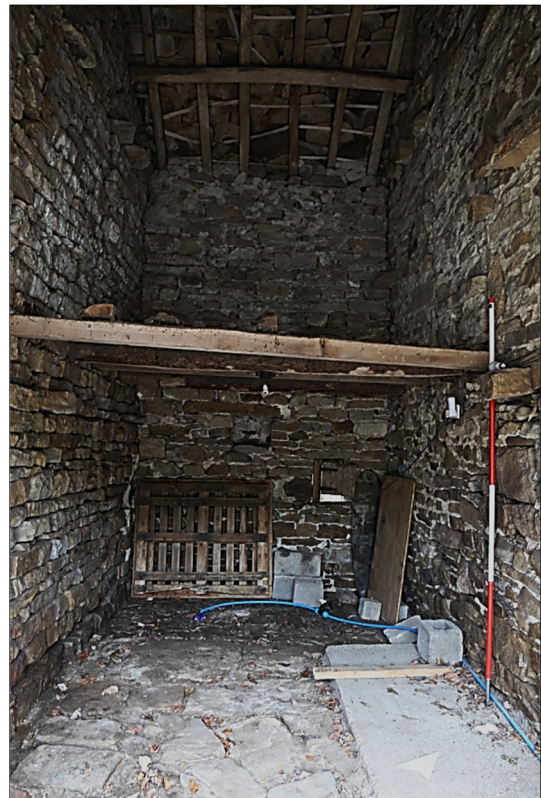
Plate 9 and 10: (left) blocked door in south wall of barn (415), visible above ranging rod; and (right) general view of the room 410 with stone floor (411) in foreground.

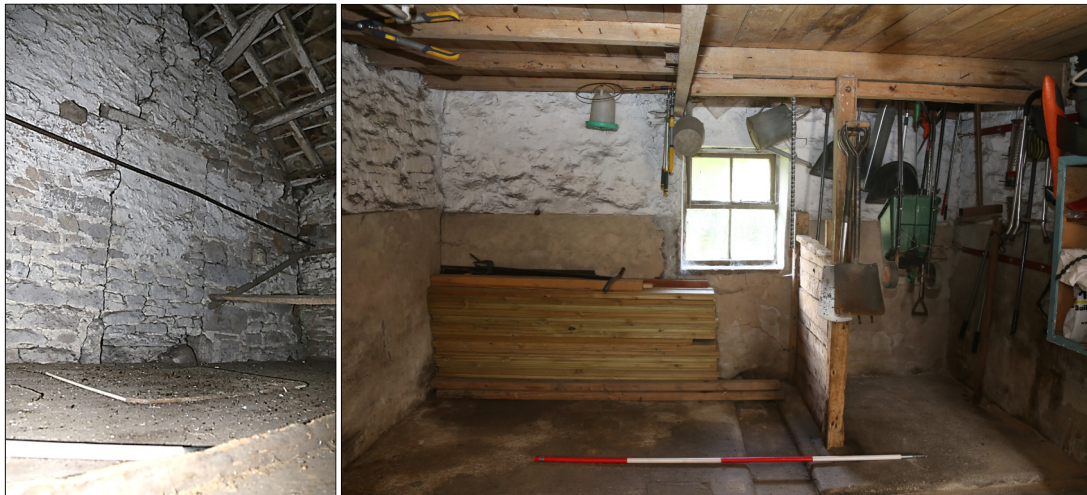
Plates 11 and 12: (left) blocked door (416) leading into room 410 in the upper storey of room 420, and (right) general view of room looking north-west with animal stall (423) and drain (421) visible.

- 6.5 The 1921 sale brochure mentions a 'loosebox with cheese room over', which is assumed to be the current storage room (**420**). The drain and stalls (**421** and **423**) below and the remnants of a shelf (**427**) on the upper storey provide some evidence to support this interpretation. Access from the loosebox and stable would have been through the blocked door (**422**), but there was no access between the hayloft and cheese room.

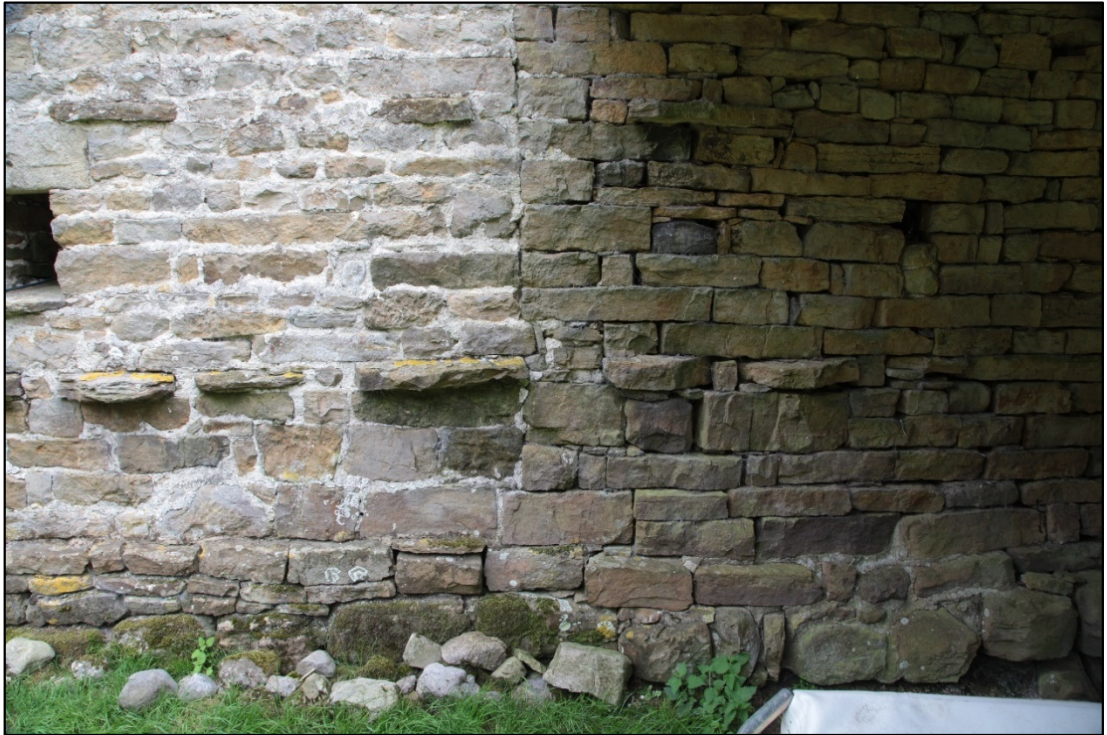
Plate 13: wall joint on the north-west elevation between the barn and the byre. The scar does not extend the full height of the wall but stops above the through-stones that extend into what is now the byre.

- 6.2 In layout, the dimensions of the surviving building have changed relatively little from that shown on the early historic maps; however, the southern end of the building was either replaced or extensively rebuilt at some stage. This is evident in the strong vertical joint clearly visible on both sides of the range. On the south-east elevation, this runs the full height of the structure, but on the north-west side it is clear that the foundation and through-stones of the earlier barn have been incorporated into the later structure (Fig.

10; Plate 13). Such a phase of extensive rebuild appears to have happened either following a period of prolonged decline or as the result of a catastrophic event, such as a fire.

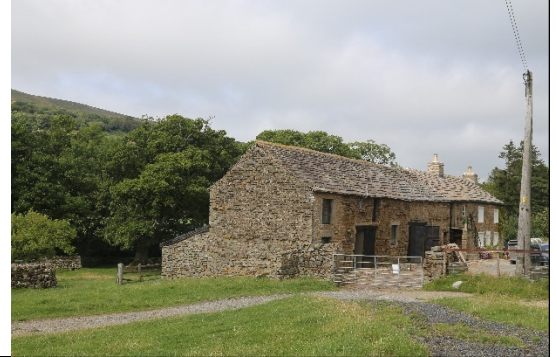
110	South-east elevation of byre	The south-east elevation is the front of the byre with a large double door and four windows. In front of the elevation is a long drain that culminates at the southernmost corner of the building. The elevation is of square rubble with low dry-stone walls extending to the south, through which passes the drain.	Late 18th–early 19th century	High: evidential in terms of the various wall scars and joints, also of considerable aesthetic value as part of the wider complex.	111 – door 112 – door 113 – upper south window 114 – upper central window 115 – lower north window

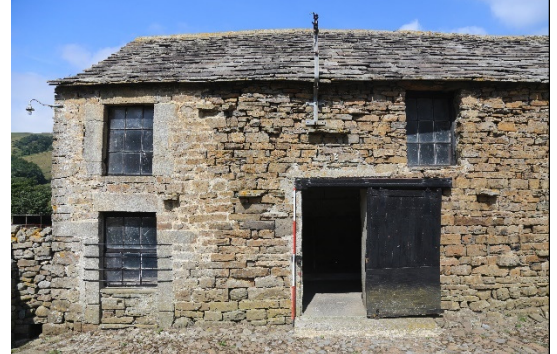
ID No	Name	Description	Date	Significance	Related Features	Photo
111	Door	The main door into the byre is a sliding door with a wooden lintel extending to the north to accommodate the door when open. Mounted on the lintel is a large metal bar that holds the door and allows it to slide. Set in the frame are two large quoins.	Late 19th–early 20th century	Low: of some evidential value in terms of the development of the building. A later addition to facilitate movement of animals.

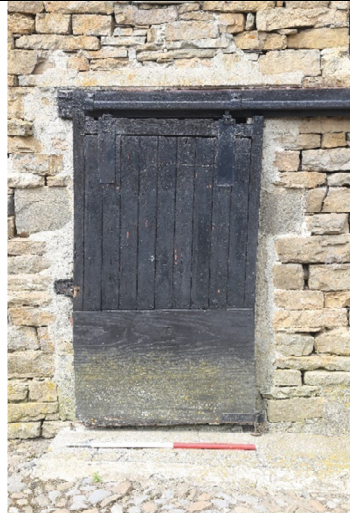
112	Blocked door (window)	Set in a stone surrounds with a cut-stone lintel above. This was the original door into the building before the insertion of 111. Subsequently partly blocked and a casement window inserted. This has nine panes, three in the upper frame, with six below.	Late 18th–early 19th century with later blocking	High: evidential value as an original feature and also shows subsequent development	111 – later door 113 – upper south window 114 – upper central window 115 – lower north window

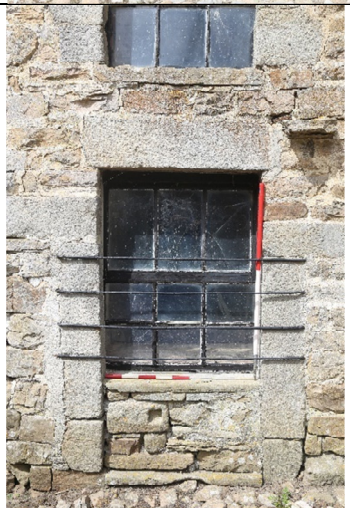
ID No	Name	Description	Date	Significance	Related Features	Photo
113	Upper south window	The upper window also has a cut-stone surrounds and a lintel. The window is a nine-pane fixed window. The location is original to the building, although the iron frame may be later. Contemporary with 112.	Late 18th–early 19th century	High: evidential value as an original feature.	112 – lower south window 114 – upper central window 115 – lower north window

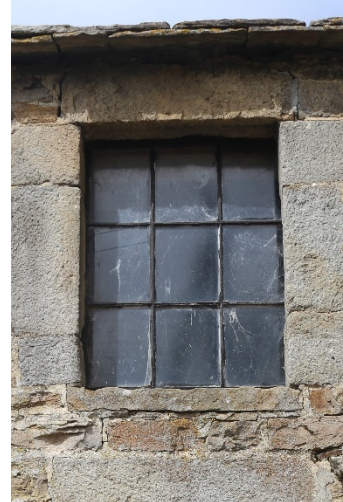
114	Upper central window	Later insert. A nine-pane fixed window inserted with no surround. Lintel sits right under the eaves.	Late 19th or early 20th century	Moderate: evidential value as shows later phase of change.	112 – lower south window 113 – upper south window 115 – lower north window

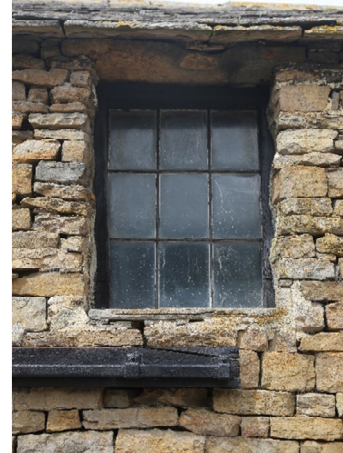
ID No	Name	Description	Date	Significance	Related Features	Photo
115	Lower north window	A small casement window with six panes. It has a concrete lintel and is a later insert.	Late 19th or early 20th century	Moderate: as above change.	112 – lower south window 113 – upper south window 114 – upper central window

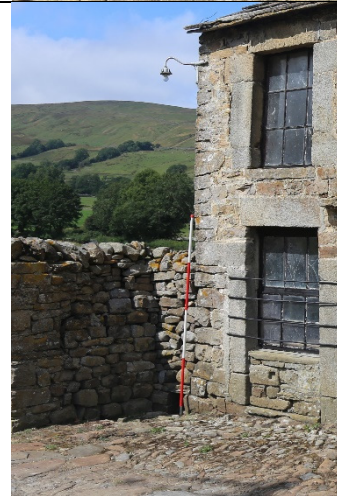
ID No	Name	Description	Date	Significance	Related Features	Photo
117	Long drain and cobbled surface	Cobbled surface in front of the barn incorporating a long drain stretching along the whole length of the barn and byre elevations, measuring approx. 20cm wide. Drains into the field south of the byre.	Unknown	High/Mod – both the drain and surface have an evidential value in terms of the agricultural purpose and function of the building. The surface also has aesthetic appeal.	116 – side drain

- 5.7 In front of the elevation is a long, 40cm wide, drain (117) that runs along the front of the whole property. It discharges into another drain (116) in the south corner of the elevation, which is built into the abutting field boundary wall. These drains are set into the cobbled surface in front of the building (Plate 5).

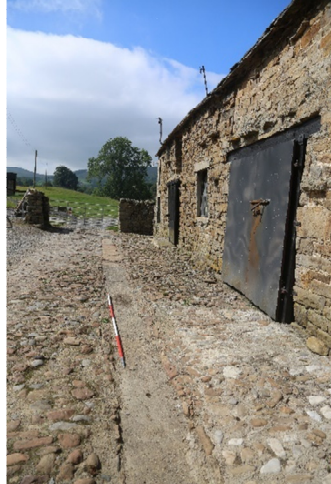
120	South-west elevation	Gables end wall composed of square rubble with through-stones. End wall of lean-to shelter also visible.	Late 18th–early 19th century	High – evidential value as part of the modifications to the linear range. Also, of some aesthetic value.	121 – drain 122 – drain

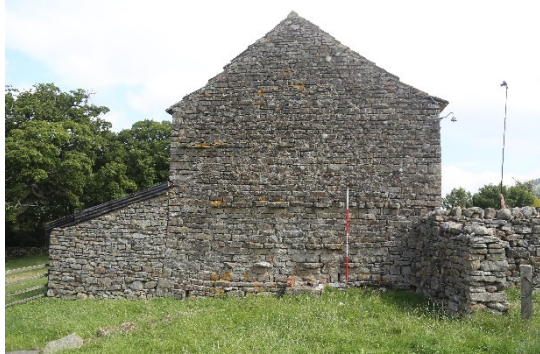
ID No	Name	Description	Date	Significance	Related Features	Photo
121	Modern drain	A large square drain in the centre of the elevation. It is a large square of concrete with a terracotta interior, and bricks around the sides.	20th century	Low: some evidential value as to function of byre.	122 – old drains

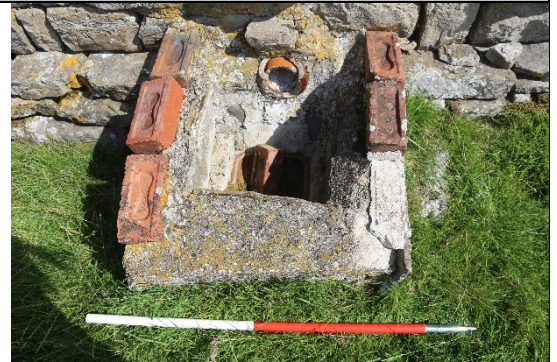
122	Old drains	Two old drains are located in this elevation. The first connects with the side drain of the south-east elevation (116). The other lies to the west of the modern drain and stands 25cm high.	Late 18th–early 19th century	Moderate: some evidential value relating to the use of byre.	121 – modern drains

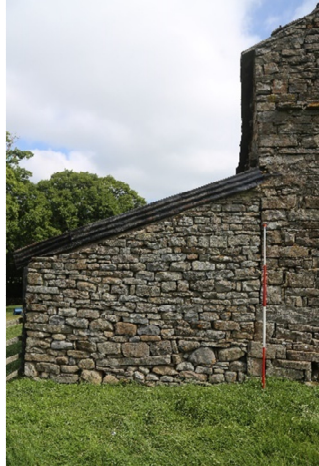
124	Field boundary walls	The field boundary walls are of even courser rubble and abut the byre wall but do not tie into it.	Post-1850	Low: evidential value related to the use of the farmstead and the surrounding area.

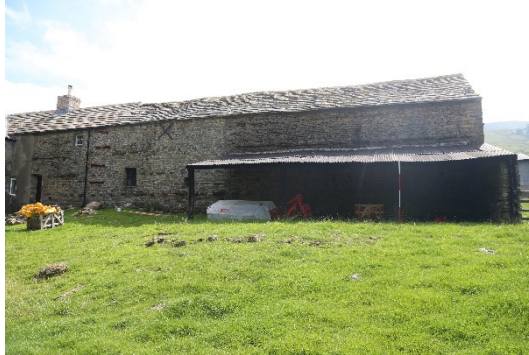
131	Lean-to shelter	The shelter is a lean-to construction of wood with a corrugated metal roof and two stone support walls.	20th century	Low: a later addition to the building and has some association with the function of the building. However, could be seen as having negative significance as detracts from aesthetic value of the elevation.

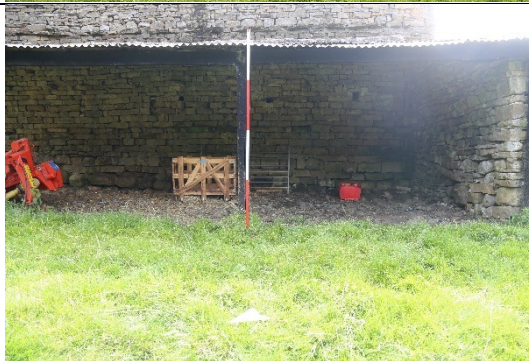
132	Modern vents	Four modern vents were identified in the wall of the byre. These consist of a square hole with a terracotta pipe inserted. The four vents are not evenly spaced. Three lie closer to the south wall with a single vent near the northern edge of byre. Some of these modern vents fill the older ventilation slots (133).	20th century	Low: evidential value related to the later use of the byre.	133 – ventilation slots

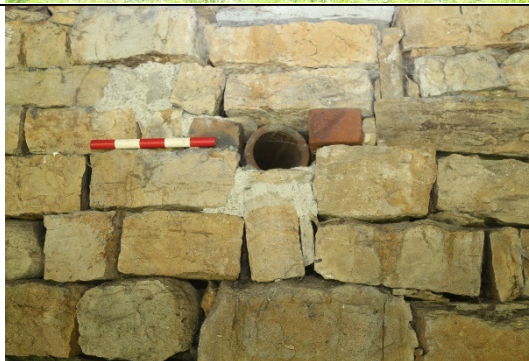
ID No	Name	Description	Date	Significance	Related Features	Photo
133	Blocked ventilation slits	Four blocked ventilation slits were identified running the length of the byre. These were also unevenly spaced. Two incorporated later vents (132).	Late 18th–early 19th century	High: evidential value related to the use of the building and an original feature.	132 – modern vents

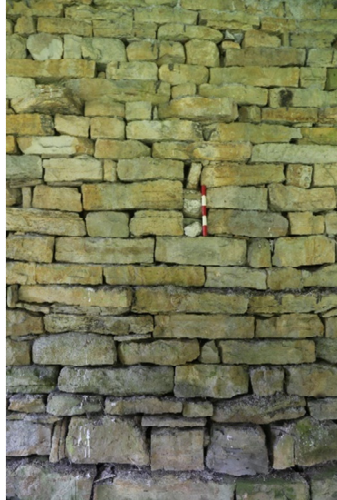
134	Blocked window	A single, square blocked window on the far south side of the elevation. It measures approx. 40x40cm.	Late 18th–early 19th century	High: evidential value as an original feature also provides information related to the phasing of the byre.

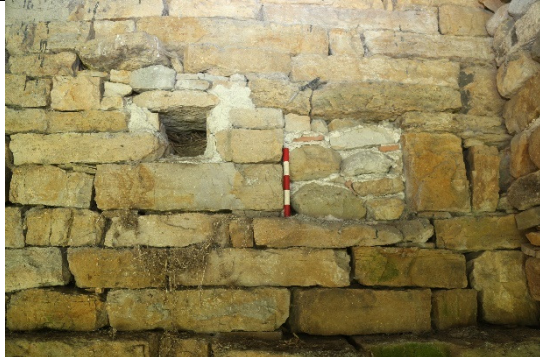
- 5.9 Below the elevation, on the slope descending towards the beck, is a rubble platform (**135**), approximately 2.00m from the edge of the shelter, that runs parallel to the north-west elevation of the byre and barn. It is uncertain whether this platform forms the foundation of another wall or feature.

ID No	Name	Description	Date	Significance	Related Features	Photo
135	Rubble platform	Further to the west of the elevation, along the whole length of the byre and barn, is a line of rubble that mirrors the current shape of the building and shelter. This could be buried demolition debris relating to the rebuilding of the barn/byre.	Unknown	Moderate: evidential value possibly relating to the demolition of the southern part of the barn.

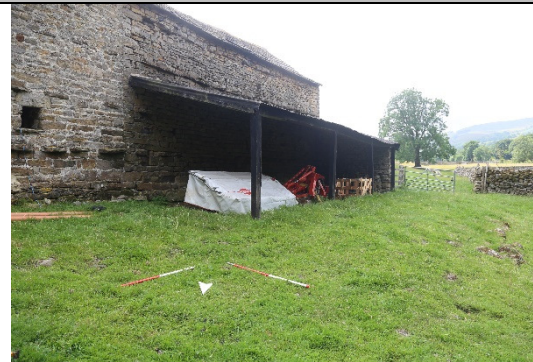
200	Barn	The barn, like the rest of the building, is constructed of square rubble. Unlike the byre, it is lime pointed. There is a clear butt joint visible between the barn and byre. Building features several through-stones set in horizontal bands up the height of the building. Their location is aligned, unlike on the byre. Today the barn includes a garage space and two storage rooms.	Late 17th–early 18th century	High: of considerable evidential value as part of the complex, as well as relating to the agricultural function of the building and its later development. Considerable aesthetic value.

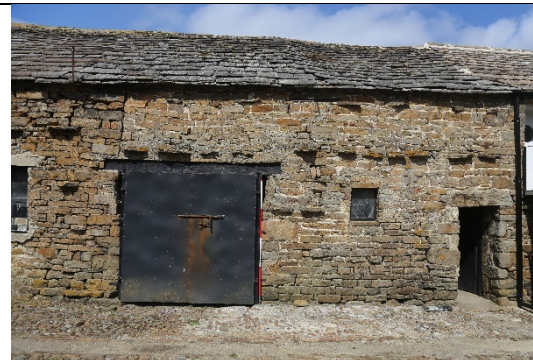
ID No	Name	Description	Date	Significance	Related Features	Photo
211	Double door	A large metal double door with a large wooden lintel stretches most of the width of the garage. Large stones set on north side of the door may be associated with the original barn door in this location.	20th century	Negative: is a modern, unsympathetic alteration and detracts from the aesthetic value of the property.

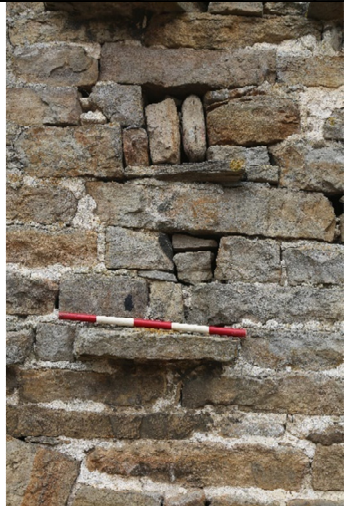
ID No	Name	Description	Date	Significance	Related Features	Photo
215	Filled joist holes?	Across the south-east elevation, above the through-stones between both doors are a series of filled niches. They may be former putlog holes associated with and adjoining structure or could just be a variation in the build.	Unknown	Low: of some evidential value.

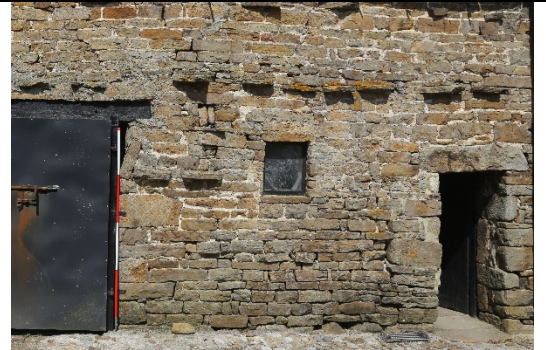
220	North-west elevation	The north-west elevation of the barn. Features include two windows and a series of blocked wall drains or ventilation holes.	Late 17th - early 18th century	High: considerable evidential and aesthetic value as part of the original barn building. Also includes evidence of development over time.	221 – window 222 – window 223 – drain

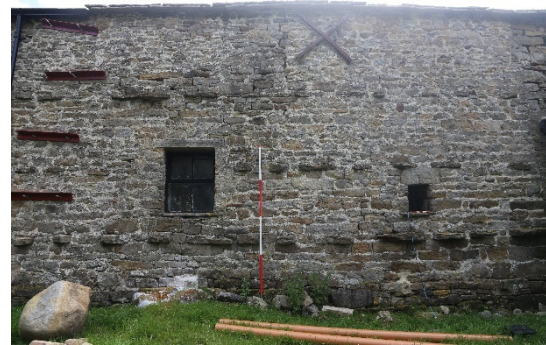
ID No	Name	Description	Date	Significance	Related Features	Photo
221	Small window	A small window of roughly 30x30 cm with a large stone lintel. The lintel is a reused cill with a carved linear recess for glass and a central glazing bar socket. Therefore, this window is obviously a later intervention.	Late 18th – early 19th century	High: evidential value related to extensive modification of this side of the bar. Clearly relates to a phase of partial rebuild

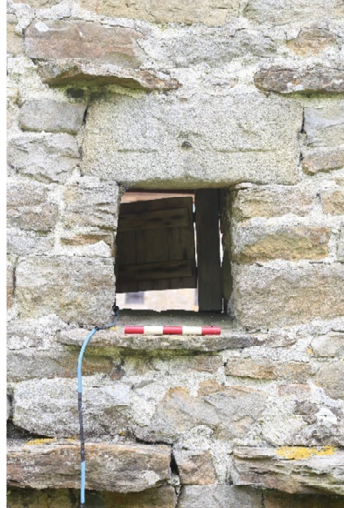
222	Large window	A casement window with a stone lintel and cill. The window has a wooden frame and four panes. A later insert.	Unknown	Moderate: evidential value with regards the later development of the barn but not original to it.

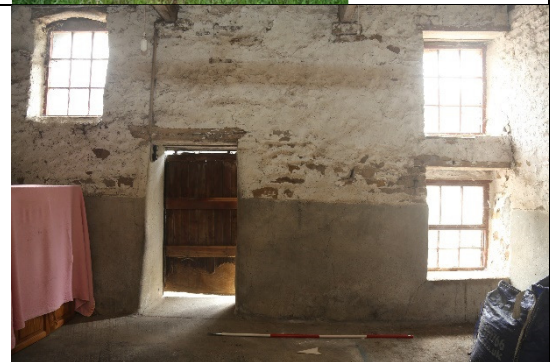
ID No	Name	Description	Date	Significance	Related Features	Photo
301	Central drain	The drain runs the whole length of the byre and is approx. 1.00m wide and about 20cm in depth. The drain flows from the north end of the room down a hole in the south wall, presumably to the modern drain (131) outside.	20th century	Low: of minor evidential value.	423 – drain

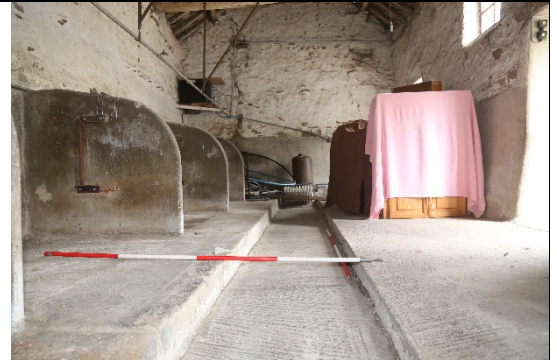
302	Cattle stalls	Concrete stalls are a modern addition to the building. Evenly spaced, five stalls line the west wall of the room. Feeding and watering installations remain.	20th century	As above	303 – byre installations

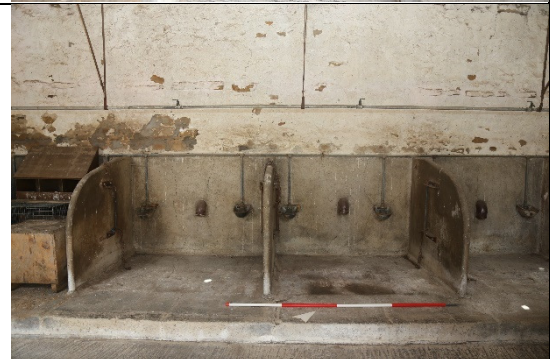
303	Byre installations	Above the stalls, hoses with spigots line the walls descending from a tank in the north-west corner.	20th century	As above	302 – byre stalls

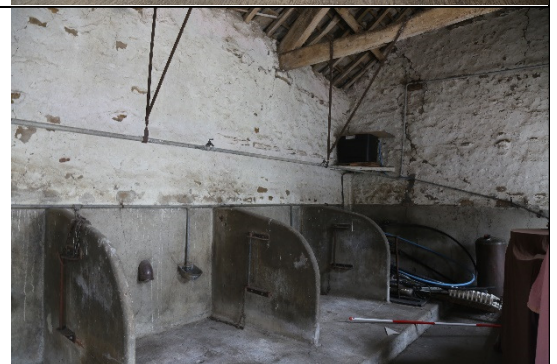
ID No	Name	Description	Date	Significance	Related Features	Photo
304	Roof trusses	The roof is held by four A-frame roof trusses, supporting a split-stone slate roof.	Late 19th–early 20th century. Building has been re-roofed.	Moderate – has considerable aesthetic and evidential value but is not original to the barn building. Possibly constructed when the byre was built but uncertain.	401 – trusses

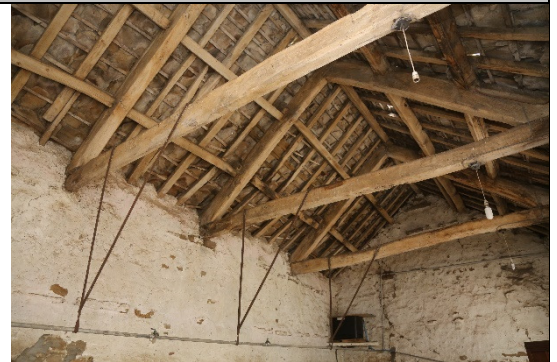
400	Barn interior	The barn is subdivided into three rooms, currently used as a garage and two storage rooms. Building features two storeys, although the upper storey only partially survives.	Late 17th–early 18th century, with later mods.	High: evidential value as part of the original linear range.	410 – garage 420 – storage room	No photo
401	Roof trusses	There is only one roof truss in the barn, above the storage room. The truss is similar to that of the byre. Whole building has been re-roofed in a single phase. Queen post truss, however, appears to be original to the building.	See 304	As 304	304 – trusses

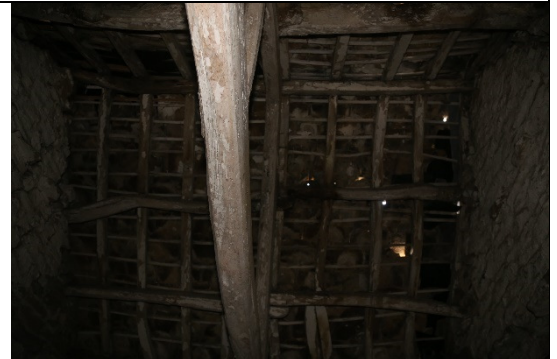
ID No	Name	Description	Date	Significance	Related Features	Photo
410	Garage passage	<p>The garage is a narrows space with the remains of an upper storey. Features discrete areas of stone and cobbled floors. Currently the room features a single window and a blocked window and door.</p> <p>Interpreted as a through-passage with the remains of a winnowing floor.</p>	Late 17th–early 18th century	High: considerable evidential value with regards the original function and form of the barn. Also, includes important evidence relating to the later development of the structure.	411 – stone 412 – cobbled floor – calf pen? 413 – niched 414 – drain 415 – blocked door 416 – blocked door 417 – sparrow holes 418 – cobbled surface

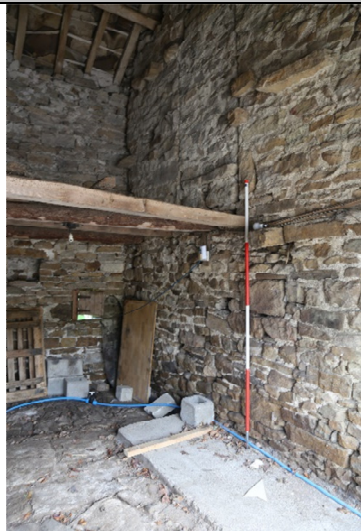
411	Stone floor	The stone floor covers the central third of the garage floor. Believed to be the remains of a winnowing floor	Late 17th–early 18th century	High: evidential value related to the use of the space and agricultural function of the barn.	412 – cobbled floor – calf pen?

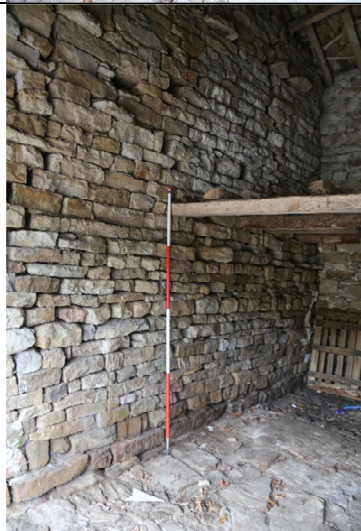
ID No	Name	Description	Date	Significance	Related Features	Photo
412	Cobbled floor associated with calf pen	Cobbled surface set with end on stones in the north-west corner of 410. Unclear if this original to the barn or if part of the winnowing floor has been removed	Poss. 19th century	High: evidential value showing the use of the building for housing animals.	411 – stone floor

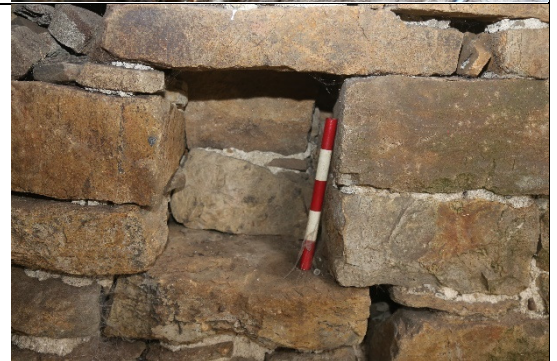
414	Drain	A small drain is located on the north side of the west wall, beneath the window. It forms one of the blocked drains on the west elevation. Date uncertain but probably modern.	Poss. Late 19th–early 20th century.	Low- minor evidential value in terms of the changing use of the building but could be original.	421 – drain

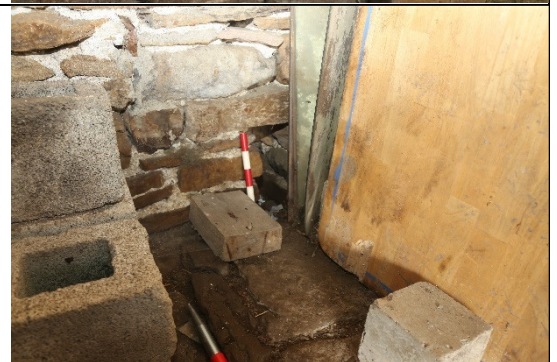
ID No	Name	Description	Date	Significance	Related Features	Photo
415	Blocked door	High on the south wall is the evidence of a blocked door leading through to the south side of the building. Date uncertain because of rebuilding of south section of the barn. Further evidence might be revealed during unblocking.	Uncertain	High: evidential value as a clue to the former layout of the barn and phasing of the building. Needs further investigation.	416 – blocked door

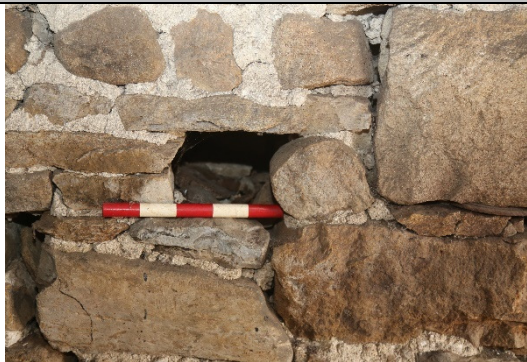
420	Storage room	The storage room has a stall division visible in the north-west corner of the room with an adjacent drain. On both sides of the room are windows above which is a floor, accessed but there is currently no access.	Late 17th–early 18th century, with later mods.	High: evidential value as an original space within the barn.	421 – drain 422 – blocked door 423 – stall 424 – bolts 426 – sparrow holes 427 – shelving

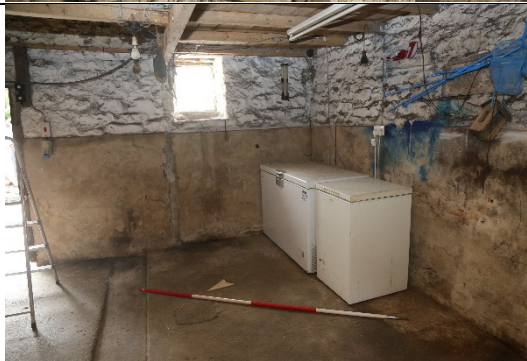
421	Drain	The drain encloses the stall and runs the whole length of the room from east to west, before exiting by the other drain beneath the small casement window (222).	20th century	Low: some evidential value but feature looks to be a late addition.	301 – drain

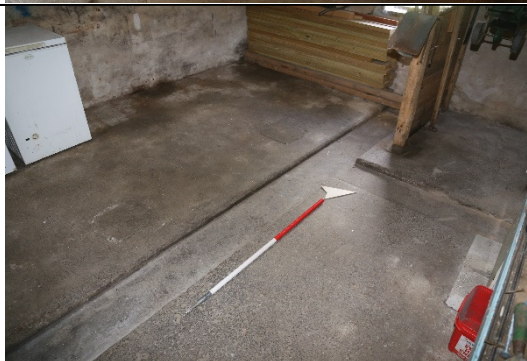
ID No	Name	Description	Date	Significance	Related Features	Photo
422	Blocked door	A blocked door is located in the north-east corner of the room providing access to the northern part of the building.	Late 17th–early 18th century	High: evidential value as part of the original barn and indicating movement around the building.	416 – blocked door 415 – blocked door

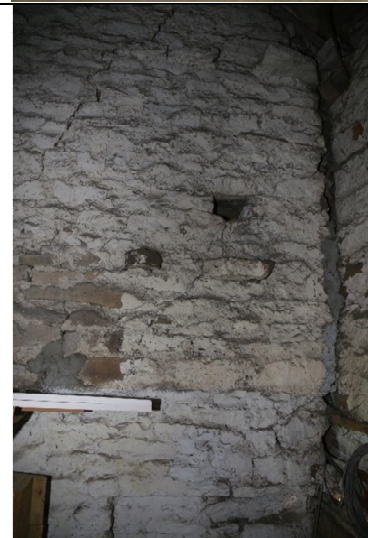
ID No	Name	Description	Date	Significance	Related Features	Photo
427	Shelving	On the south-west side of the upper floor are the remains of what may have been a shelf for holding hay.	Unknown	Low: moderate evidential value related to the agricultural use of the space.

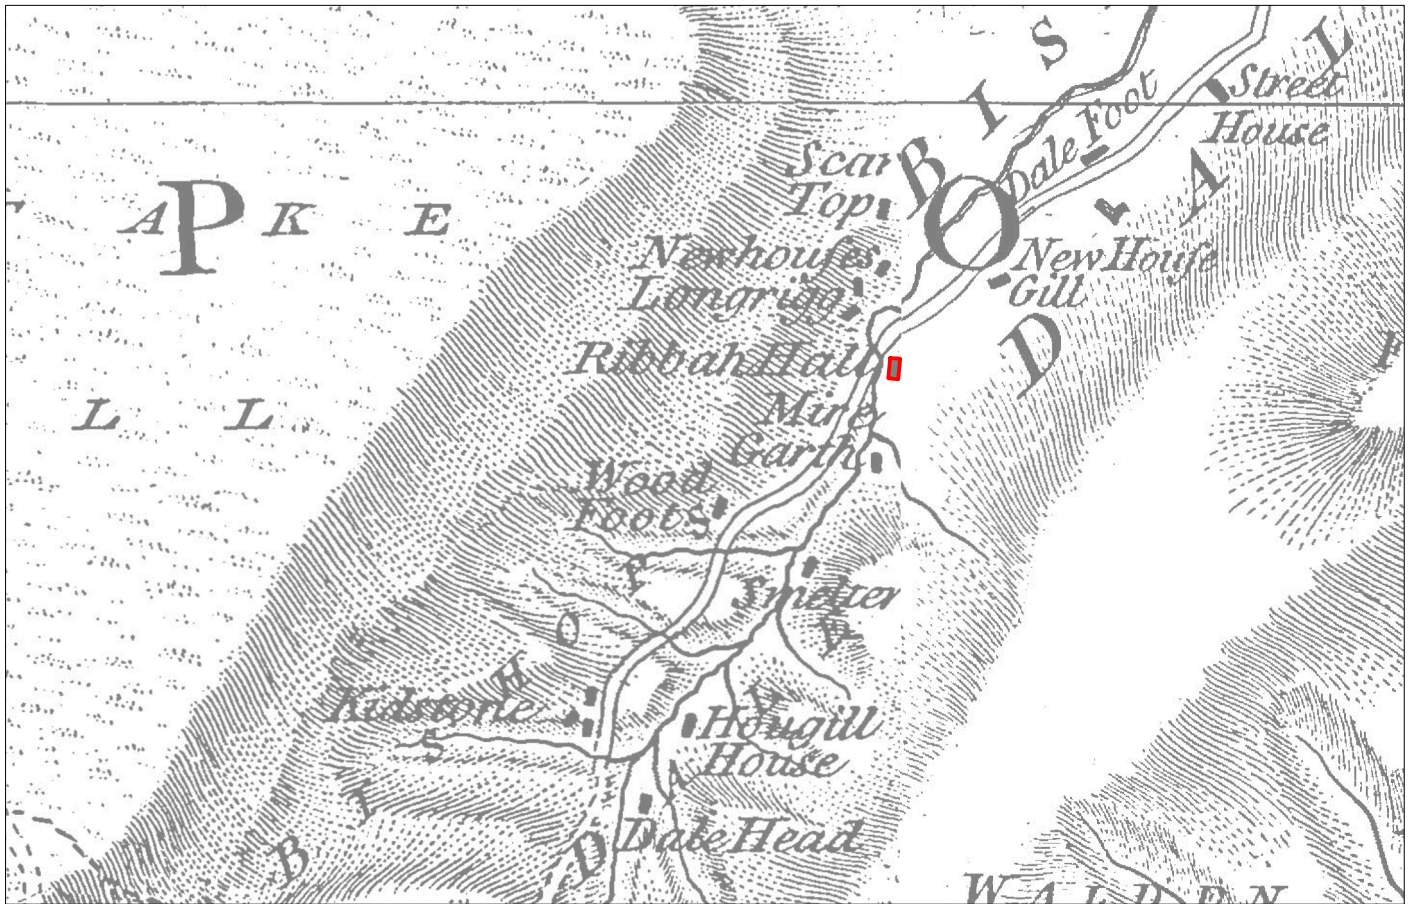
Figure 4

Ribba Hall, Leyburn: 1771 Jeffrey's Map showing 'Ribbah' Hall

- 4.16 The earliest map to show Ribba Hall is Jeffrey's Map of North Yorkshire, dated 1771 (Fig. 4). The farm is marked as 'Ribbah Hall' and is one of a cluster of farms shown dotted along both sides of the road through the valley.

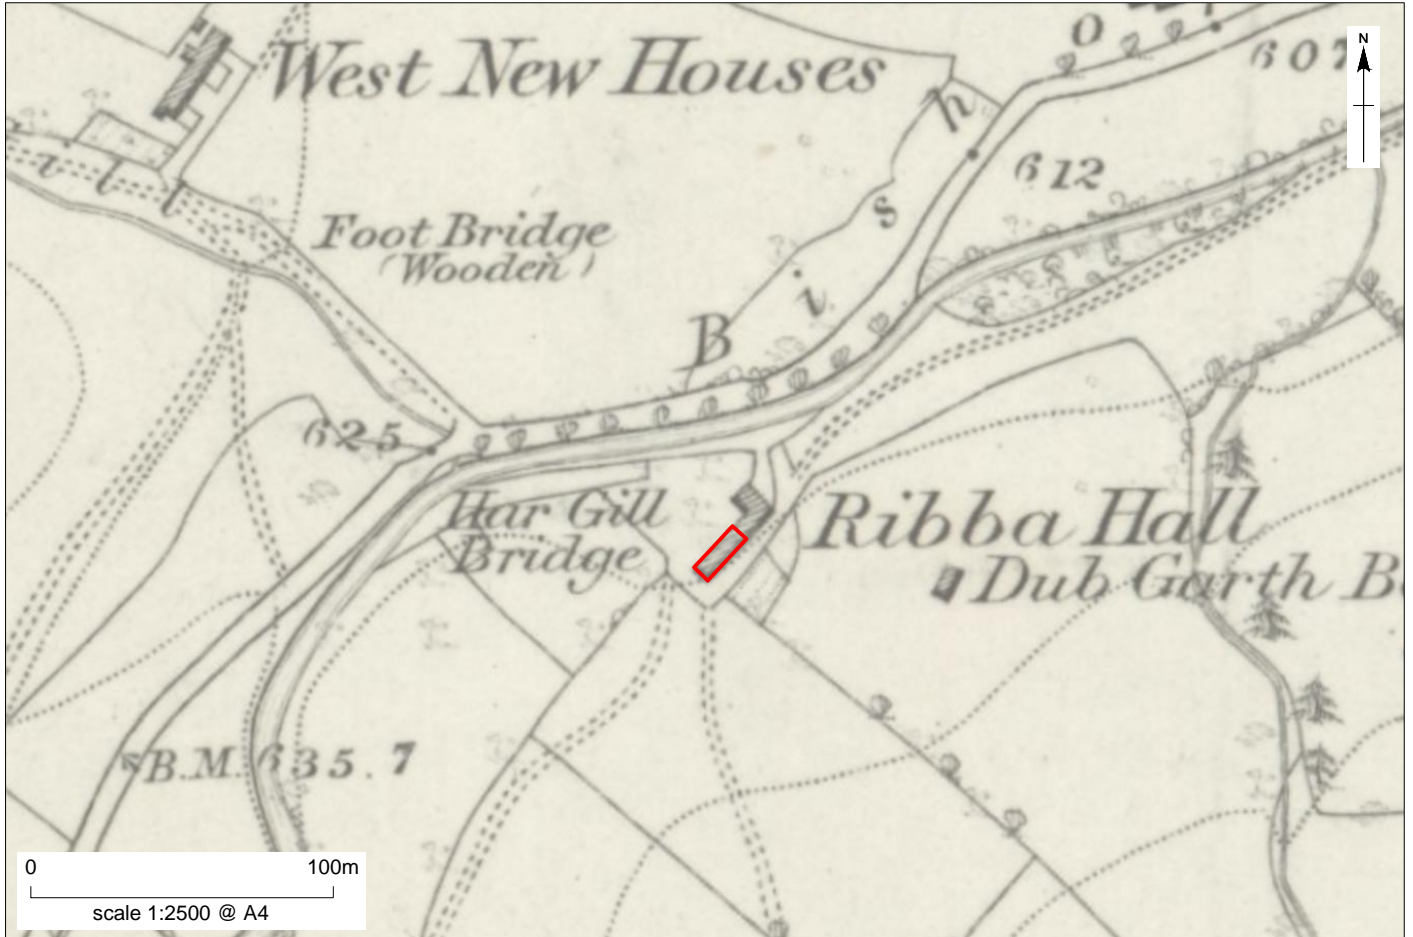
Figure 5

Ribba Hall, Leyburn: First edition six-inch Ordnance Survey map, 1856

- 4.17 It appears as 'Ribba Hall' in the later six-inch First Edition Ordnance Survey (OS) map, published in 1857 (Fig. 5). This shows the layout of the hall range as very similar to how it appears today. A series of footpaths link the farm with Myers Garth to the south and New Bridge to the north. A barn is shown in the field east of the farm, which was named 'Dub Garth' barn. This also appears on the 1894 Second Edition 25-inch OS map (Fig. 6), where it is called 'Dockengarth', a name which appears in 17th- and 18th-century documents relating to the farm (Brigantia 2015). This building is no longer extant.
