ARCHAEOLOGICAL
MONITORING AND BUILDING
RECORDING REPORT

TEES COTTAGE PUMPING
STATION, DARLINGTON,
COUNTY DURHAM

NAA 20/04
January 2020

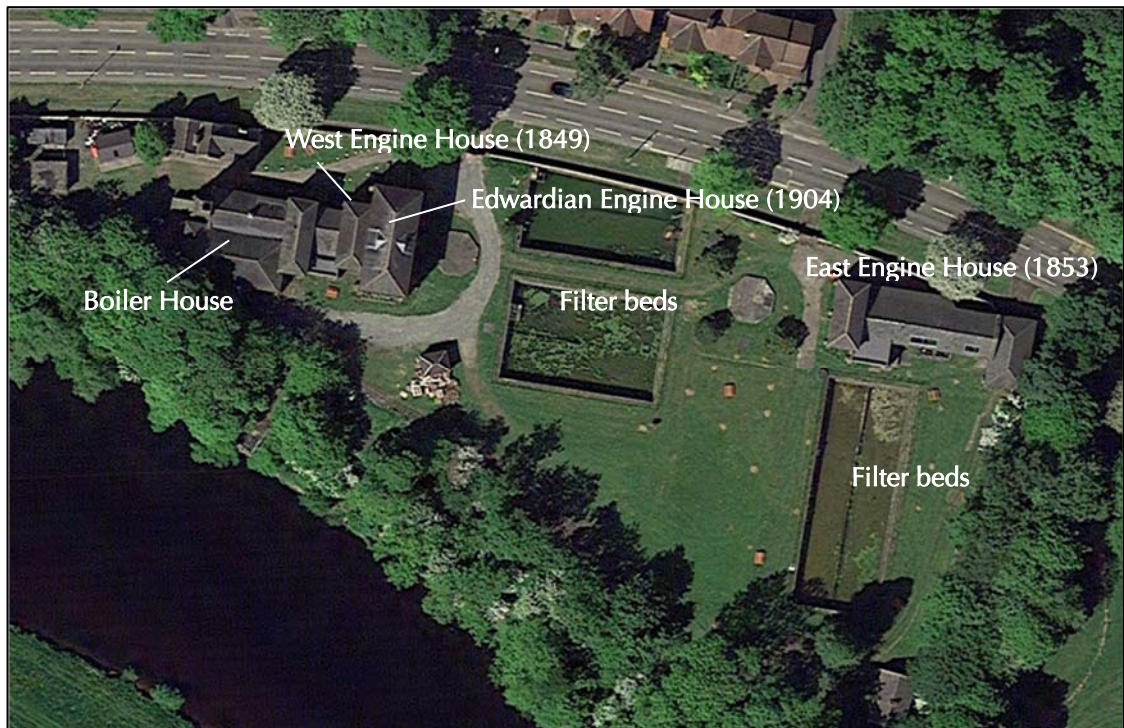
Figure 2: Google Earth aerial image showing the pumping station complex with key elements annotated.

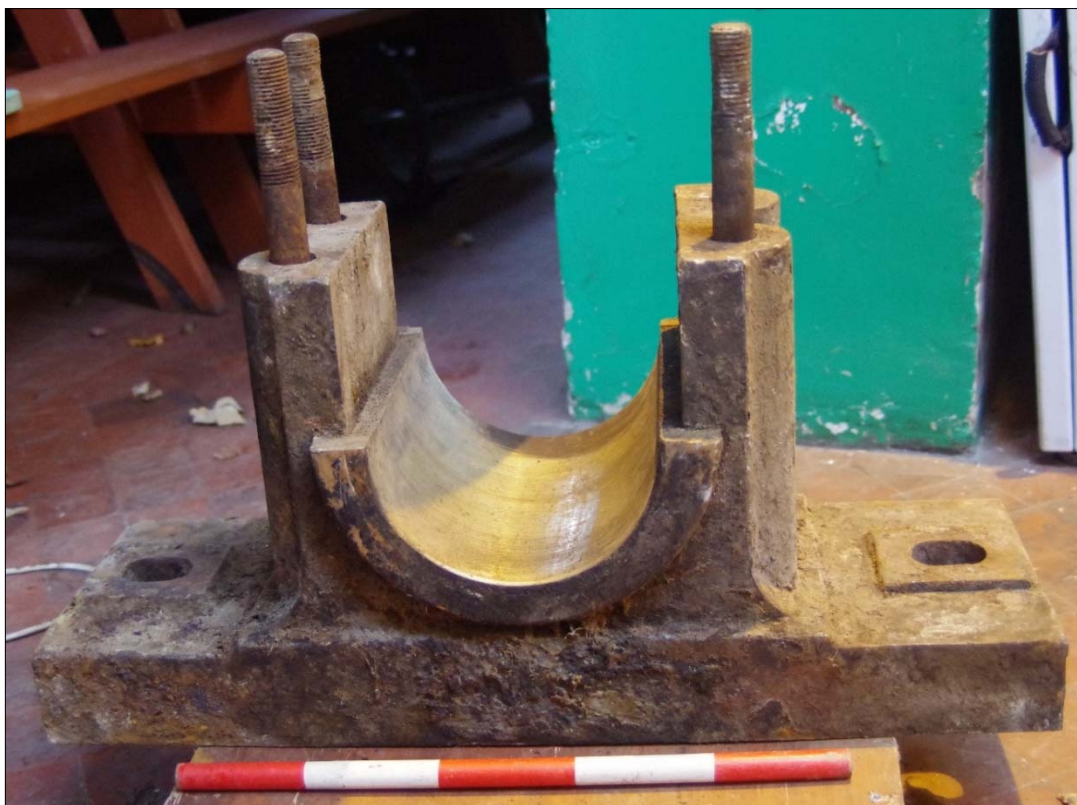
Plate 1: base of a brass bearing recovered from the flywheel pit.

- 6.1 As outlined in the methodology, the rubble removed from the flywheel pit primarily comprised broken bricks, mortar, rotten timber and generic iron items such as brackets, nuts and bolts. These were inspected and assessed by the archaeologist onsite but not retained.
- 6.2 The only item recovered of interest was the base of a large brass bearing, measuring 0.8m by 0.3m by 0.4m in height (Plate 1). Two holes for securing the bearing to the masonry were situated 0.6m apart at either end. The bearing would have housed the shaft for the flywheel and been mounted on an iron plate (32) secured to sandstone blocks to the east of the flywheel pit by anchoring mechanism 31 (Plate 2). This is discussed in more detail in sections 6.17 and 6.18.

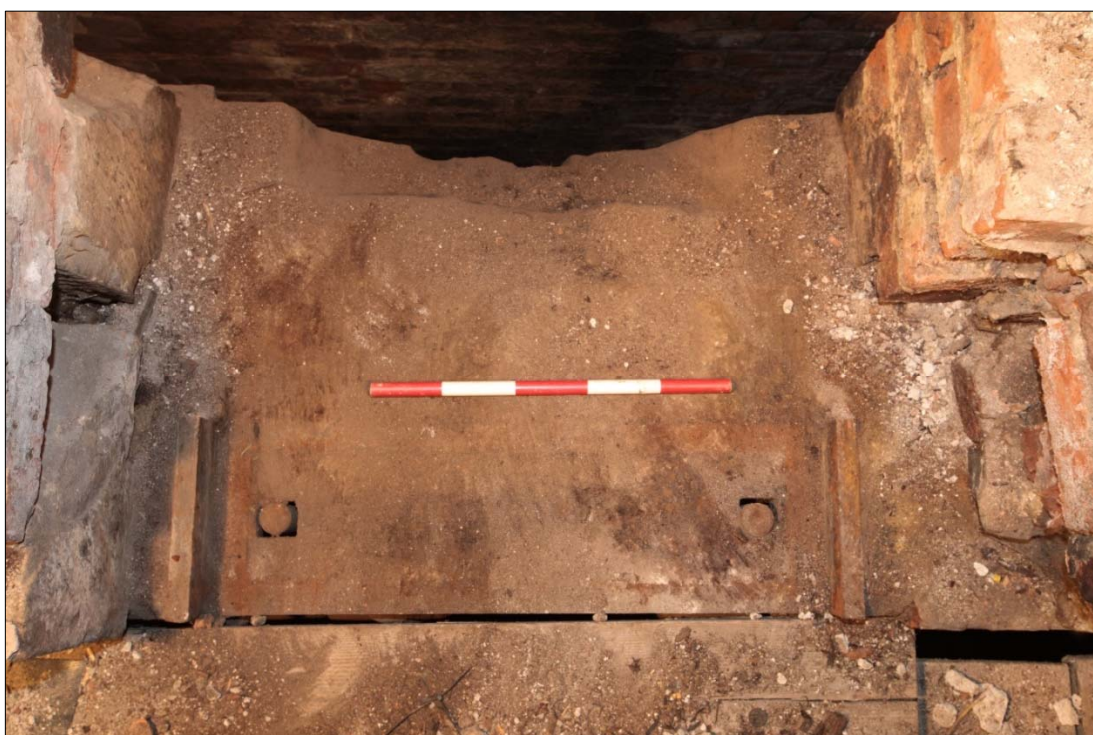
Plate 2: sandstone blocks to the east of the flywheel pit and iron plate 32 for mounting the recovered bearing base.

- 6.19 The tops of the steel rods could be seen protruding from the upper sandstone blocks on top of wall 30 at ground floor level (Plate 2) and were also threaded, indicating the points to which mechanical components were secured. A second anchor plate could be seen flush with the underside of the sandstone block within the northernmost niche and a third, smaller niche, containing a fourth square anchor plate located at the south end of wall 30, 1.13m above floor level (Plate 9).

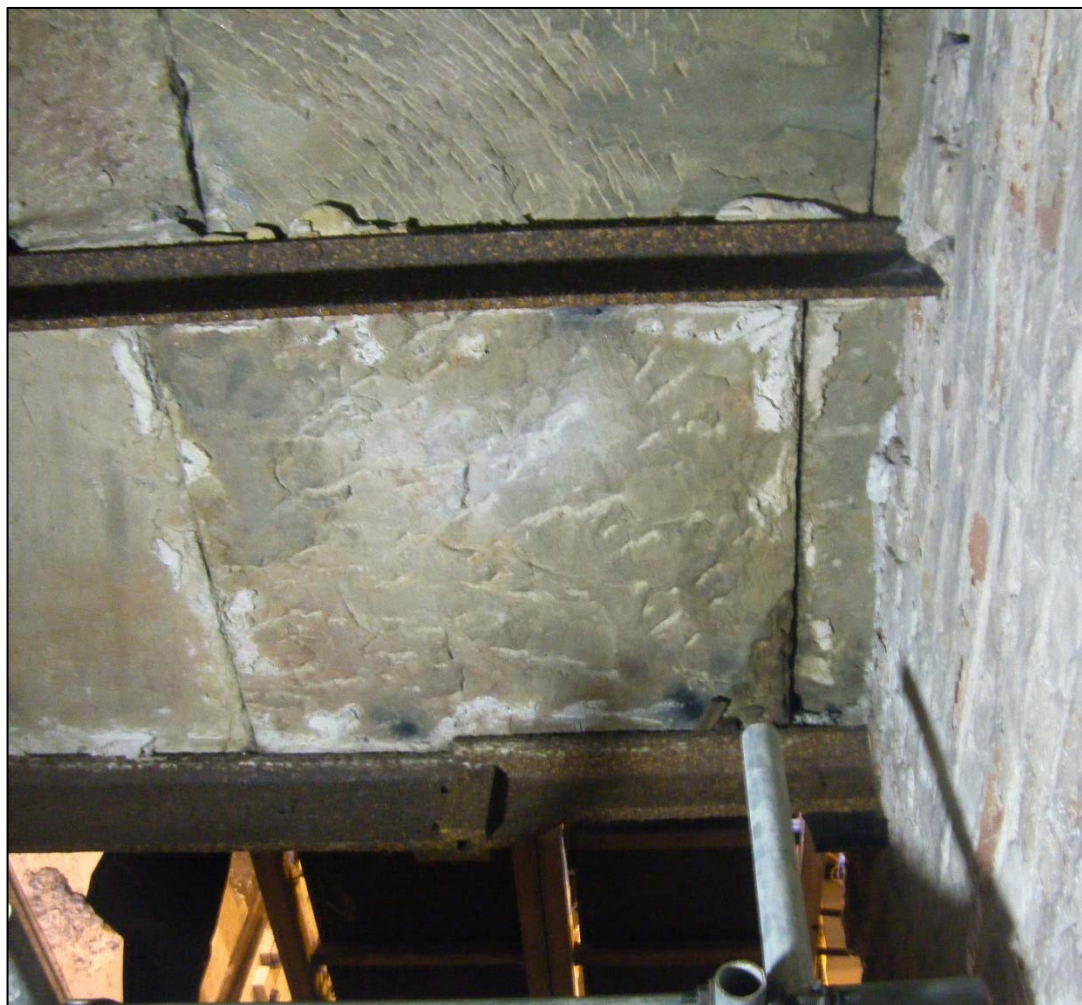
Plate 3: underside of the original sandstone floor surface (110) of the west engine house.

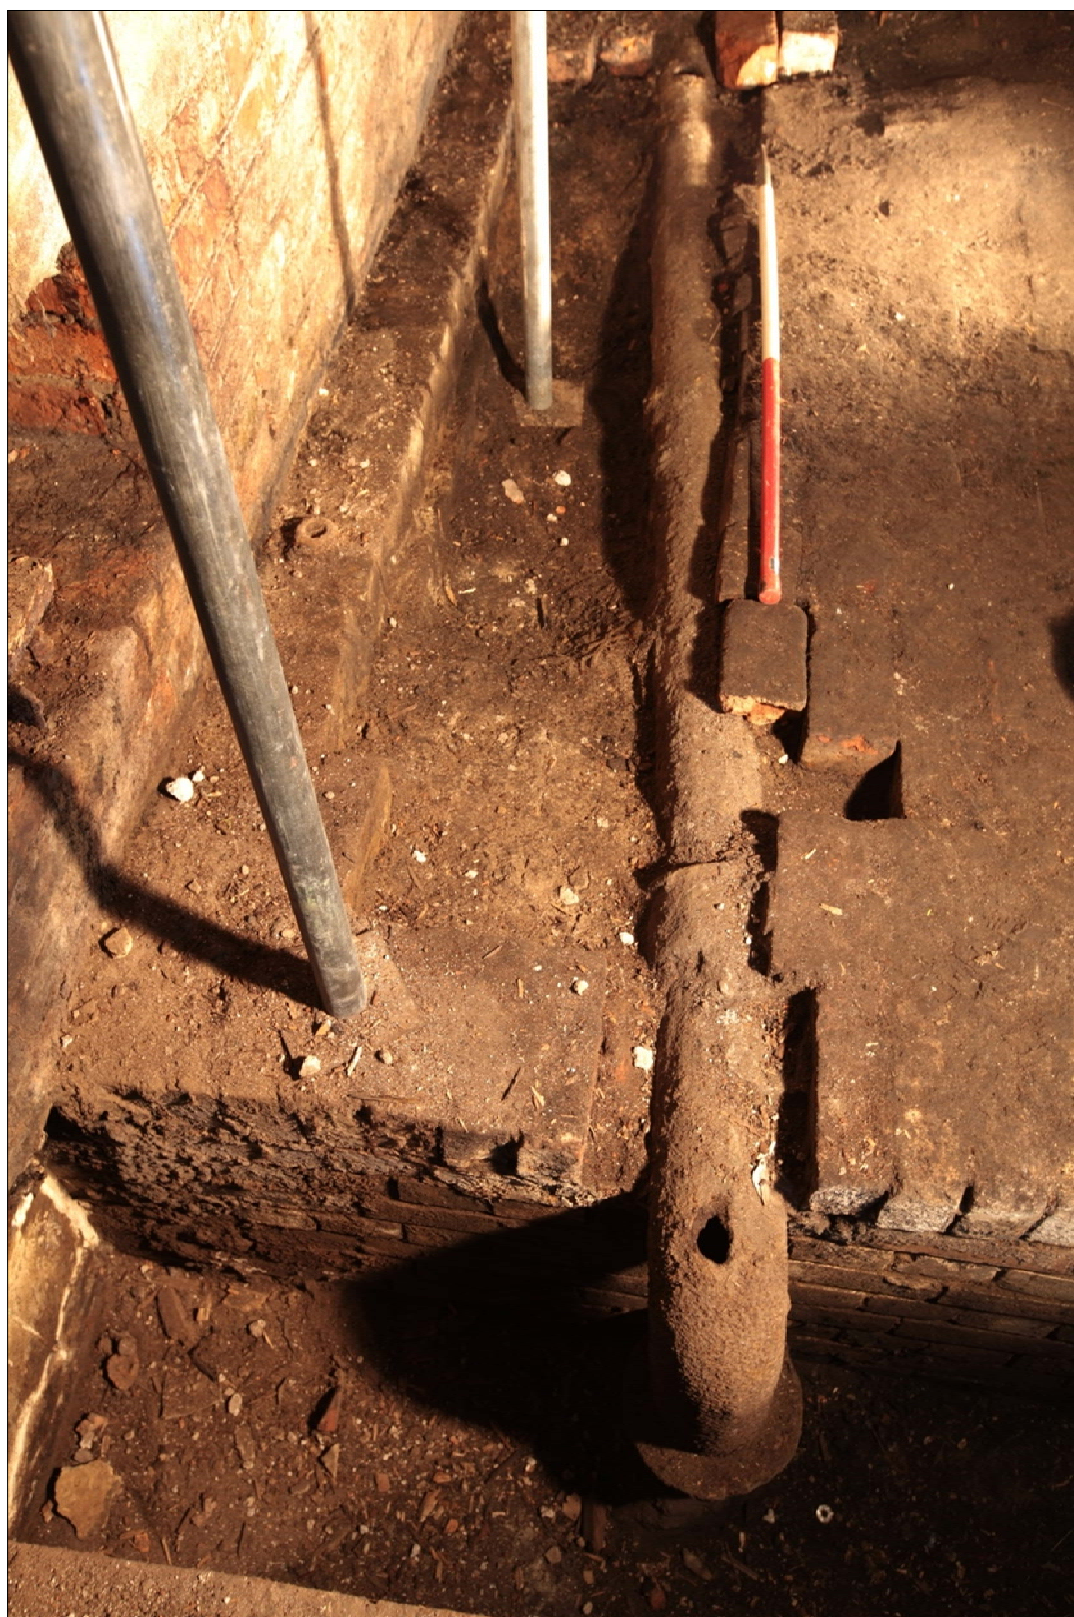
Plate 4: iron pipe 51 running north-west to south-east through brick floor surface 52.

still in situ (51) running through a channel in brick floor (52) is of a smaller diameter (0.2m) and follows a slight north-west to south-east alignment before descending below the floor of sub-basement 60. This smaller pipe, and the channel excavated through brick floor 52, appears to be a later addition to the pumping chamber and perhaps relate to the period where the Gilkes, Wilson & Co engine served as a secondary engine to supplement the larger Edwardian engine after its completion in 1907.

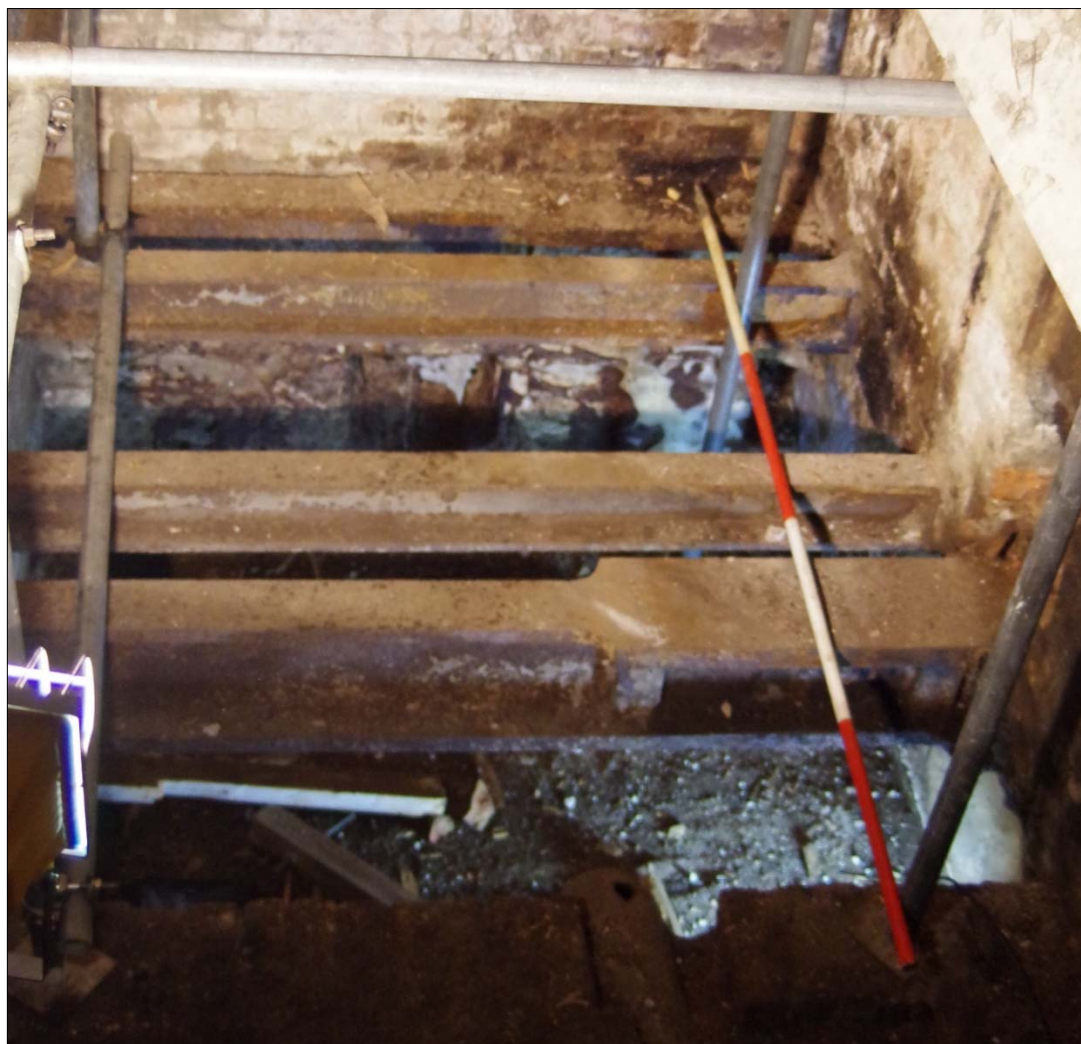
Plate 5: iron girders 53 over sub-basement level 60.

the two larger girders and measured 0.1m in width. They were separated from each other by 1.50m (Plate 5).

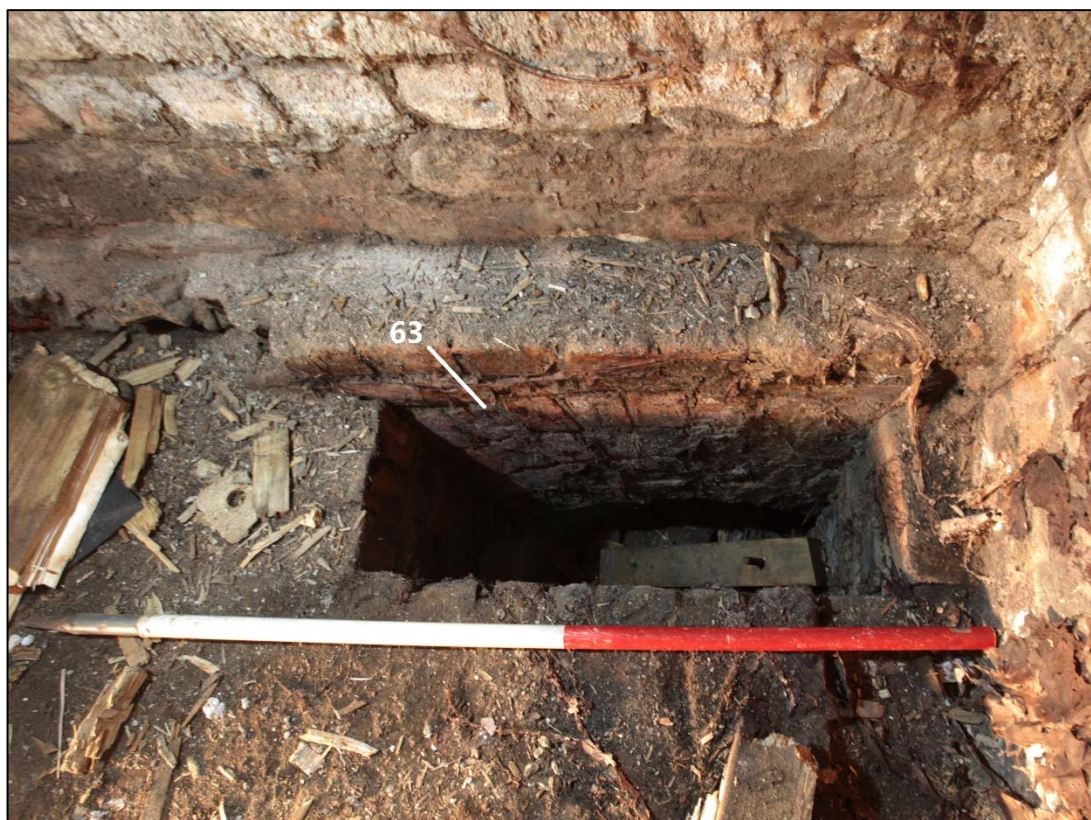
Plate 6: opening 62 in sub-basement floor showing brick arch 63 in the east wall.

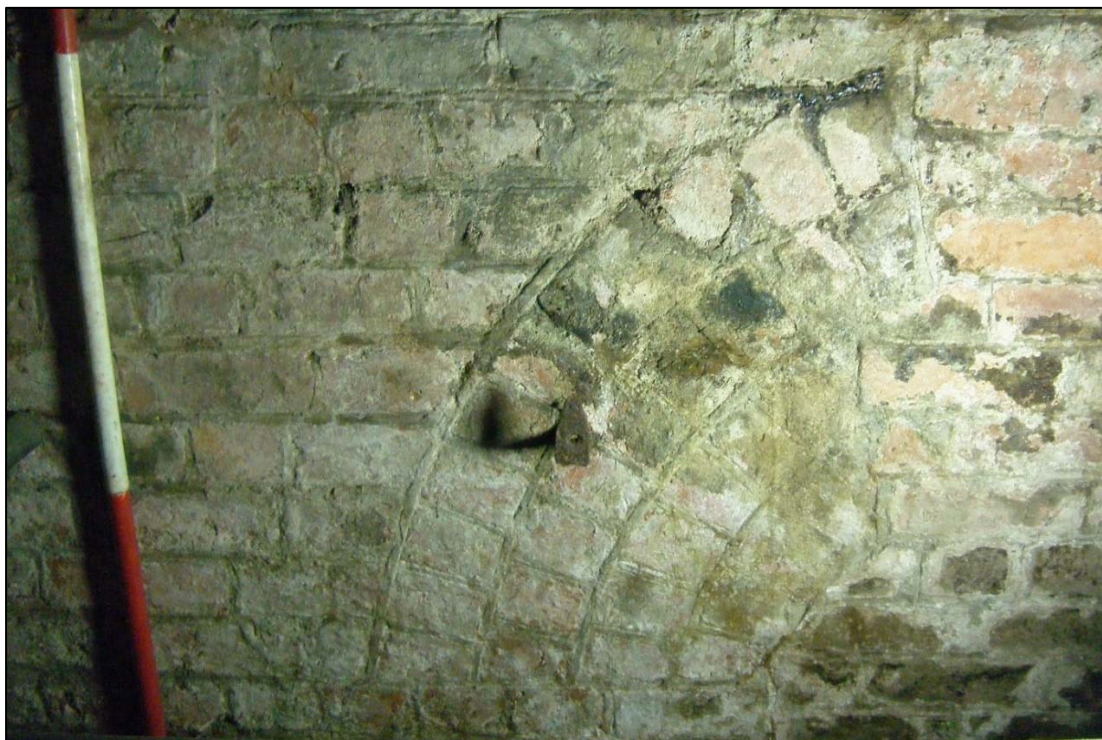
Plate 7: remains of bricked up arch 21 in the south wall of the pumping chamber.

- 6.16 Set centrally in wall 20 were the partial remains of a second, larger round arch (21). This had been bricked up with only the eastern portion remaining exposed (Plate 7). An iron hook within the brickwork appeared to be a later addition. The form of the archway in its entirety could be seen in elevation 70, where it had been left open. This was recorded as feature 71. The arch itself comprised four courses of red brick, laid header, with an overall span of 1.8m, the aperture within measuring 0.8m in width and 1.35m in height. At the base of the arch was a protruding brick ledge, 0.1m in width, that ran across the entirety of elevation 70. The base of archway 71 sat on top of a large sandstone block, 0.3m in thickness, extending to the east end of wall 70 (Plate 8).

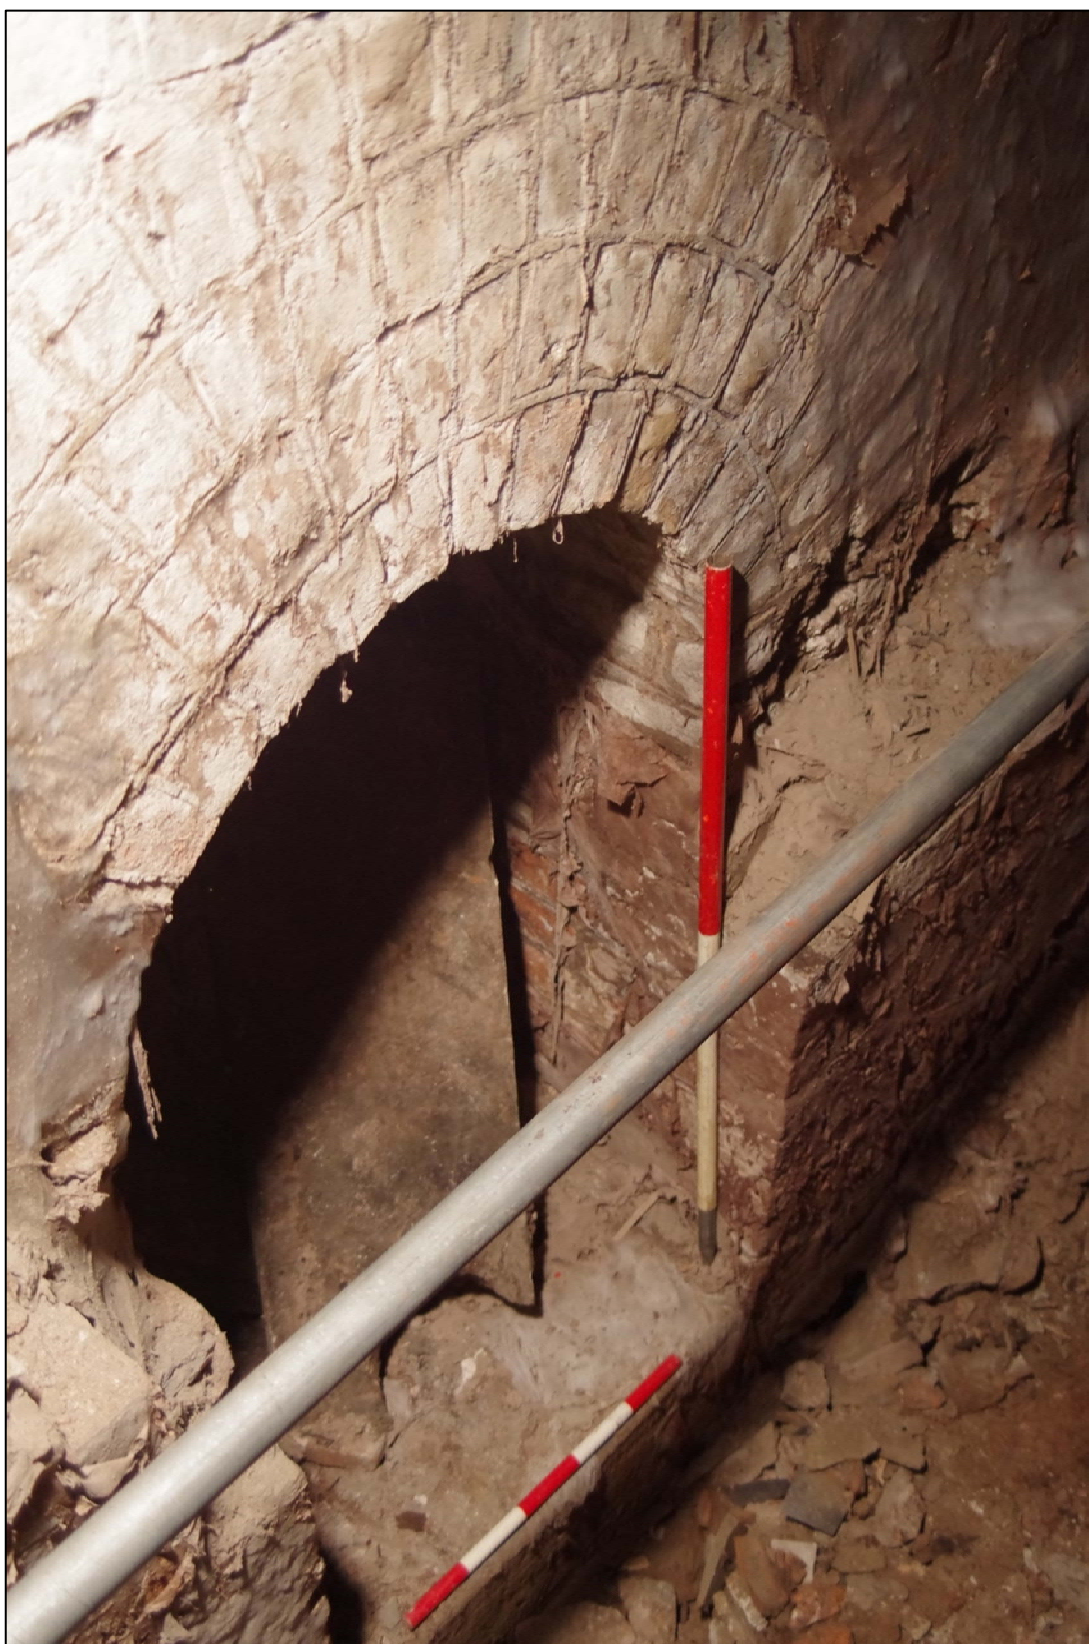
Plate 8: archway 71 in north wall of the southern room, southern egress of arch 21.

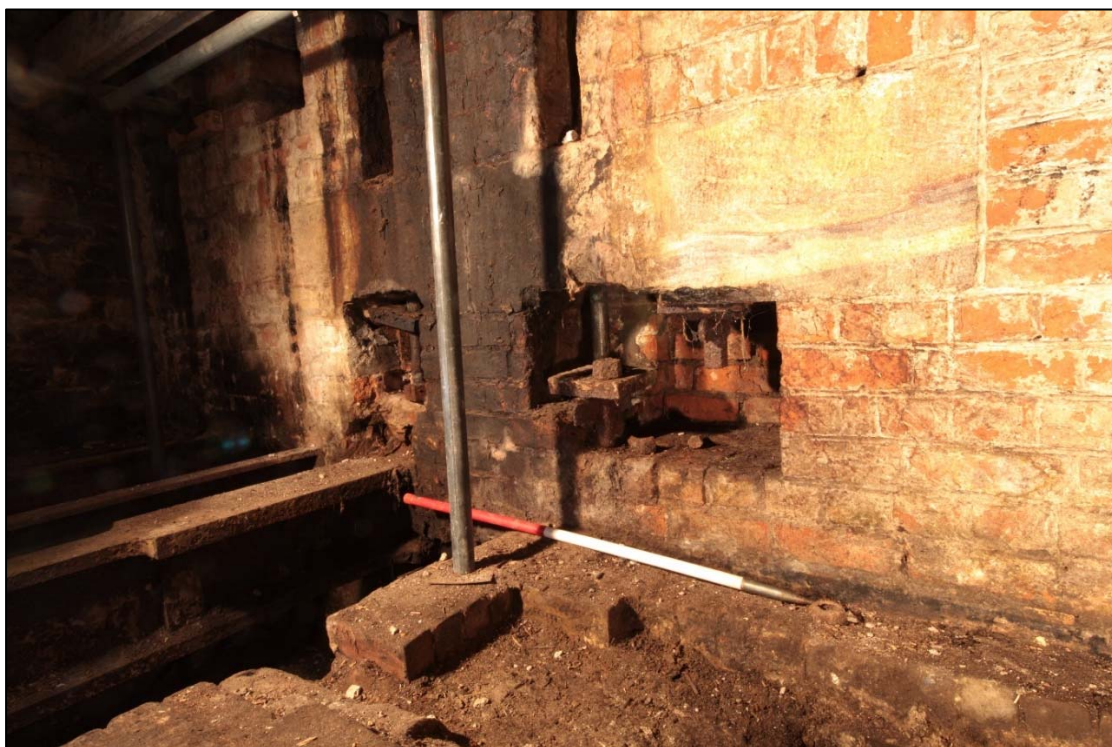
Plate 9: anchoring mechanism 31 within west wall (30) of the pumping chamber, facing south-west.

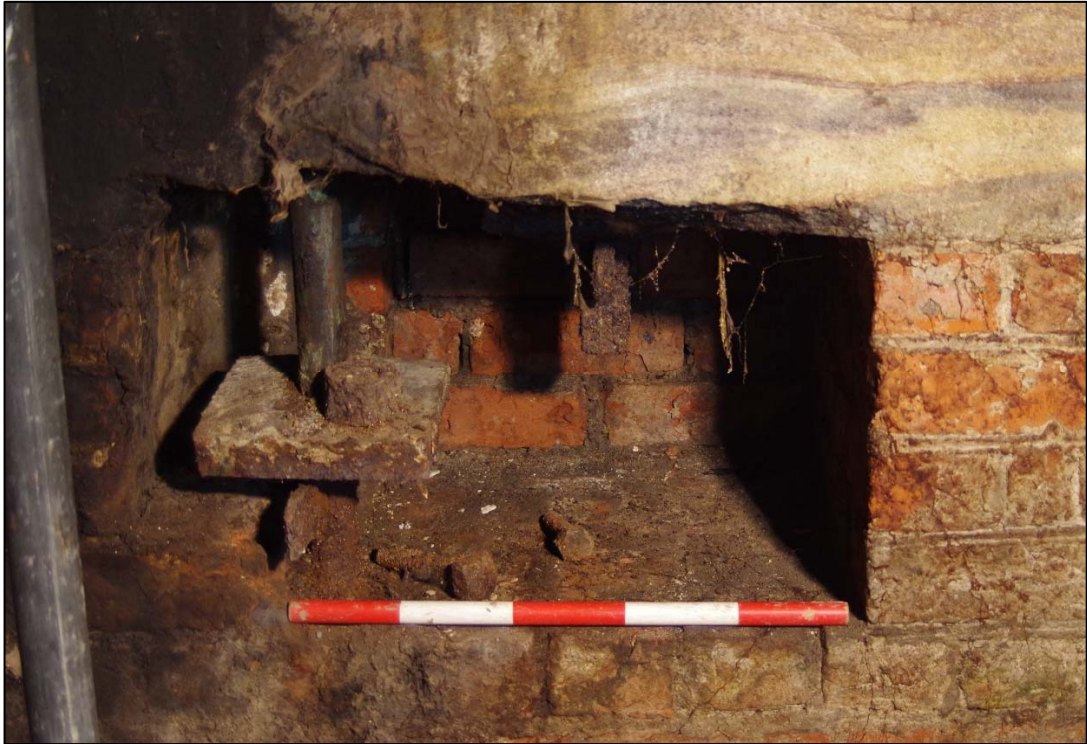
Plate 10: detail of anchoring mechanism 31, niche 36, showing crank handle beneath the square anchor plate.

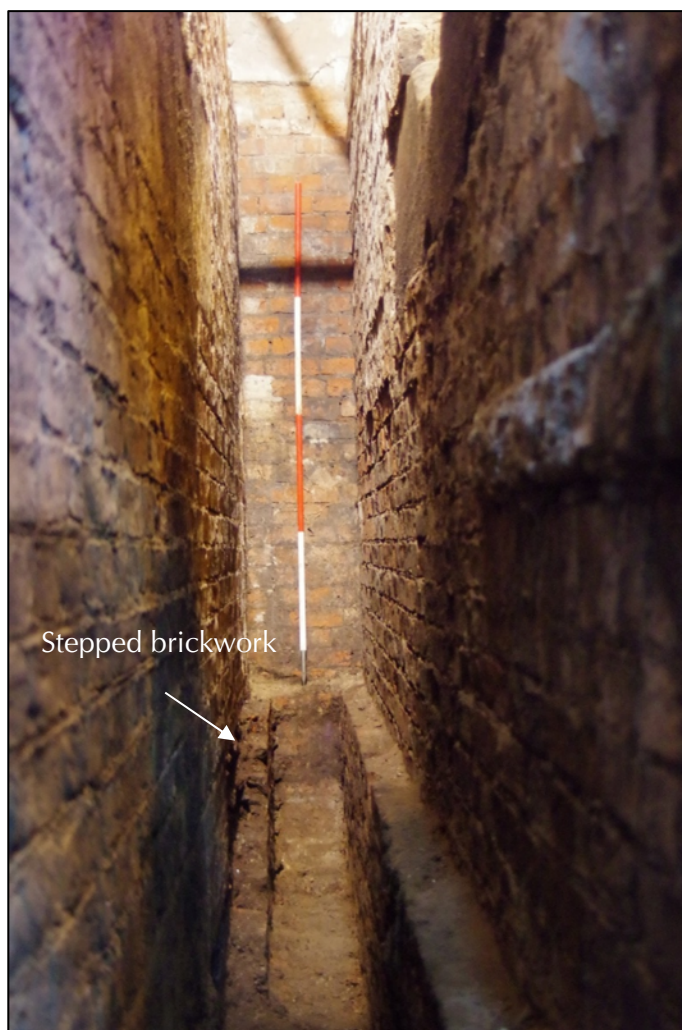
Plate 11: interior of flywheel pit 100, looking north, showing internal brick ledge and stepping within the east-facing elevation to accommodate the profile of the flywheel.

- 6.23 The flywheel pit (100) was located on the west side of the engine house. It stretched along the west wall for 5.6m from the north-west corner of the building and measured 0.5m in width and extended down 3.6m from the level of the ground floor. At the base, the brickwork stepped inwards at the east and west ends to a width of 0.3m. The ledge along the west wall was stepped at its centre to accommodate the circular profile of the bottom of the flywheel (Plate 11).

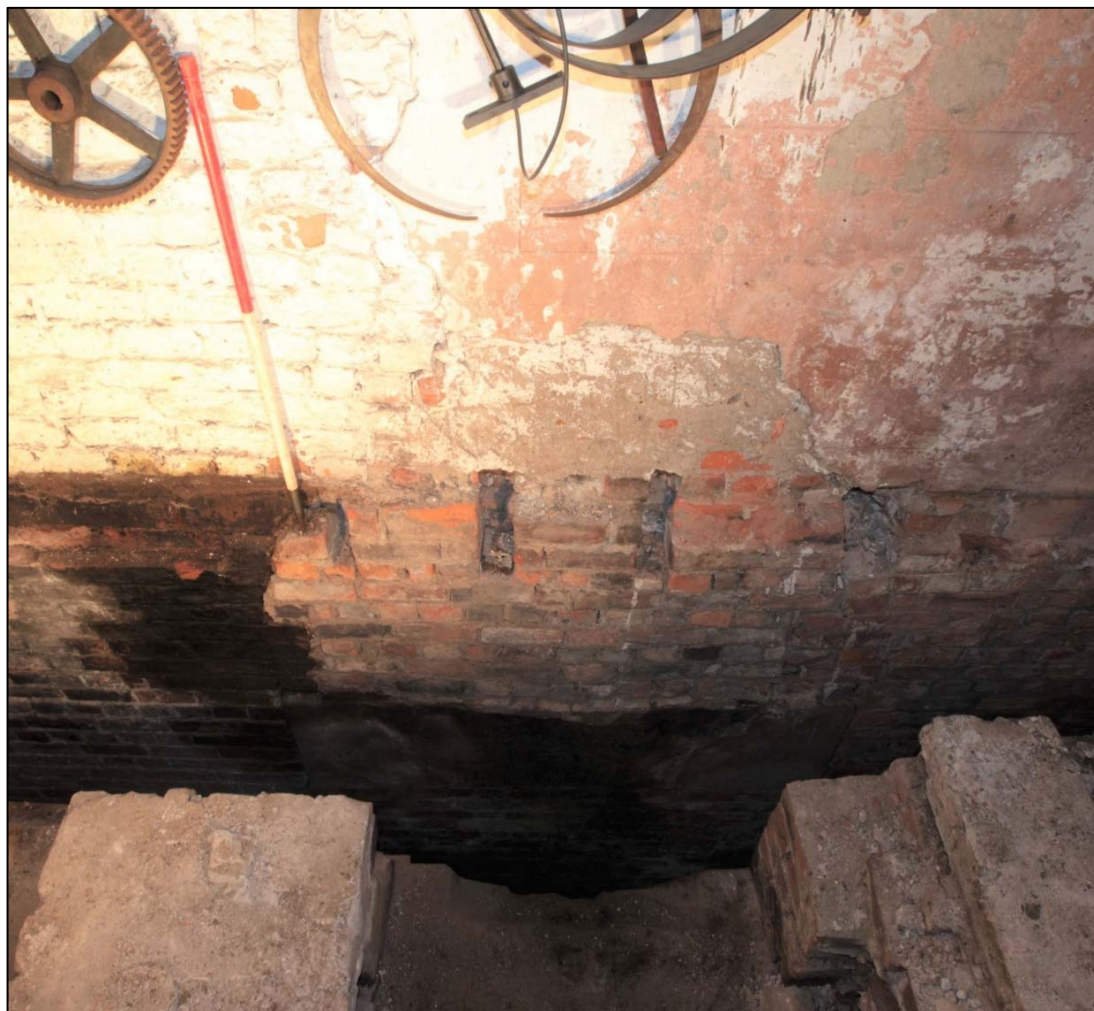
Plate 12: sandstone lintel and bricked up aperture 101 marking the original location of the western flywheel bearing. Iron mount for the eastern bearing (32) is situated in the niche in the foreground.

- 6.24 In the centre of the west wall was a sandstone lintel (2m by 0.38m) and bricked up aperture (101). This was the second anchor point for the flywheel shaft, mirroring the location of iron anchor plate (32), located in the niche on top of the west wall of the pumping chamber (Plate 12).

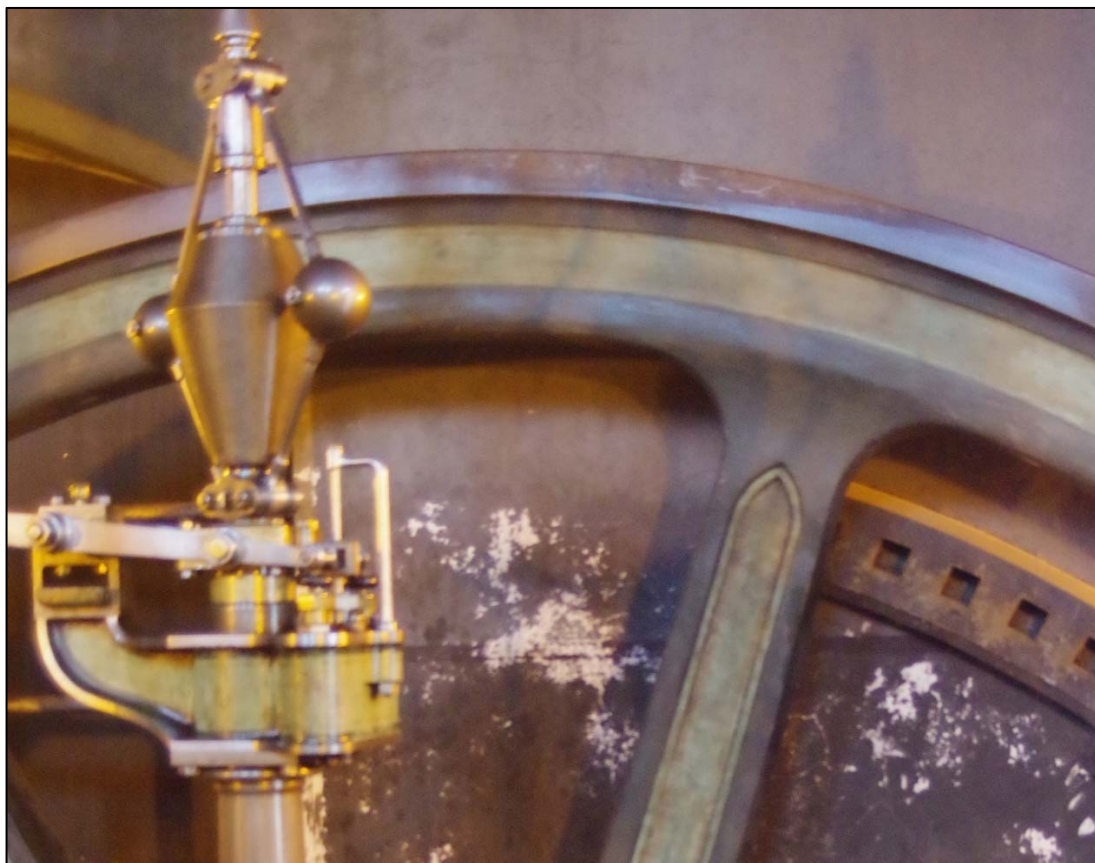
Plate 13: wall fixture relating to manual cranking of the flywheel in the Edwardian beam hall. Centrifugal governor visible on the left side of the photograph.

- 6.17 The west wall of the pumping chamber (30, Fig. 10) measured 4.7m in width and 3.45m in height and contained four anchoring points (31) to secure the flywheel and crankshaft mechanism and probably a centrifugal governor (Plate 13), as seen in the Edwardian beam hall.

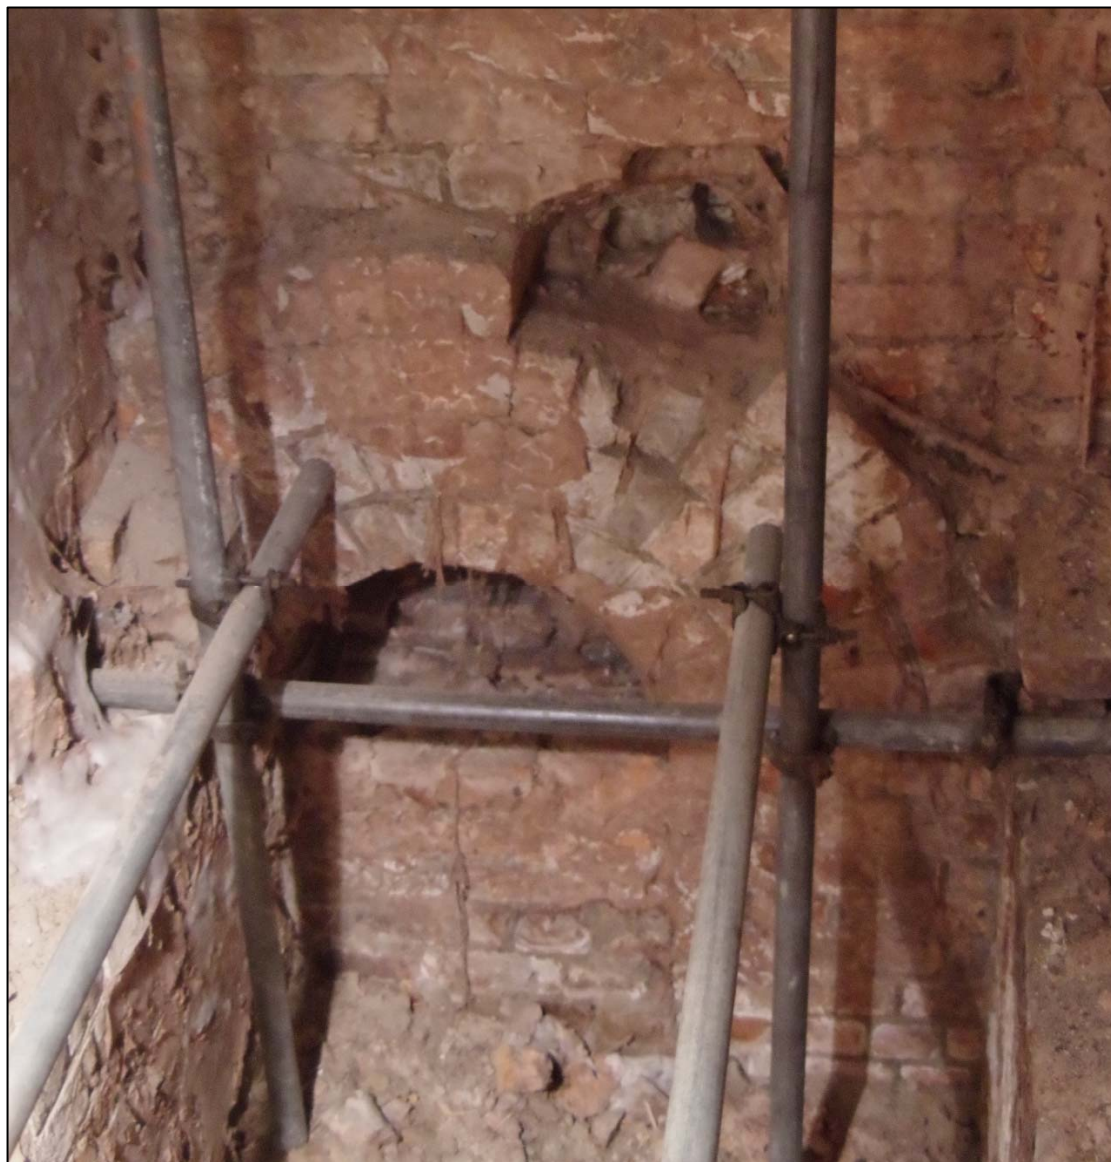
Plate 15: archway 81 in the east wall (80) (west-facing elevation) of the southern room.

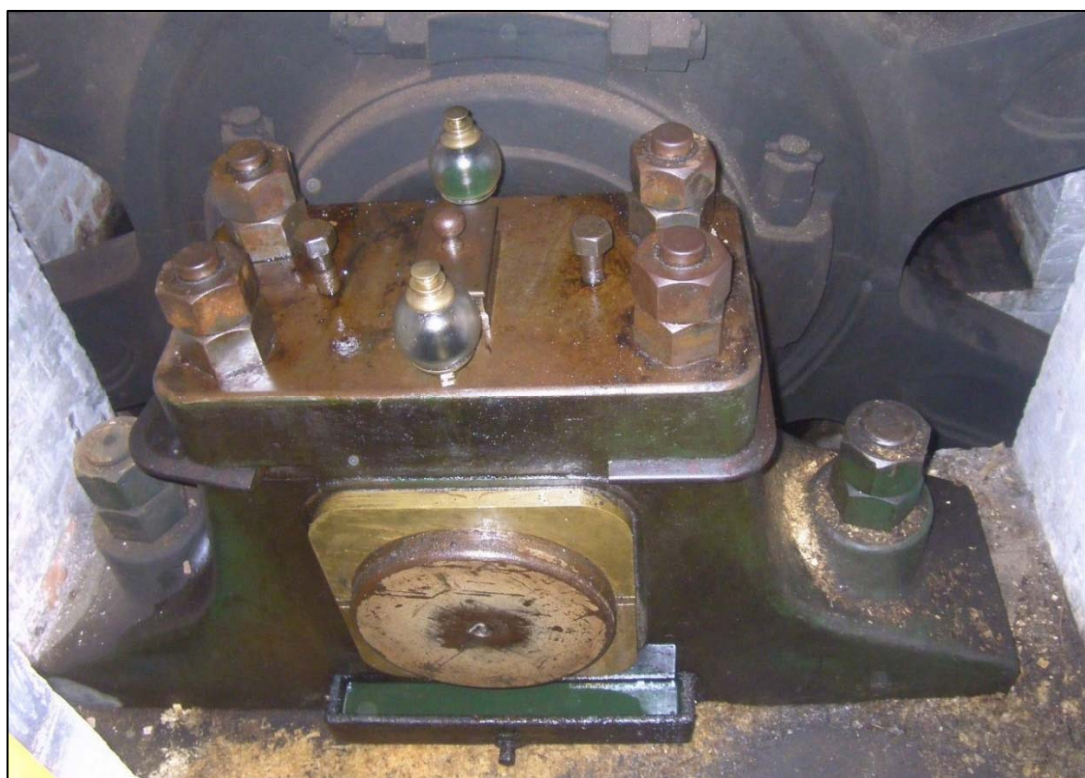
Plate 16: in situ bearing securing the flywheel within the western wall of the flywheel pit in the Edwardian beam hall.

- that is used to secure the machinery to the support structure is also identical to that observed in the west engine house, comprising steel rods, attached to iron anchor plates set within square recesses and tightened to the underside of sandstone lintels using a handle, secured with a large nut.

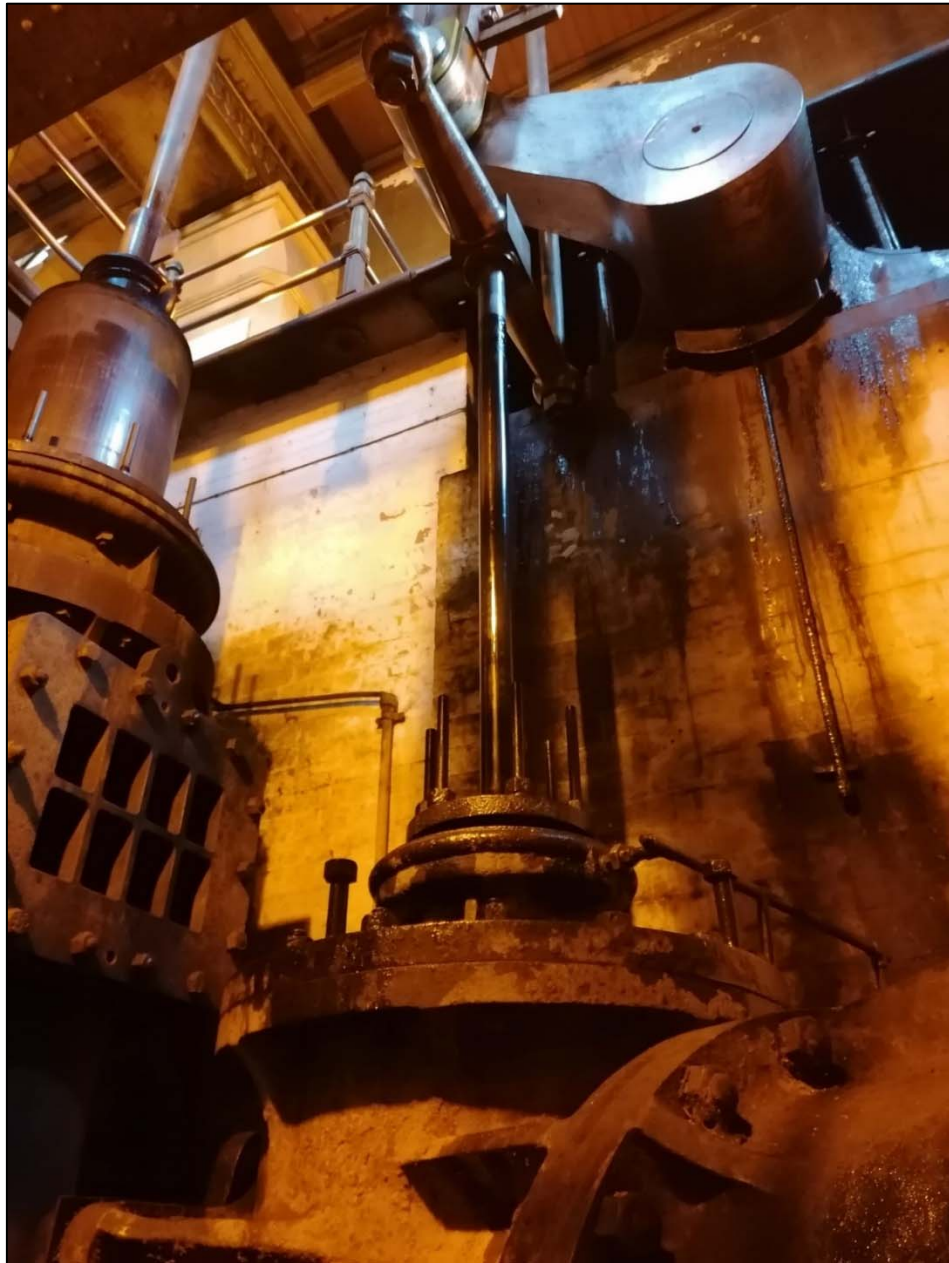
Plate 17: crankshaft (above) and 'town' (left) and 'river' (right) water pumps for the operational Edwardian beam engine

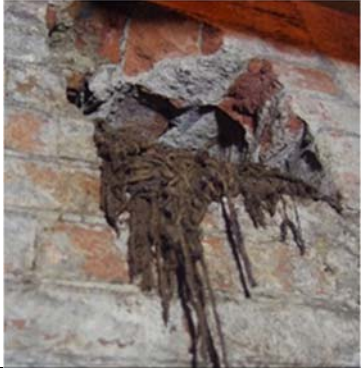
Context Number	Description	Components	Measurements	Notes
10	East wall of the pumping chamber	Red brick (0.23m x 0.13m x 0.08m). English bond. Features 11, 12, 13	4.7m x 3.45m	
11	Roughly square recess in upper portion of east wall 10, containing hemp 'matting' material

0.36m x 0.36m	Likely a later addition, after the decommissioning and removal of the original pumping machinery.
12	Aperture in east wall 10, possibly to accommodate earlier scaffolding

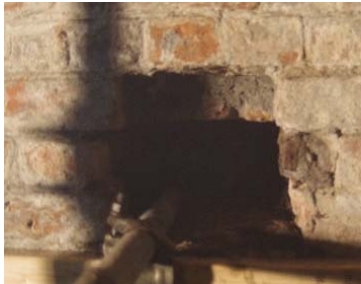
0.3m x 0.3m x 0.37m depth	Bricks possibly removed to accommodate scaffolding.

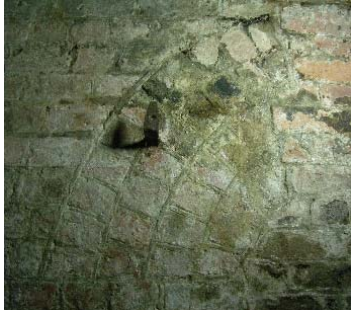
East section of bricked up archway	Four courses of red brick, laid header	0.52m x 0.72m	Seen complete as archway 71 within wall elevation 70.

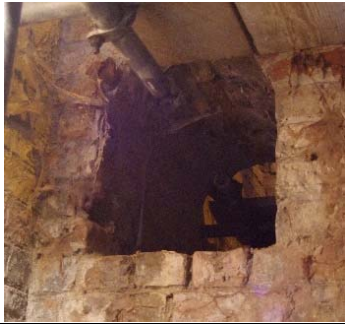
Brick archway in the upper east corner of wall 20		Aperture = 0.41m width x 0.64m height	Continues through to wall 70 as archway 72 . Likely housed pipework relating to the water pumping machinery.
23

- 6.15 A round arch (22), measuring 0.54m in height and 0.41m in width, was recorded located 0.13m from the eastern limit of wall 20. This was situated 2.1m above the height of the iron girders (52) and continued through to elevation 70. At the western limit, 2.04m from the level of the iron girders, was an iron fitting (23) secured by two large bolts, which continued through to elevation 70. This was set within a recess in the brickwork, which was partially obscured by extensive dry rot. As such, the complete form of feature 23 could not be seen.

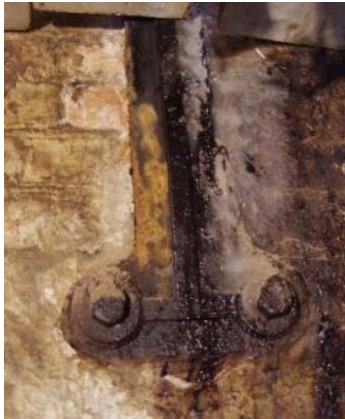
Iron fitting at the upper western corner of wall 20	Two large iron bolts at the base, securing T-shaped fitting to the brickwork	0.5m width at base, 0.15m width at top, 0.6m in length.	Recorded on the south-facing elevation 70 of southern room as feature 72 .

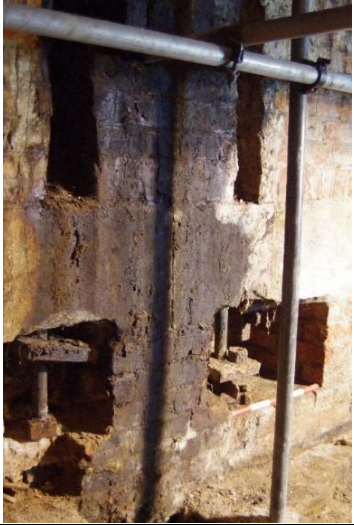
Anchoring mechanism and sandstone lintels within wall 30 , related to the flywheel	<p>35 Two sandstone blocks</p> <p>33 Two steel rods</p> <p>34 Recesses to allow for the tightening of the steel rods</p> <p>Three square/rectangular niches for anchor plates</p>	<p>1.15m x 0.4m</p> <p>0.05m diameter</p> <p>0.1m diameter</p> <p>36 0.63m x 0.4m 37 0.54m x 0.4m 38 0.3m x 0.3m</p>	<p>Two steel rods anchored within sandstone blocks and vertical recesses in the brickwork. These protrude through iron plate 32 on top of wall 30. Mechanism of square iron plates and handle at the base of the rods for tightening and anchoring components of the flywheel.</p> <p>Three recesses in total containing four separate anchors.</p>

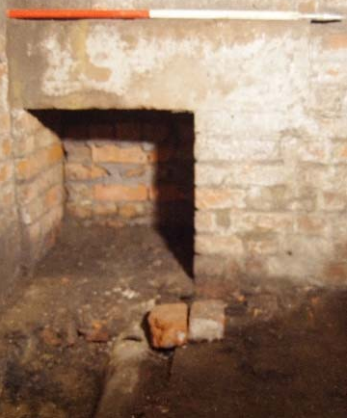
<p>Sandstone lintel-capped square opening in the lower left-hand corner of wall 40</p>	<p>Sandstone lintel</p> <p>Brick alcove</p>	<p>1.04m x 0.3m</p> <p>0.63m x 0.60m x 0.46m depth</p>	Square opening that would have originally held a 12-inch pipe, as shown on the original 1849 plans. Pipe 51 and flooring 52 , along with rear brickwork within the archway are later additions.
42

- 6.21 The north wall (40, Fig.11) measured 1.85m by 3.45m in height. The brick ledge noted in relation to the east wall (10) continued on this side at a height of 0.9m above brick floor 52. The main feature of the north wall was a square opening (41) in the brickwork on the west side. This measured 0.60m by 0.63m in height and 0.46m in depth and was capped with a sandstone lintel measuring 1.04m by 0.3m. The archway aligned with the northern visible extent of iron pipe and channel 51, which continued under the brick flooring at the base of 41.

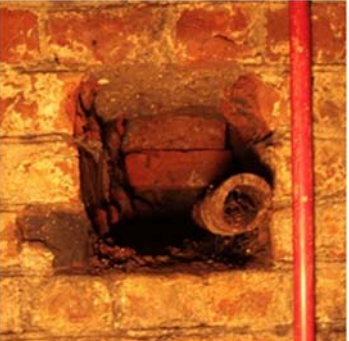
<p>Recess at the east end of wall 40, containing 80mm diameter iron pipe</p>	<p>Recess</p> <p>Iron pipe</p>	<p>0.26m x 0.26m</p> <p>0.08m diameter</p>	Crude execution of the recess indicates that this was not an original feature of the west engine house and has been inserted after the initial construction of the pumping chamber. Possibly relates to the later usage of the original engine as a reserve after the implementation of the larger Edwardian engine in the beam hall.

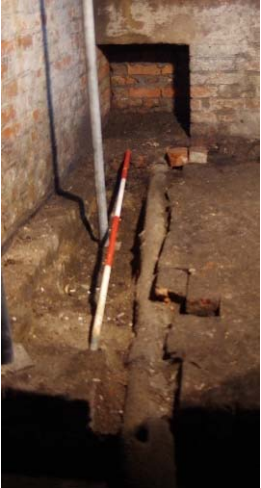
Iron pipe set within channel in brick floor 52	Iron pipe Channel	0.2m diameter x >3m length 0.5m diameter x 2.7m length x 0.2m depth	Iron pipe and brick channel appear to have once been underneath floor 52. Both the pipe and channel and brick floor are later additions to the engine room, presumably after the original 12-inch diameter iron pipe, seen on the original 1849 plans, was removed.
52 (For photo, see 51)	Brick floor covering northern half of the pumping chamber floor	Red brick (0.23m x 0.13m x 0.08m), laid flat in irregular courses. 2 rowlock courses along the southern and western edge, laid on edge, stretcher	1.85m x 2.7m	A single course of bricks, laid flat across the northern extent of engine room floor 50, presumably on top of an original floor surface.

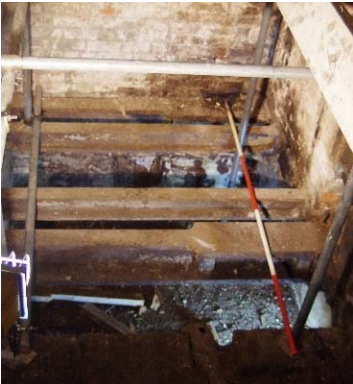
Four iron girders ent to clientforming the southern half of the pumping chamber floor level. These are supported on large sandstone blocks	H-profile iron girders Outer girders Inner girders Sandstone blocks	2m x 1.85m 0.13m – 0.24m width x 0.35m thickness 0.1m width x 0.35m thickness 0.3 – 0.5m x >1m length	The girders presumably supported the pump machinery and allowed access for the associated pipework into the sub-basement.

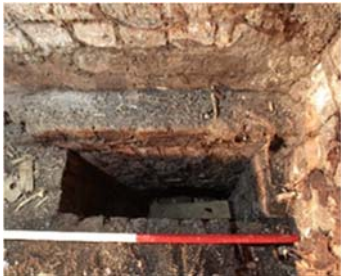
Rectangular opening in south-east corner of brick sub-basement floor	Red brick (0.23m x 0.13m x 0.08m) Brick arch 63	0.25m x 0.7m x 0.66m depth	Rectangular hole in the sub-basement floor containing brick arch 63. Perhaps an egress for waste water.
62

- 6.10 The sub-basement chamber (60) consisted of four brick walls, set in English bond, and a brick-paved floor in the manner of 52. The floor was set 0.77m below 52. A rectangular opening (61) was located in the south-east corner of the sub-basement chamber floor and measured 0.25m by 0.7m and 0.66m in depth. The east wall featured a squat brick archway (63, Plate 6) which would have originally exited through the east wall of the west engine house. A square opening (62) was also recorded in the south wall containing the base of a steel rod and square iron anchor plate.

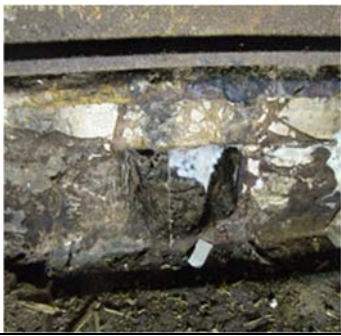
Square recess in southern wall of sub-basement containing anchoring mechanism	Recess Iron mechanism consisting of a steel rod, square plate and securing nut	0.4m x 0.3m	Anchoring mechanism related to the tip of a steel rod protruding from the top of wall 20.
63 (For photo see 61)	Brick archway in the east wall of 61	Four courses of brick laid header, on end.	0.25m x 0.75m x 0.66m height	See 61.

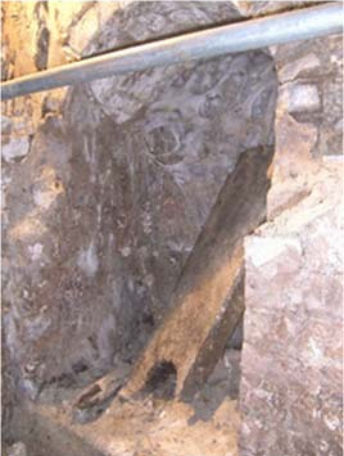
Brick archway visible in elevation 70 . Constructed on top of a large sandstone block	Red brick archway, 4 courses, bricks laid header, on end. Sandstone block	1.8m width x 1.83m height. Aperture 0.8m width x 1.35m height 0.3m thickness >1.5m length	Southern egress of bricked up arch 21 in the south wall (20) of the pumping chamber. Outlet for 12-inch iron pipe shown on the 1849 plan.
72
