ARCHAEOLOGICAL
MONITORING AND BUILDING
RECORDING REPORT

TEES COTTAGE PUMPING
STATION, DARLINGTON,
COUNTY DURHAM

NAA 20/04
January 2020

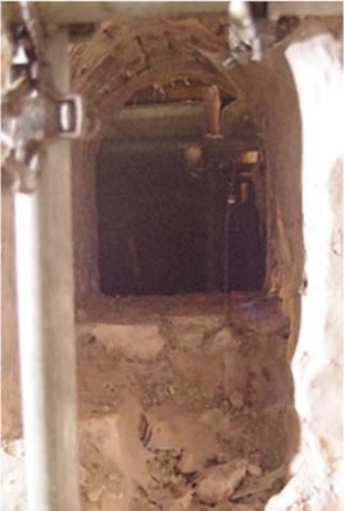
Southern egress of brick archway 22 within wall 20/70	Red brick, apex of archway comprises single course of brick laid header, on end	0.64m x 0.41m	See 22 .

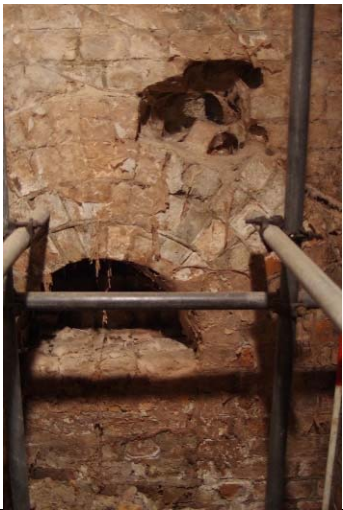
Squat brick archway in wall 80	Red brick archway, 4 courses, bricks laid header, on end.	1.2m width x 0.85m height. Aperture 0.6m width x 0.36m height	Squat brick archway, shown on original 1849 plans as western egress for 12-inch iron pipe after it exited the pumping chamber via archway 71 .
82	Sandstone lintel towards the top of wall 80	Sandstone lintel	1.2m x 0.3m	Sandstone lintel towards the top of wall elevation 80 , function unknown. Surmounted by three courses of red brick, English bond and three rough courses of bricks relating to the later floor of the lathe workshop.

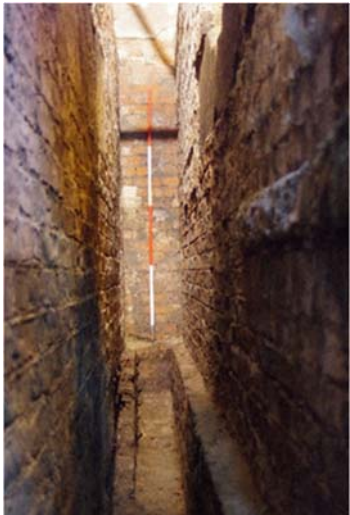
Flywheel pit	Red brick (0.23m x 0.13m x 0.08m). English bond. Features 101, 102, 103	5.6m x 0.5m width x 3.6m depth	The profile of the flywheel pit steps inwards from both the west and east elevations to a width of 0.3m, approximately 0.4m above the base. The western ledge has in turn been stepped to accommodate the circular profile of the flywheel.

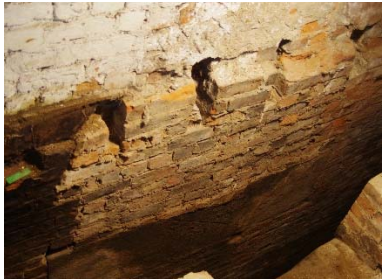
Bricked-up aperture and sandstone lintel	Ten courses of re-used brick, roughly laid in English bond. Sandstone lintel	1.8m width 1.1m height at apex 2m x 0.38m	The original location for the western flywheel bearing which would have sat atop the sandstone lintel. Presumably the metal fittings were removed when the original beam engine was decommissioned and the niche bricked up.
102 See Figure 10	Semi-circular wall scar	Scarring on the upper brickwork above the flywheel pit	4.2m diameter	Scarring likely related to fixtures to facilitate manual cranking of the flywheel using a lever. As seen fixed to the wall behind the flywheel in the neighbouring Edwardian beam hall.
103

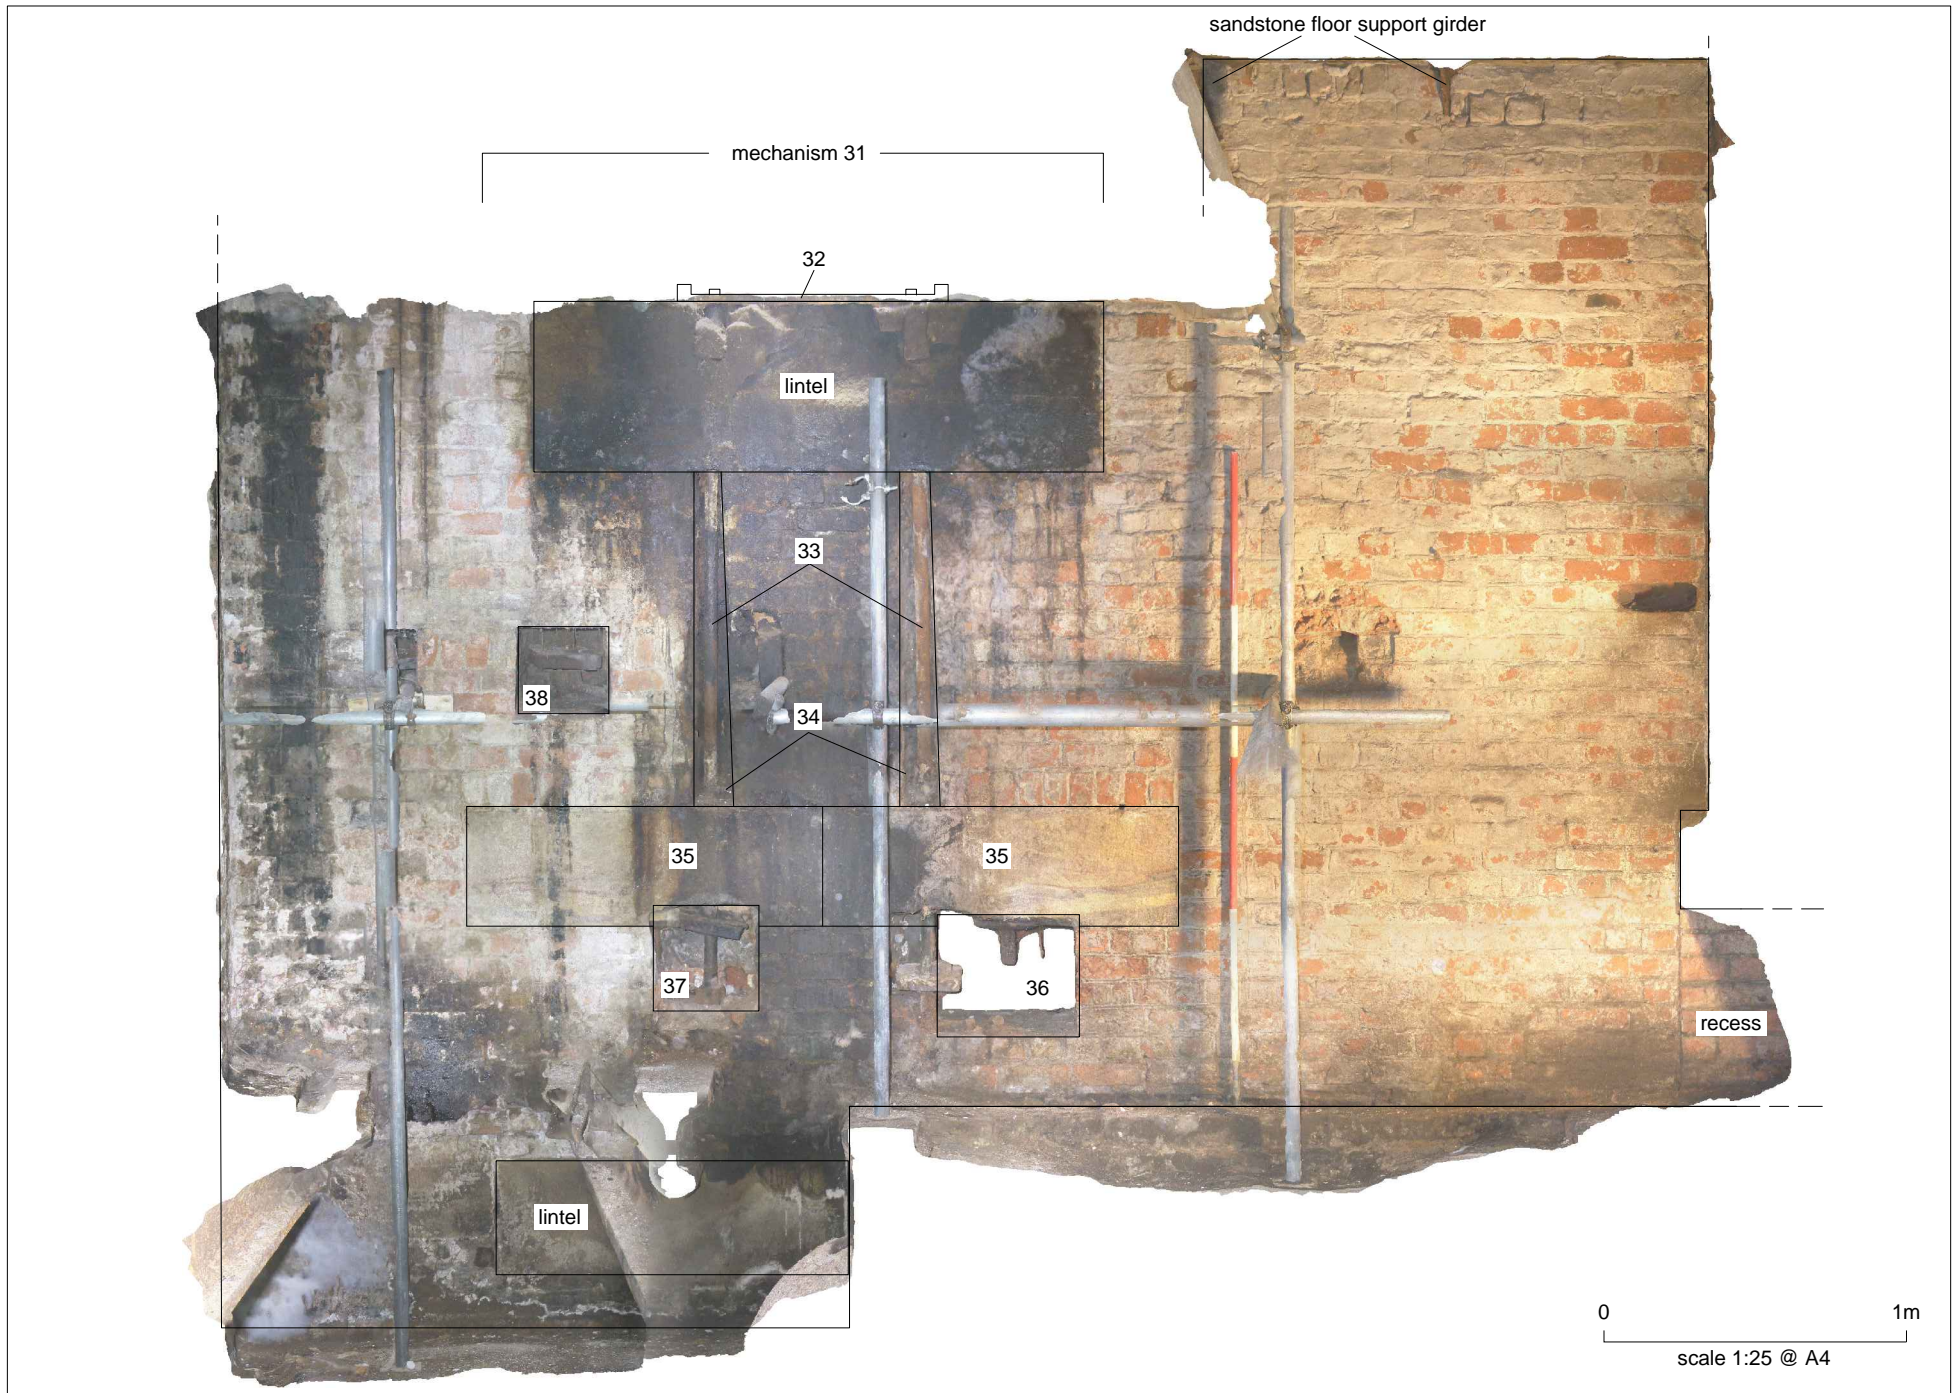
Tees Cottage Pumping Station: pumping chamber west wall (30) showing feature (31)

- 6.17 The west wall of the pumping chamber (30, Fig. 10) measured 4.7m in width and 3.45m in height and contained four anchoring points (31) to secure the flywheel and crankshaft mechanism and probably a centrifugal governor (Plate 13), as seen in the Edwardian beam hall.
