# ARCHAEOLOGICAL MONITORING OF GROUND INVESTIGATION WORKS

# HEMLINGTON GRANGE SOUTH, MIDDLESBROUGH

QUALITY ASSURANCE			
Project Number	2055		
Report Number	20-108		
Manager	Alice James		
Edit	Matt Town and Helen Devonshire		
Authorised	Alice James		
Issue 1		18/01/2021

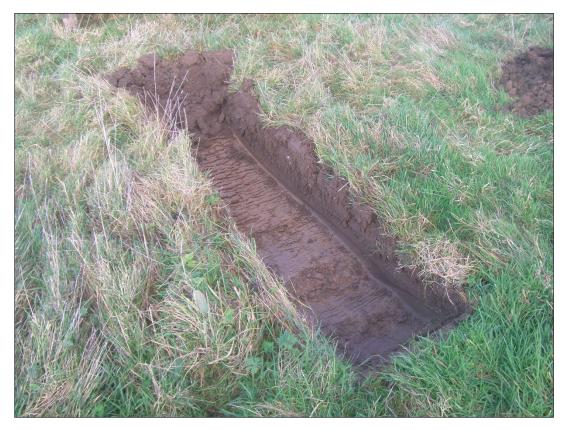
Archaeological monitoring of the GI encountered topsoil to a depth of between 0.1m and 0.2m with intermittent subsoil ranging from 0.1m to 0.2m in depth across the PDA. Below this, the natural substrate represented a glacial boulder clay ranging from a plastic weathered light yellowy orange to a much more friable dark grey red (Plate 1).

Plate 1: view of TP 10 showing natural glacial boulder clay with overlying topsoil and subsoil visible in section, facing south-east.

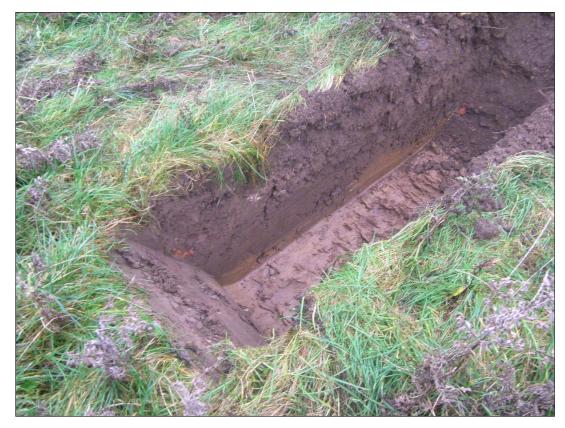
- During monitoring of the GI it was noted that a large amount of imported modern material had been deposited within Area A, comprising a mixed silty clay with ceramic building material (CBM), concrete, plastic and ferrous inclusions. This deposit was present in TP 47 to TP 60 and ranged in depth from 0.5m to 1.5m, deepening around the centre of the field (Plate 2). Anecdotally, it is understood that this deposit was imported during construction of the Larchfield Community Centre located approximately 125m south of the PDA. An examination of satellite photography (Google Earth) suggests that this part of Area A was altered sometime between 2000 and 2005. It is possible that the imported modern material deposited in this area is masking archaeological features and/or deposits associated with the Romano-British pottery sherds identified during field walking within Area A (NAA 2020a, 17).

Plate 2: view of TP 60 showing imported modern material with CBM and concrete inclusions overlying natural glacial boulder clay, facing north-west.

5.1 The lack of archaeological features or deposits encountered during monitoring of the GI works does not preclude the presence of such features or deposits in the PDA. As a result, it is recommended that further archaeological monitoring be conducted during any subsequent groundworks within the PDA.

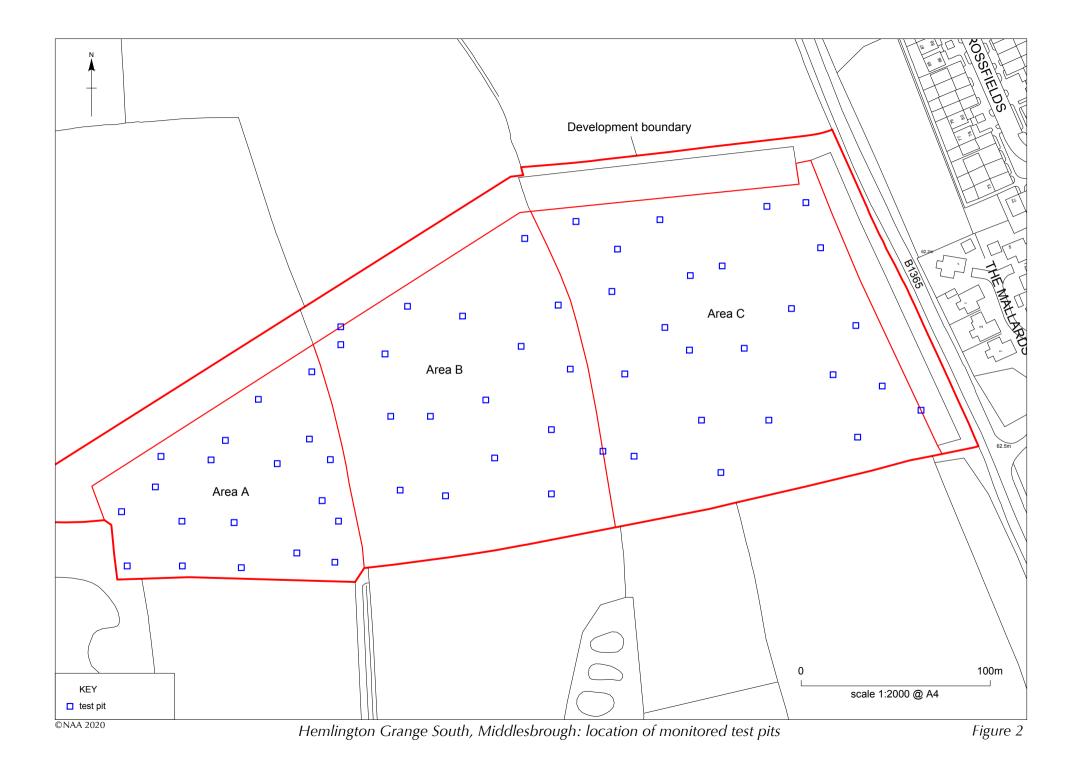
- 2.1 The PDA was divided into three Areas (A, B, and C from west to east; see Fig. 2) corresponding to the three fields that the PDA occupied. The scope of the ground investigation works (hereafter GI) comprised:
  - 30 boreholes, six of which were rotary drilled with the remainder percussion drilled. The starter pits for these were approximately 150mm in diameter and thus were too small to be appropriately monitored.
  - 28 Dynamic Cone Penetration (DCP) tests. These tests were performed from surface and could not be monitored.
  - 15 Window Samples which could be performed from surface and did not require monitoring.
  - 60 mechanically excavated trial pits (TP); 61 TPs were specified in the WSI (NAA 2020b). The TPs were excavated to a maximum depth of 3m.
- 2.2 The location of the TPs are shown in Figure 2.

- 3.2 During the magnetic gradiometer survey carried out by NAA, a former field boundary depicted on the 1857 First Edition Ordnance Survey (OS) map was identified as a linear anomaly bisecting Area C (Fig. 2) from north to south. A second, weaker linear anomaly running west from this possibly represented another boundary. All of the areas contained linear trends representing former ridge and furrow. A high level of magnetic disturbance was identified covering the majority of Area A. Another series of linear anomalies were identified extending across Area B and the western half of Area C, potentially representing infilled ditches relating to an enclosure system aligned from north-west to south-east. Although very tentative, the assessment speculated that these anomalies might have been associated with the Iron Age and Roman settlement a short distance to the south.
